St Vincent's Hospice
Shared Use Path, Howwood:
Archaeological Watching Brief
Data Structure Report

issued 4th April 2018

on behalf of St Vincent's Hospice

RATHMELL  
ARCHAEOLOGY LTD

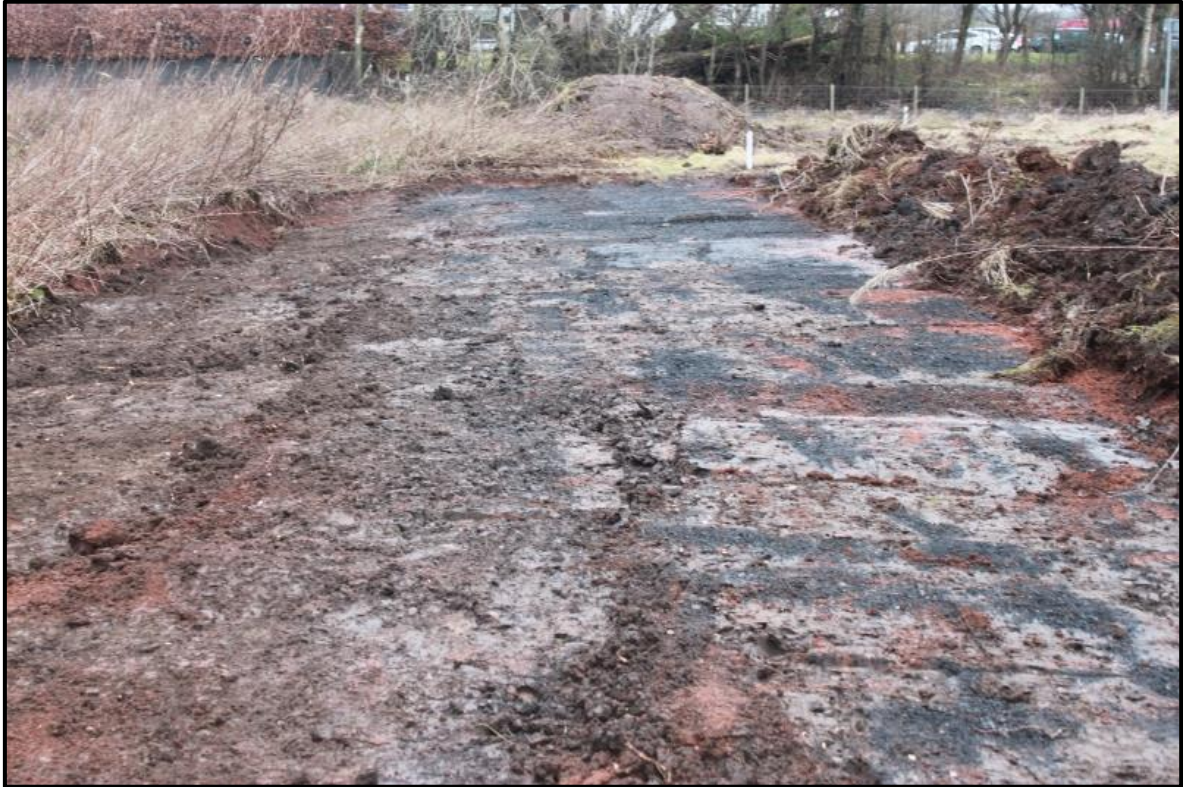
9. The topsoil identified within the footpath excavation, (001), consisted of a moderately compacted dark brown clay with frequent root and stone inclusions which had a maximum thickness of 0.13m. The topsoil was overlay a layer of made ground (002) (Figure 1a). This layer consisted of moderately compacted deposit of fine light red, silty gravel with ash like inclusions. The layer had a thickness range of between 0.1m and 0.2m (Figure 2a). The natural subsoil (003) underlay (002) and was a moderately compacted dark brown clay with occasional sub-angular small stones and manganese inclusions. The subsoil was excavated to a depth of 0.10m-0.15m.

Figure 1a: Post excavation shot of footpath showing topsoil (001) and made ground (002). Taken from the South

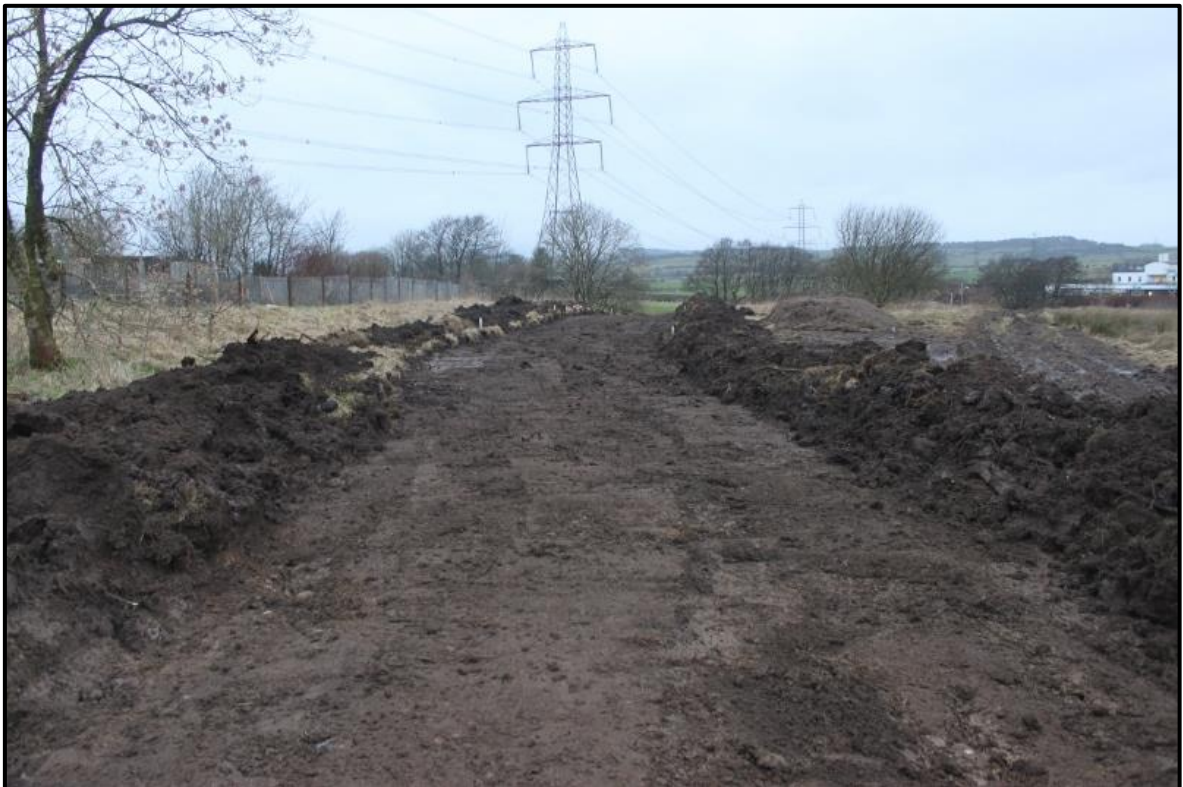
10. At the southern stretch of the footpath excavation the made ground (002) were not present (Figure 1b), due most likely to the increasing distance between the new path and the playing grounds to the northeast. The natural subsoil within this area (003) was excavated

Figure 1b: Post excavation shot of footpath showing subsoil (003). Taken from the southeast.

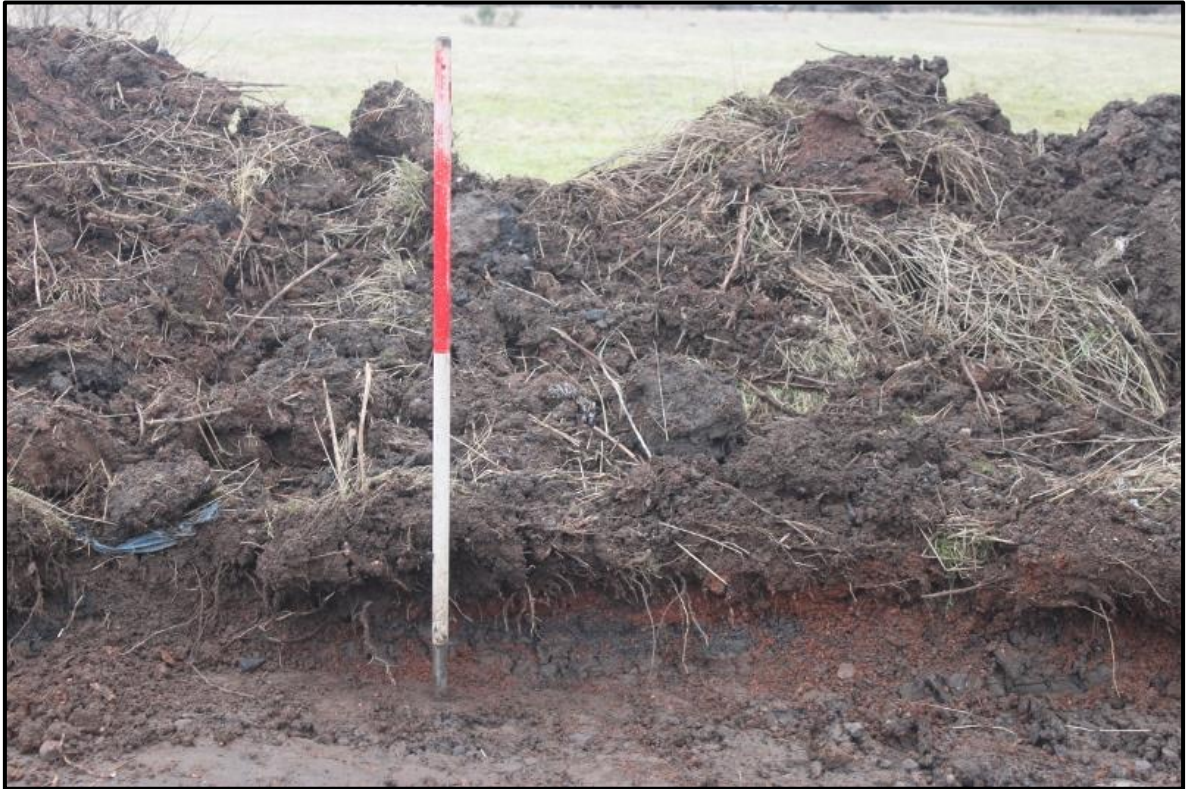
Figure 2a: Northwest facing section of footpath showing topsoil (001), made ground (002) and subsoil (003). Taken from the northwest.

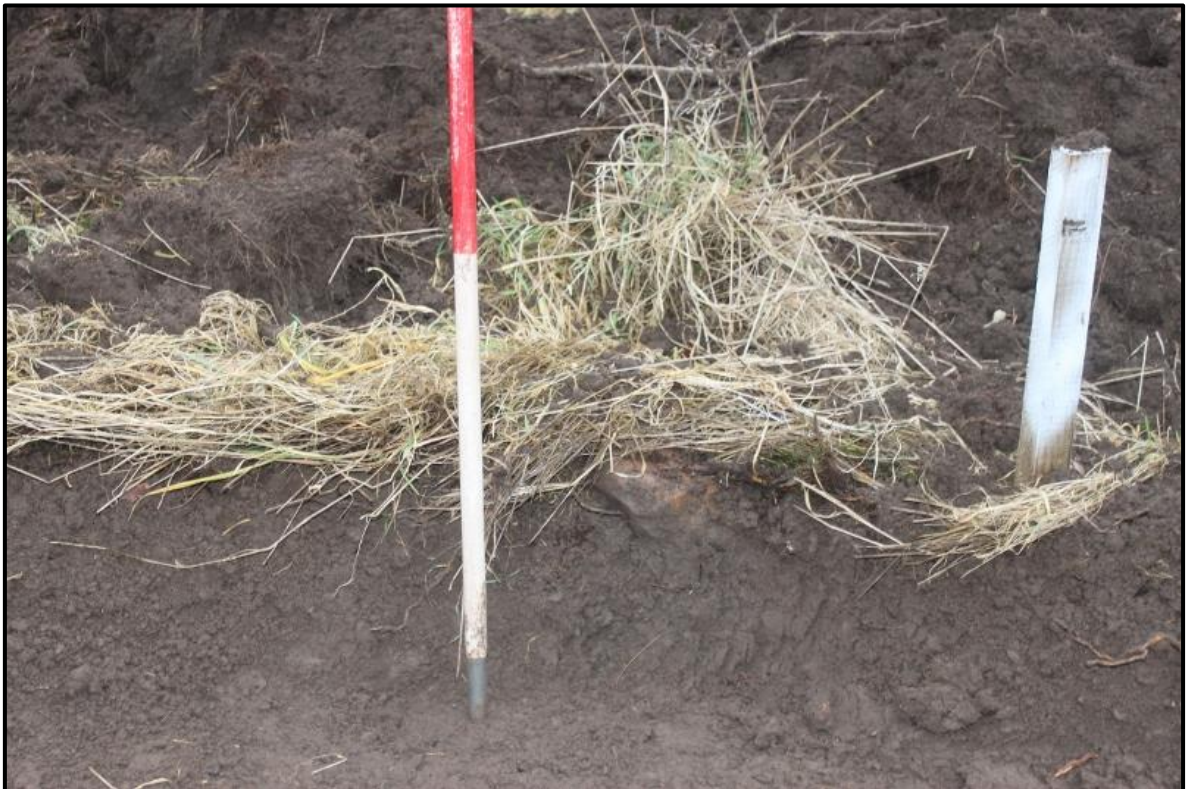
Figure 2b: Northeast facing section of footpath showing subsoil (003). Taken from the northeast.

to a depth of 0.36m-0.5m (Figure 2b). A small amount of 19th and 20th century ceramic sherds were identified within the subsoil (003) and a representative sample was collected.

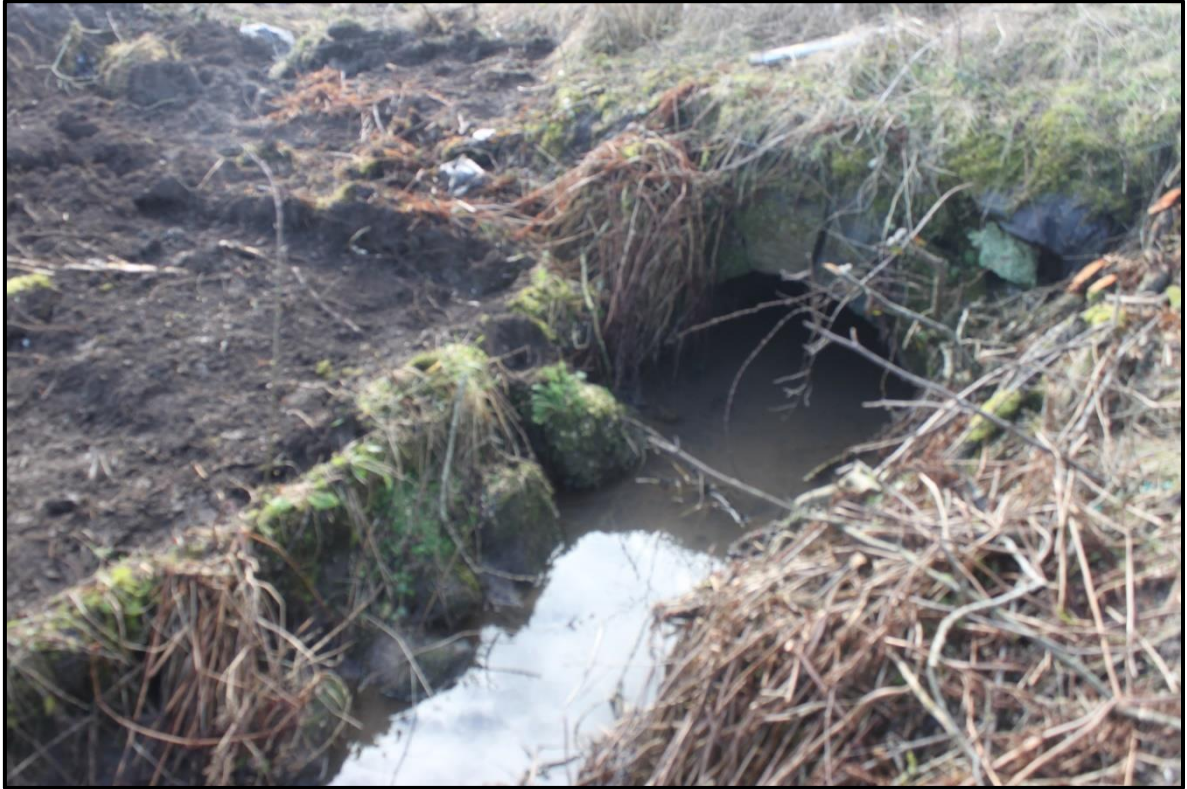
Figure 3a: Covered 'Arched' sluice channel and south eastern stone lining [006] mid excavation. Photo taken from the northeast.

12. The diversion trench cut through the north eastern bank of the burn and then through the south eastern and north western sides of the sluice channel and parts of its stone lining [006] and [007] (Figures 3a and 3b) where they met a covered stone arch (Figure 3a). The stone lining on the north western side of the sluice channel [007] consisted of four courses. The stones forming the lining were roughly faced grey-black, sub-angular shaped, stones with an average size of 0.30m by 0.25m by 0.10m. The stone lining on the south eastern side of the sluice channel [006] consisted of one visible course. The stones forming the lining were roughly faced grey-black, sub-angular shaped, stones with an average size of 0.30m by 0.25m by 0.10m.

14. The only archaeological features identified within the development area was the stone lining, [006] and [007], which was part of an open sluice channel associated with Crossford mill to the north of Beith Road. The stone lining was noted where the sluice channel emerged from a covered stone arched culvert which was over part of the sluice channel and the northern end of Midtown Burn. This covered area was a point of convergence with one subterranean channel feeding into what would have been a mill pond for Crossford Mill and another open sluice channel which headed to the northeast (and which would eventually join Midtown Burn to the north of the mill building).

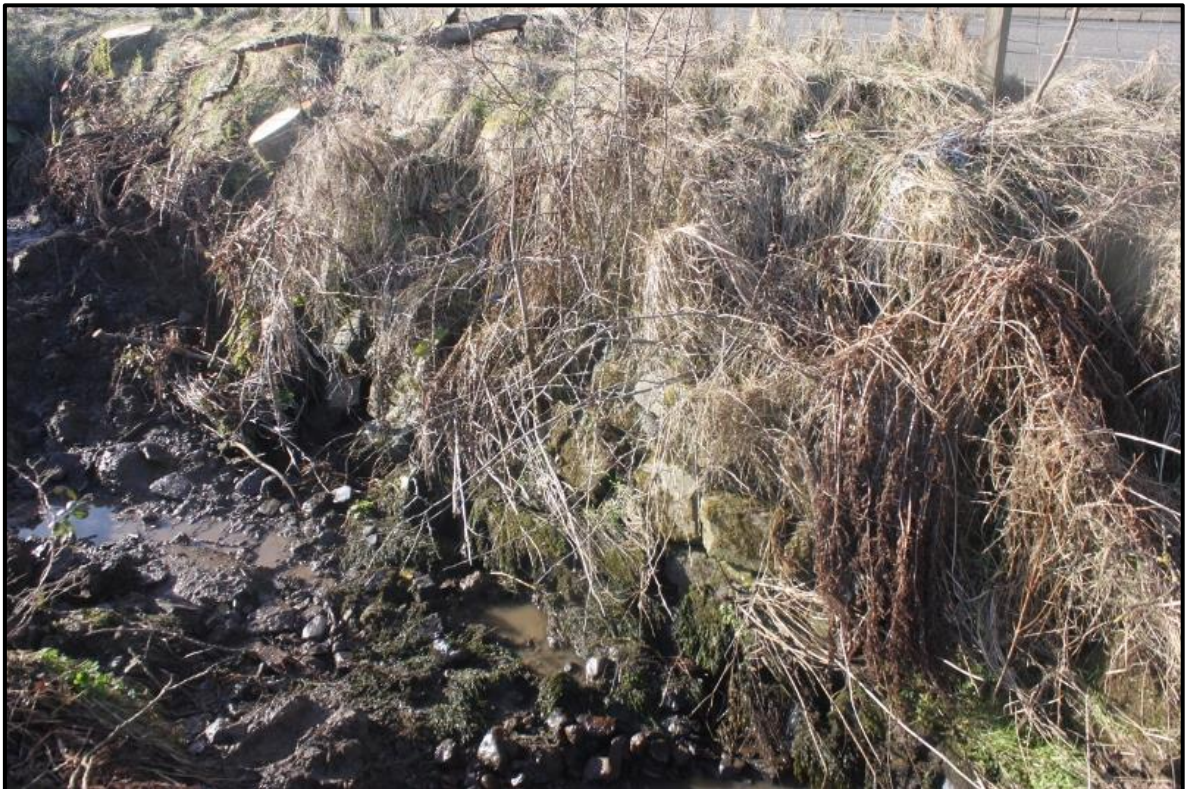
Figure 3b: View of the northwest side of sluice channel, showing stone wall [007]. Photo taken from the east.

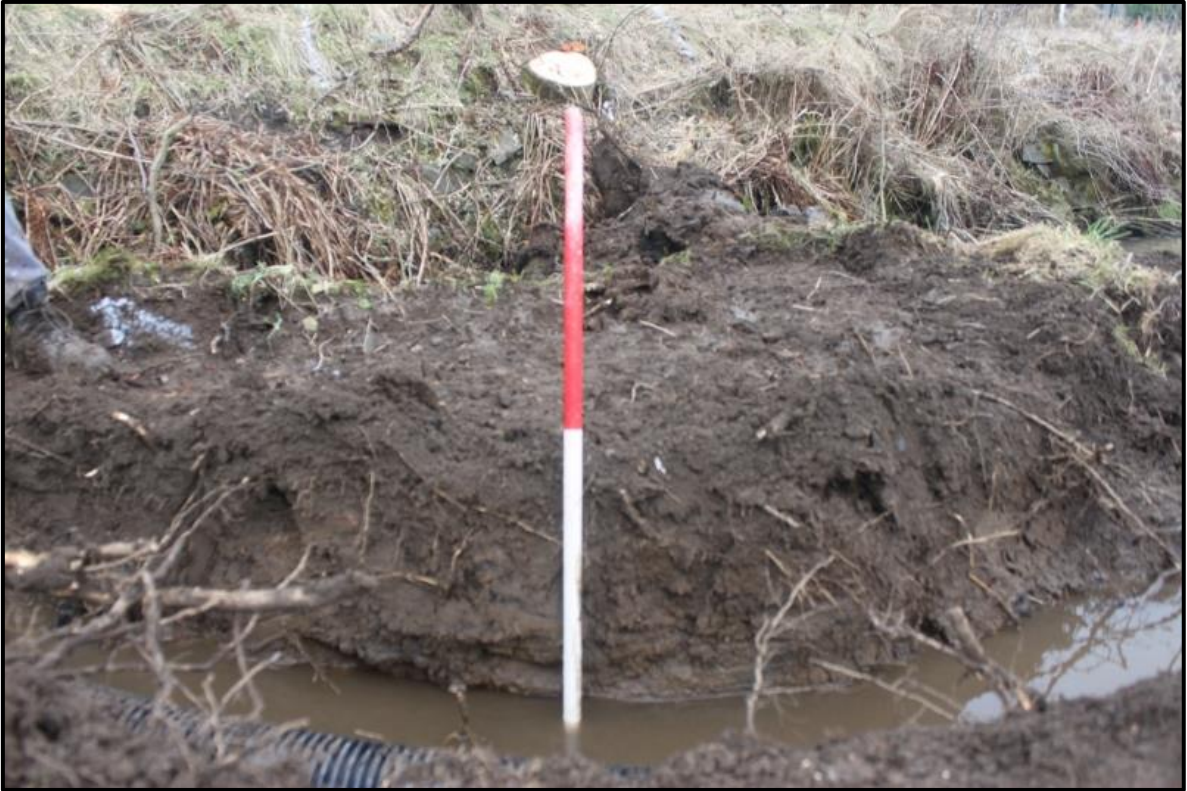
Figure 4a: South facing section of burn diversion with the pipe laid showing (001) and (003). Photo taken from the south.

13. The diversion trench also cut through an area of made ground (008) which consisted of a layer of moderately compacted, fine greenish grey gravel. Layer (008) overlay a natural subsoil layer (003) (Figure 4a) which consisted of a moderately compacted, dark brown clay with occasional sub-angular small stones and manganese inclusions. This subsoil layer overlay the natural bedrock (005). The bedrock consisted of mid grey slate that had broken off into sub-angular sections. Due to the depth of excavation it was impossible to measure how far the slate had been cut into.
