**Fair-A-Far Weir, Cramond  
Edinburgh:  
Archaeological Mitigation**

Data Structure Report

issued 5<sup>th</sup> March 2018

on behalf of Green Cat Contracting Ltd

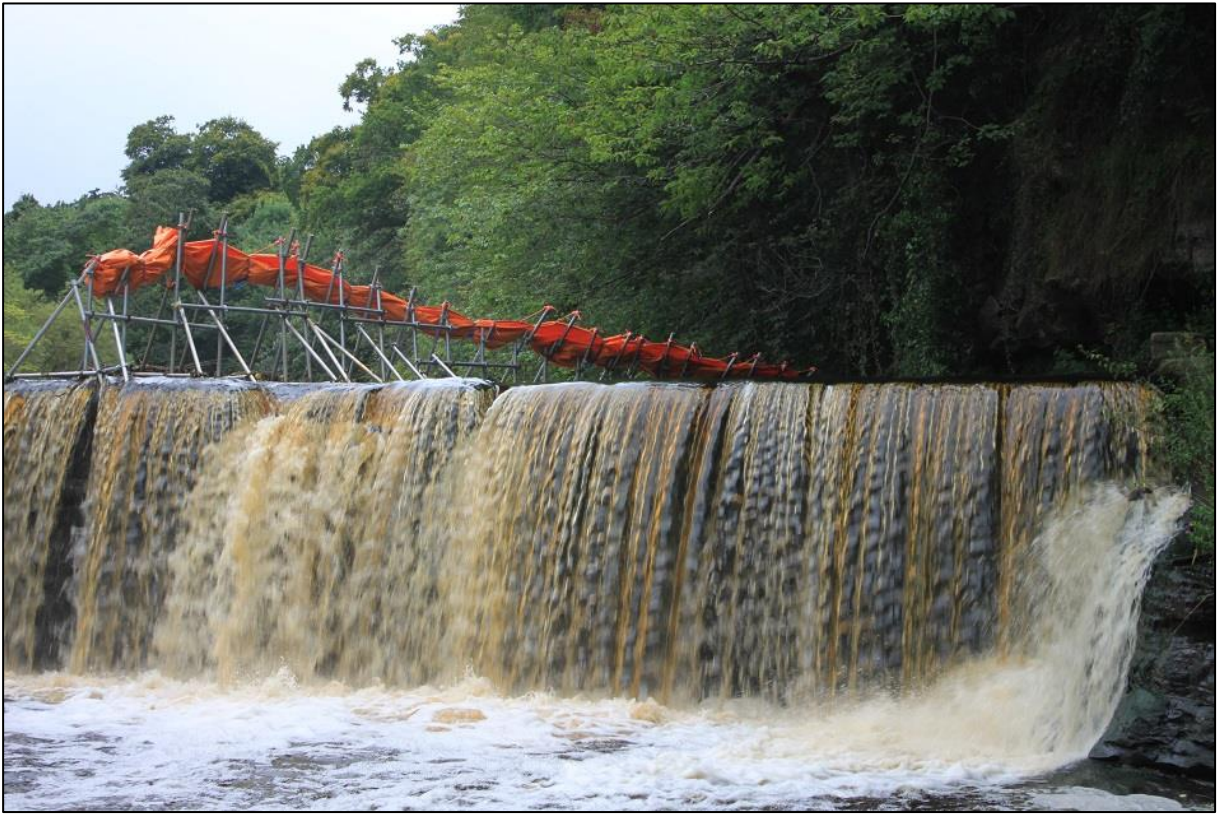
Figure 2a: View of the Weir before works commence. From the W.

12. The purpose of the building recording was to investigate and record the surviving elements of the 20<sup>th</sup> century Fish Pass and the damaged Crest Blocks of the 19<sup>th</sup> century Weir. The aim of the exercise was to provide a baseline record of the extant structures prior to the demolition of the Fish Pass and the repair of the Crest Blocks at the Weir (Figures 1, 2a and 2b).

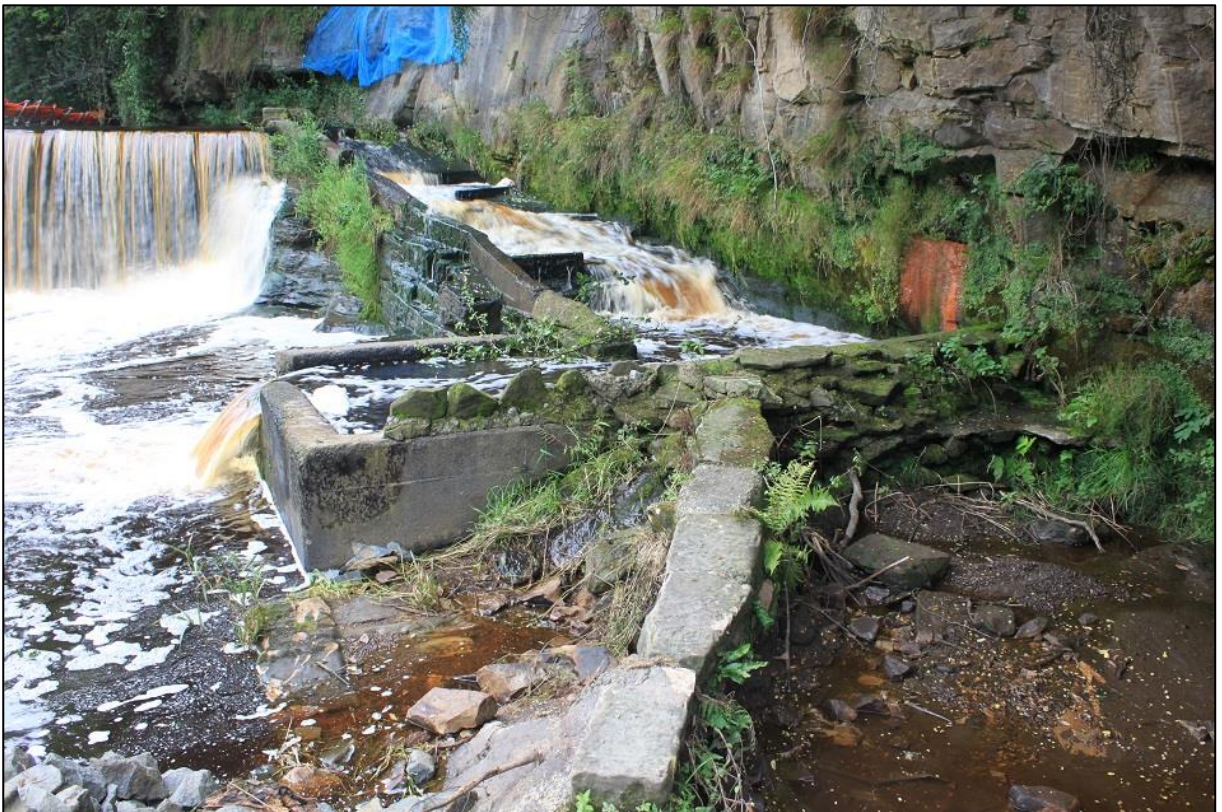
Figure 2b: View of the Fish Pass before works commence. From the ESE.

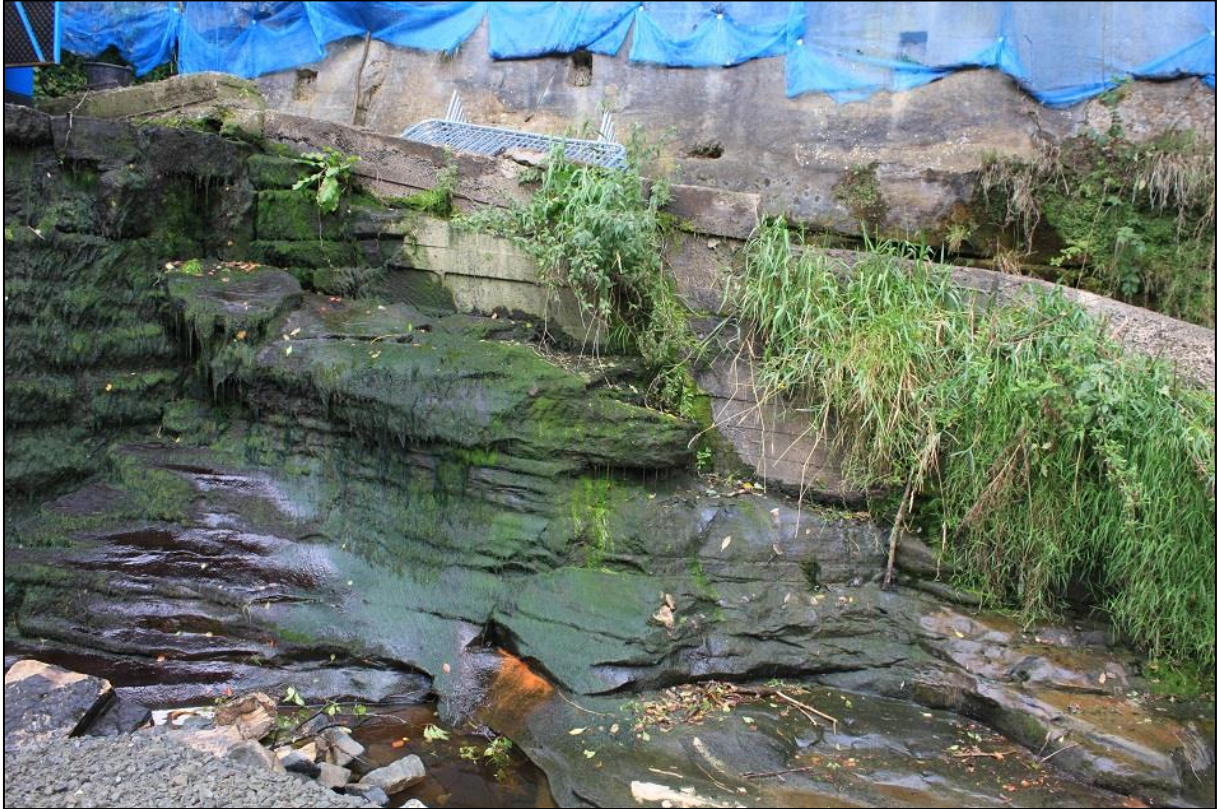
Figure 3a: View of shuttered concrete walls [010] & [005] and the sandstone wall [015] beneath. From the SSE.

28. These earlier structural elements, [003], [007] and [015], may have been associated with the Category B Listed Fair-A-Far Weir (Figures 1, 3a, 3b and 5b), possibly as an earlier version of a Fish Pass but it may also have served as a spillway or sluice for the Weir. It is unclear if the artificial terrace cut into the bedrock was part of the weirs original design or if it was an earlier feature. The series of putlog holes [012] (cut into the bedrock) which were most likely associated with the 19th century Craigie Quarry, which was used to supply stone for the construction of the Victoria Docks at Leith, located some 150m to the ENE of the weir and Fish Pass. These holes may have been used to accommodate an elevated, cantilevered track or carriageway from the quarry to the Craigie Quarry Docks further downstream (Cramond Association 2014). The bedrock terrace and the sections of sandstone walling may have been originally constructed to accommodate uprights supports for this cantilever carriageway. It is also possible that the carriageway, as well as supplying stone to Leith, may also have been used to convey stone from the quarry for the construction of the weir.

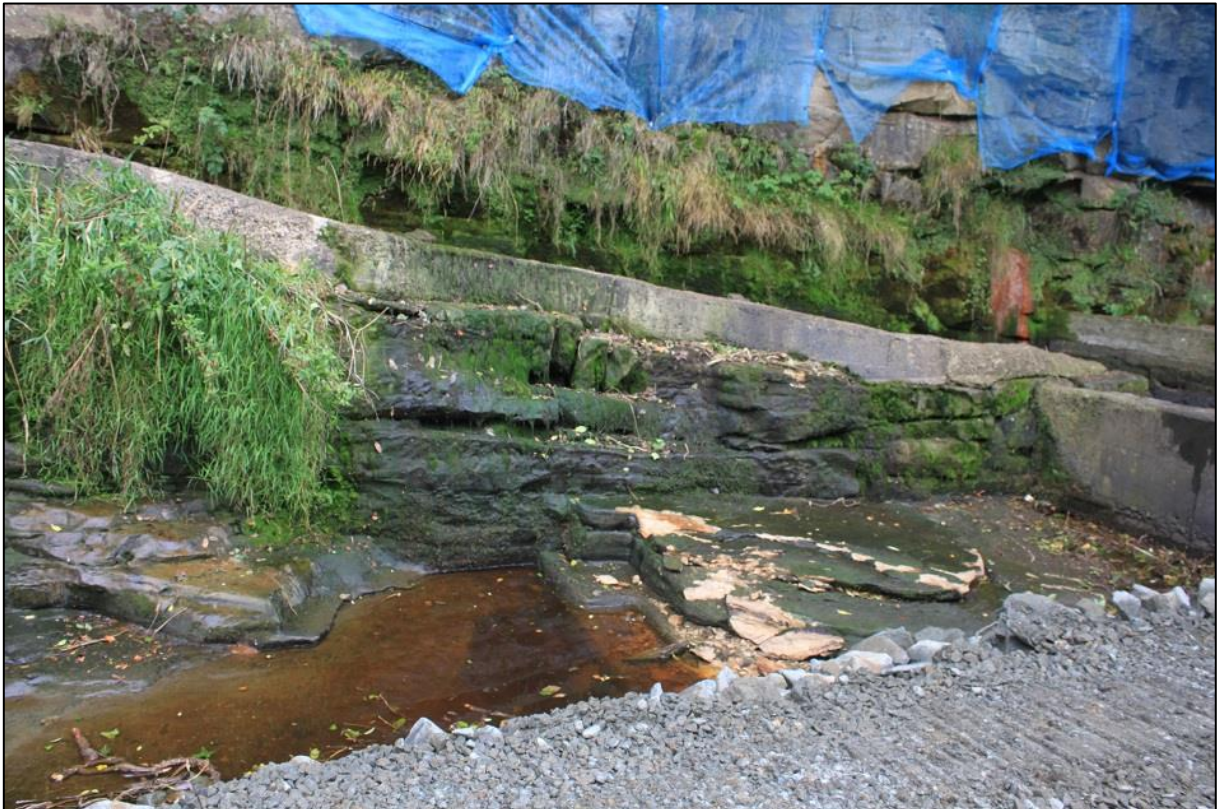
Figure 3b: View of shuttered concrete wall [005] and the sandstone wall [003] beneath. From the S.

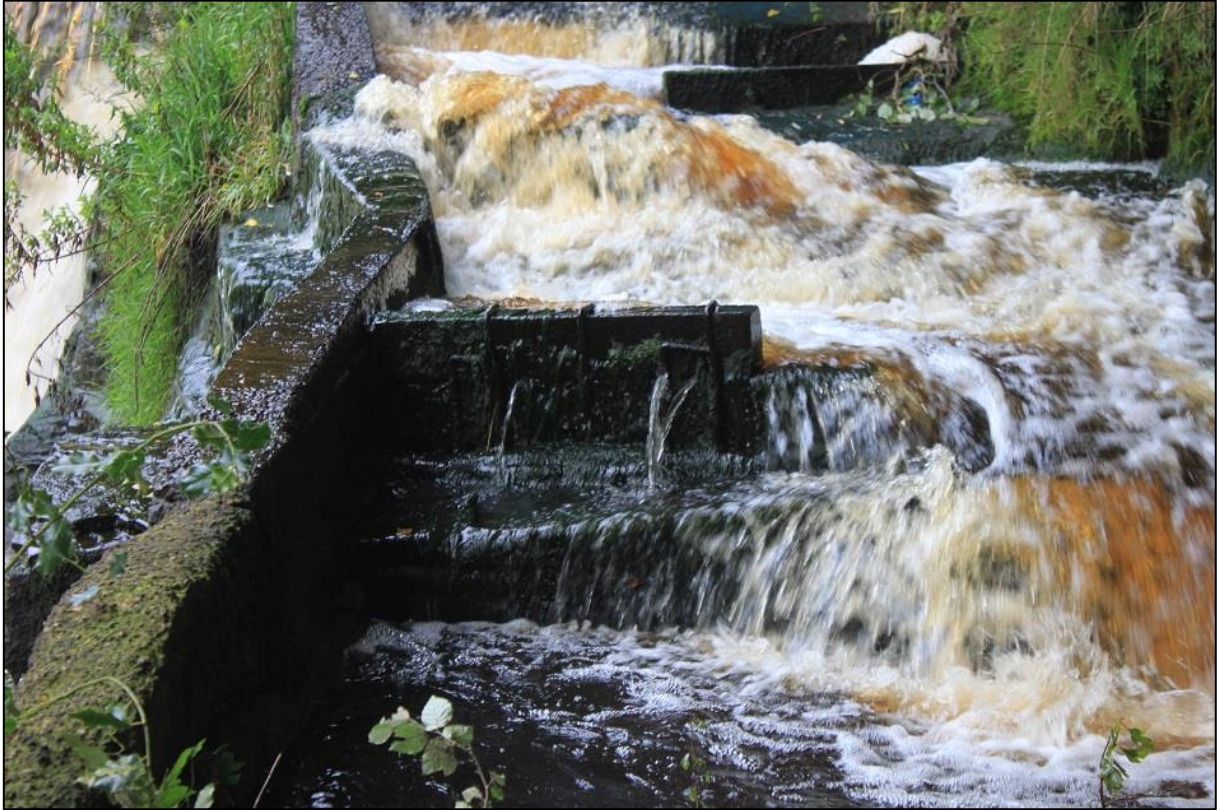
Figure 4a: Close up view of Riser A. From the ENE.

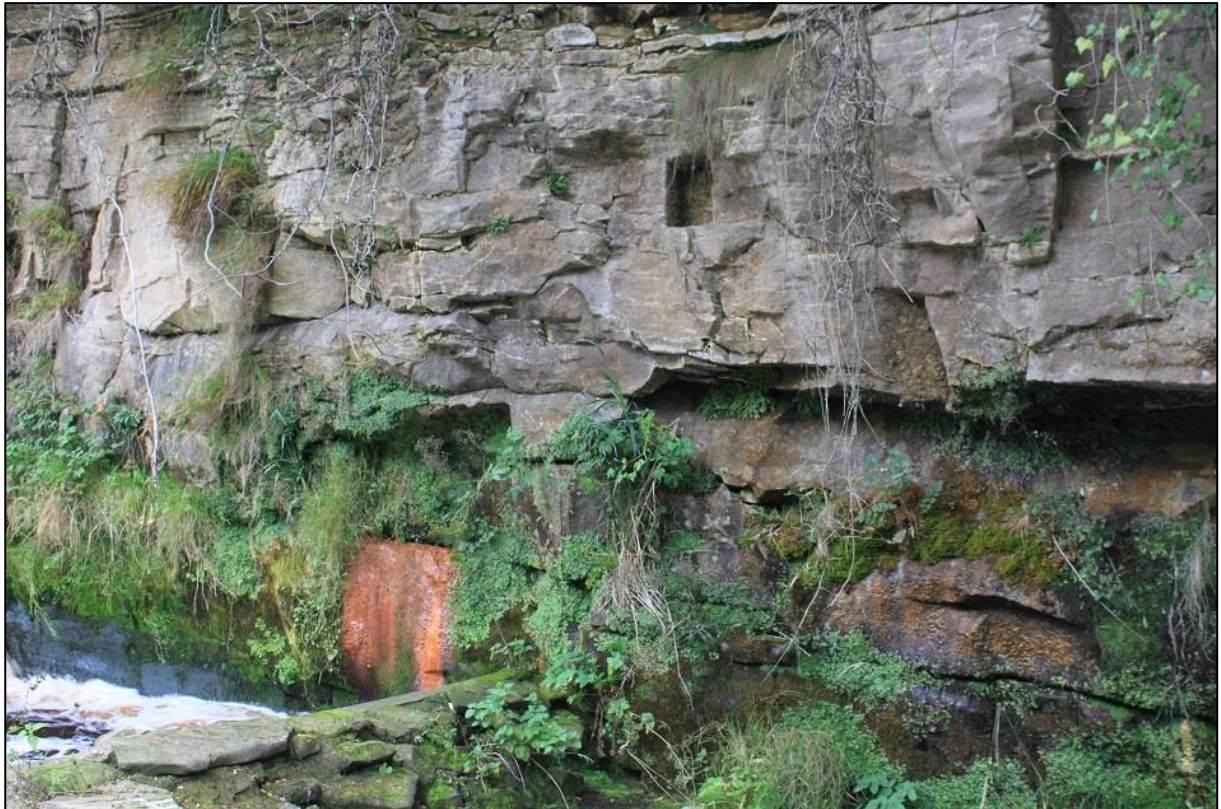
Figure 4b: View of Putlog Hole close to the ENE end of Basin 2. From the SSE.

24. A series of square shaped holes, or putlogs, [012] cut horizontally into the southern face of bedrock were noted (Figure 4b). The southern face of the bedrock itself appeared to have been quarried to create a vertical face in which the putlog holes had been cut. The holes measured approximately 0.2m by 0.4m. They were located at an approximate height of 1m from the uppermost part of the fish pass and were spaced 2.5m to 3m apart. Two spigot holes were also noted within Basin 2, close to its sluice hole.

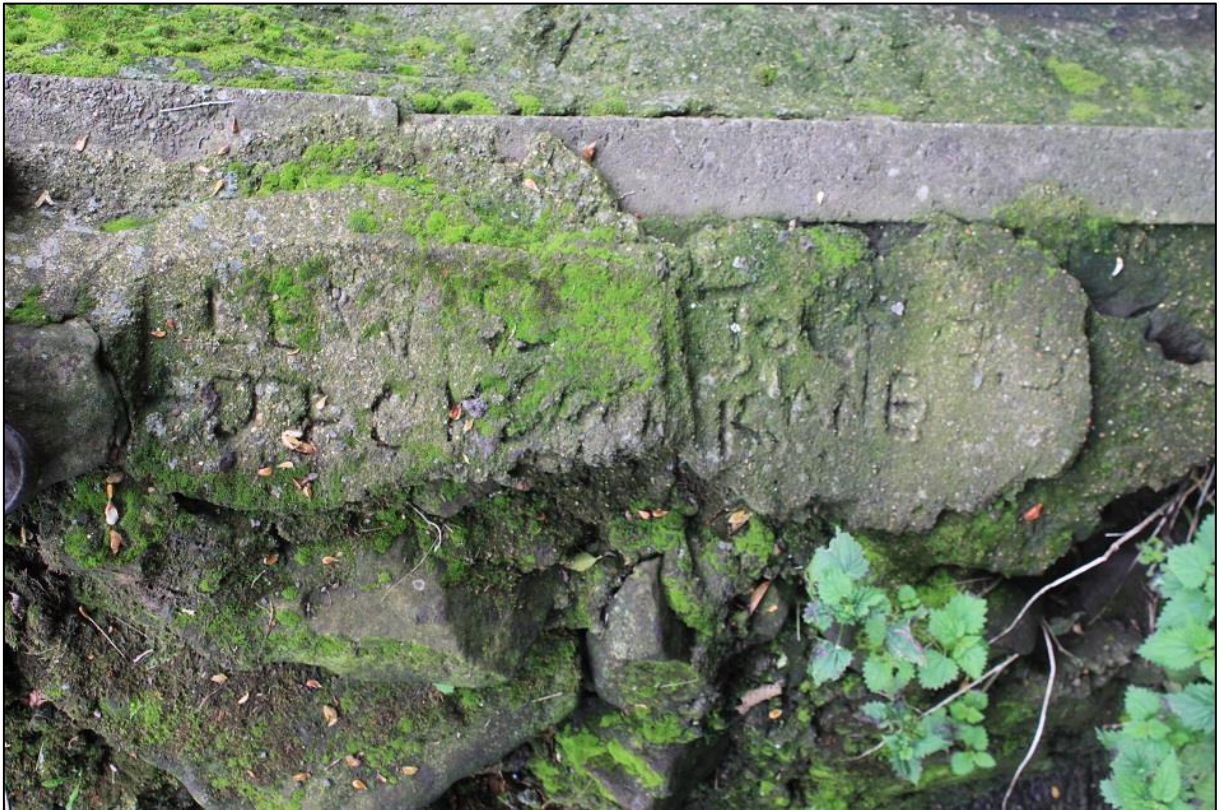
Figure 5b: View of the Graffiti (001) within Basin 1. A possible reading of it could be "LEWIS....JOE...75..JACK..(or JECK)..COCHRANE'

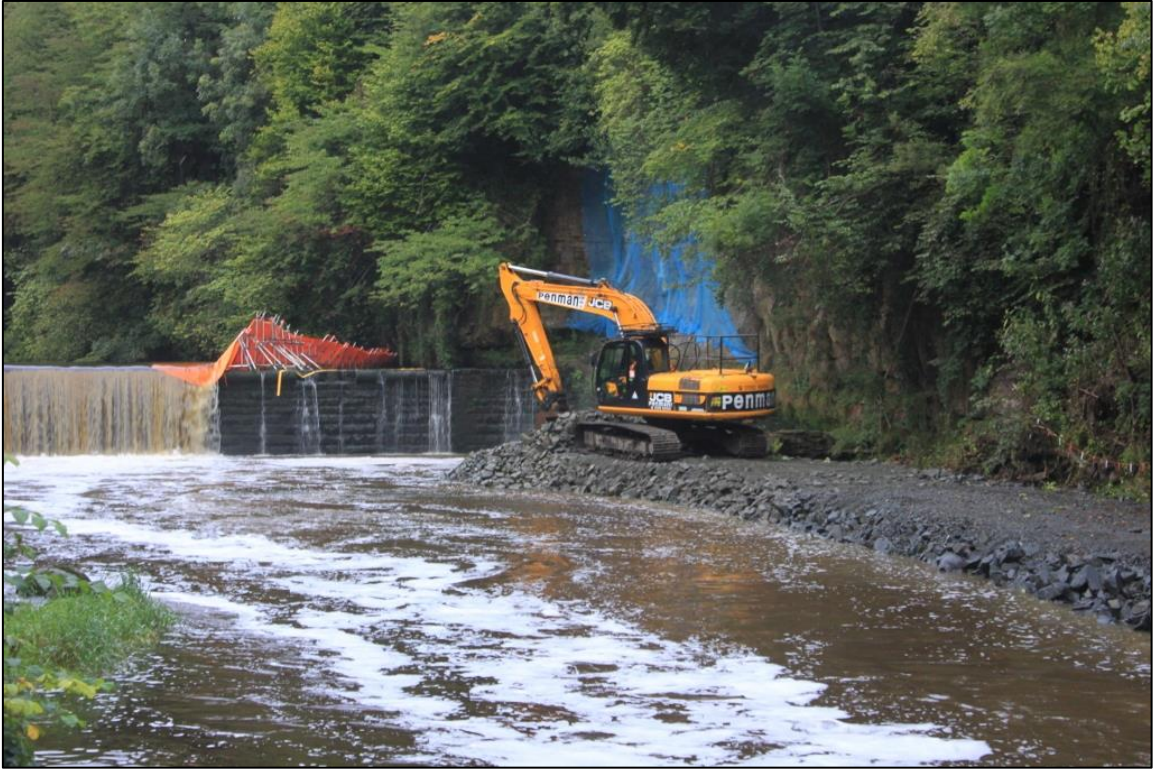
21. The Weir structure [011] (Figures 1, 2a, 6a and 6b) curved slightly across the river from the N to the SSE. The ENE facing main retaining wall was constructed with rectangular shaped sandstone blocks mortared into place. This wall was approximately 30m long (across the river), 2.9m wide at the top (N end) and had a height range of between 2.5m-3m. The upper most part of the Weir structure was formed with squared sandstone crest blocks (Figures 6a and 6b) [011] which measured 1.1m by 0.65m and had a thickness of 0.3m. These crest blocks (Figure 7a and 7b), which were damaged in several places at the N end of the Weir, had rounded edges where they formed a lip over the ENE side of the Weir. The N end of the Weir had been built up against the naturally occurring bedrock and was abutted by the SW end of the Fish Pass.

Figure 6a: General view of the Weir and the Fish Pass at the start of site works. From the ENE.

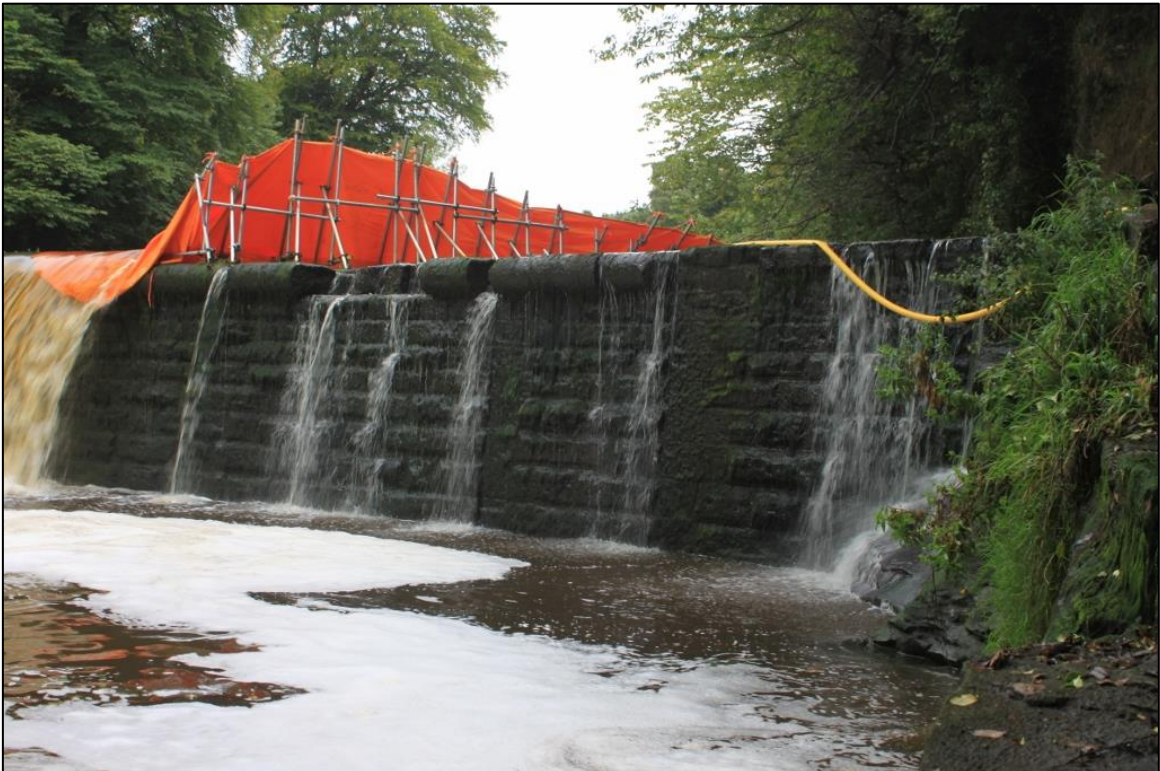
Figure 6b: Close up view of the Weir structure from the NE.

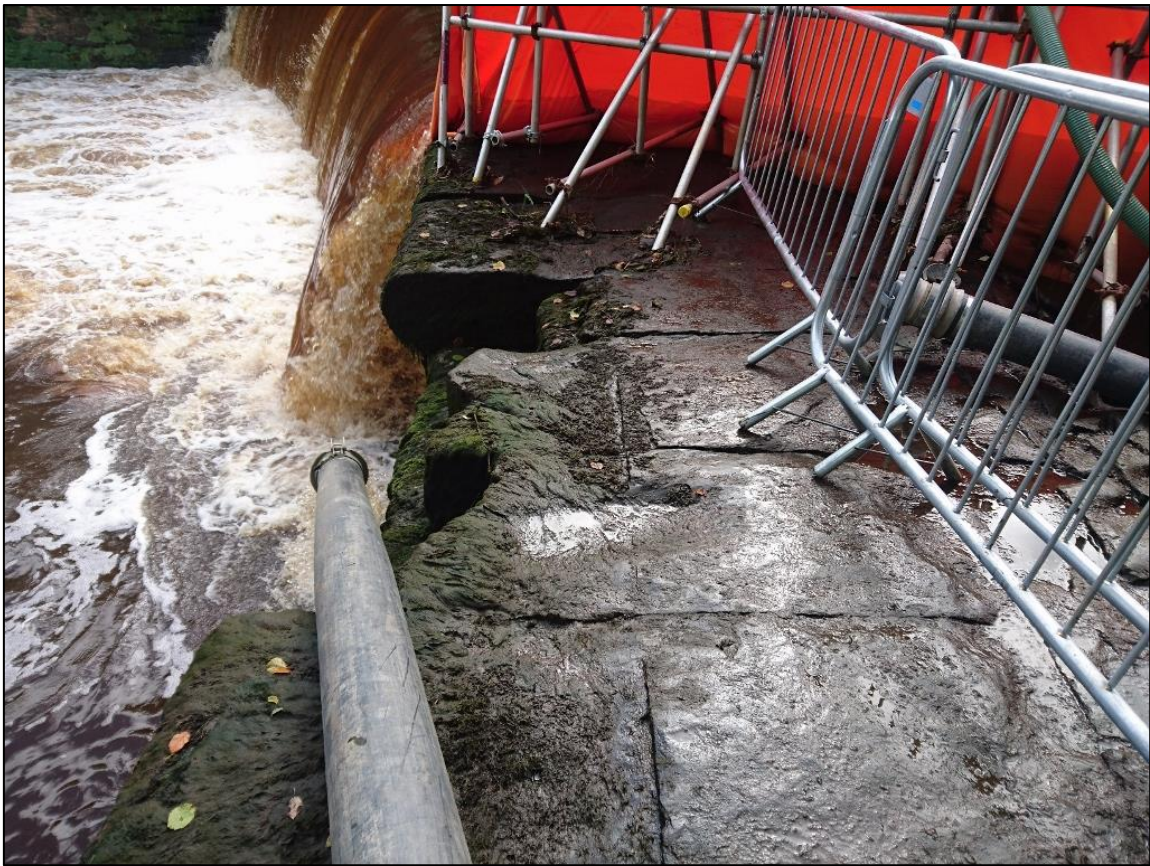
Figure 7a: View of damaged crest blocks at N end of Weir. From the N.

29. The Weir was one of the later additions to the mill which had been in existence in some form since the 17th century. The Weir was built sometime between 1787 and 1839 (when it was first depicted in a map by Carfrae) (Moloney 2017) to provide a new water source for the Cramond Iron Works at Fair-a-Far mill. The Ironworks had previously been supplied by a wooden dam located further upstream but the increasing needs of the ironworks required something more substantial. The Weir was almost destroyed in 1935 during severe floods and this may have caused some of the damage to the N end of the Weir, which over the years became progressively worse. This historic and ongoing damage was noted in many of the crest block stones (Figures 7a and 7b) which made up the N end of the weir [011] which was the reason for the current repair works.

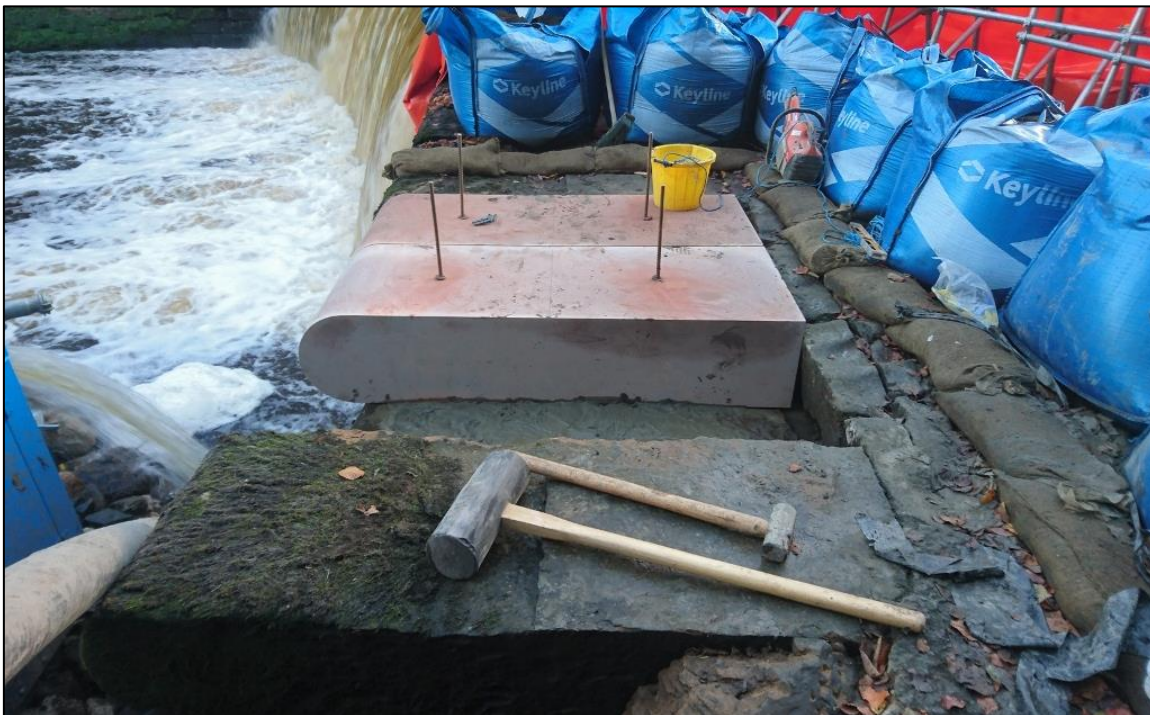
Figure 7b: View of repairs at N end of Weir. From the N.
