# **Culzean Overspill Carpark: Archaeological Watching Brief**

Data Structure Report

issued 7<sup>th</sup> March 2018

on behalf of National Trust for Scotland

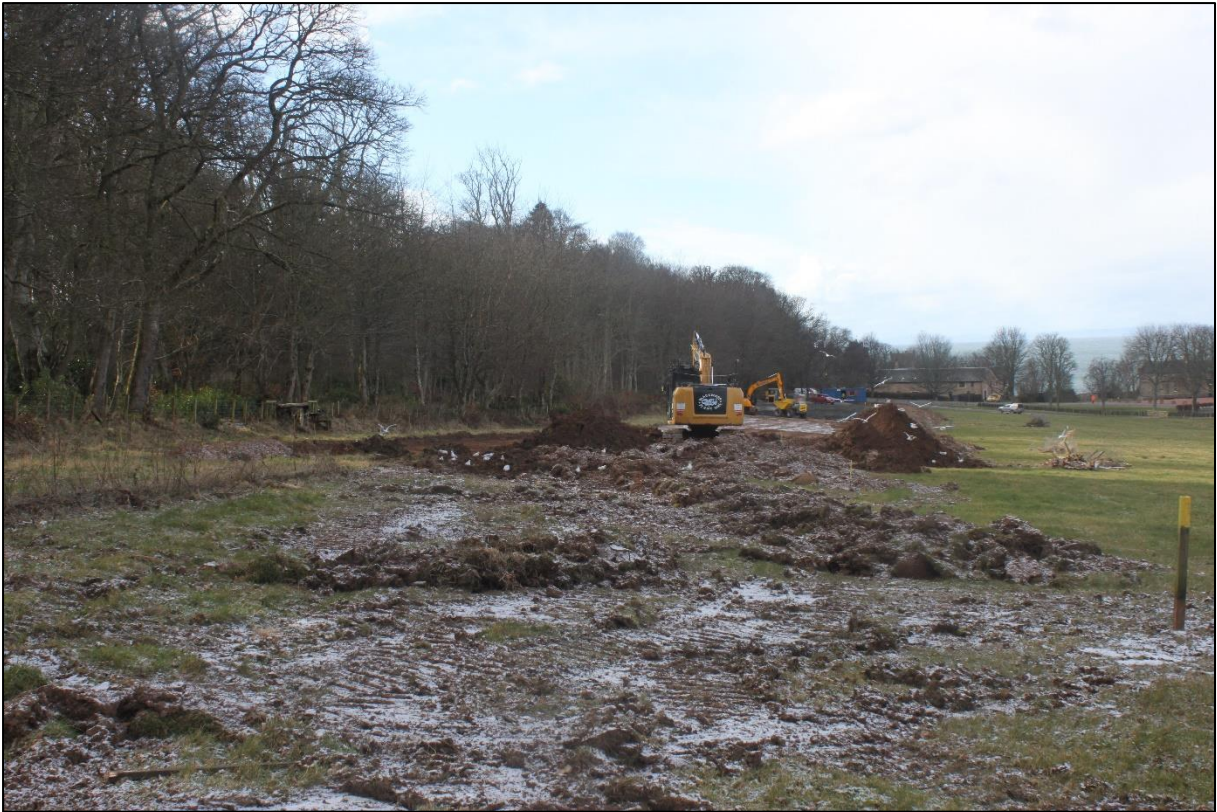
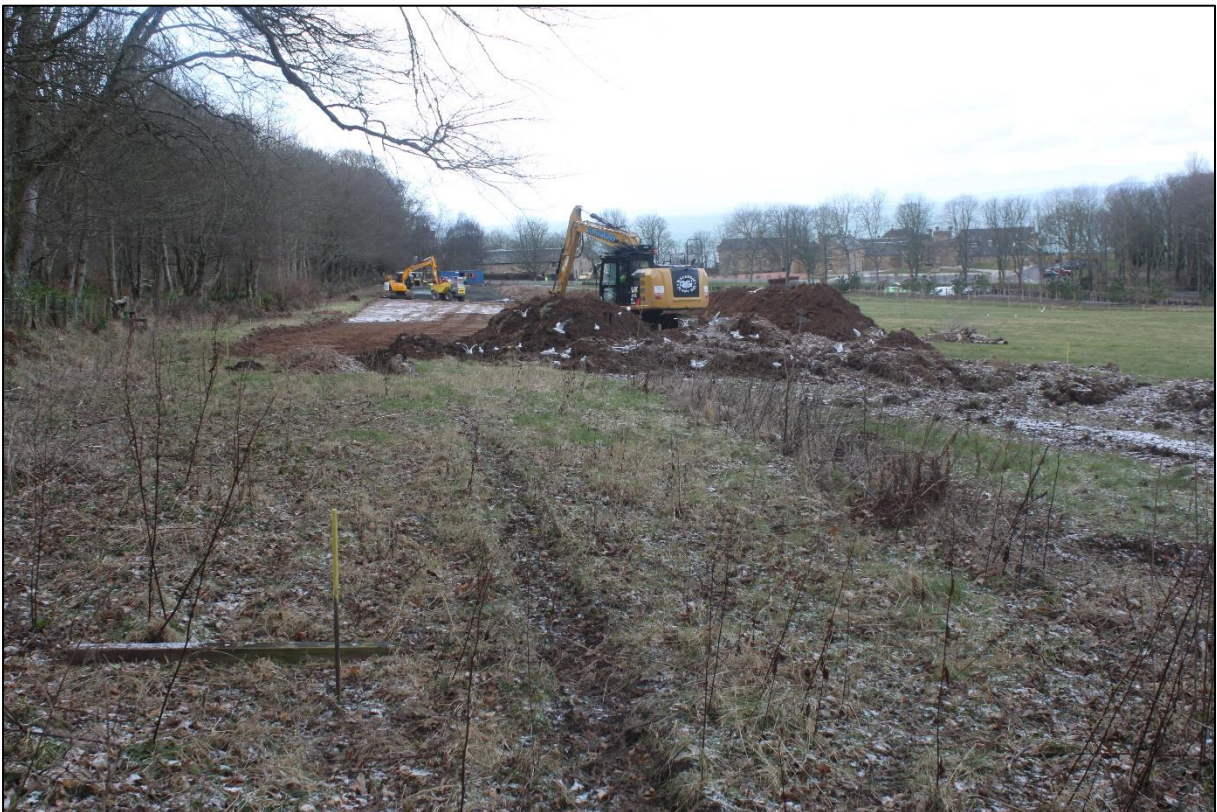
Figure 2a: From eastern limit of excavation, unmonitored area.

Figure 2b: From eastern limit of excavation, unmonitored area.

4. The overspill carpark is located approximately 200m southeast of Home farm, directly south of the previous car park expansion works at Home Farm (Figure 1). The works were undertaken from 27<sup>th</sup> to the 28<sup>th</sup> of February 2018, however initial ground breaking works had already commenced prior to Rathmell Archaeology's archaeologist arrival on site. The programme of works consisted of the monitoring of the proposed overspill carpark, which ran from east-west along the southern edge of the events field (stretching from the access road to Home farm in the west to an existing utilities structure in the east). The area was machine stripped, under archaeological supervision, by two 13-tonne 360° mechanical excavators with flat trenching buckets and one bulldozer. Due to extreme weather conditions on the 28<sup>th</sup> of February the final 20m stretch at the eastern end of the strip was not monitored (Figure 2a-2b).

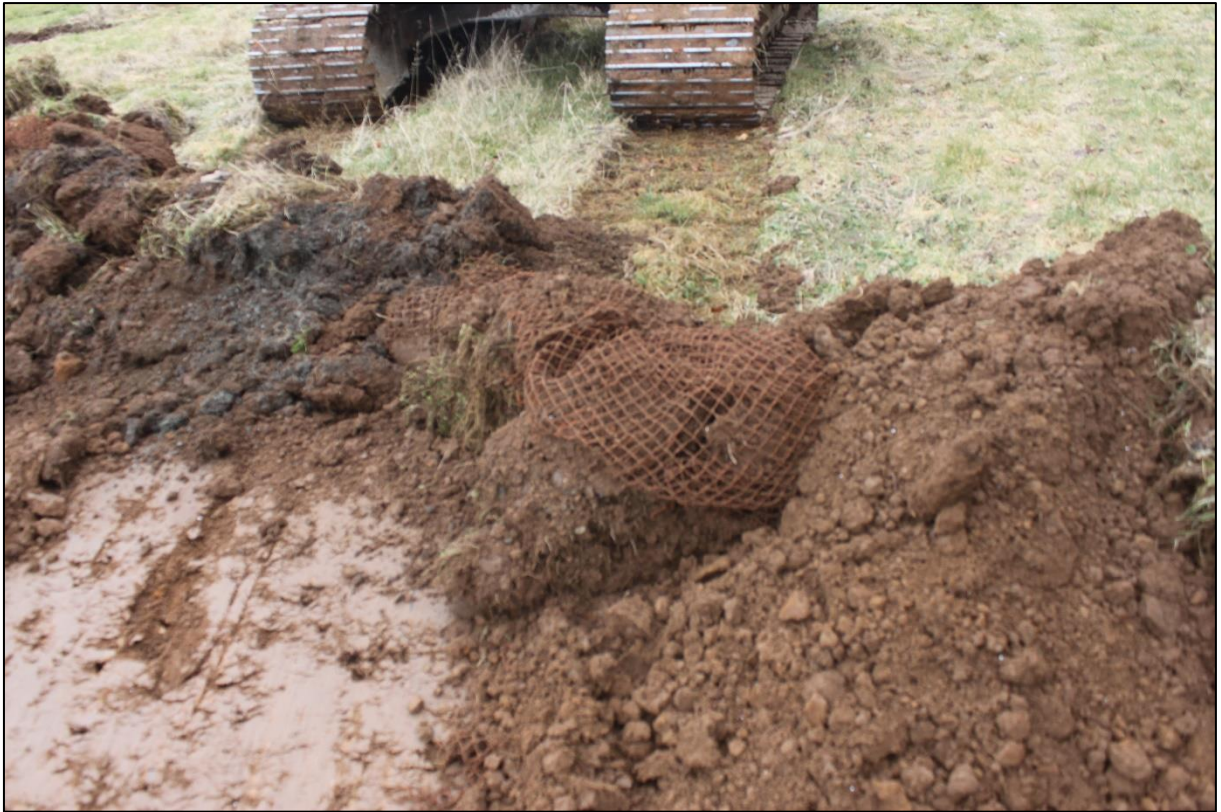
Figure 3a: Orange netting (006) under topsoil, seen along length of excavation.

5. The existing topsoil within the development area (002) comprised of plastic, dark orange-brown, silty clay, with medium sub angular inclusions. The topsoil layer had a maximum thickness of 150mm. Beneath the topsoil layer lay orange netting (006), presumably associated with landscaping carried out after the previous phase of works (Figure 3a). Beneath the (006) lay an upper subsoil layer (003) which comprised of friable, mid orange-brown, sandy silt, with small stone inclusions. This layer had a maximum thickness of 150mm. Underlying the upper subsoil layer (003) lay another subsoil layer (001) which comprised of compacted, mid brown-orange, sandy-clay, with medium sub-angular inclusions (Figure 3b).

8. The next phase of activity identified within the area was the 18th or 19th century stone lined culvert [004] which showed early attempts at landscape and drainage management. More modern (or recent) activity was noted in the orange netting (006) which was used to consolidate the topsoil in a landscaped area within and close to the stripped area.

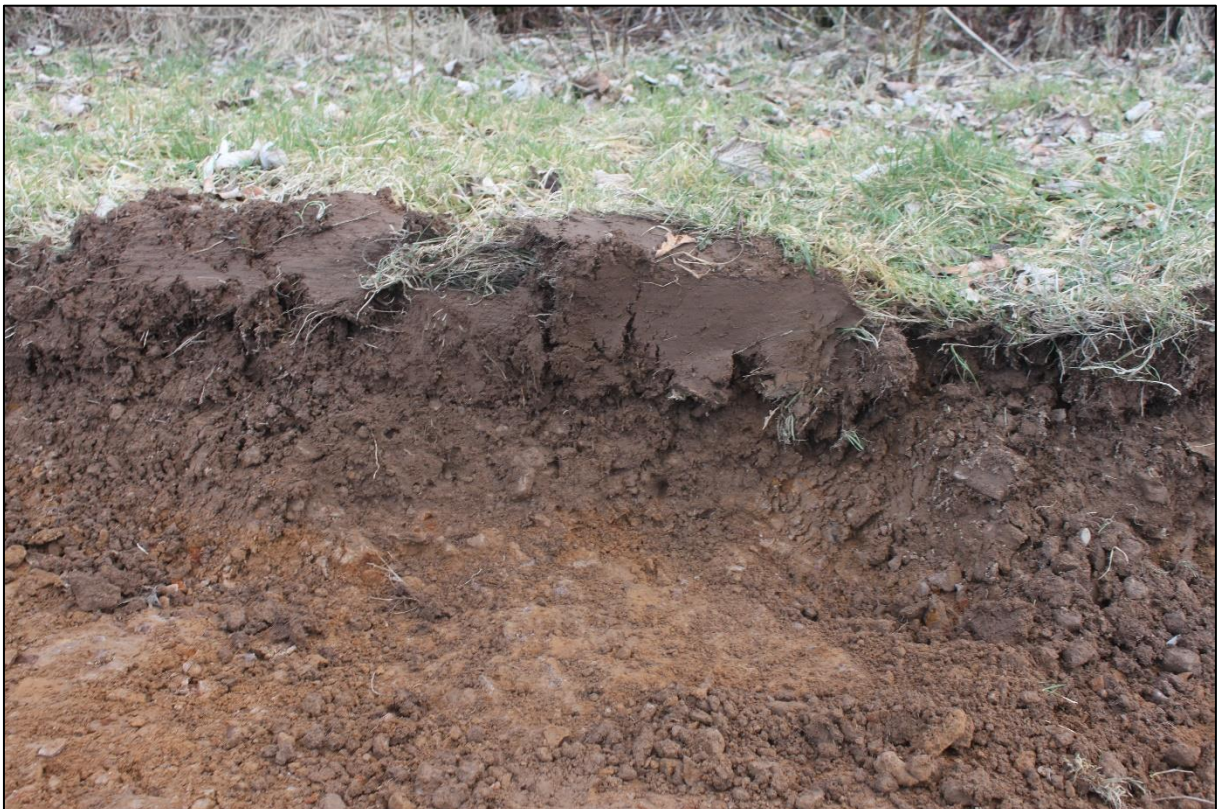
Figure 3b: North facing section showing natural (001), topsoil (002) and subsoil (003).

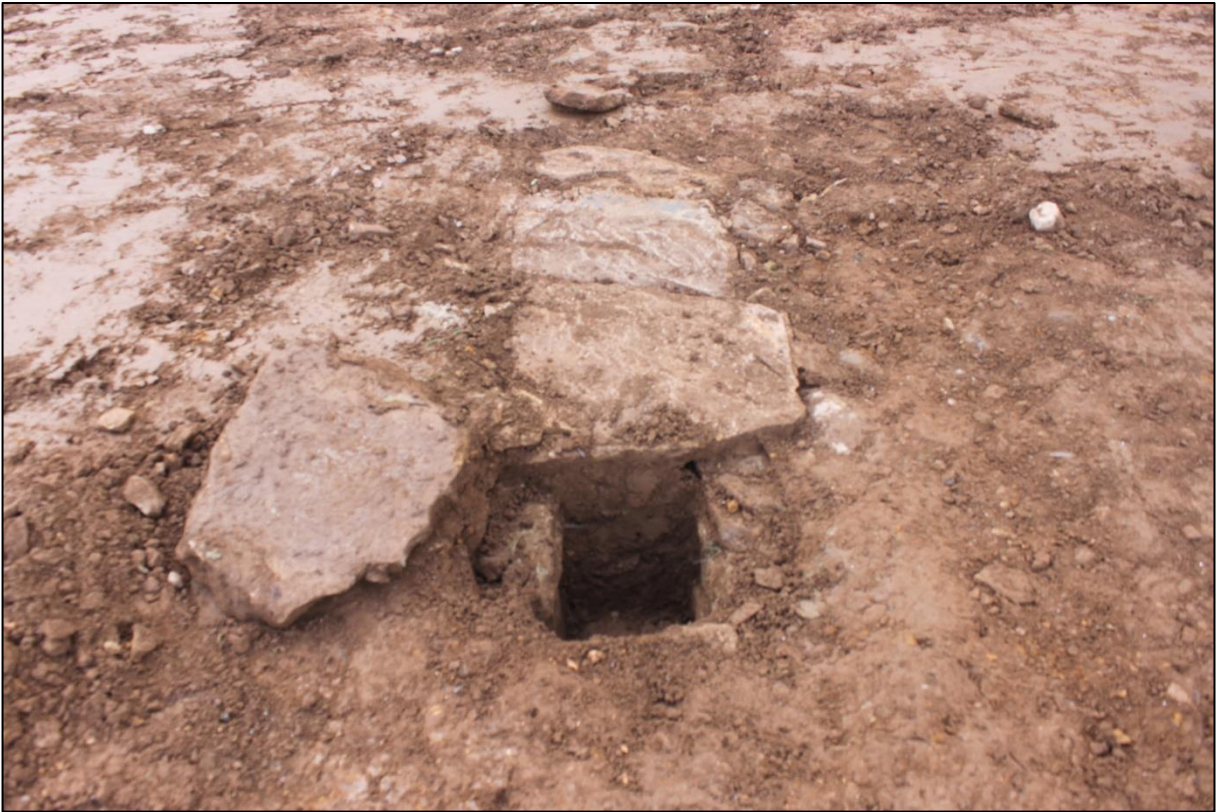
Figure 4a: South facing shot of culvert [004] north facing section.

6. Approximately 120m along the strip a stone built culvert was identified [004] orientated north-south. The culvert was approximately 1.62m in length and 660mm wide. The culvert [004] was 3 courses deep measuring 440mm deep, 4 large capping stones were present each measuring approximately 600mm, [004] was filled by (005) friable, mid orange grey, silt with infrequent charcoal inclusions. Measuring 400mm high x 300mm wide (Figure 4a).

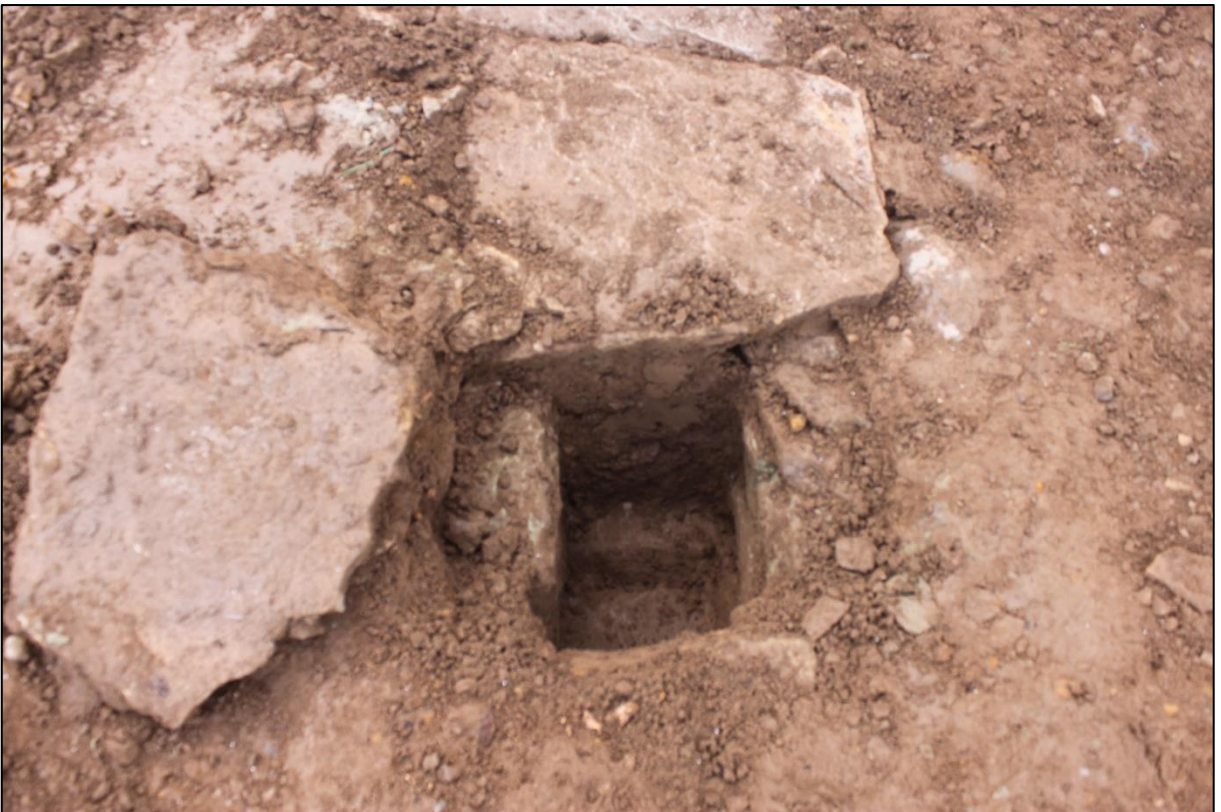
Figure 4b: South facing shot of North facing section through culvert [004] view of interior.
