Galloway Glens Landscape Partnership

Can You Dig It?

Data Structure Report

1.2.f Medieval or Later Rural Settlement –
Upper Gairloch

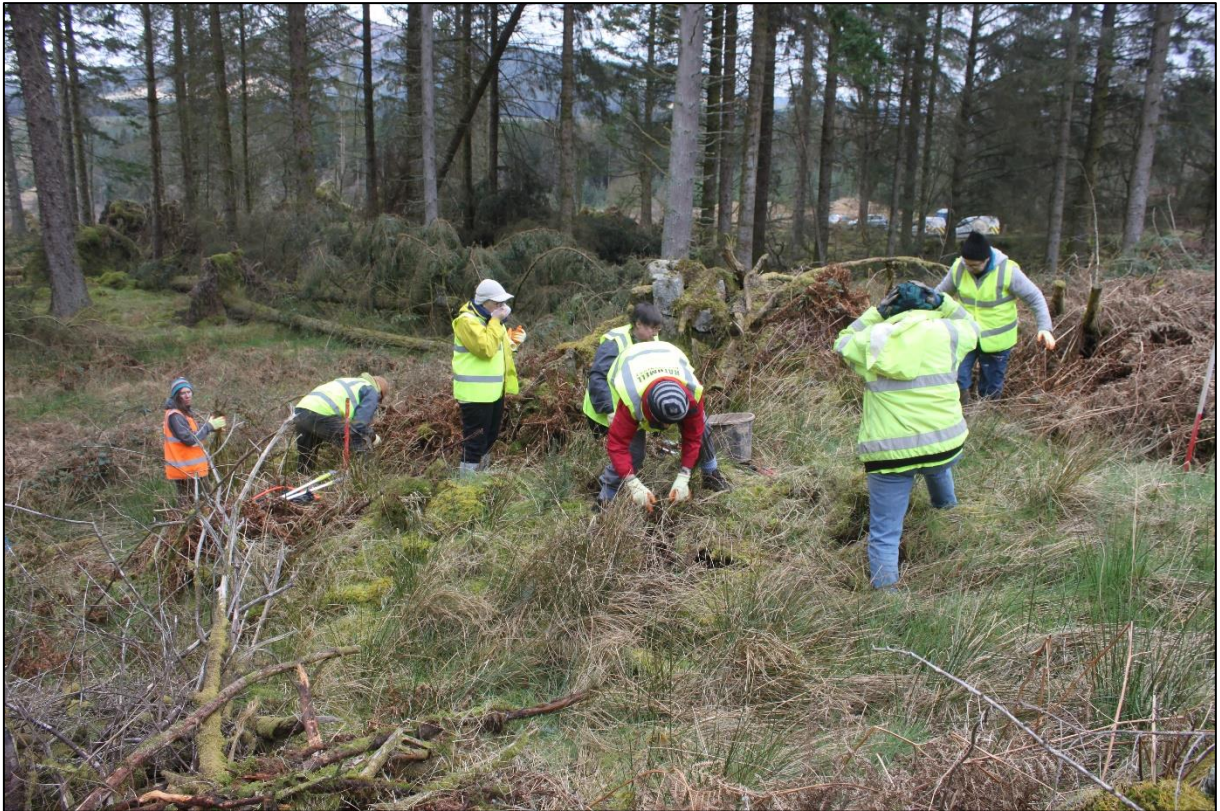
Figure 1a: Pre-excavation shot of structure [001] from the northeast

4. This phase of the archaeological works focussed on the site of a kiln barn at the former settlement of Upper Gairloch along Raiders Road (**S5** in Turner & Rees 2019). The site was located within a small clearing in forestry on uneven ground. Prior to the works the structure were just visible but mostly covered by overgrown vegetation and fallen branches (Figure 1a).

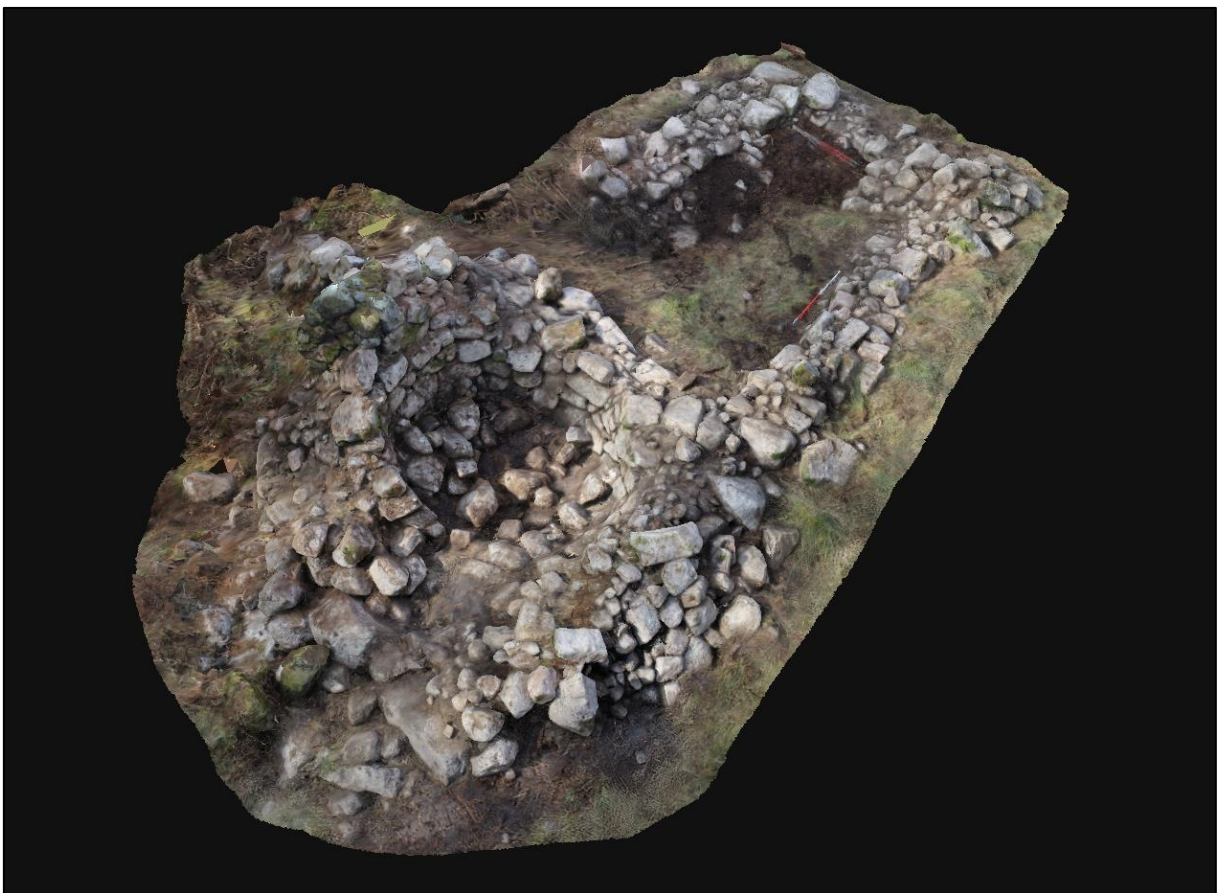
Figure 1b: 3D model of structure [001] shown from the southeast

7. The site was cleared of all vegetation to expose the remains of one structure [001] (Figures 1b and 2) which had been subdivided by an internal crosswall to form two compartments: a kiln [001a] (Figure 3a) and its adjacent barn [001b] (Figure 3b).

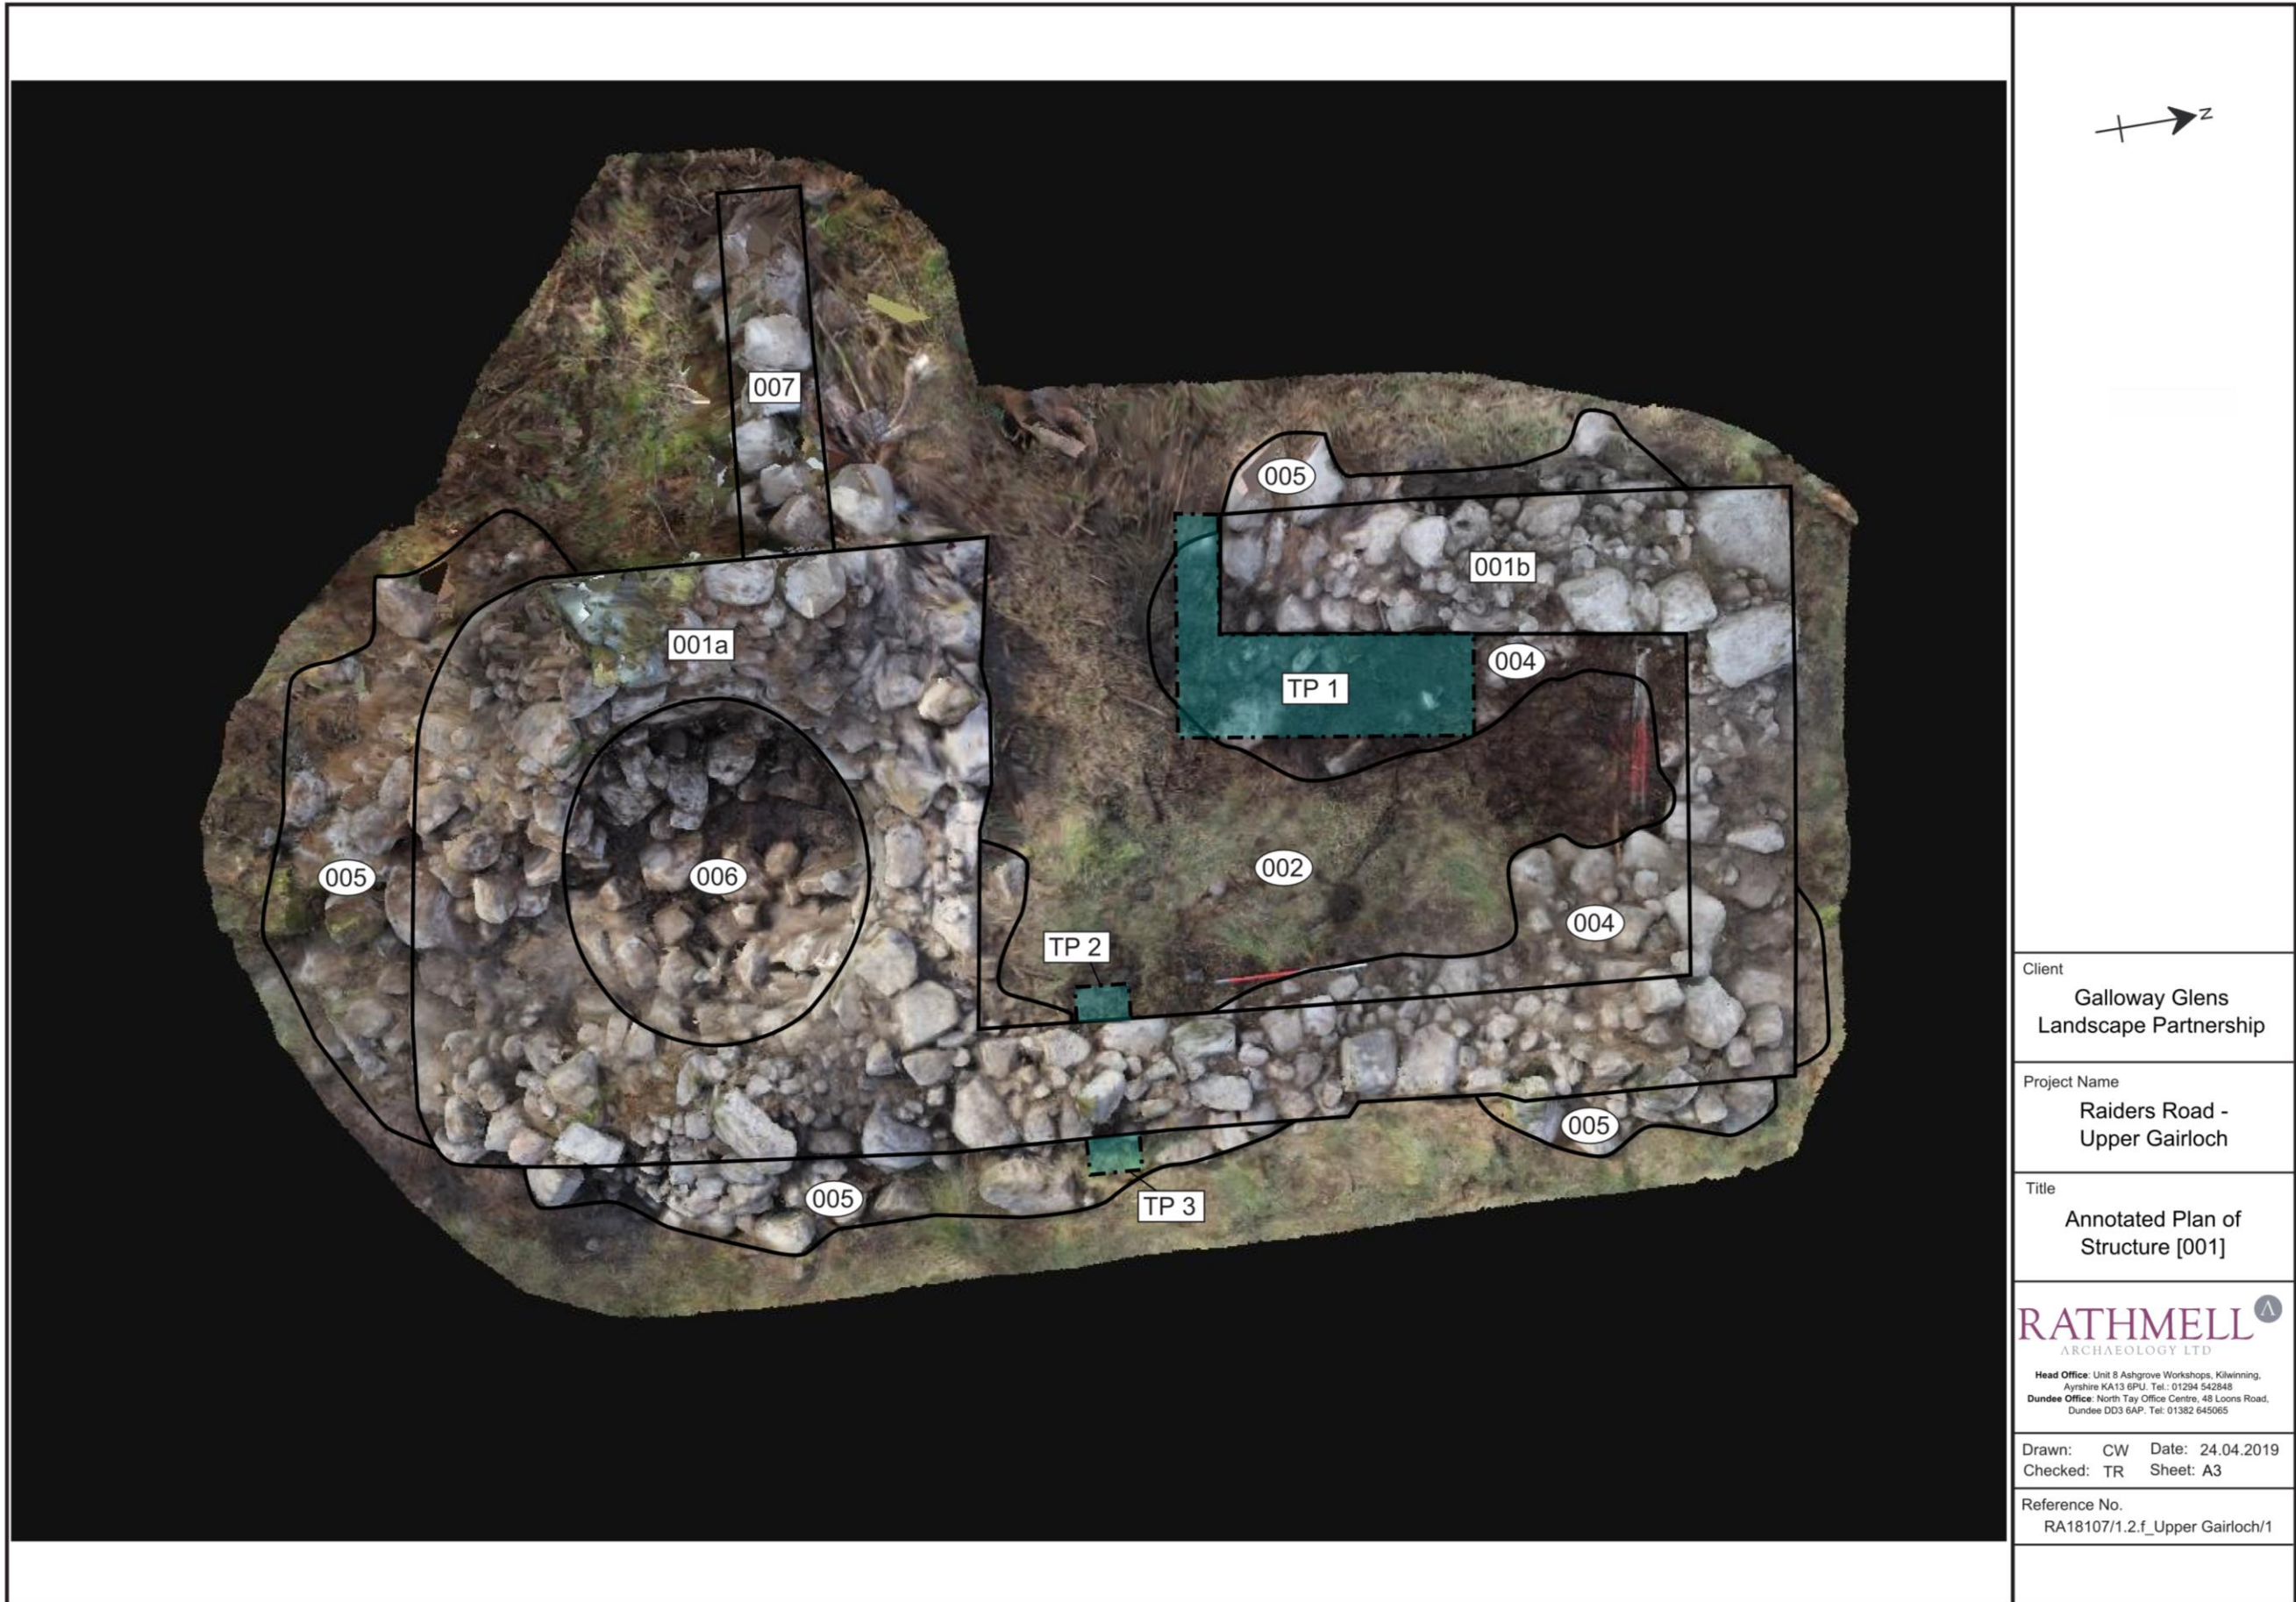
Figure 2: Annotated plan of structure [001]

14. Three test pits (TP 1 – TP 3) were excavated in the area of the barn [001b] (Figure 2).
15. TP 1 and TP 2 were both located within the interior, positioned against the internal faces of the western and eastern walls respectively. TP 1 was located at the entrance to the barn and was L-shaped, running along the northern side of the entrance for 1.5m, before turning north to run down the interior of the western wall for 1.6m. It measured 0.4m wide. TP 2 measured 0.4m square in plan and was positioned against the internal face of the eastern wall (towards its southern end). TP 3 was positioned against the external face of the eastern wall (opposite TP 2) and also measured 0.4m square.

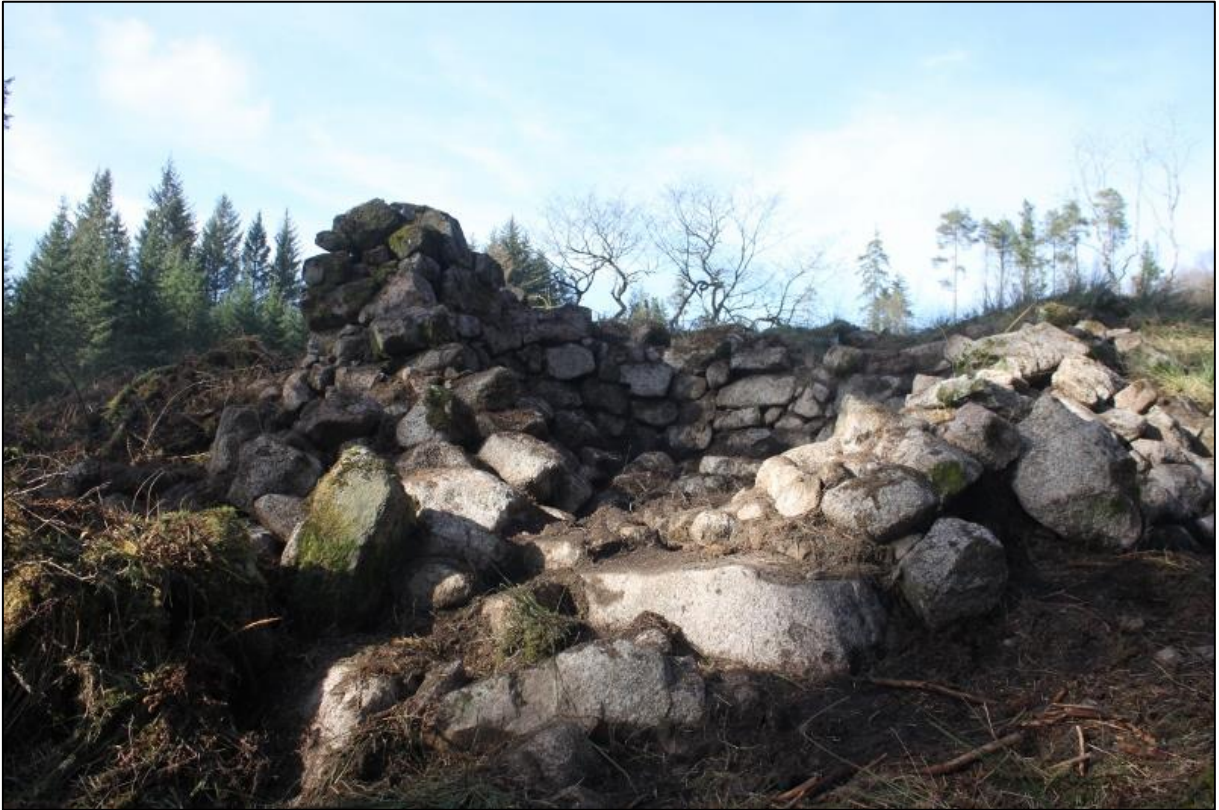
Figure 3a: General shot of kiln [001a] from the south-southeast

11. The walls of the kiln [001a] – which occupies the southern end of the structure – are thicker at the corners so that its interior is circular in shape (to create a bowl-like structure for the kiln) measuring 2.4-2.6m in diameter. The southern wall only survives to a height of one course and it is possible that this was the location at which the flue entered the base (Figure 5b). No other obvious openings are visible in the surrounding walls. Traces of a possible scarcement can be seen roughly two thirds up the highest surviving western wall of the kiln (Figure 6a) but as only a small section is visible it is difficult to be certain.

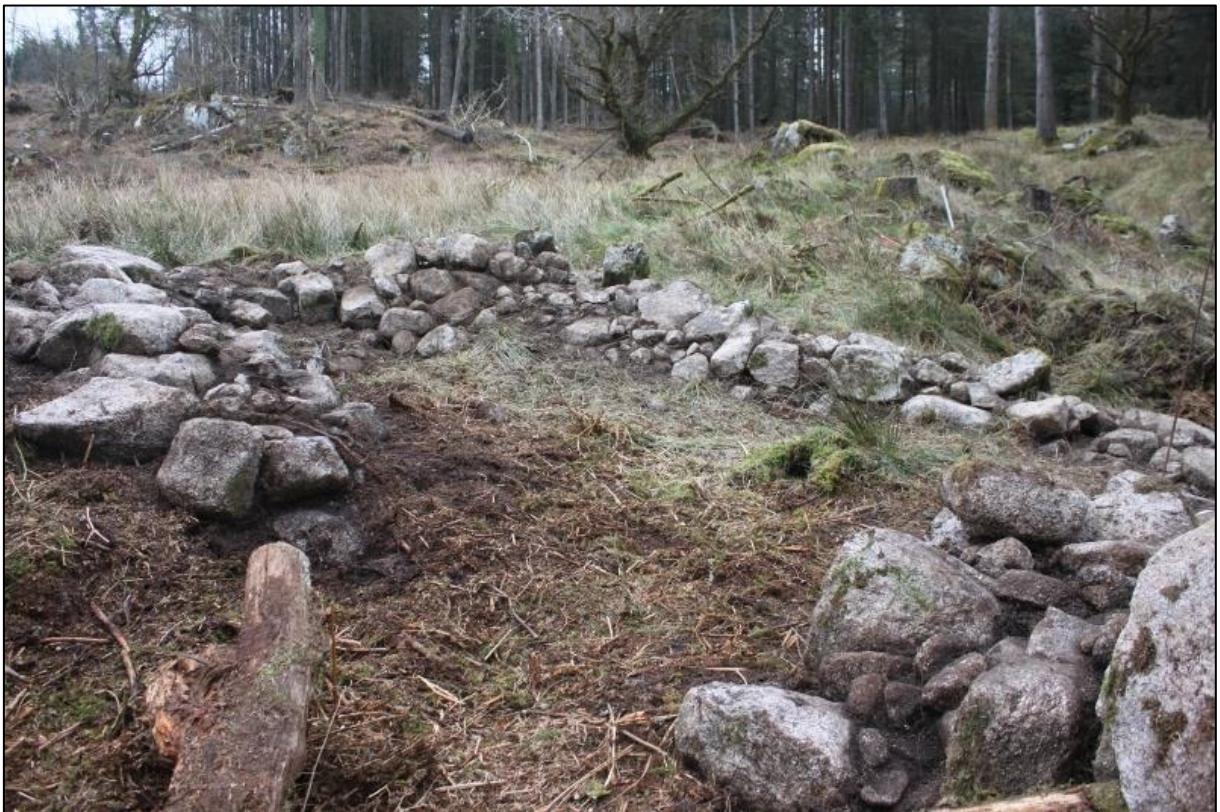
Figure 3b: General shot of barn [001b] from the west-southwest with entranceway in foreground

12. At the northern end, the barn [001b] measures approximately 2.5m wide (E-W) by 4.95m long (N-S) internally. There are no further subdivisions apparent within it, and an opening at the southern end of its western wall is likely to represent the only entrance (Figure 3b). This opening measures 1.6m wide.

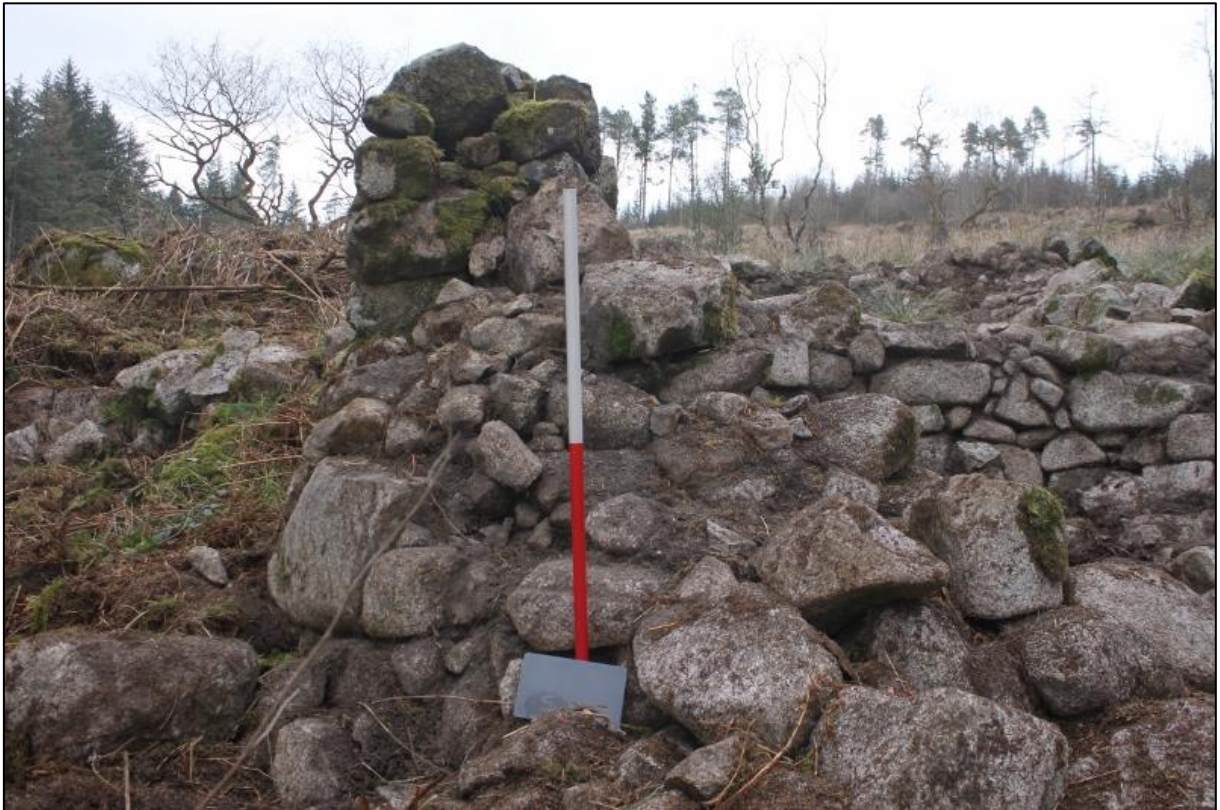
Figure 4a: Detail of cross-section of western wall of kiln [001a] from the south

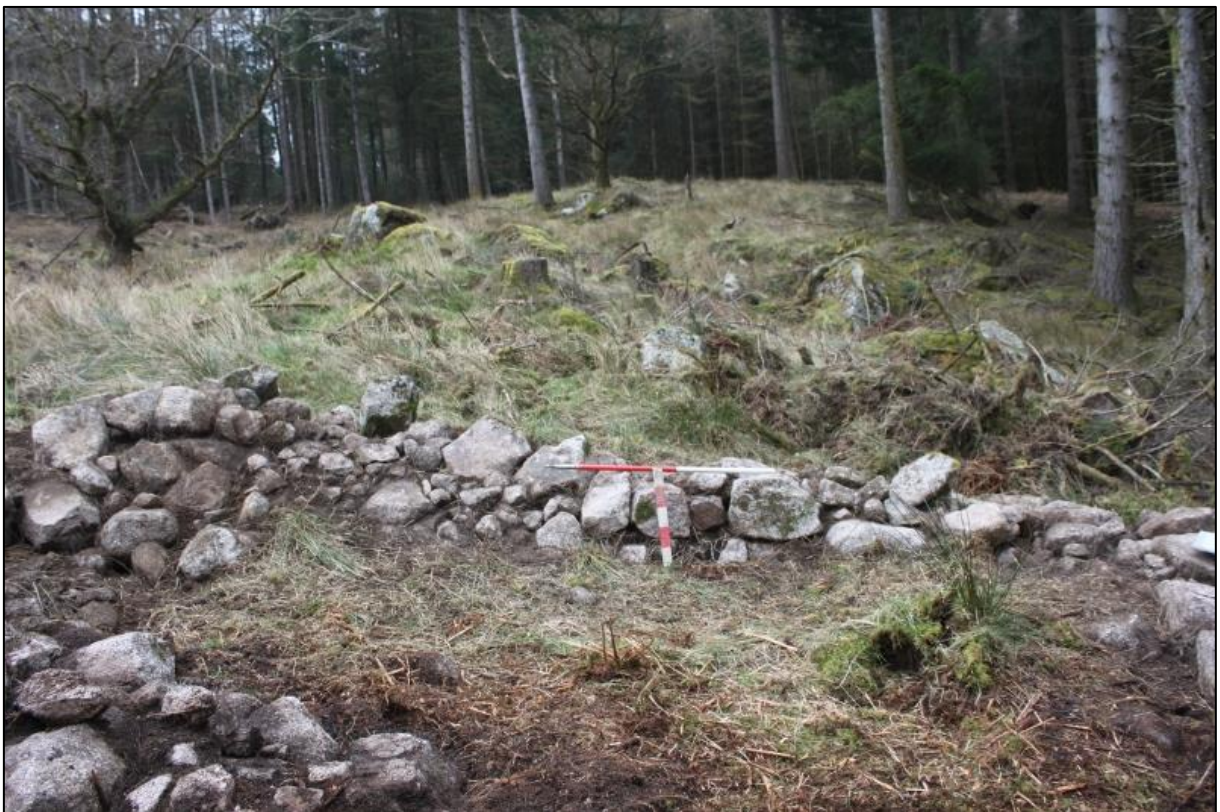
Figure 4b: Detail of eastern wall of barn [001b] from the west-northwest

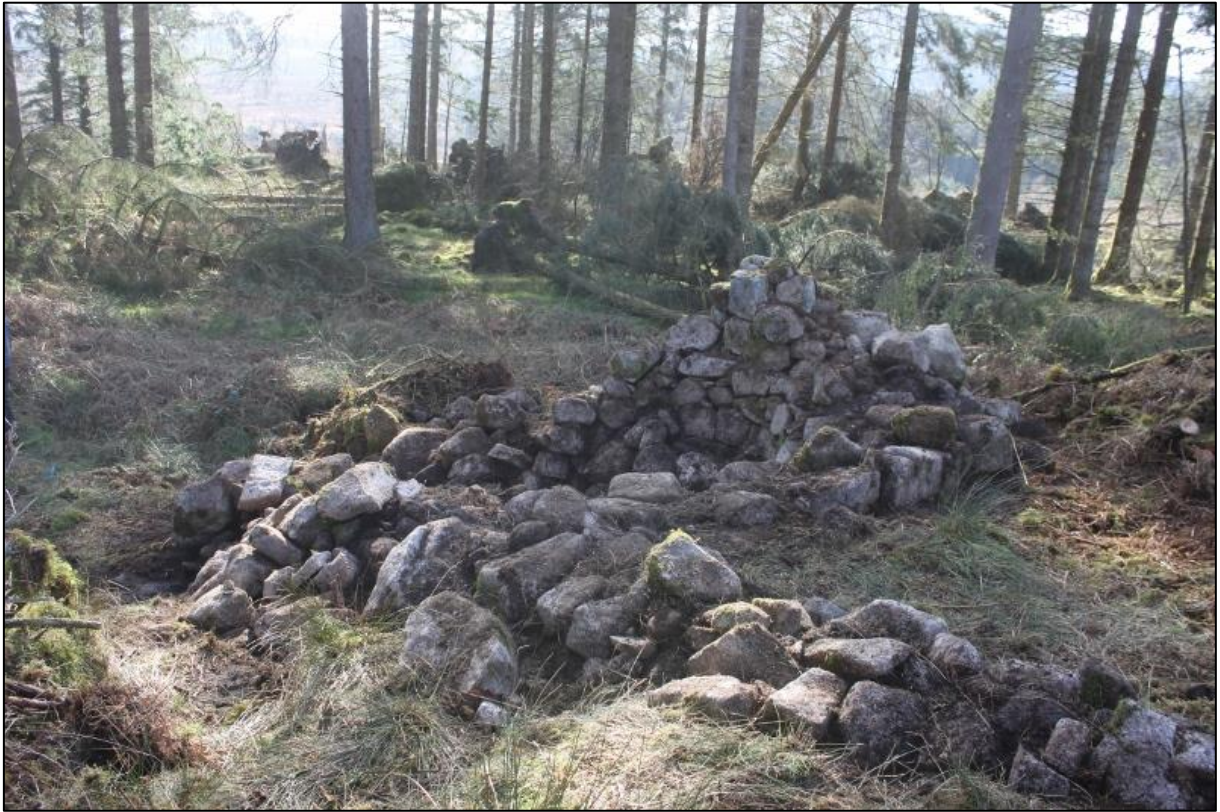
Figure 5a: Shot showing difference in height between barn [001b] on the right and kiln [001a] on the left, set into natural slope

26. The floor of the kiln sat lower than that of the barn which may have contributed to a higher survival of its walls. This step in height appears to have made use of a natural slope in the topography, although it is likely that the slope was at least partly cut into to form the near vertical drop seen in the northern wall of the kiln.

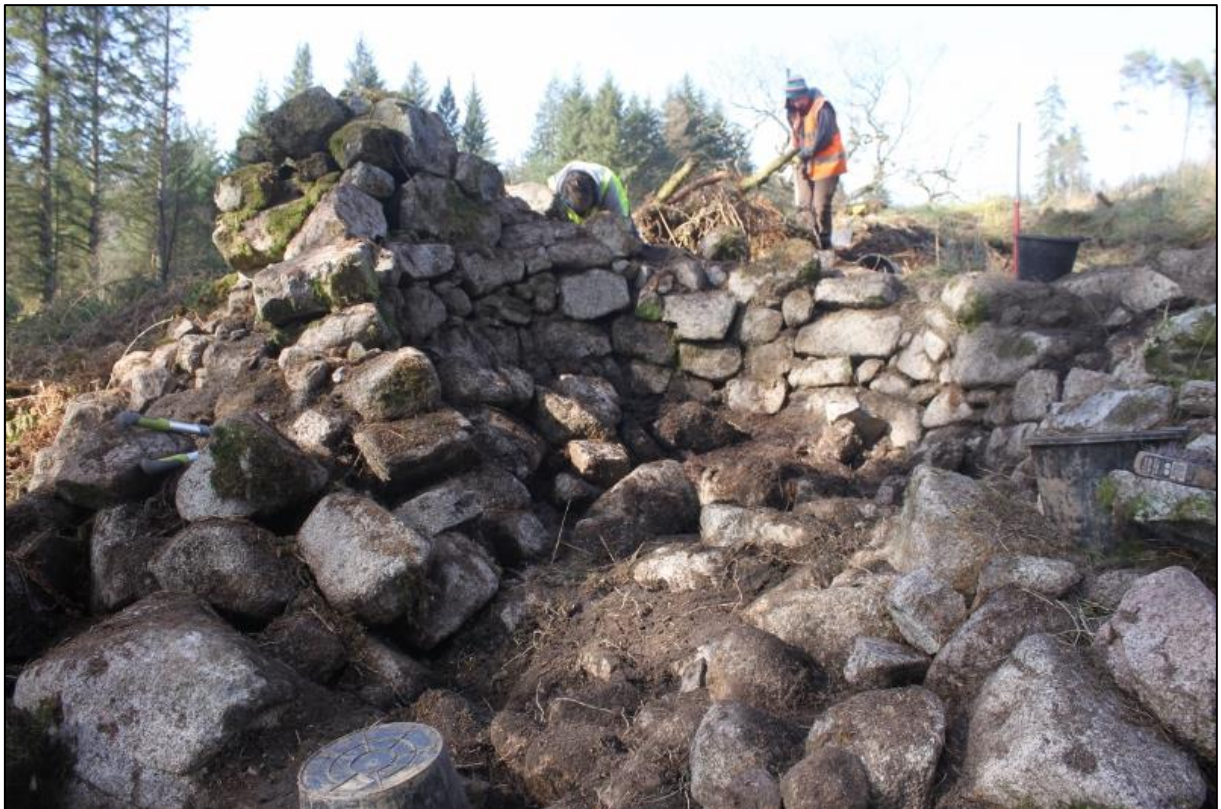
Figure 5b: Shot of kiln [001a] from the southeast showing possible site of flue

25. As stated, this phase of on-site works focussed on the site of the kiln barn, [001]. The entire structure was formed of drystone construction using unworked whinstone rubble. The barn portion consisted of a single rectangular compartment of which the basal footings of the external walls remained. There appeared to be only one entrance to the barn which entered from the exterior on the western side. The kiln occupied the southern end of the structure with the walls of the interior rounded to form a bowl shape. A dip in height along the southern edge of the kiln could represent varied survival, but is also a good candidate for the position of the flue.

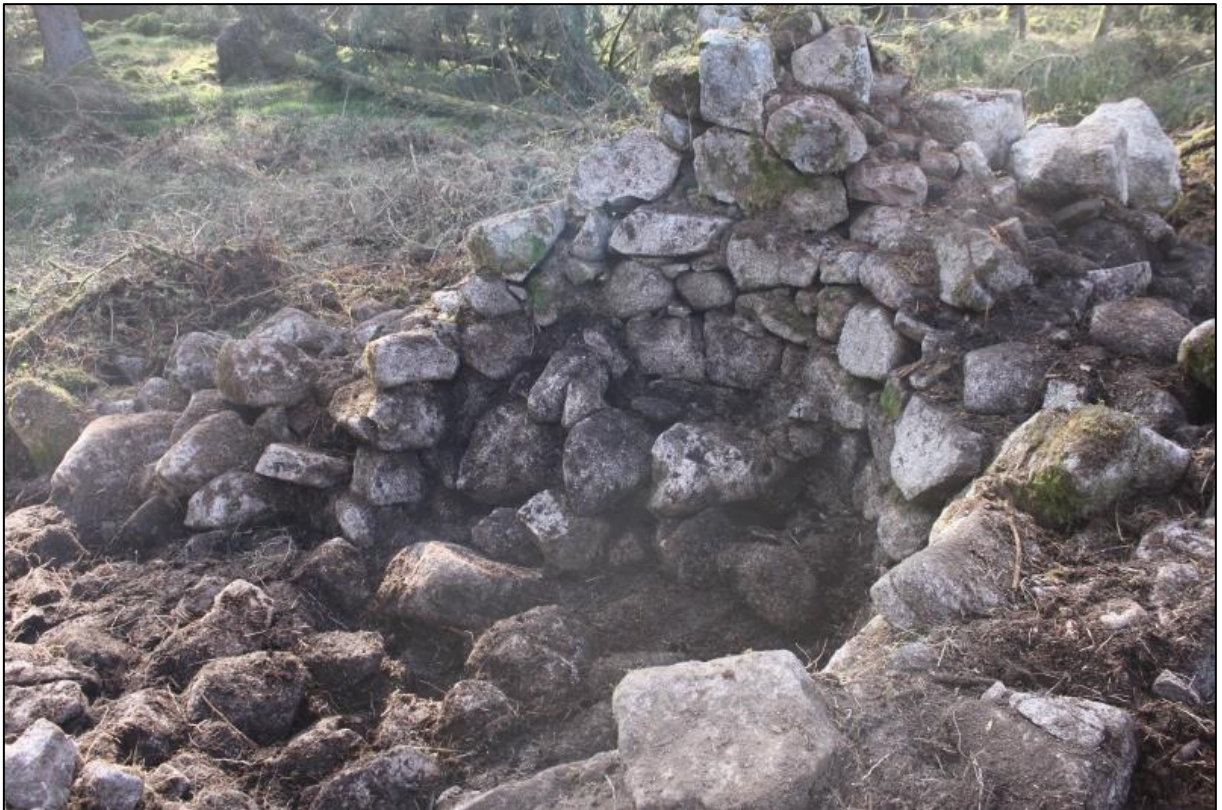
Figure 6a: Shot of kiln [001a] from the east-northeast showing higher western wall and tumble (006) across interior

17. Spreads of unworked whinstone rubble, identified as tumble from the walls, are present both within the interior of the structure and around its exterior. Within the interior of the barn [001b], the tumble (004) is built up against the internal faces of the walls on all four sides extending inwards to a width of between 0.4-1.3m. Prior to the works it was mostly overgrown. TP 1 revealed (004) to be between 0.25-0.48m thick (Figure 7a). Within the interior of the kiln [001a], the tumble (006) extends across the entire area (Figure 6a). As this area was not tested during this phase the thickness of this tumble remains unknown.

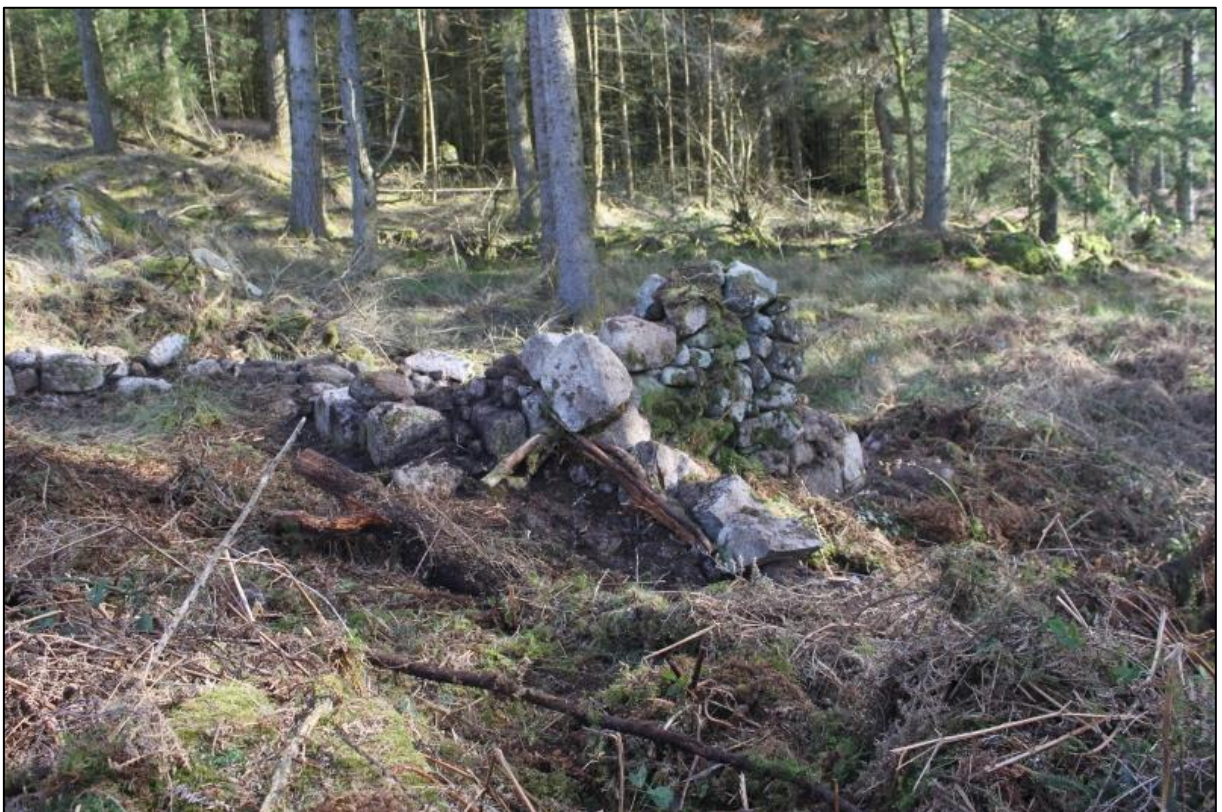
Figure 6b: Shot of possible boundary wall [007] from the northwest

13. Possible boundary wall [007] abuts the exterior of structure [001] on its western side (Figure 6b). It runs perpendicular to the structure on an E-W orientation and is of drystone construction with a single face of unworked whinstone rubble. It measures approximately 0.5-0.6m wide and survives to a height of two courses (approximately 0.6m). It was exposed for an approximate length of 2.8m although continues further to the west beyond the cleared area. It appears to be set into the side of the natural slope and may have also been intended to act partly as a revetment.

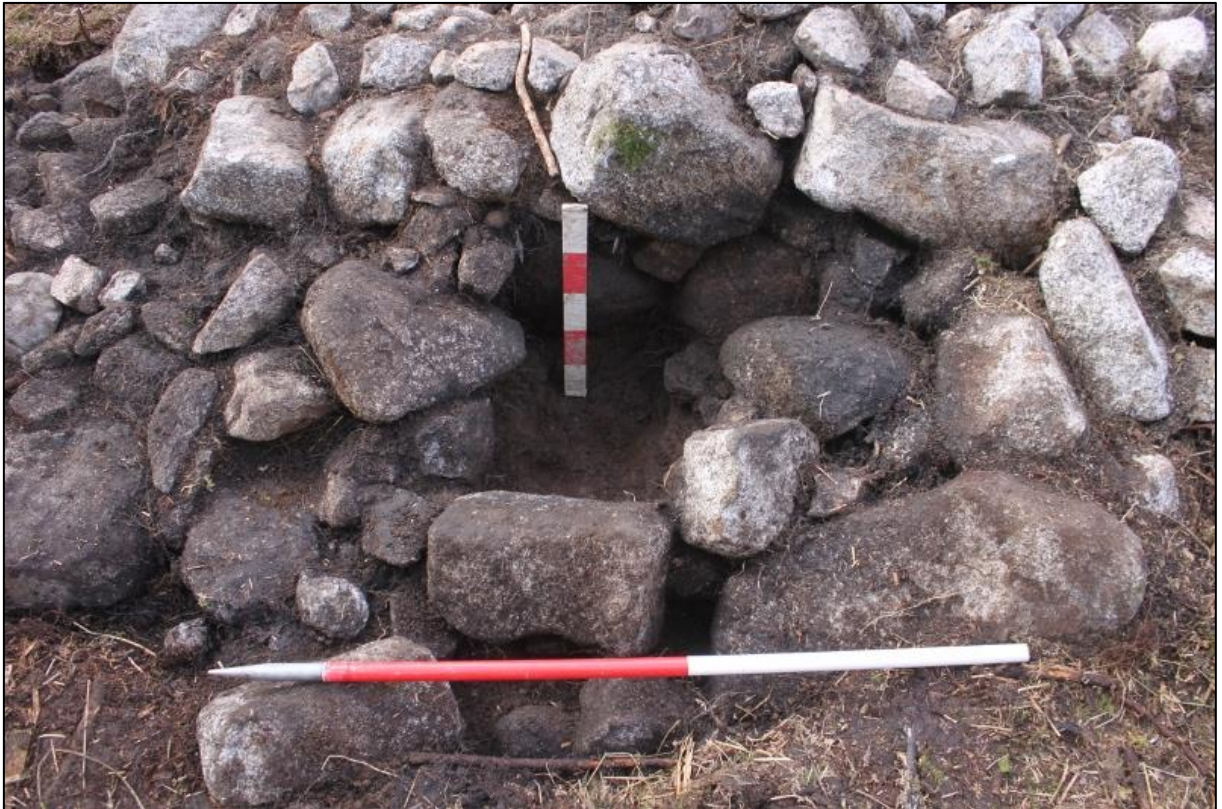
Figure 7a: Shot of sondage in TP 1 from the east showing tumble (004), and possible subsoil (003) at the base

19. At the base of TP 1, possible subsoil (003) was exposed (Figure 7a). This consisted of moderately compacted mid- orange-brown clayey sand with occasional small stone inclusions. It sat underlying both the topsoil (002) and the tumble (004), and also looked to be underlying the walls of the structure [001] itself. As only a small sample of this deposit was exposed at this stage though, its exact interpretation remains unclear.

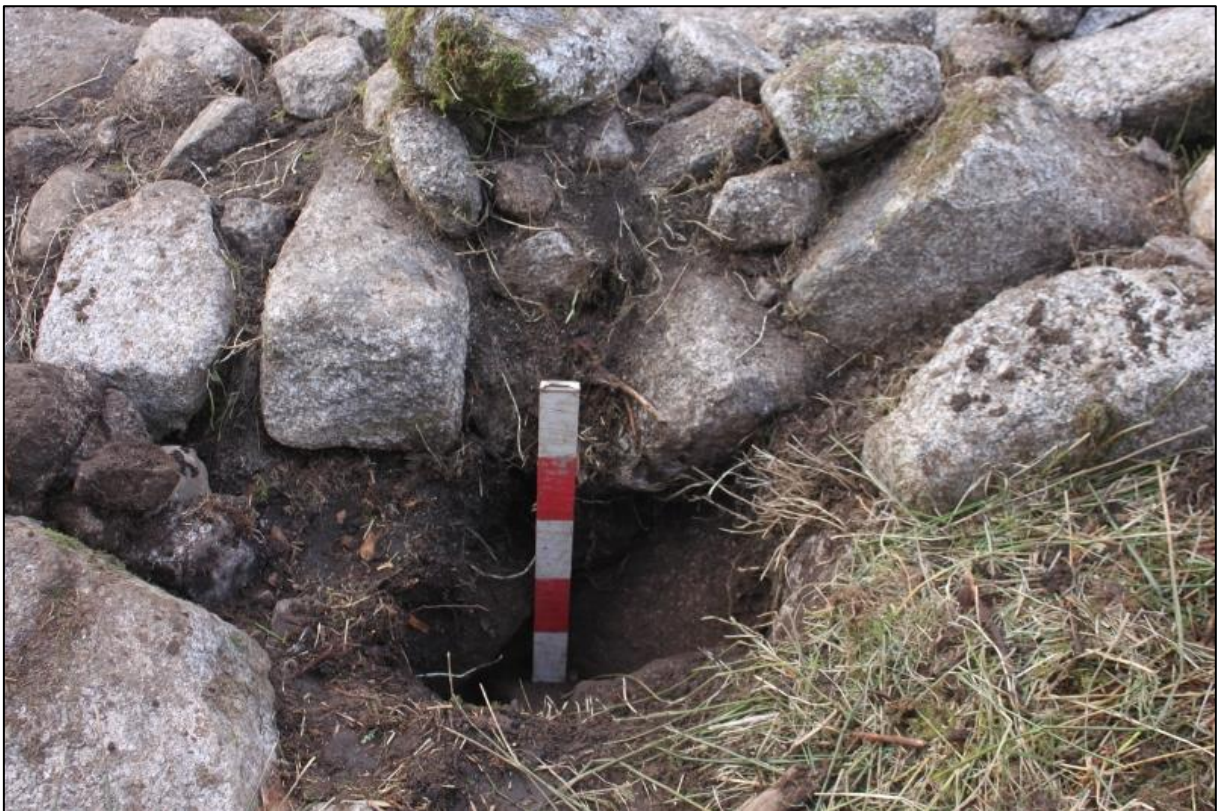
Figure 7b: TP 3 from the east showing tumble (005)

18. Around the exterior of the entire structure, built up against the external wall faces on all four sides, sits tumble (005). This extends outwards for the walls for a width of between 0.4-0.7m. TP 3 was excavated to a depth of 0.4m (Figure 7b) but did not reach the base of the tumble in this area so its full depth is uncertain.

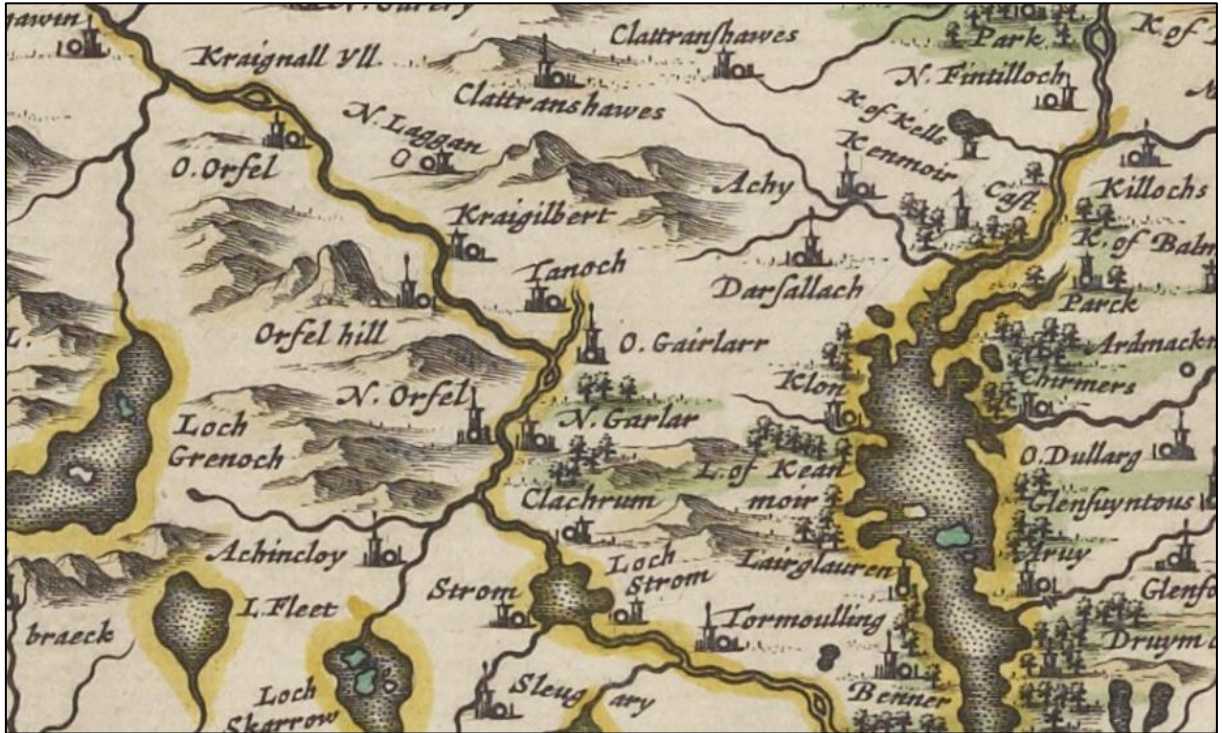
Figure 8a: Extract from Blaeu's Atlas of Scotland, Gallovidia (Galloway), 1654

23. As already described in the Research Design (Turner & Rees 2019), the first detailed depiction of the farmsteading at Upper Gairloch can be seen on the 1st edition Ordnance Survey map of 1852, although earlier origins are hinted at by the presence of the name 'O. Gairlarr' (i.e. Over Gairlarr) visible on Blaeu's map of 1654 (Figure 8a). In 1852, the steading is shown as a spread of two roofed and four unroofed buildings with an accompanying field system (Figure 8b). Structure [001] is visible to the northeast of the main steading as an unroofed building labelled 'Old Kiln (in ruins)', and the depiction of a boundary line running out of its western side corresponds nicely with possible boundary wall [007].

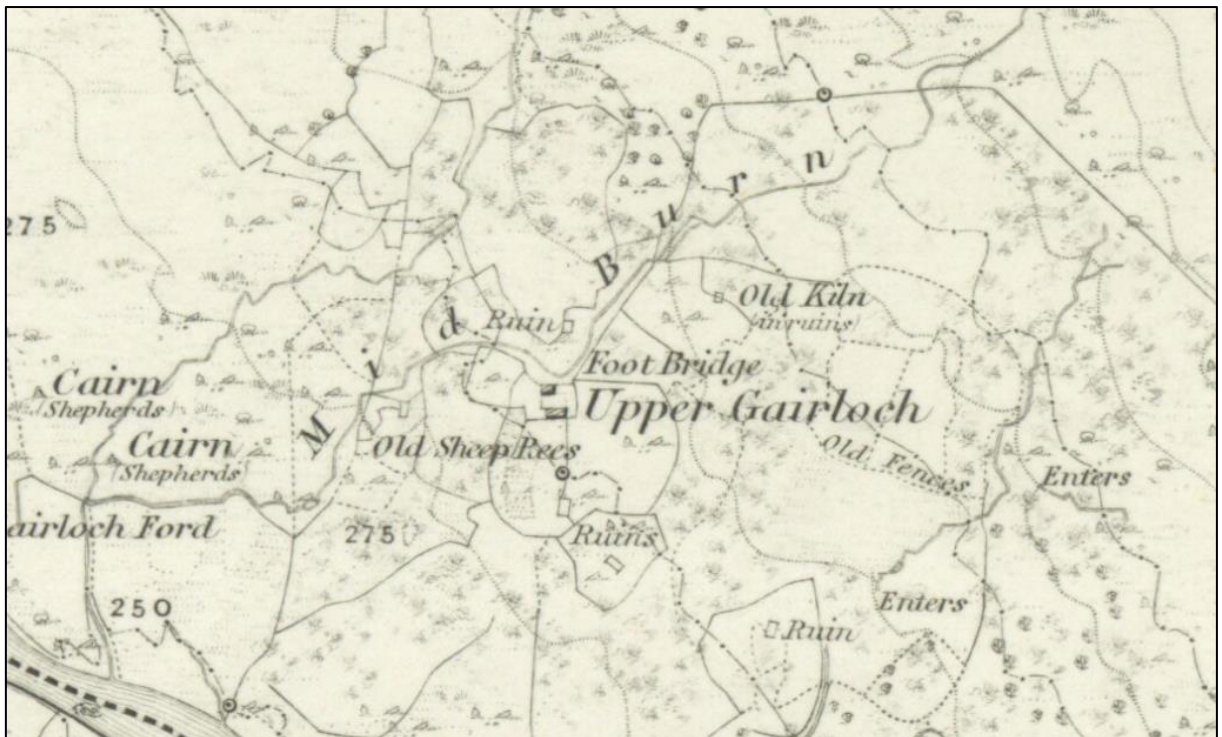
Figure 8b: Extract from 1st edition Ordnance Survey map published 1852
