Lennox Church, Dumbarton: Archaeological Mitigation

Data Structure Report

issued 23rd October 2018

on behalf of C & S Architects

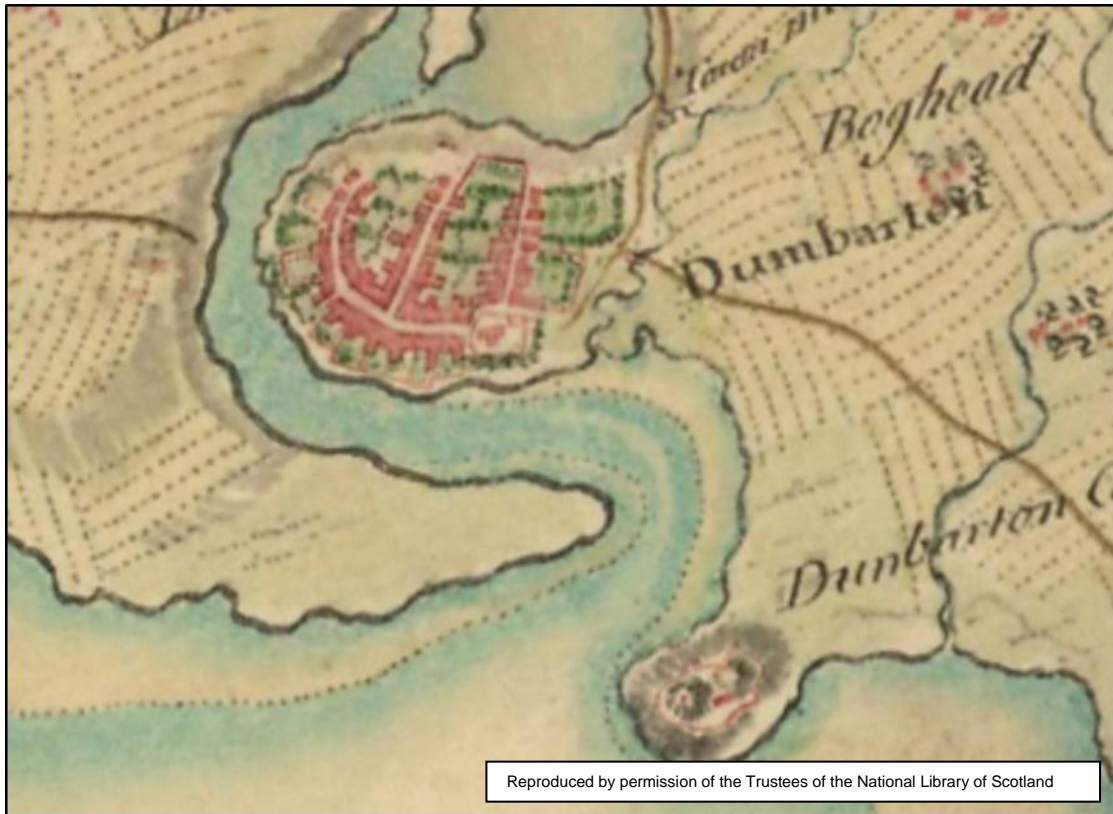
Figure 1a: Roy's Military Survey of Scotland (1752-55)

5. Dumbarton is first depicted on Timothy Pont's map of Scotland (1583-96) which shows both the castle and the town. A later map from the 17th century (Gordon 1636-52) shows a more detailed layout with the original medieval burgh lying on the north bank of the River Leven. William Roy's map of 1752-55 (Figure 1a) shows High street with buildings on either side and wooded or garden areas to the rear of these buildings in what would have been the original medieval burgage plots.

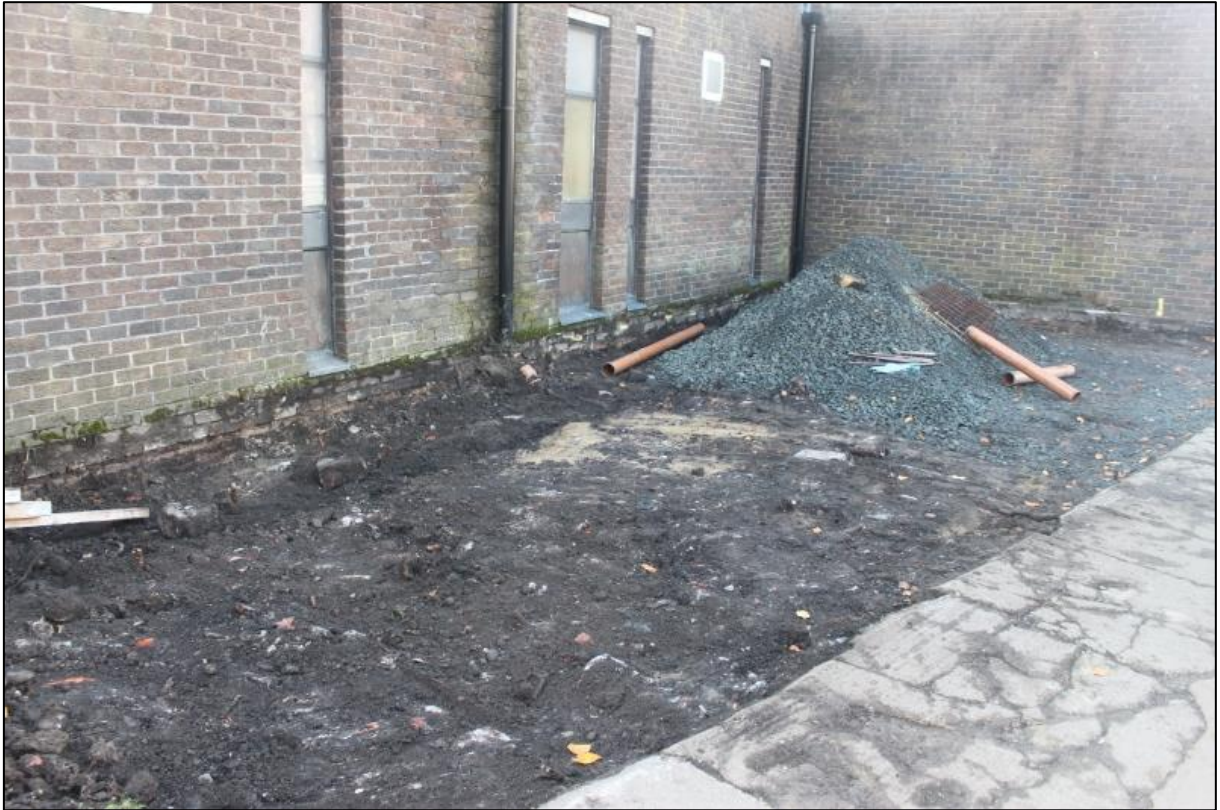
14. The entire development area was stripped of topsoil which had a depth of between 0.2 and 0.25m. The topsoil (001) consisted of a moderately loose dark black brown clay with frequent inclusions of plastic, brick, metal and large roots. Throughout the development area the topsoil was underlain by a loose dark brown made ground deposit of clayey silt (002) with frequent inclusions of sand, brick, metal and stone (Figure 3a).

Figure 3a: Post-excitation shot of development area showing made ground (002). Photo taken from the north.

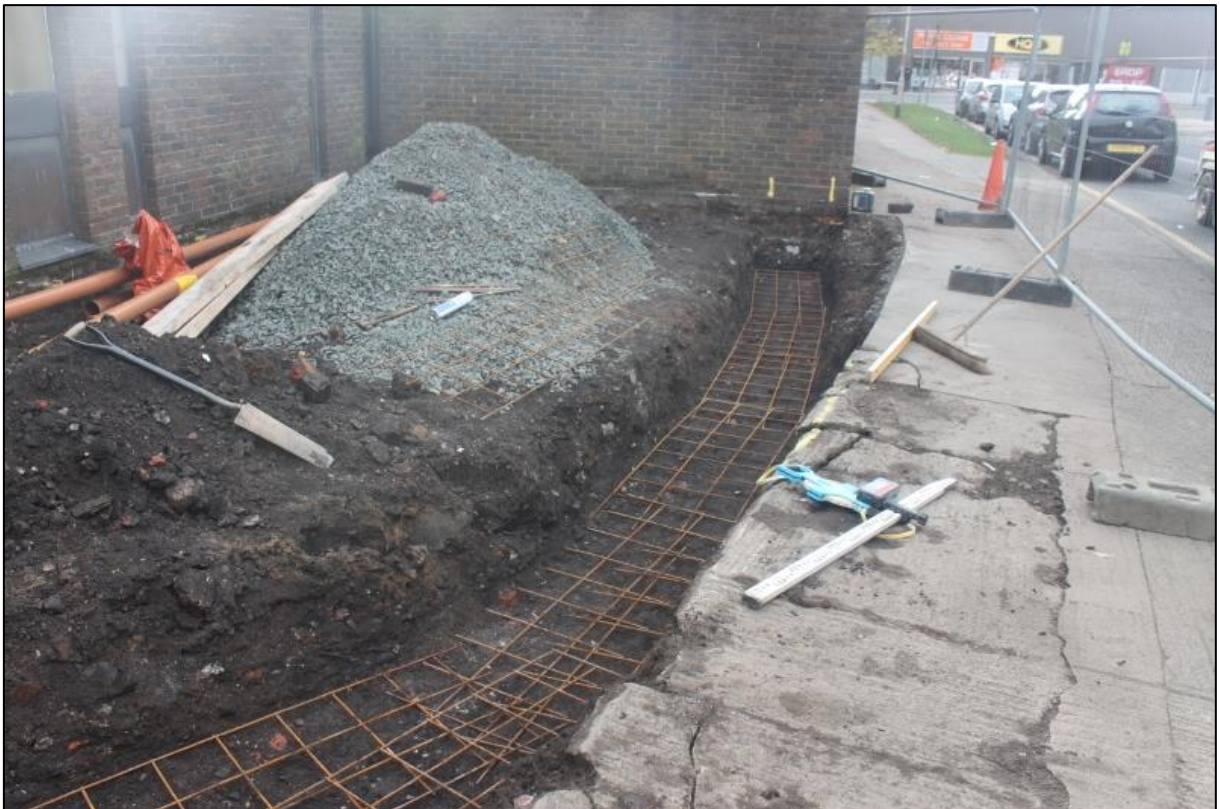
15. The foundation trench ran southwest-northeast along the northwestern perimeter of the reduced area for 6.76m before turning to the northwest-southeast for a further 4.3m until it met the wall of the existing church (Figure 2). The trench was between 0.84m and 1.1m wide, and was excavated for a further 0.45m in depth (Figure 3b).

Figure 3b: Post-excitation shot of foundation trench. Photo taken from the north.

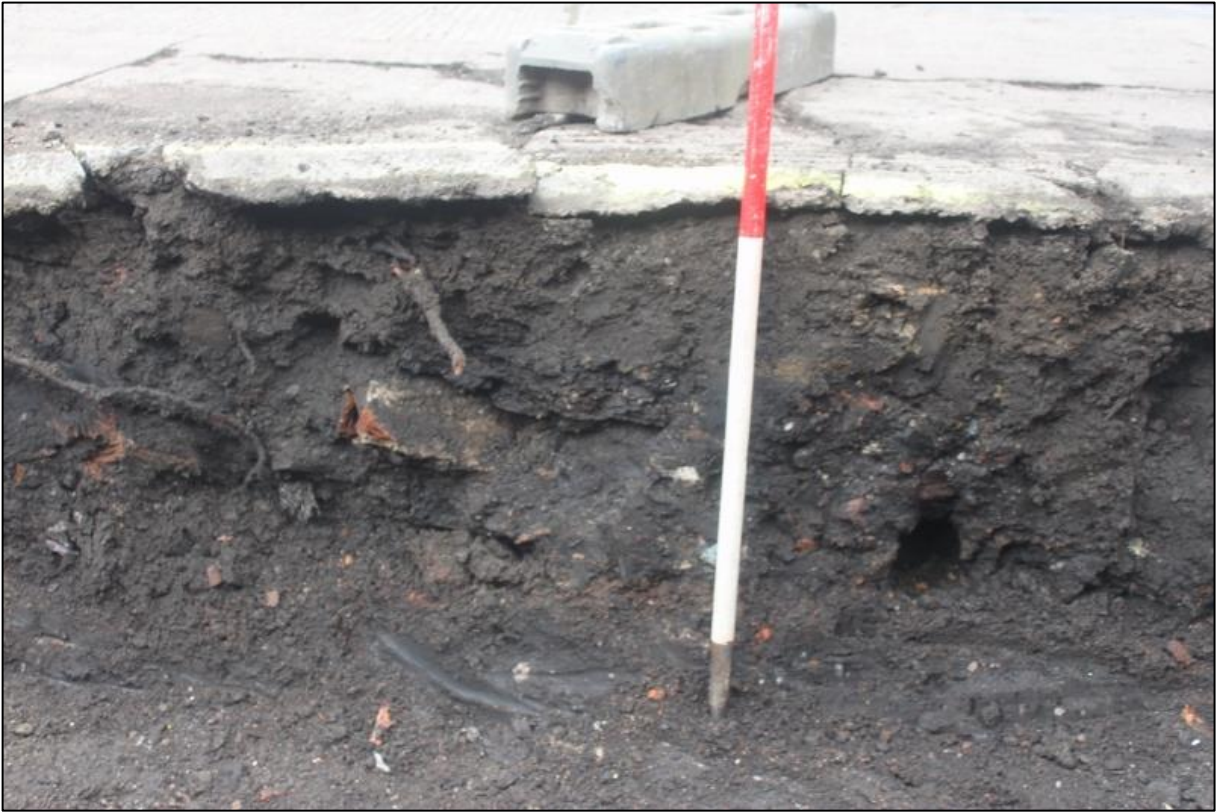
16. The trench was excavated through made ground (002) which had a depth of 0.35m. (002) was underlain by made ground (003): a moderately compact mid- to dark black brown clay with frequent small brick and charcoal inclusions. This deposit was excavated to a maximum depth of 0.7m below street level (Figure 4a).

Figure 4a: Section shot of foundation trench adjacent to pavement. Photo taken from the southeast.

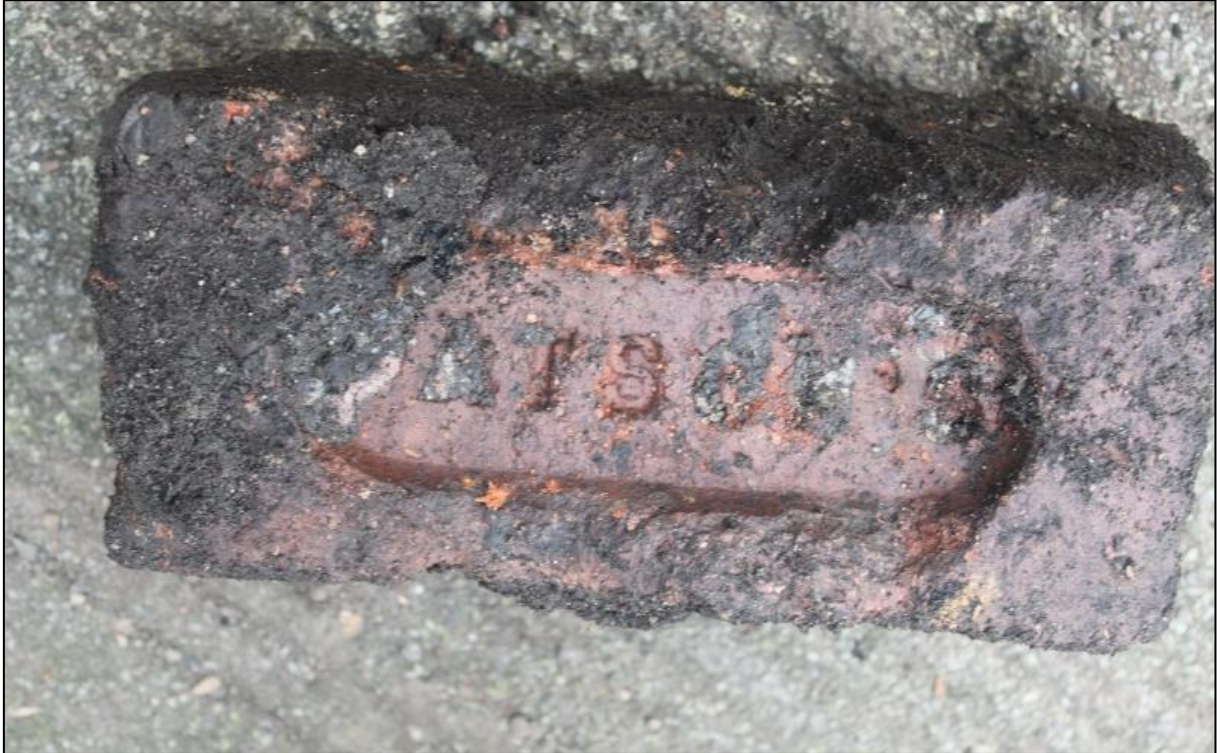
Figure 4b: Detail shot of brick showing stamp "WATSON'S".

20. The second brick was red and measured 0.21m long by 0.1m wide by 0.09m thick. It was stamped "WATSON'S" within an oval frog (Figure 4b). This brick was produced by John Watson & Sons Brick Manufacturers in Armadale, West Lothian. This company was in business between 1859 and 1874 (Scotland's Brick Manufacturing Industry).
