# **Inverquharity Farm, Kirriemuir: Archaeological Watching Brief**

Data Structure Report

issued 21<sup>st</sup> May 2018

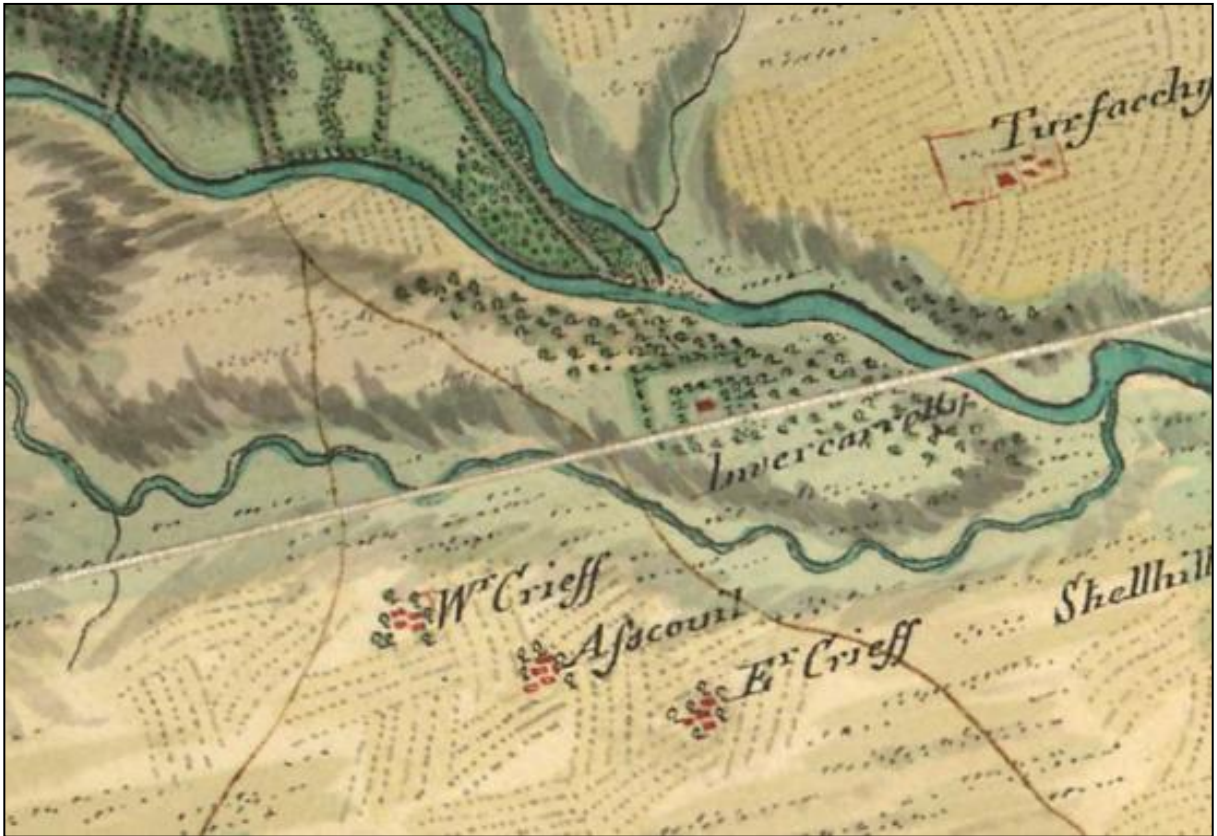
9. Regarding the development area, William Roy's *Military Survey of Scotland, Highlands* (1747-52) (Figure 1a) is the first to provide a depiction of the area of Inverquhariry. Roy depicts the site of the 15<sup>th</sup> century Inverquhariry Castle (Canmore ID: 33734, ACAS HER: NO45NW3) as a single structure surrounded by a designed wooded landscape in the shape of two squares.

Figure 1a: Extract from Roy's *Highland Military Survey* (1747-52)

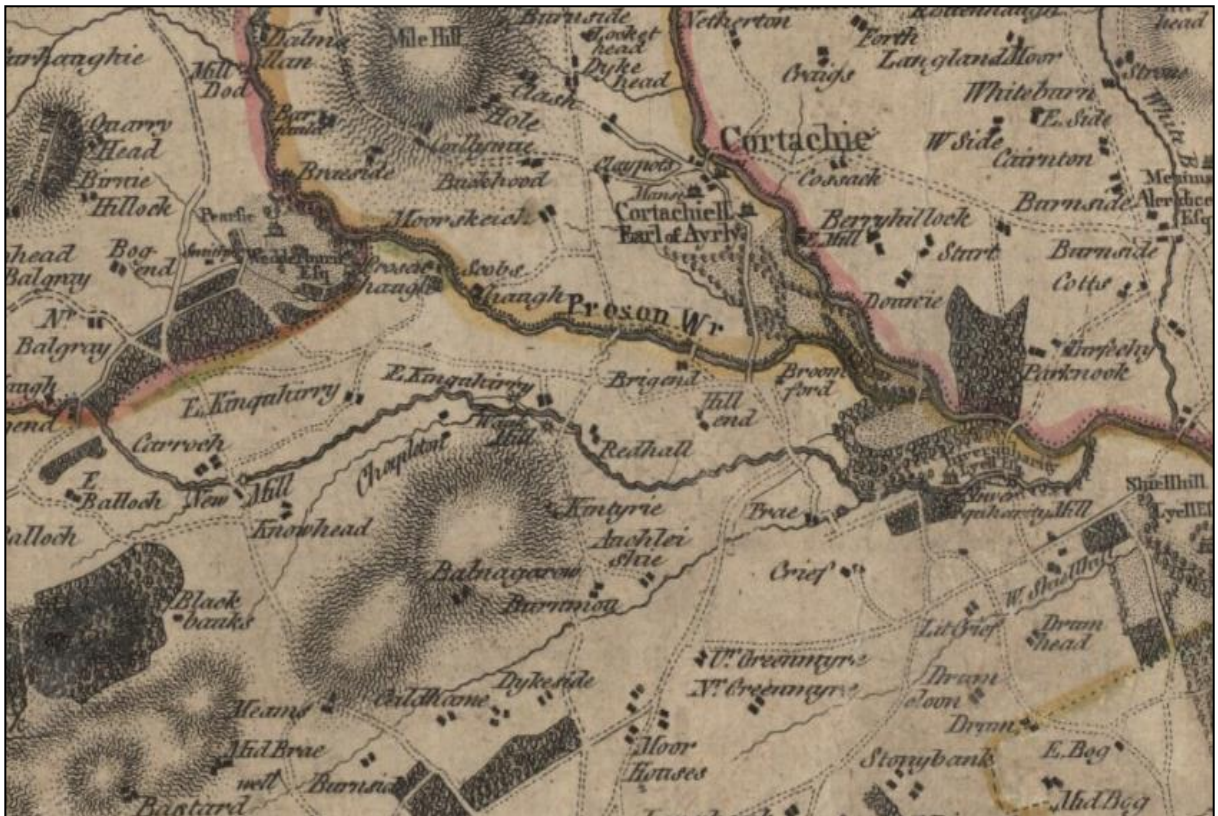
10. John Ainslie's *Map of the County of Forfar or Shire of Angus* (1794) (Figure 1b) similarly depicts the area of Inverquhariry Castle surrounded by a wooded landscape but not the designed elements depicted by Roy (1747-52).

Figure 1b: Extract from Ainslie *Map of the County of Forfar or Shire of Angus* (1794)

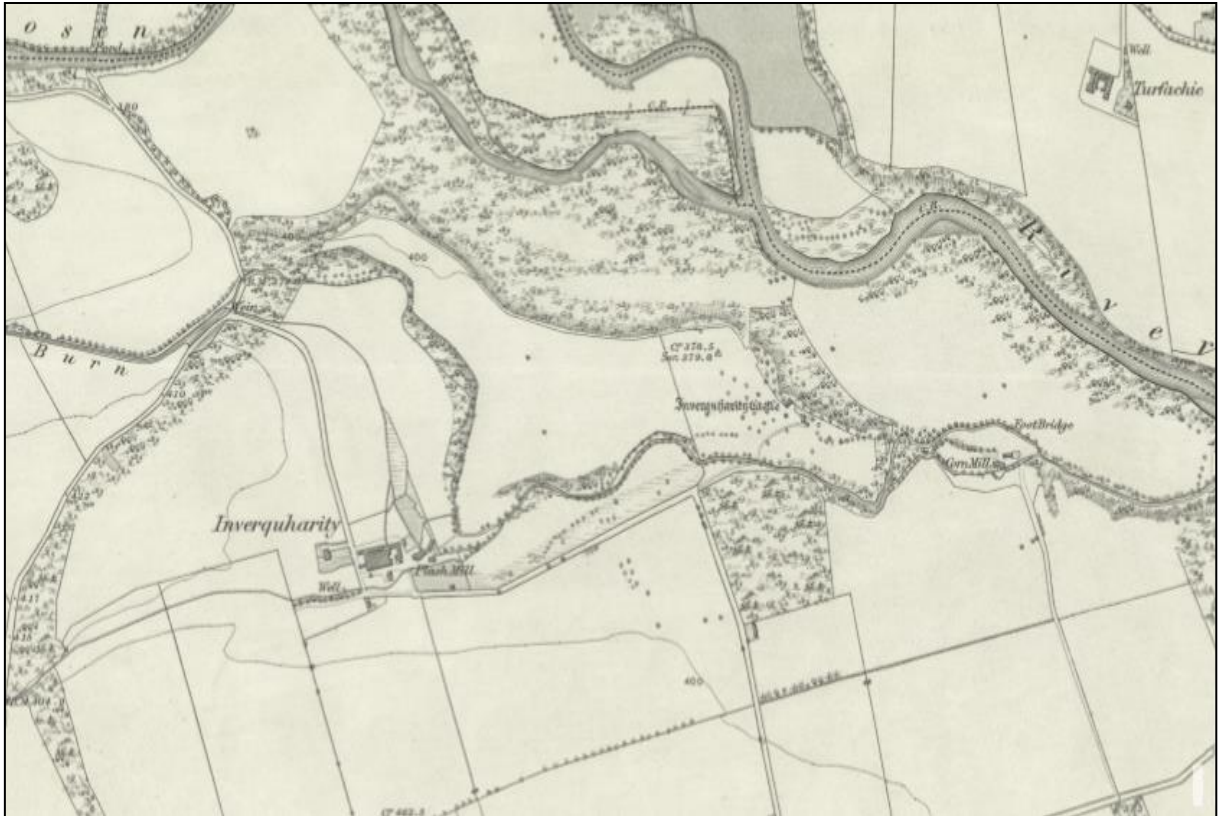
11. The 6-inch 1<sup>st</sup> edition Ordnance Survey (1865) (Figure 2a) is the first to depict Inverquhariry Farm. The farm is a substantial area of buildings and depicted as roughly rectilinear. Regarding the area for development, this is an open field. There has been little change in the 6-inch 2<sup>nd</sup> edition Ordnance Survey (1903) (Figure 2b) and the 1:25,000

Figure 2a: Extract from the 6-inch 1<sup>st</sup> edition Ordnance Survey Forfarshire, Sheet XXXII (includes: Kirriemuir; Oathlaw; Rescobie; Tannadice) (1865)

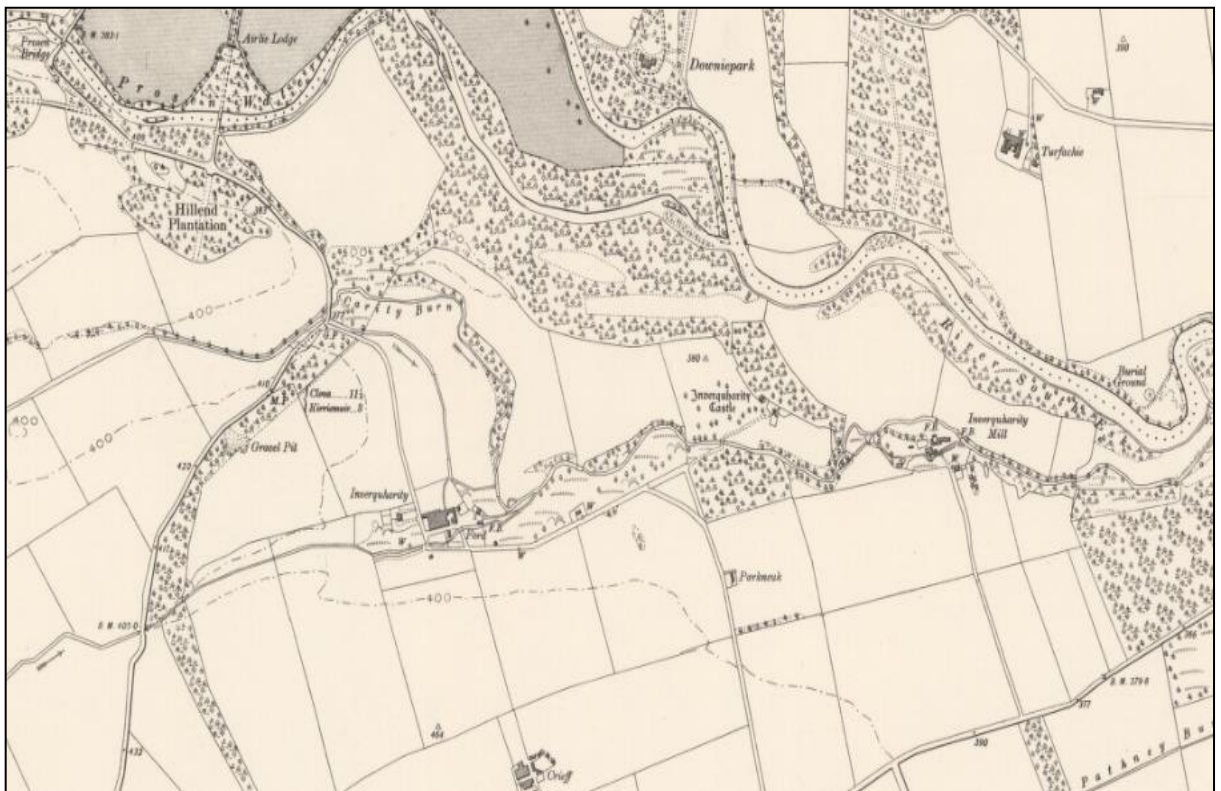
Figure 2b: Extract from the 6-inch 2<sup>nd</sup> edition Ordnance Survey Forfarshire, Sheet XXXII.NW (includes: Cortachy and Clova; Kirriemuir; Oathlaw; Tannadice) (1903)

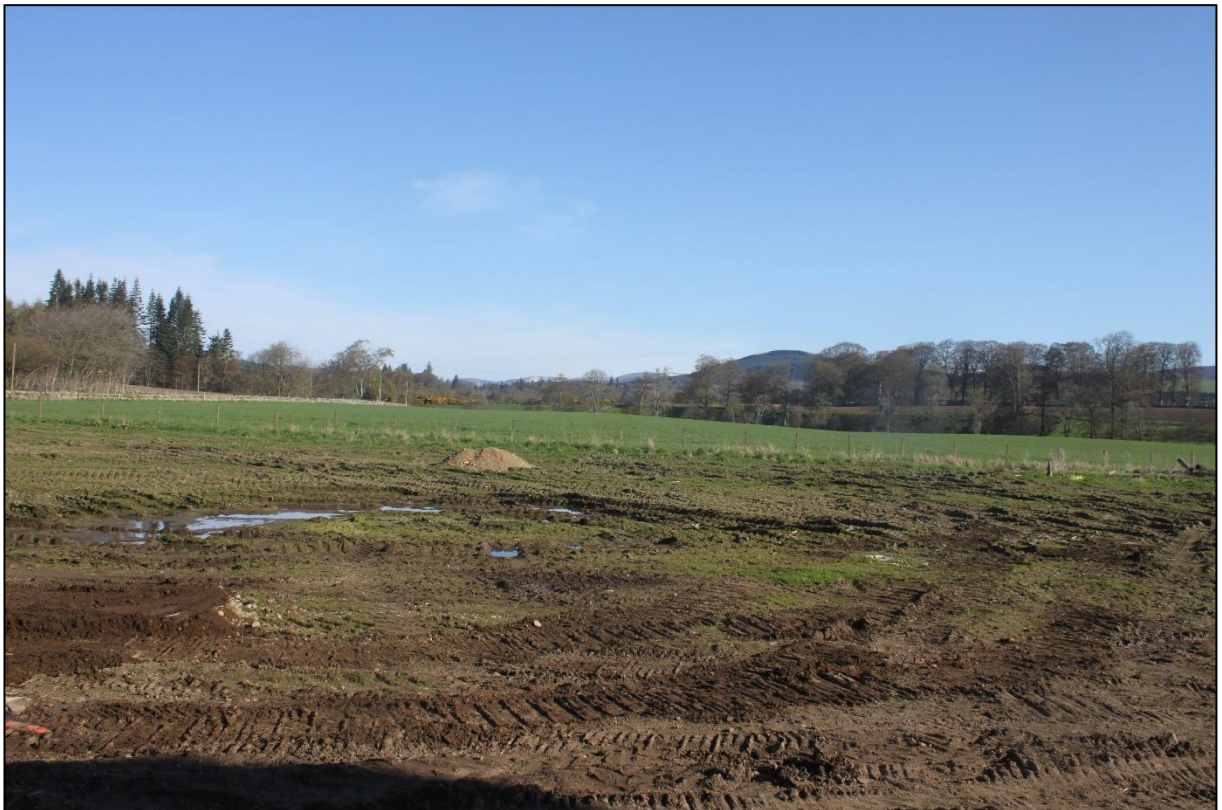
Figure 3b: Shot of enclosed development area pre-excitation from the south

14. The development area sat within an enclosed yard directly north of the farm (Figure 3b), separated by an access track. The shape of the area was sub-rectangular in plan, running roughly east-west, measuring approximately 83m in length by 45m wide (Figure 4).

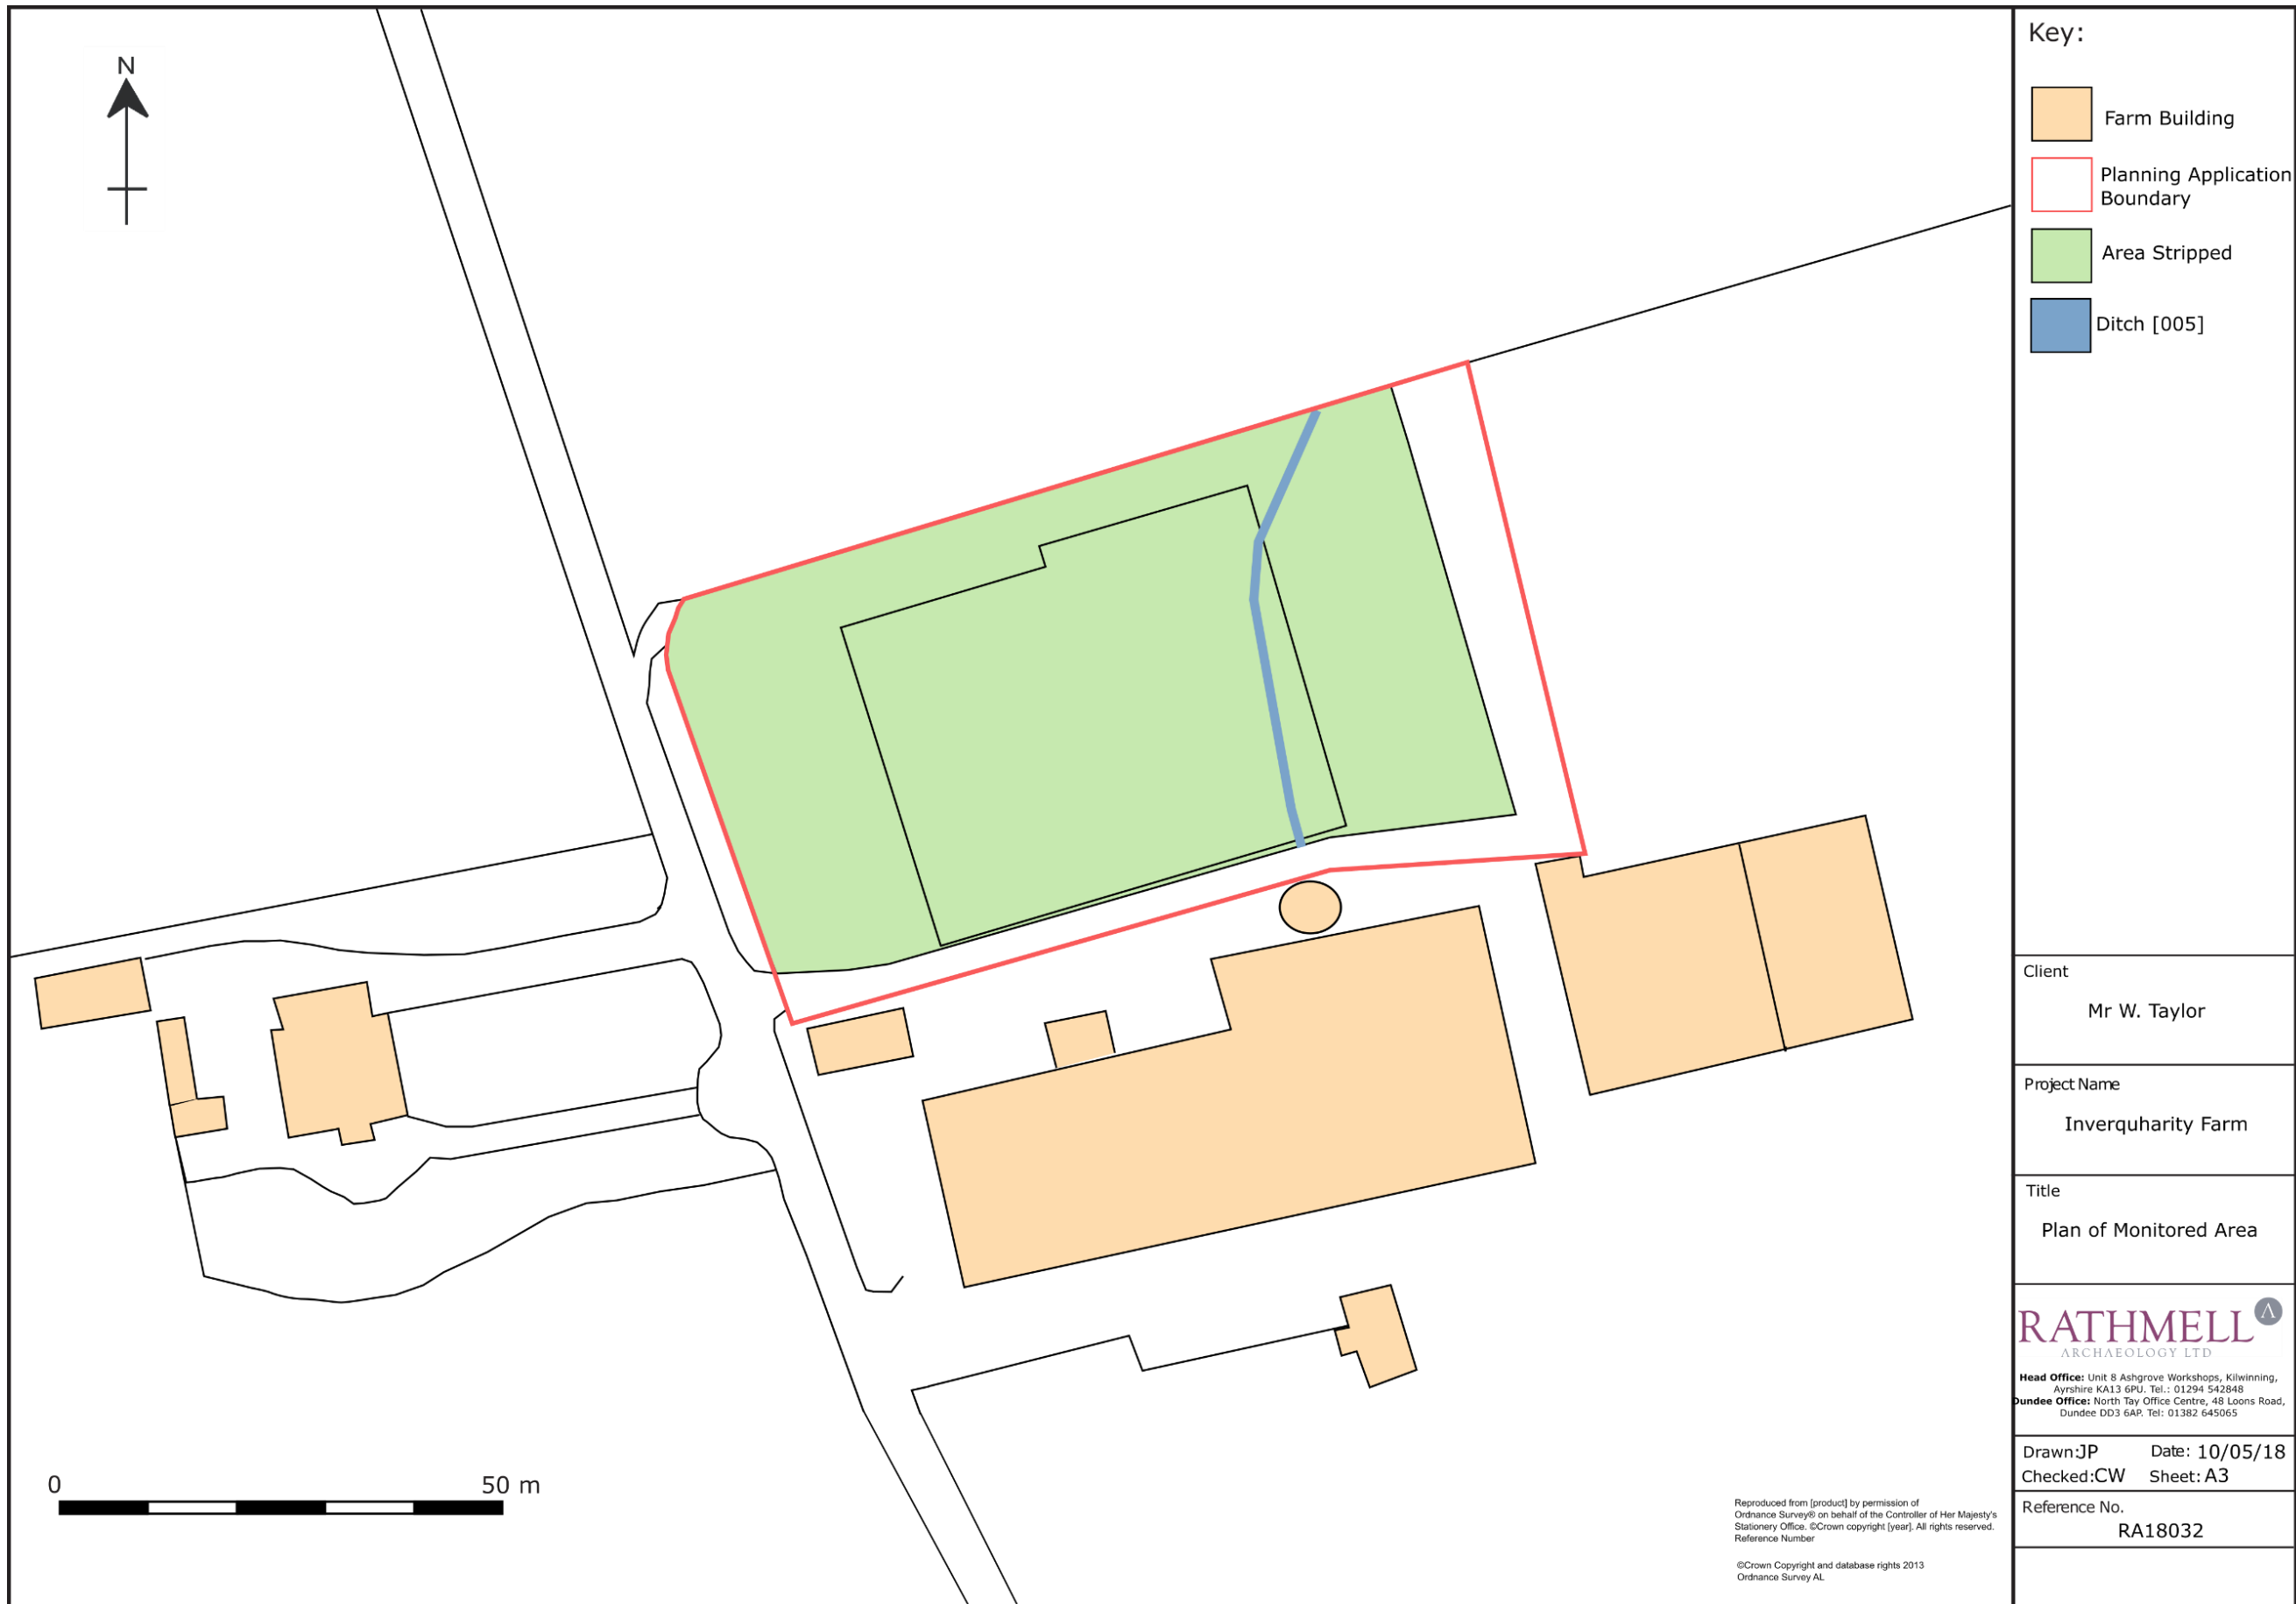
Figure 4: Plan of monitored area

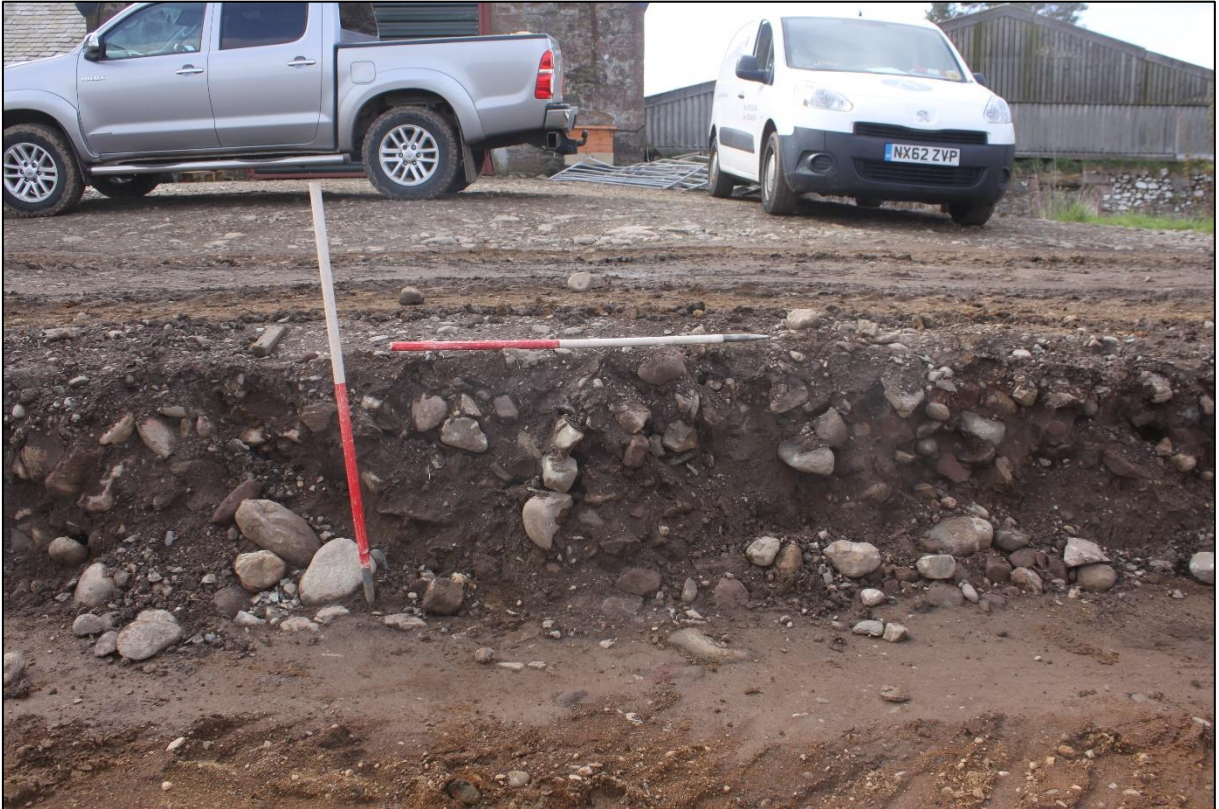
15. Prior to excavation, the existing topsoil within the development area (003) comprised a friable, mid grey brown sand silt with small stone inclusions. This topsoil layer had a maximum thickness of 0.6m. Along the southern extent of the area, which was being used as the current access track for the farm, the topsoil comprised (002), a compacted, dark grey brown, sandy silt with large stone inclusions extending for a maximum length of 60m (stopping roughly 20m in from the eastern edge), a width of 4m and thickness of 0.6m (Figure 5a).

Figure 5a: North facing section of (002) along southern limit of excavation

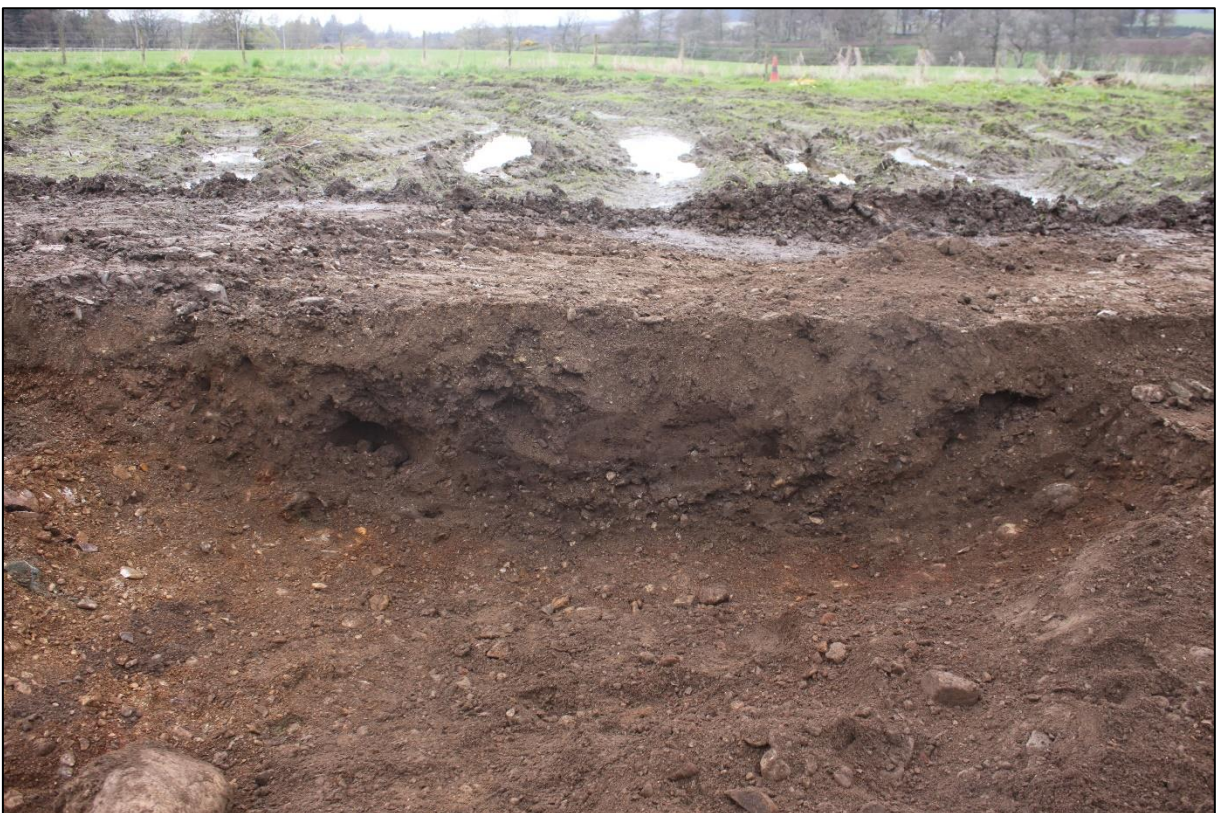
17. Starting from the southern edge, approximately 60m in from the western end, ditch [005] was identified orientated south-north. [005] had gently sloping sides and a flat base. Measuring approximately 50m in length, 3m wide and 0.65m deep, it was filled by (006): a friable, dark grey brown, silt sand, with small to large stone inclusions (Figure 5b).

Figure 5b: South facing section of [005], possible sluice off mill lade

presence of an additional offshoot which runs from the mill lade to the southwest and into Inverquhariry Farm, first shown on the 1<sup>st</sup> edition Ordnance Survey of 1865; this appears to be a match for ditch [005]. While on site, the client's father identified this ditch as acting as a sluice to feed an internal water wheel that powered the electrics on the farm; the ditch then infilled by his father during the mid-20<sup>th</sup> century (pers. comm., 2<sup>nd</sup> May 2018) with its last depiction on the mapping appearing on the 1:25,000 Ordnance Survey of 1957.

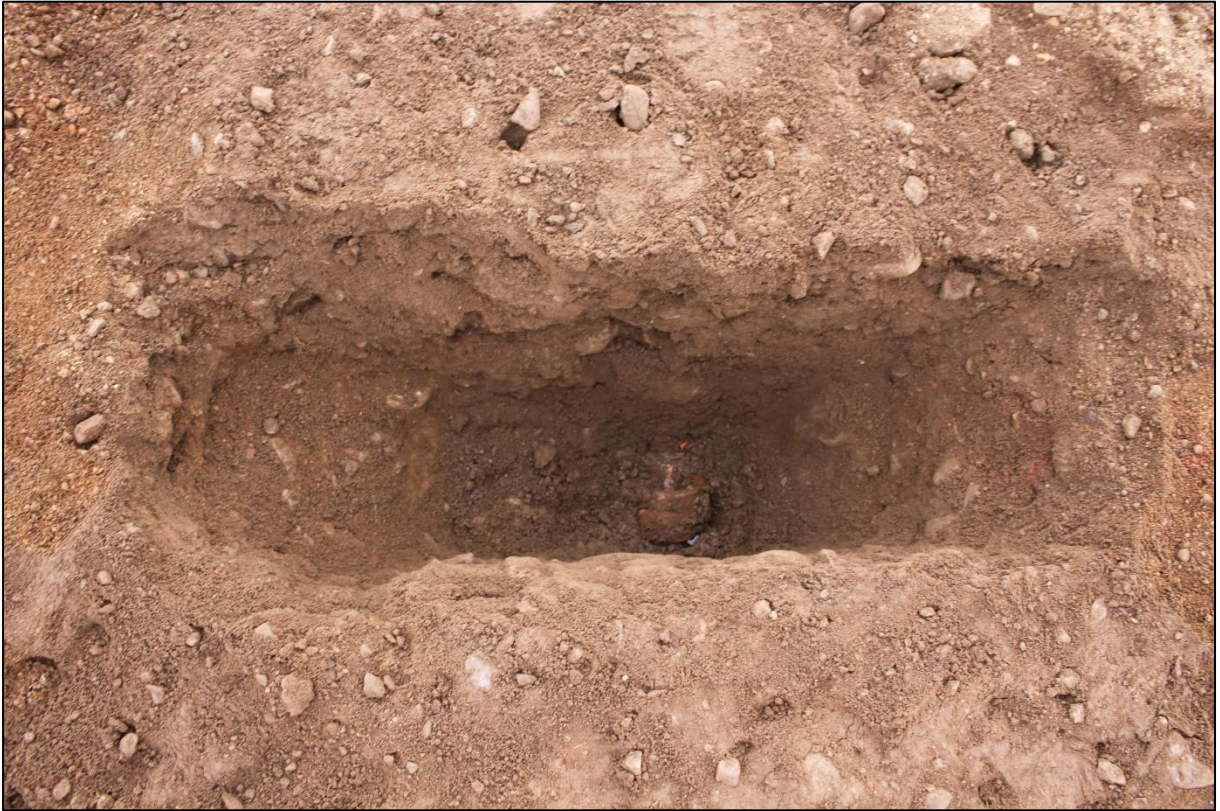
18. In the southwestern corner of the site, a red tile field drain [007] was observed running south-north then curving to run to the east. The drain measured 0.1m in diameter and sat at the base of a steep sided V-shaped cut which measured approximately 50m in length by 1.3m wide by 0.6m deep. [007] was filled by (004), a friable, mid-orange brown, silty sand, with small to medium stone inclusions (Figure 6a).

Figure 6a: [007] southwest-northeast running red tile drain

20. The activity identified within the development area, such as red tile drain [007], reflects 19<sup>th</sup> century improvements to landscape and drainage management; common practice in the 19<sup>th</sup> and early 20<sup>th</sup> centuries to help to improve the productivity of farms. The presence of furrows [008] also attesting to agricultural use of the land.
21. Of particular interest was the presence of ditch [005]. This appeared to have acted a sluice which fed from a mill lade situated to the north of the farm. This mill lade can be seen on Ordnance Survey mapping throughout the 19<sup>th</sup> and 20<sup>th</sup> centuries running to a 'Plash mill' depicted to the east of Inverquhariry Farm (Figure 2a). Plash mills or 'Splashing mills', were used to clean and work yarn throughout Scotland. These maps also depict the

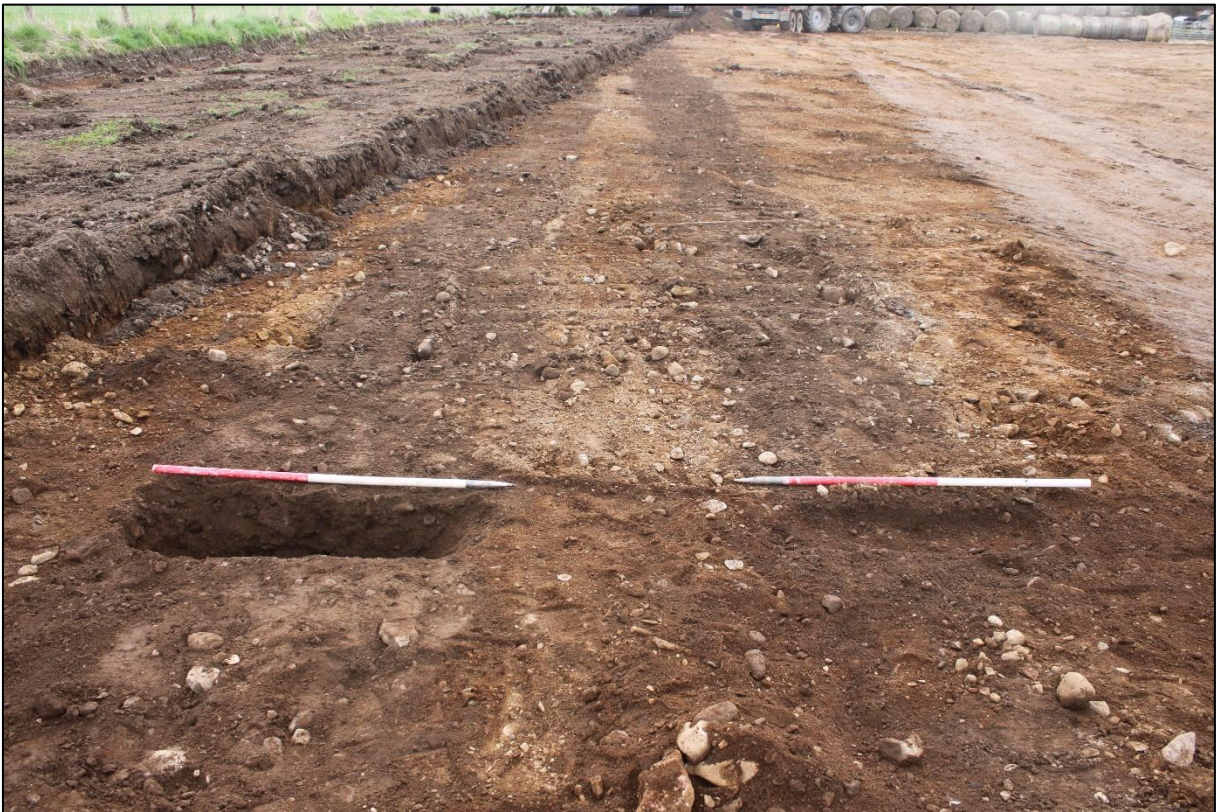
19. Two furrows [008] running west to east were also noted within the development area. These sat separate from each other; one in the southwestern corner, the other towards the northern edge. These linear features had gently sloping sides with a flat based and measured approximately 0.8m wide by 0.06m deep (Figure 6b). They were filled by topsoil (003).

Figure 6b: Slots through southwest–northeast running drain [007] and furrow [008] from the southwest
