**Marine & Coastguard Site,
Isle of Gigha:
Data Structure Report**

issued 11th May 2018

on behalf of Portakabin (Scotland) Limited

RATHMELL  
ARCHAEOLOGY LTD

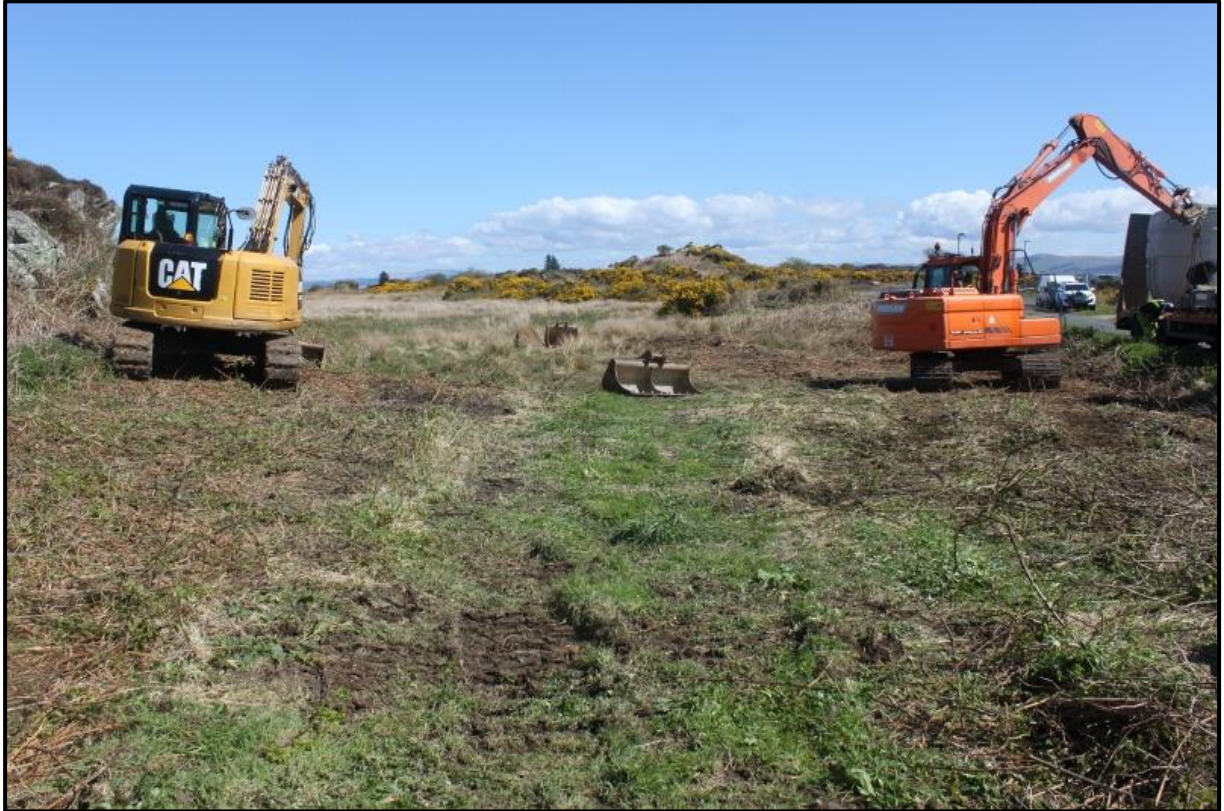
Figure 4a: Pre-excitation photo of development area. Photo taken from the southwest.

12. The site was located on an area of rough pasture (Figure 4a) directly to the northwest of the road leading to the ferry slipway at the small bay, Portan Sean Reidhe. To the southeast of the road was a white sand beach and the bay. To the north of the development area were midsize outcrops of Amphibolite and Hornblende Schist. The site was roughly level. At the northeast of the development area the land opened out into a wide area of pasture that continued outwith the development area. This field is noted to contain rig and furrow (CANMORE ID 88300) that was recorded as being heavily ploughed down in 1993 (Hood, 1993). However, the rig and furrows were not visible during the archaeological monitoring works.

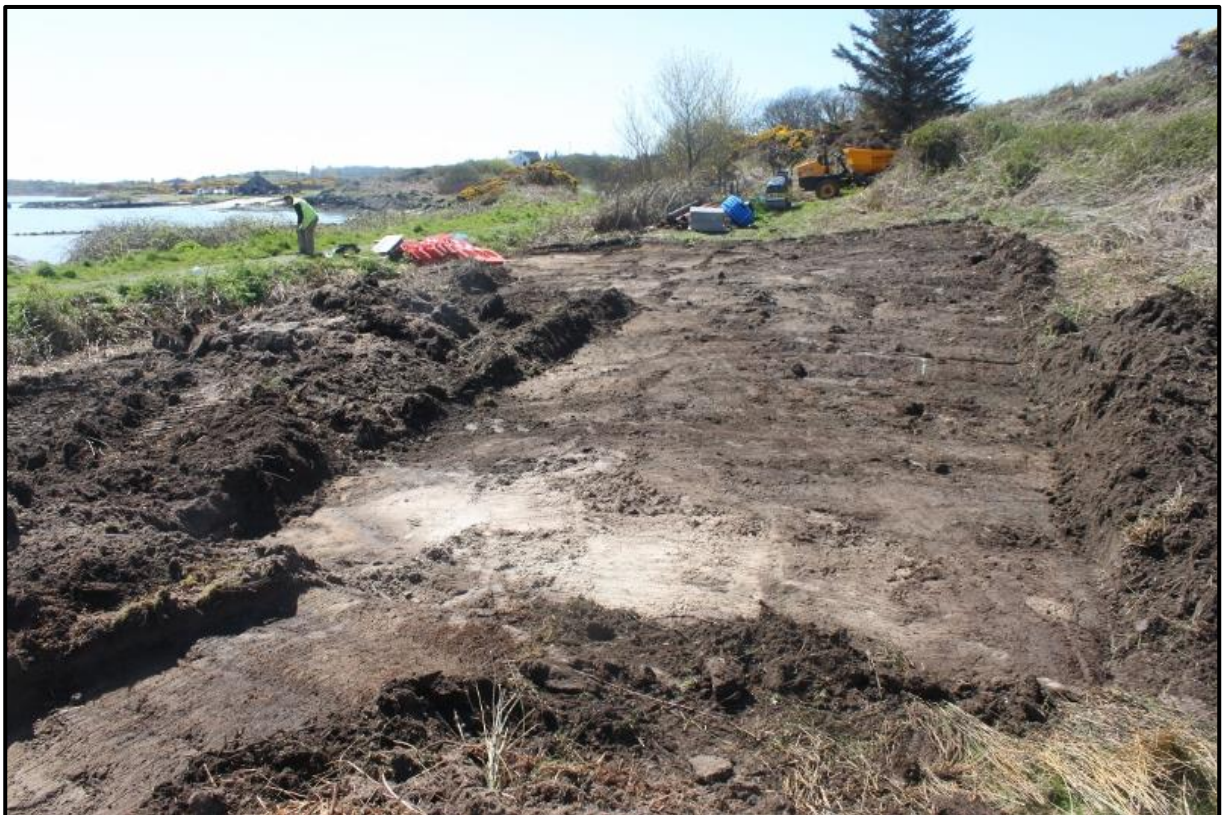
Figure 4b: Post-excitation shot of excavation area showing Area B. Photo taken from the northeast.

17. Area B was excavated to a depth of between 0.20m and 0.30m across the entire development area and sloped gently downhill to the southeast. The area was covered in topsoil (001), which had a maximum depth within the area of 0.25m. In the southwest corner of the area (001) was not completely removed, although patches of layer (002) were uncovered in places. Layer, (002), consisted of a loosely compacted, orange-brown sand with frequent large stone inclusions. A 3m long stretch of grey bedrock, (011), was uncovered along the northwest edge of Area B at 8.5m from its southwestern edge. In the southern corner of Area B the topsoil, (001), overlay layer (003) a moderate to loosely compacted, orange-brown sand with no inclusions. The area covered by layer (003) was 10.1m from southwest to northeast and approximately 4m from northwest to southeast. Also in the southern corner of Area B, where it intersected with Area A, layer (003) was excavated through, to a depth of 0.10m, to expose a layer of white sand, (002). In the north-western 4m of Area B (001) was underlain directly by white sand (004) (Figure 4b).

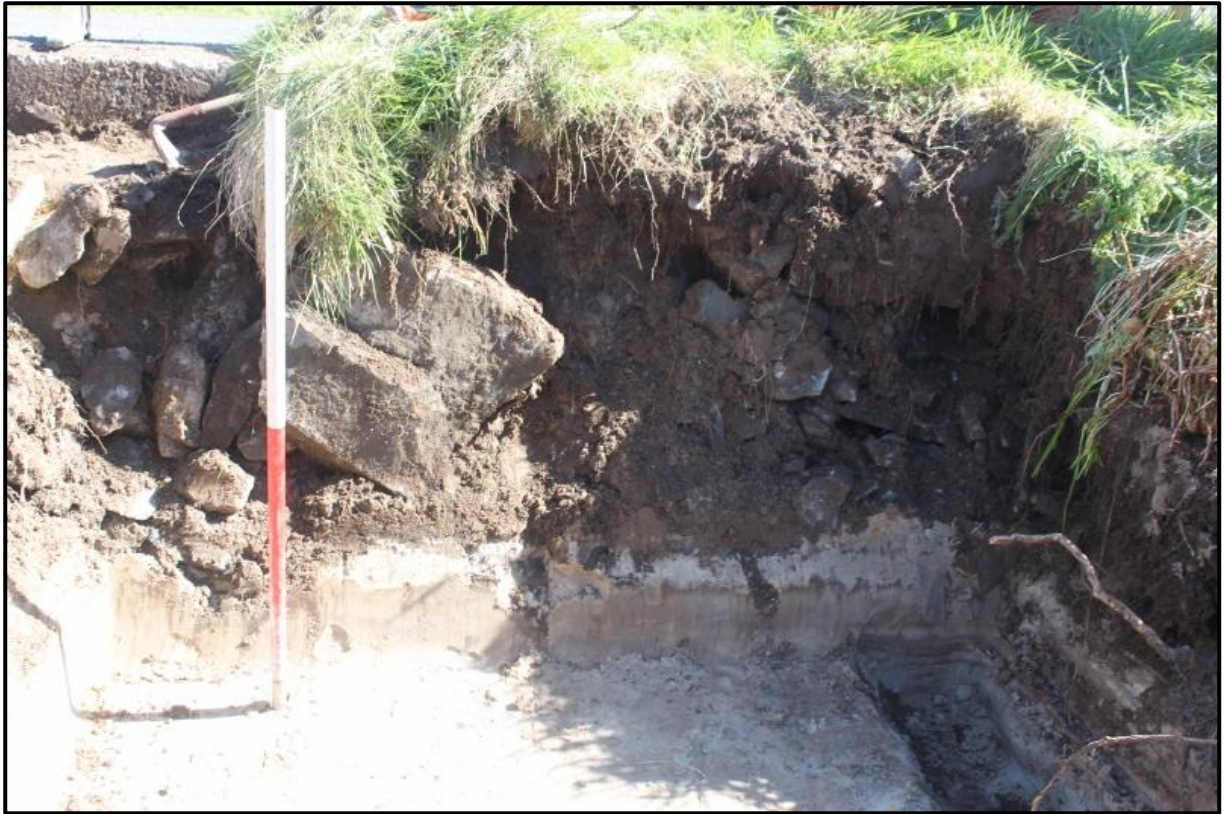
Figure 5a: Post-excitation shot of roadside bank in Area A showing topsoil [005], bank fill [006] and sand [004]. Photo taken from the northwest.

15. Area A was immediately adjacent to the road, and measured 9.4m by 3.5m wide. It consisted of a road side bank and ditch. The topsoil covering the bank, (005), consisted of a moderately compacted, dark brown silt with frequent root and small stone inclusions. Topsoil (005) covered the entirety of Area A with an average depth of 0.25m. Topsoil (005) overlay layer (006), a moderate to loosely compacted, mid-brown silty sand with frequent large stone inclusions. As with topsoil (005), layer (006) covered the entirety of Area A with a maximum thickness of 0.50m. Layer (006) overlay layer (004) which consisted of a

moderate to loosely compacted, light white-yellow sand with no inclusions. Layer (004) that covered the entirety of Area A and was excavated to a depth of 0.50m, except at the extreme northeast and southwest ends, which were excavated to a depth of 1.20m.

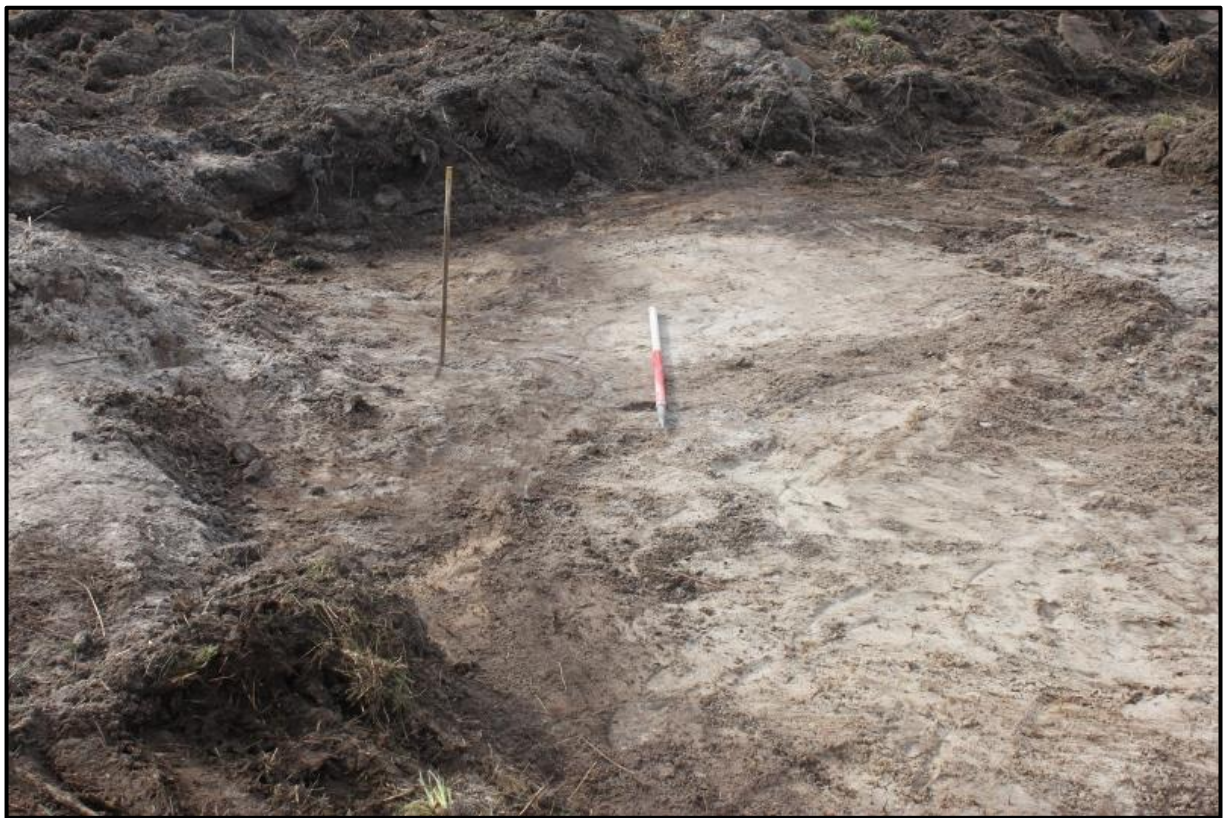
Figure 5b: Pre-excitation shot of furrow [010]. Photo taken from the north.

18. Linear [010] cut into layer (004) in this north-western part of Area B. The linear was orientated in a north-south direction. The linear had a width of 4m, a width of 0.35m. The southern end of the linear entered the excavated area 2.5m from the north-eastern corner of Area B. The northern end left the development area just to the north of the beginning of Area C (See Figure 6). Linear [010] was filled with (009) a moderately compacted, dark brown silty sand with frequent root inclusions (Figure 5b).

22. The linear features [008] and [010] are anthropic in nature. The two linear features were spaced approximately 5m apart, the same spacing which was recorded for the rig and furrows by Hood in 1993. The linear features had a uniform width of 0.35m with similar orientations, suggesting that these features were the remains of furrows. A piece of plastic sheeting was recovered close to the base of linear [008] within fill (007) which would support Hood's conclusions that the rig and furrows dated to the 1940s or later (1993). No traces of the rig and furrows remain in the wider landscape possibly suggesting that more recent agricultural activity had eroded away all surface traces since the area was surveyed in 1993.

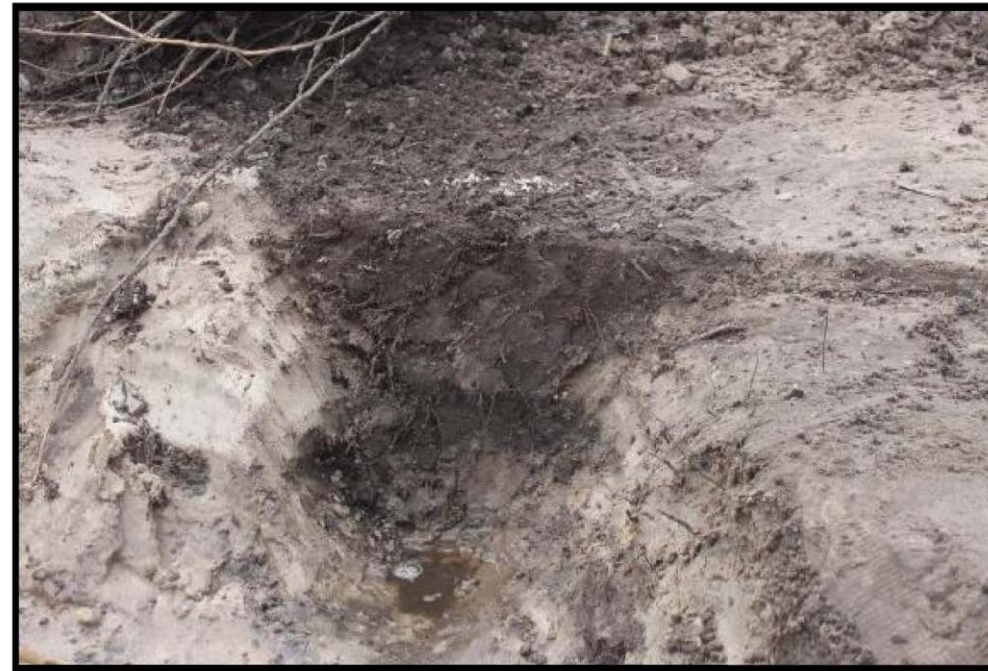
Figure 7: Section of furrow [008].

19. Area C consisted of a thin excavated strip 4m long and 1.6m wide running northwest-southeast and a rectangular area 4.25m long northwest-southeast and 3.4m northeast-southwest. The thin strip was excavated to a depth of 0.3m and the rectangle to a depth of between 4m and 4.25m. The entirety of Area C was covered by topsoil (001) a dark blackish brown silty sand with frequent root inclusions which overlay white sand layer (002). Area C contained a linear feature, [008], which was orientated in a north-south direction through the rectangular area for a length of 4.8m. The linear appeared at the south side of the rectangle 0.7m from the southern corner and ran to the northern corner of the area (See figure 6). The linear was 0.35m wide and 0.25m deep. It was filled by (007) a moderately compacted, dark brown silty sand with frequent root inclusions. The cut of linear [008] was u-shaped in section, with a sharp break of slope at the top. The sides sloped at 45° and the base was concave (Figure 7). A small piece of plastic was found close to the base of the cut within fill (007).

Section of furrow [008] from the North

007	-	Deposit	Moderately compact dark brown silty sand with frequent root inclusions. 0.35m wide and 4.8m long, with a depth of 0.25m	Fill of linear [008]
008	-	Cut	U-shaped cut with a sharp top, steeply angled sides and a concave bottom. Cut is oriented north-south and 0.35m wide x 0.25m deep. Linear is 4.8m long.	Cut of linear, fill (007)
009	-	Deposit	Moderately compact dark brown silty sand with frequent root inclusions. 0.35m wide and 4m long. Oriented north-south.	Fill of linear [010]
