Portencross Castle, North Ayrshire: Archaeological Investigation

Assessment Report

issued 26th April 2018

on behalf of Friends of Portencross Castle

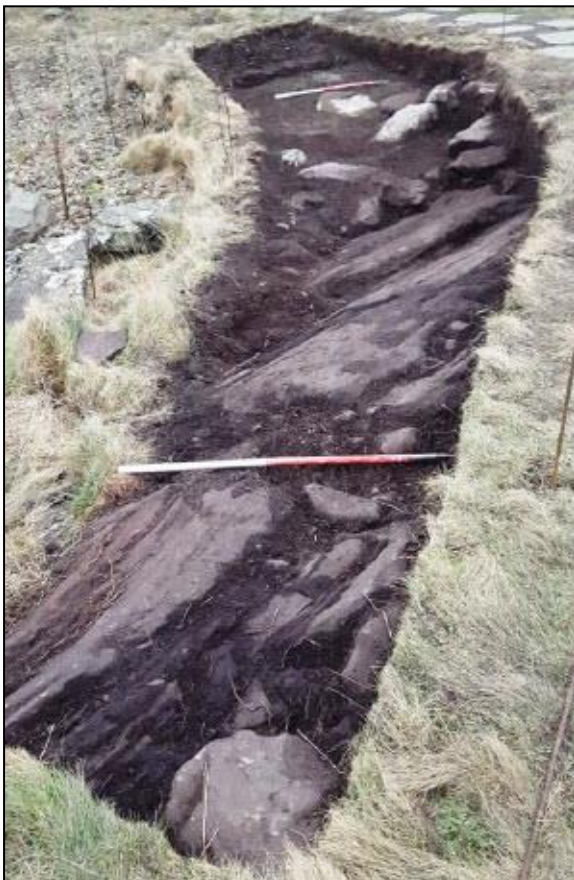
Figure 2b: Trench 1 showing bedrock (after James 2017a, Fig 5)

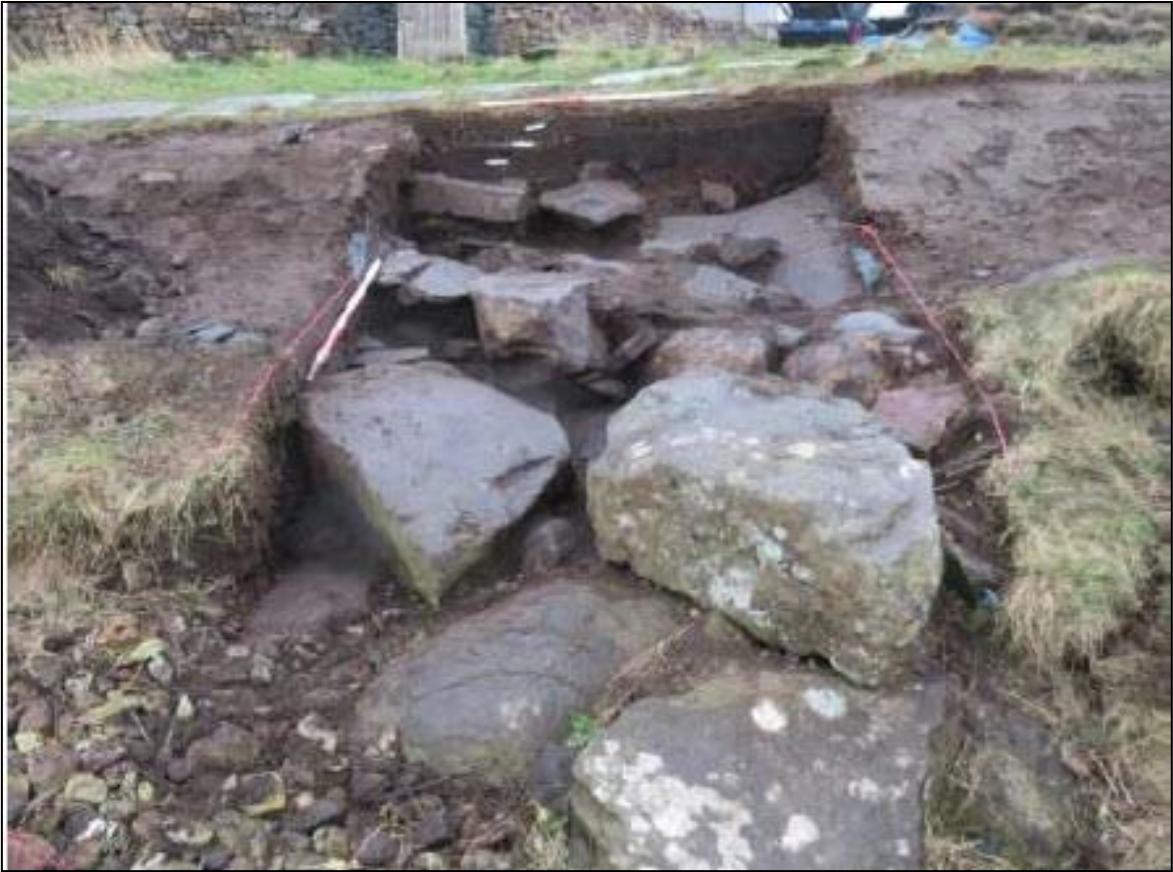
Figure 3a: Trench 2 within footprint Trench 1 (after James 2017b, Fig 3)

- b. a 4m stretch (covering the first inspection chamber and the initial portion of the septic tank) that was characterised by Trench 2 as boulders and angular blocks that did not deliver a coherent structure although the excavator suggested it may have been a slipped or spread wall from at least the late medieval period. Again most late or post-medieval artefacts recovered are *ex situ* within modern deposits (i.e. 19th century and later);

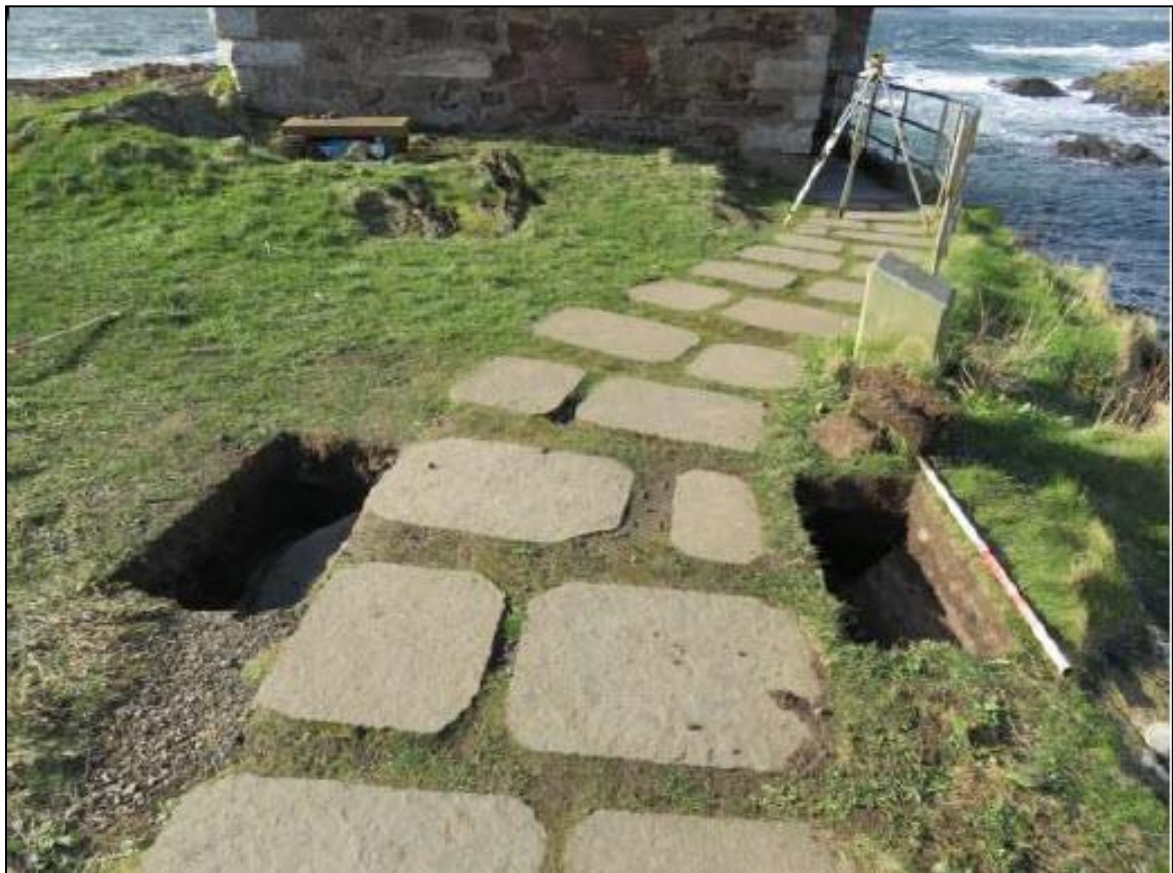
Figure 3b: Trench 3 (left) & 4 (right) straddling path (after James 2017b, Fig 4)

- a. the initial 15m running from the castle to the western side of Trench 2 that is shallow topsoil (up to 0.3m) over bedrock. Some small stones chocked amongst the bedrock were taken by the excavator to suggest an irregular surface (see Trenches 3 & 4). Any late or post-medieval artefacts recovered are *ex situ* within modern deposits (i.e. 19th century and later);
