14-16 Union Street, Edinburgh: Historic Building Recording

Data Structure Report

by Liam McKinstry

issued 9th May 2018

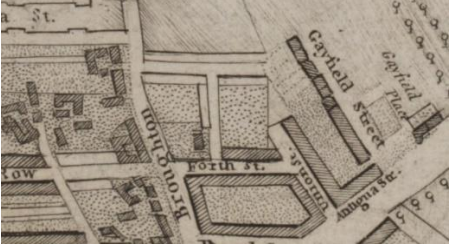
1805	R. Scott <i>The Strangers Guide, being a Plan of Edinburgh & Leith exhibiting all the streets principal buildings ...</i>	Terrace of houses along Forth Street with gardens behind.

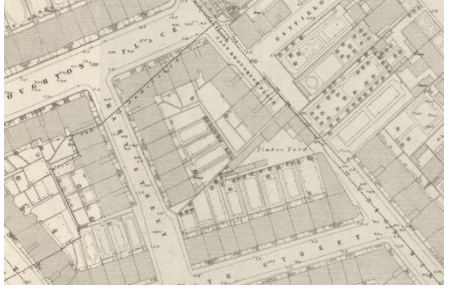
1877	Ordnance Survey, <i>Edinburgh Sheet 25</i>	Terrace of houses along Forth Street and structure extending behind 28 to 30.

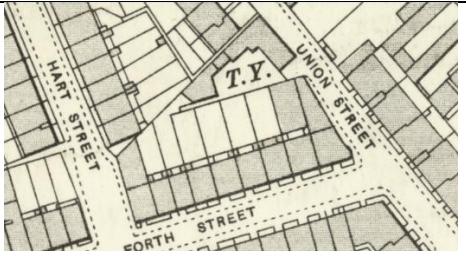
1905	Ordnance Survey <i>Edinburghshire, III.8</i>	New structure in garden of 26 Forth Street separated by retained open strip.

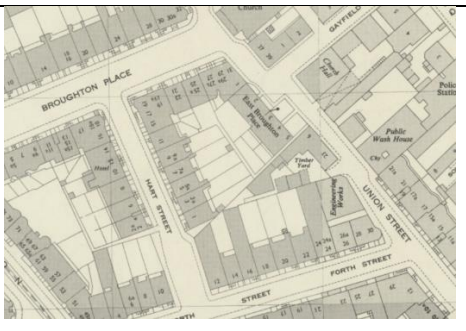
1949-50	Ordnance Survey Sheets <i>NT2574 - A</i> and <i>NT2674 - A (includes: Edinburgh)</i>	Structures behind 26 and 28 to 30 Forth street combined into current building. 24 Forth Street has been extended into garden.

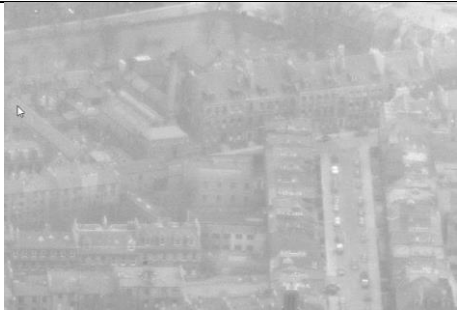
1958	Aerial Photograph March 1958	Oblique aerial photograph showing current flat roofed building and pitched roof building.

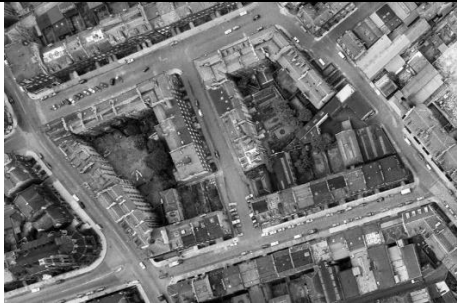
1961	Aerial Photograph July 1961	Aerial photograph showing current flat roofed building and pitched roof building.

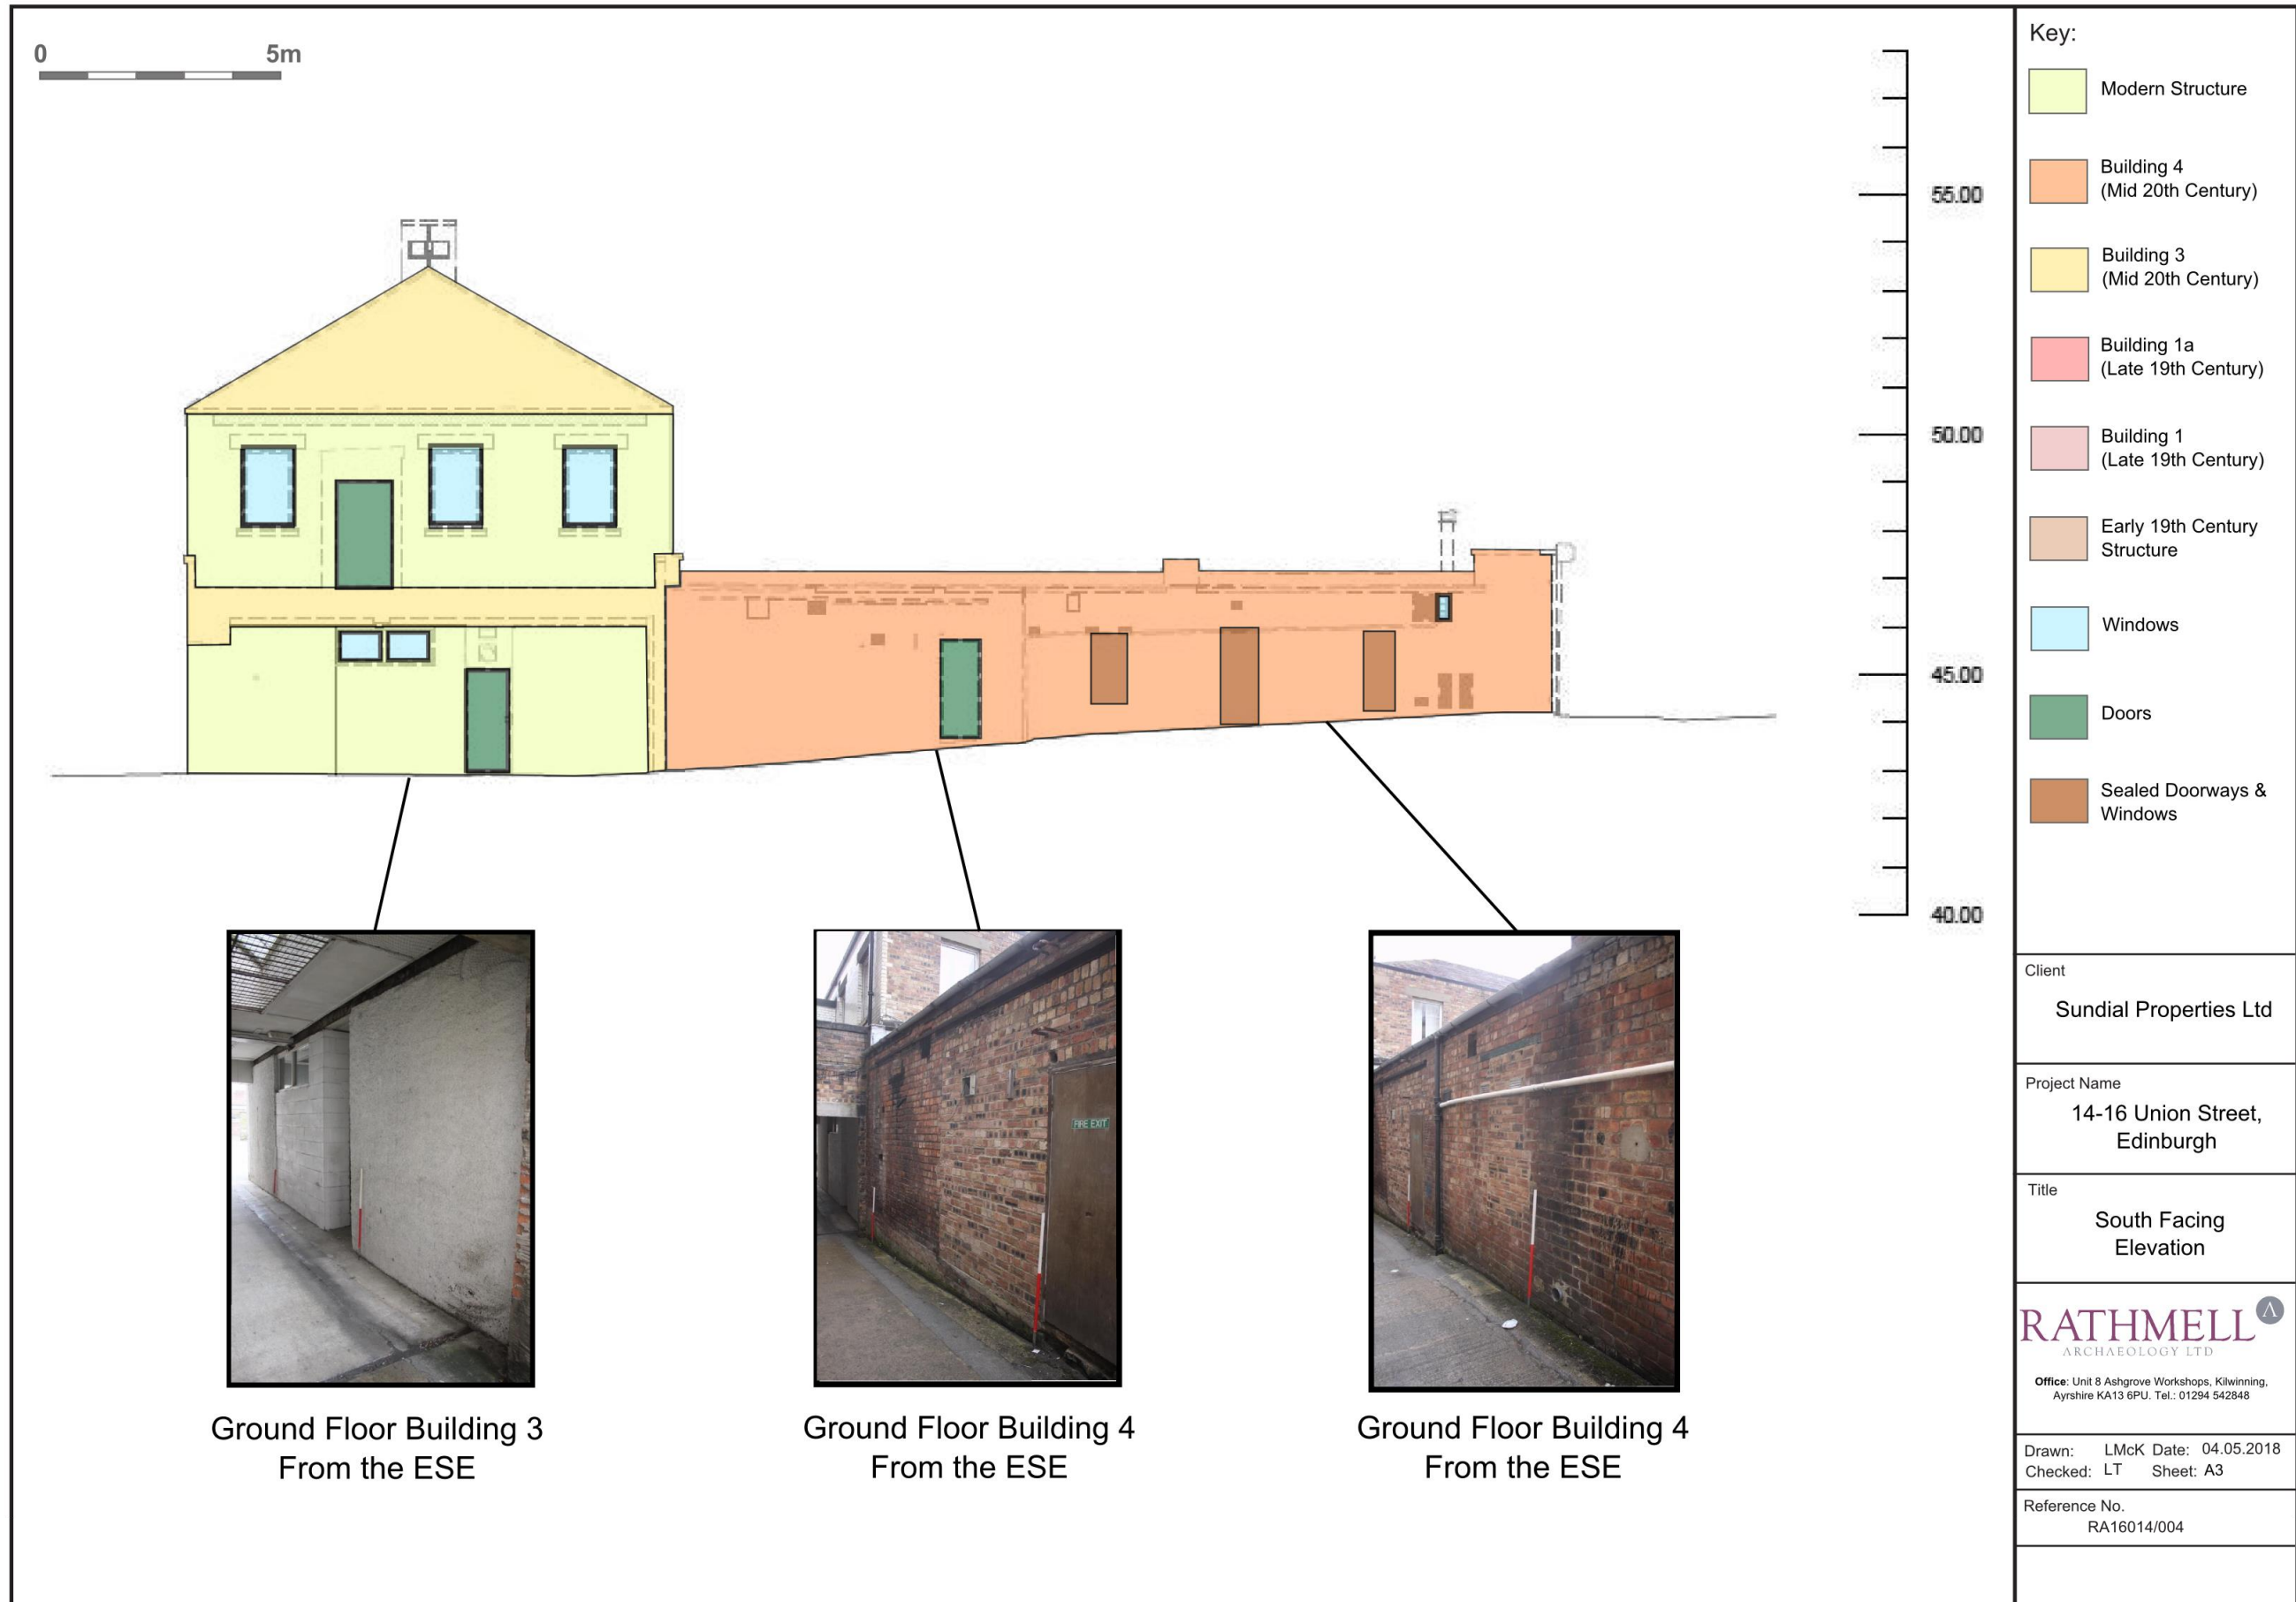
Figure 4: South facing elevation of Building 3 and 4.

24. The raised corridor (Room 11b) which joined the 1st floors of Buildings 3 and 24 Forth Street was located 2.5m from the west on Building 3's south facing elevation (Figures 17a). The raised corridor, which was faced with off white coloured glazed brick and had a width of 1.6m, rested upon a raised platform/roof, which had a width of 10m matching the east to west length of Building 3. At present there is one bay within the raised corridor with single modern windows on its west and east sides. A modern looking concrete lintel with a support under the raised platform on its west-facing side and the presence of two

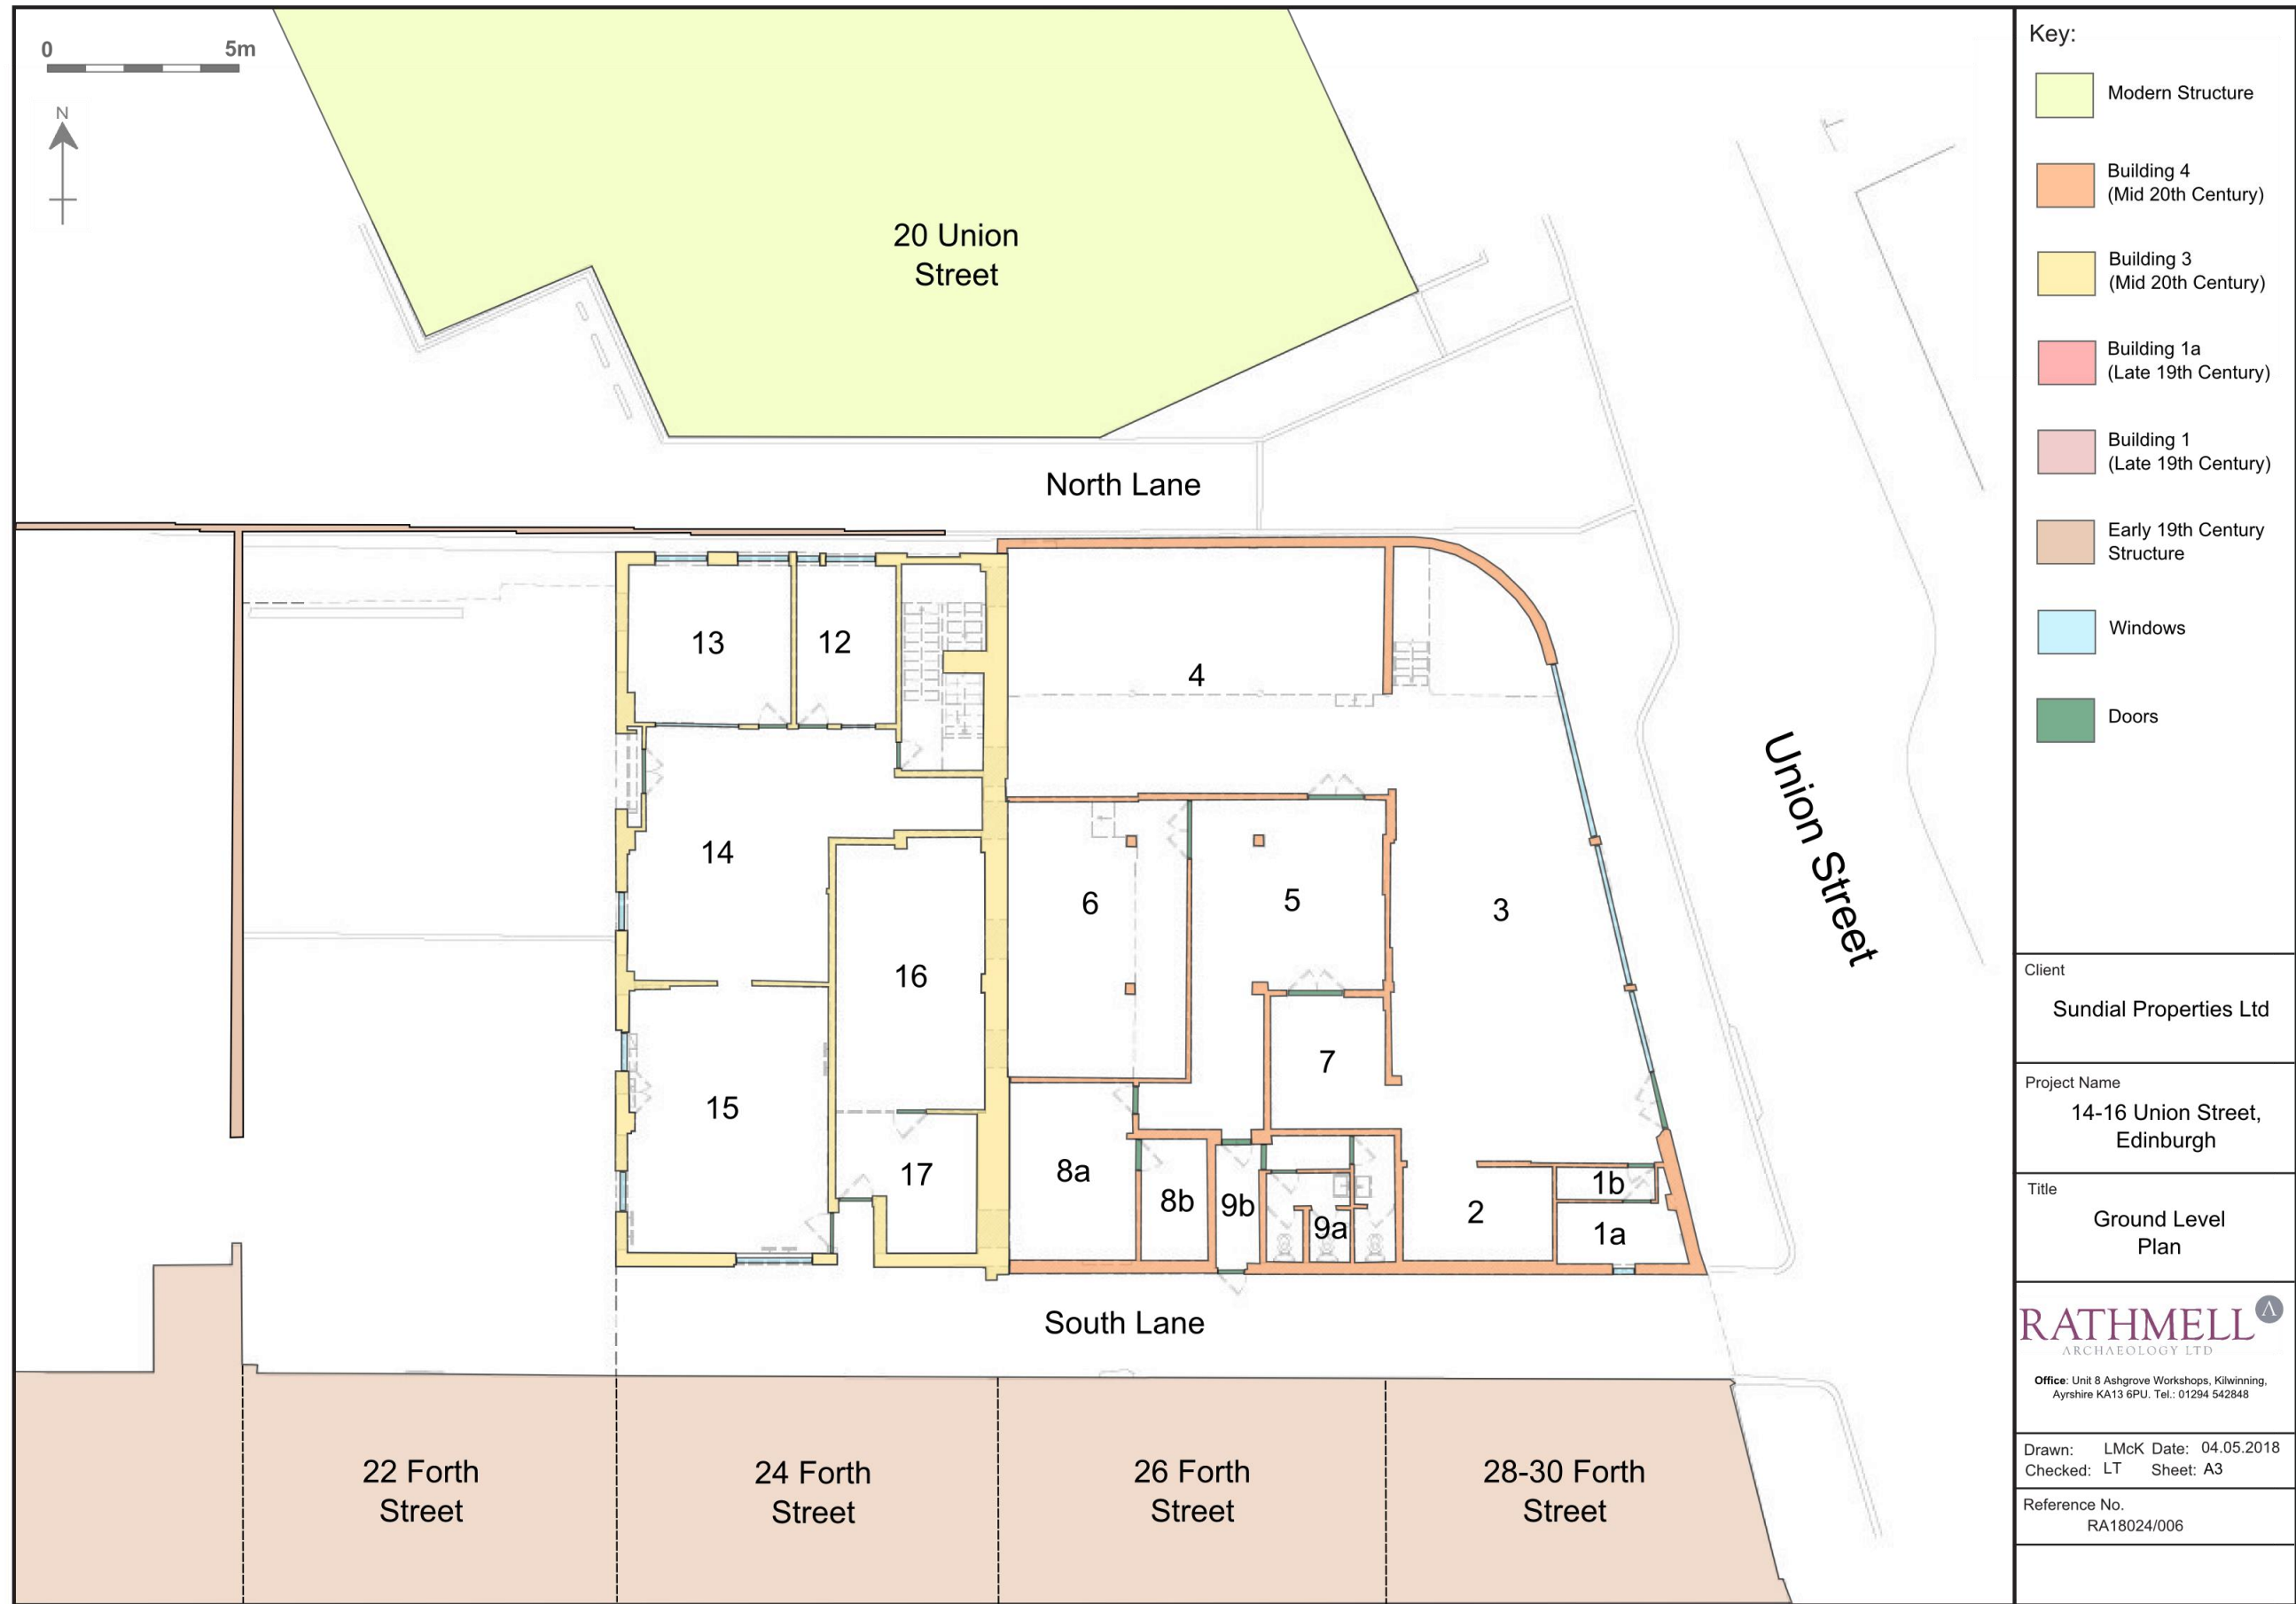
Figure 7: Ground floor plan of Buildings 3 and 4 (with room numbers).

30. The ground floor of Building 4 consisted of 12 rooms (Rooms 1a-9b) (Figure 7). Room's 1a-2 were located in the south-eastern part of the ground floor and consisted of three small storage rooms. The suspended ceiling within the rooms had been removed exposing wiring and steel roof supports. The walls were a mixture of painted brick, unpainted wood panelling and painted plastered walls. Where they survived the skirting boards were plain and painted with the flooring poured concrete covered in places with linoleum tiling. There was a doorway in the south-facing wall of Room 1b and a narrow internal window and large opening in the south-facing wall of Room 2. Rooms 3 and 4 (Figures 9b and 10a) formed two large open plan rooms (L-shaped in plan) in the eastern and northern parts of the building. Both rooms had suspended ceilings which in places was missing or damaged. Painted steel roof supports protruded from this ceiling and rested on a series of steel supports which ran from the ceiling to the poured concrete flooring. The walls of both rooms consisted of mainly painted brick, though much of the west facing wall of Room 3 was taken up with the glass frontage and the glass double doors. There was a wide opening between the two rooms and a set of narrow stairs at the northern part of Room 3 which led down into the basement level. Room's 5-8b (Figure 10b) were located within the south-western part of the ground floor and centred on a small corridor. All of the rooms had modern suspended ceilings with integrated lighting panels. The walls within the rooms were all of modern painted plaster finish with light switches and power sockets, often located within plastic-covered conduits at a height suitable for desks and workstations. The skirting within the rooms was plain and painted with the flooring consisting of either carpet or carpet tiles. The last rooms on the ground floor, Rooms 9a and 9b, comprised a small corridor which gave an access to the southern lane outside Building 4 and a set of toilets with modern fittings and décor (though in a state of disrepair) throughout.

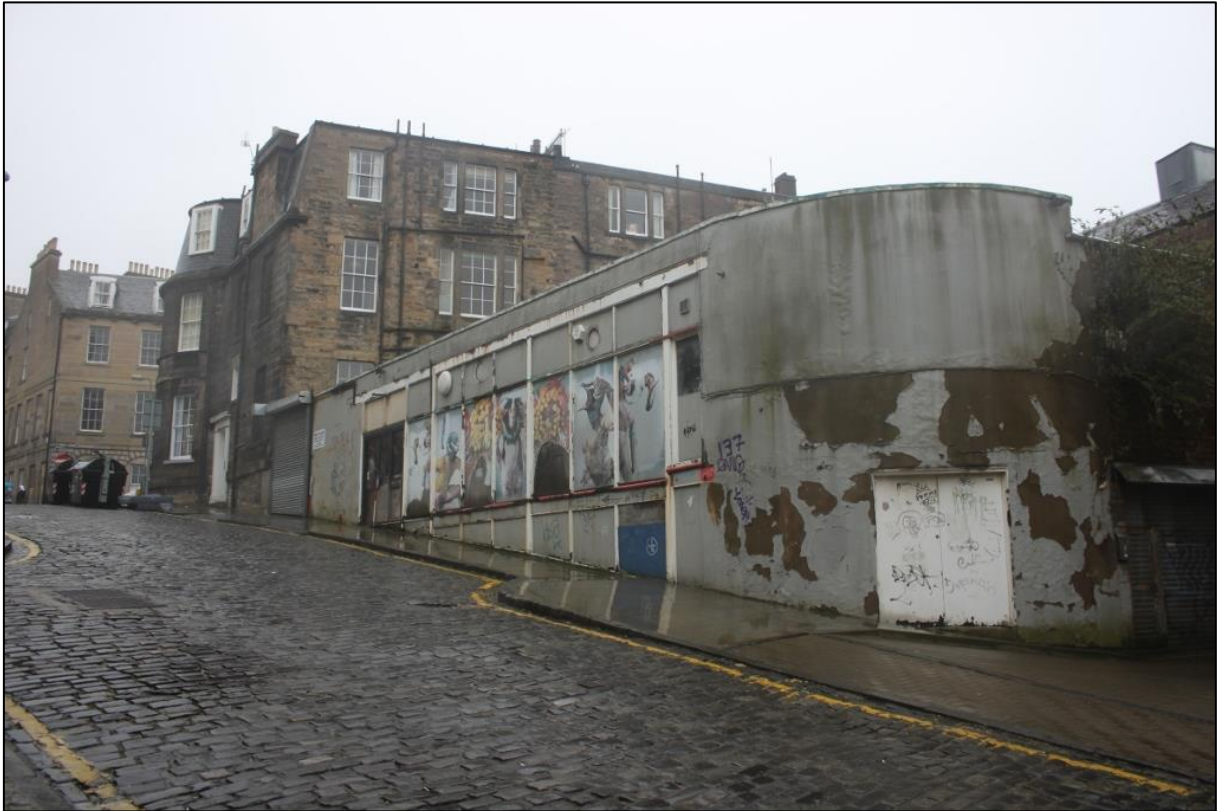
Figure 9a: General view of 14-16 Union Street. From the SSW.

1. This Data Structure Report reports on a programme of Historic Building Recording undertaken at 14-16 Union Street, Edinburgh (Figure 9a). In addition this report proposes appropriate consequent archaeological mitigation.

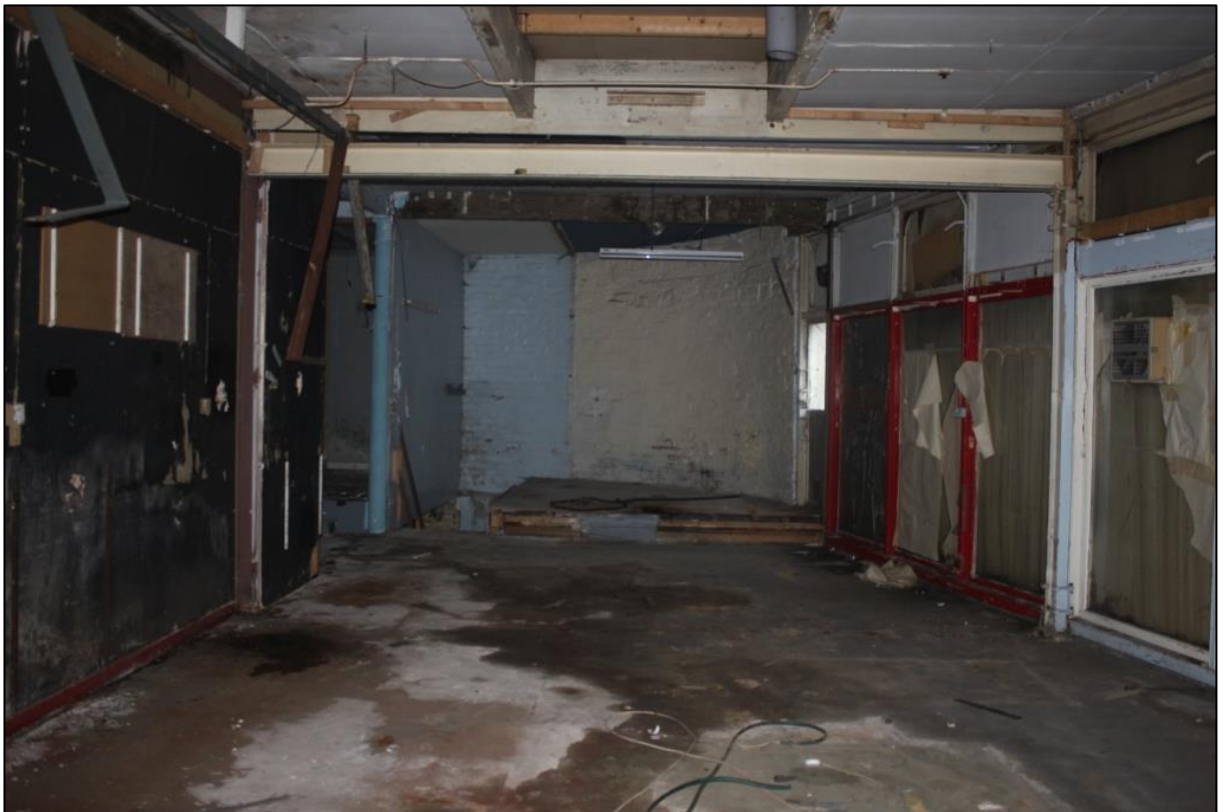
Figure 9b: View of Room 3 within building 4. From the S.

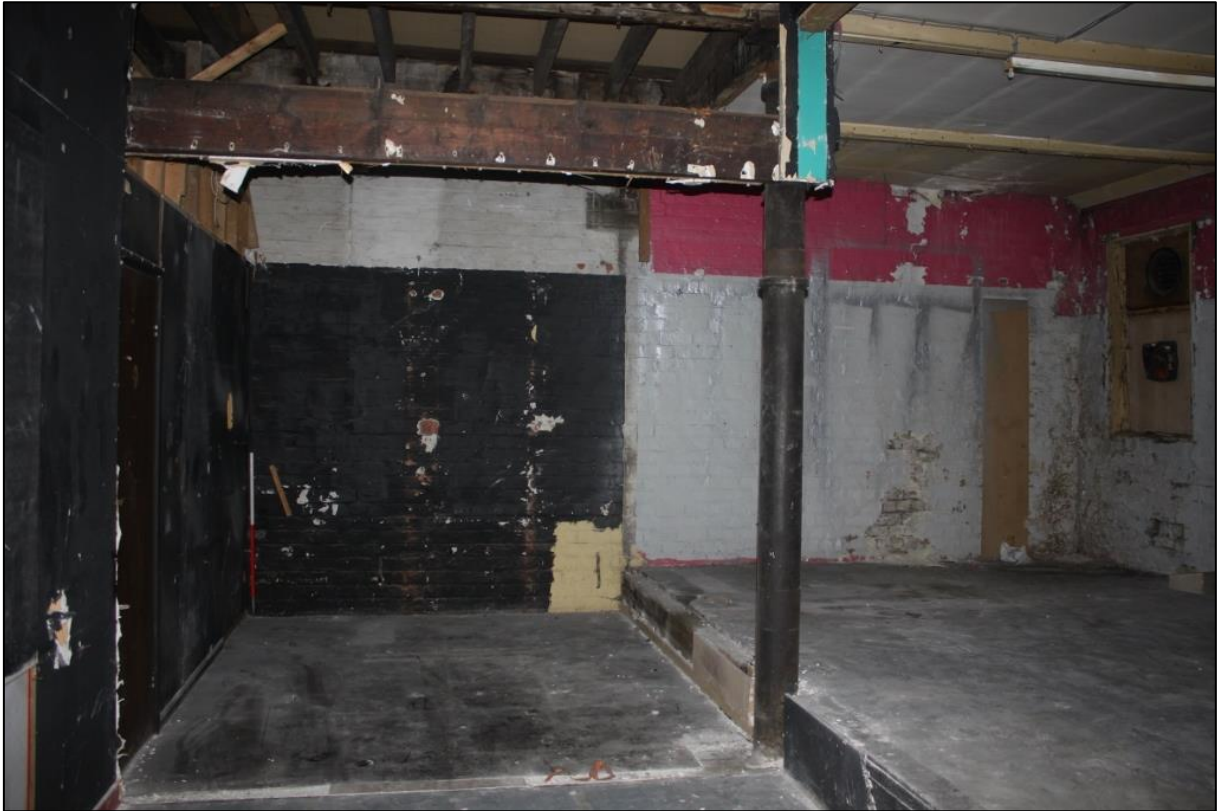
Figure 10a: View of Room 4 within Building 4. From the E.

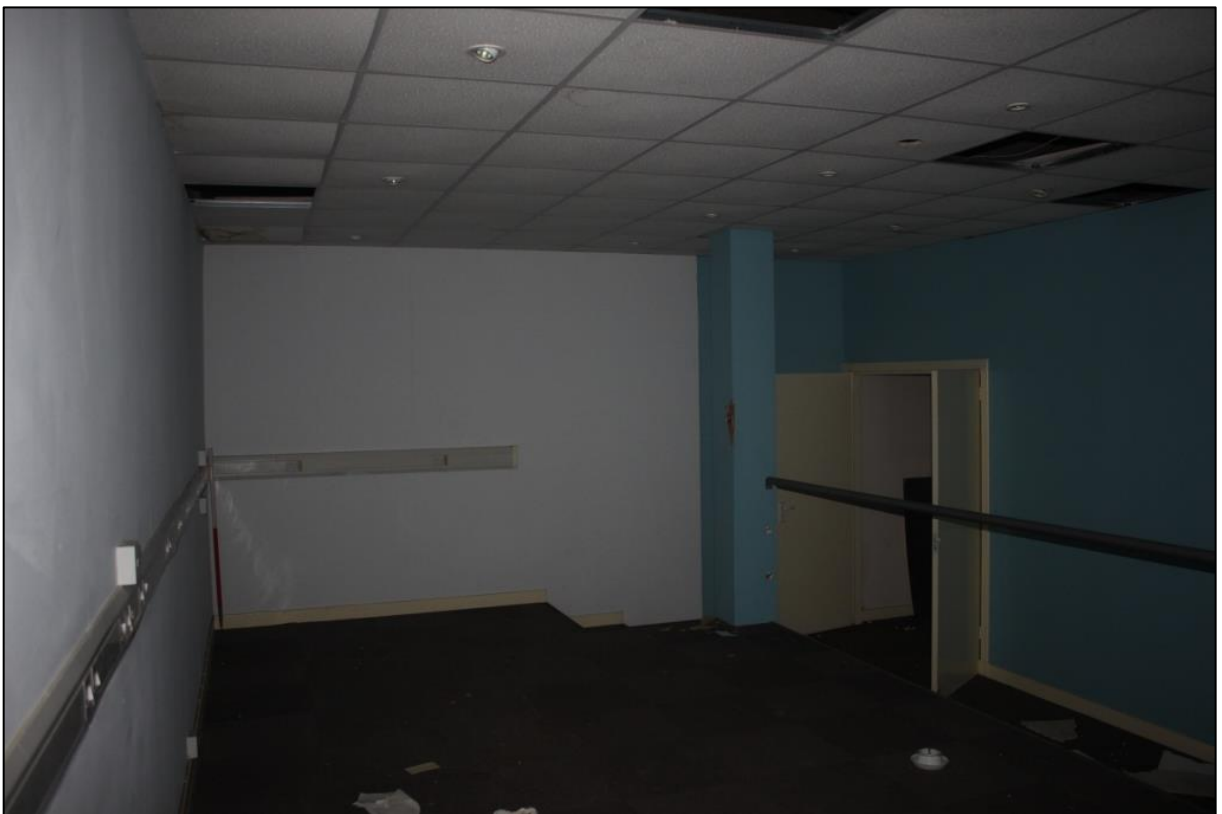
Figure 10b: View of Room 6 within Building 4. From the SSW.

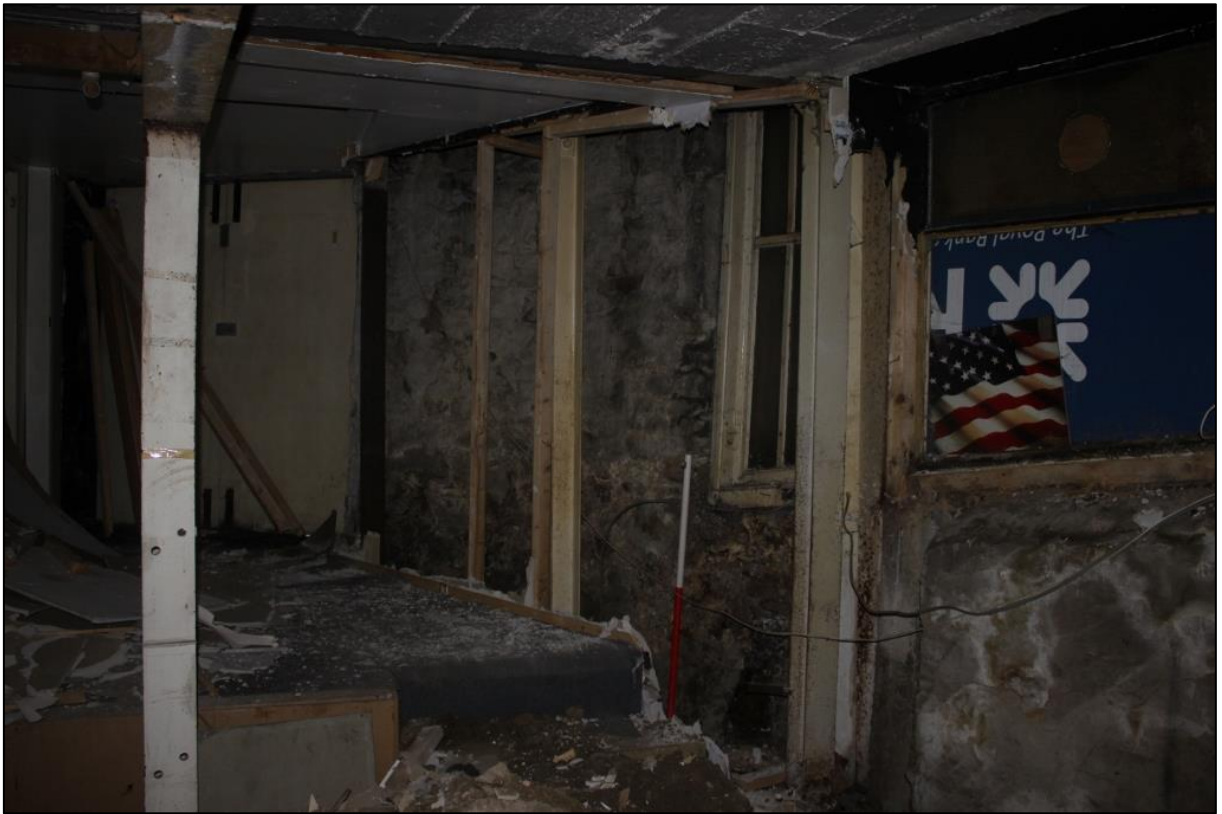
Figure 11a: Room of 10a within Building 1. From the SSW.

17. The main surviving internal elements of Building 1 consisted of part of the south-facing (slightly curved) wall and the west-facing wall (Figures 11a and 12a). Most of the west-facing wall consisted of a snecked rubble wall though a section of this wall (5.5m from the northern end of Building 1) appears to have been repaired or rendered at a later point with cement and paint. The northernmost end of the wall was also of snecked rubble construction but showed signs of later repair in the upper part of the wall using brick. The internal face of the curving south-facing wall and the northernmost part of the west-facing wall were relatively straight faced (Figure 11a) though at 5.5m from the northern end of the building the wall was battered, projecting out at floor level for 0.5m and 0.3m where it met a later 20th century window (associated with Building 4) which ran much of the length of the west facing wall (Figure 11b). It is possible that this battered section of the west facing wall may be a stretch of reused early 19th century walling associated with the garden plots behind the buildings on Forth Street.

31. The basement level of Building 4 (Figures 8) consisted of one large open plan area divided into two, Rooms 10a and 10b. The easternmost part, Room 10a (Figures 11a), contained structural elements relating to the earlier 19th century Buildings 1 and 1a (see above). Within Room 10a the main elements relating to the 20th century were a raised wooden area located in the northernmost part of the room, to which a set of narrow wooden stairs descended from Room 3 on the ground floor, with a set of double doors leading out onto Union Street. The raised area was also partially partitioned by wooden boarding. A series of painted steel roof supports (which supported the poured concrete floor of the ground floor), steel columns and brick columns were surrounded by a poured concrete floor surface. A window, also part of Building 4, within the west facing wall of Building 1 was located 4m from the northern end of the building and had a length of 10m (Figure 10b). The sill at the northern end sat at 0.7m above floor level and the window had a height of 1.5m. The window sill sloped upwards along its length, mirroring the current street level on Union Street, and tapered to a point at the south end (Figure 10b). The window frame and sill was of painted wood and divided into a series of smaller rectangular glass panes by mullions set at regular intervals along its length. Close to the northern end of the window a section had been altered and was now covered by sections derived from old metal and wooden signage (depicting the Bank of Scotland and an American flag). The glass in the window had been replaced along its entire length on the outside with painted wood

- ❖ the late 19th century surviving walls for Buildings 1 and 1a in the eastern, southern and small parts of the northern and western walls of Room 10a of the basement level, some of which may be the reuse of an early 19th century garden/retaining wall associated with the properties on Forth Street; and

33. Where practicable this significant historic fabric should be considered for retention. In the event that the consented scheme requires its loss, we recommend that an archaeologist should be present during any demolition or construction impact on this fabric to enable a record of its loss.

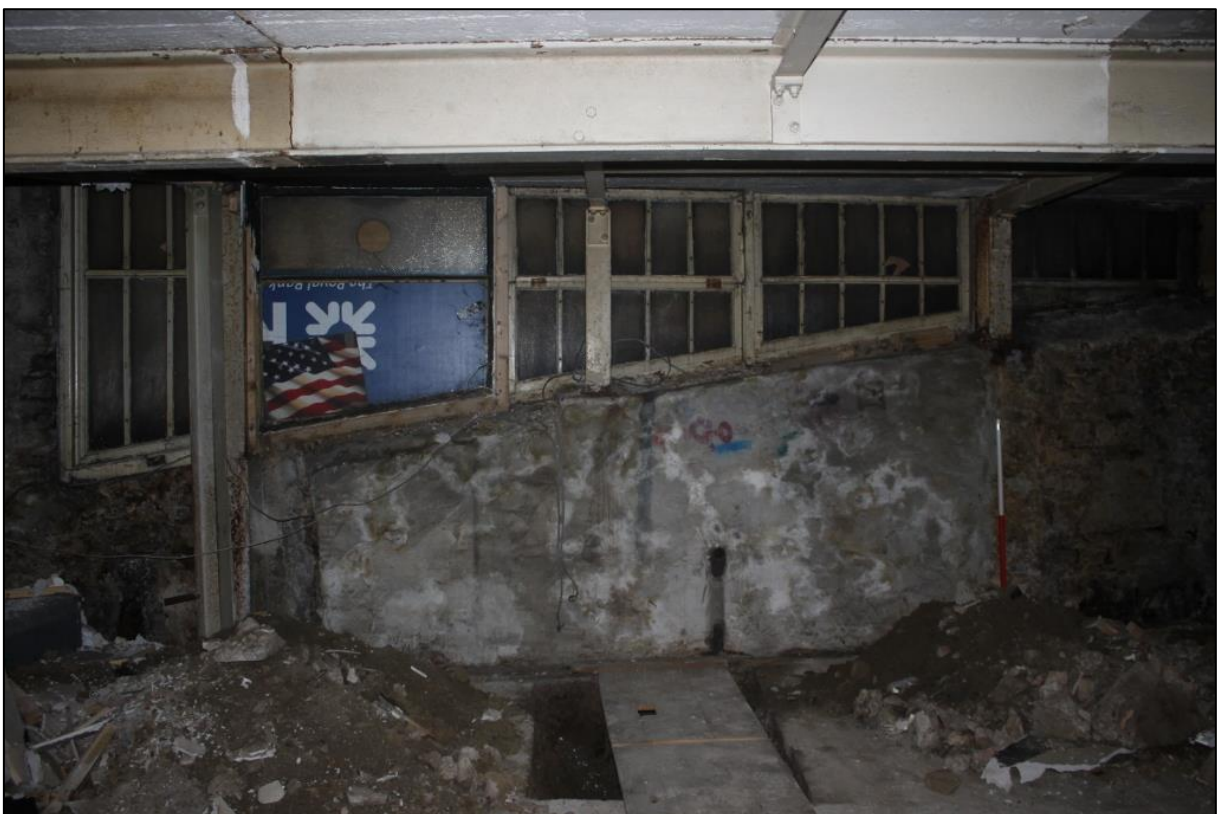
Figure 11b: View of window within Room 10a, Building 1. From the W.

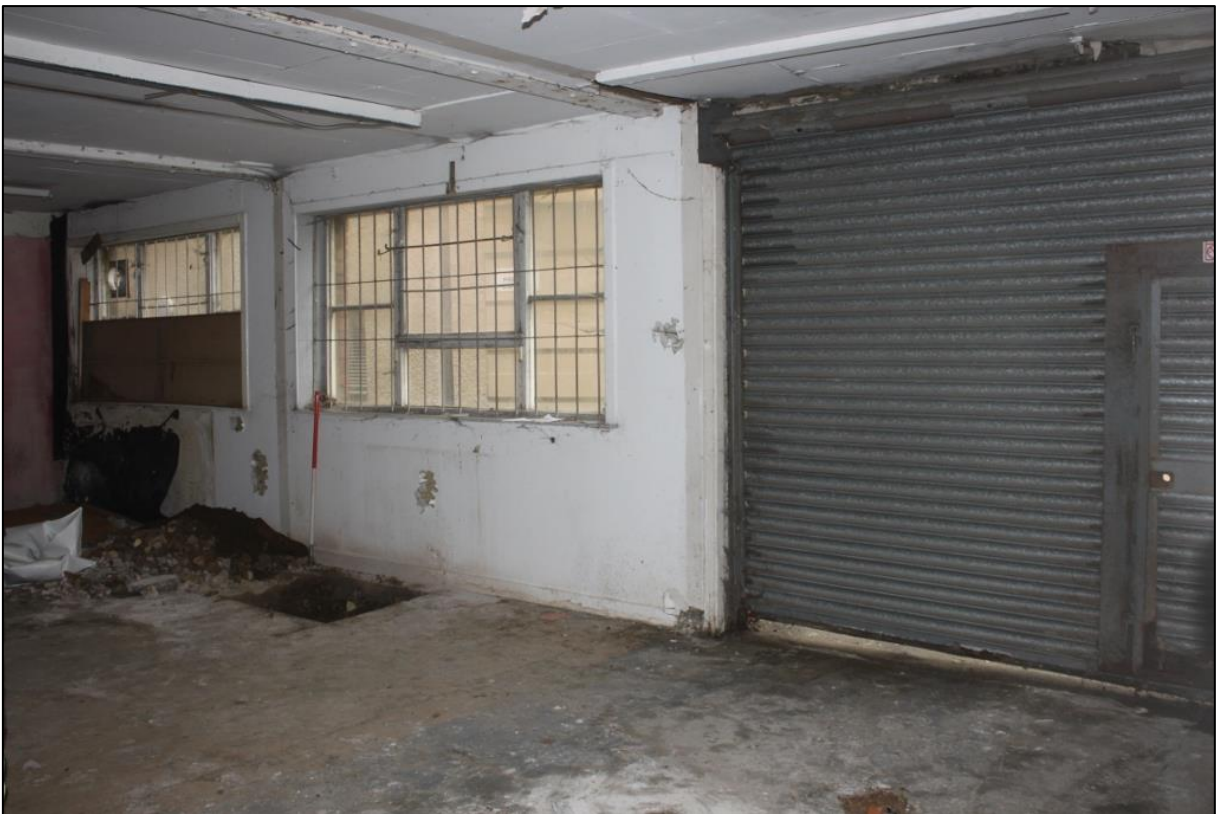
Figure 13b: View of Room 10b, Building 4. From the SSE.

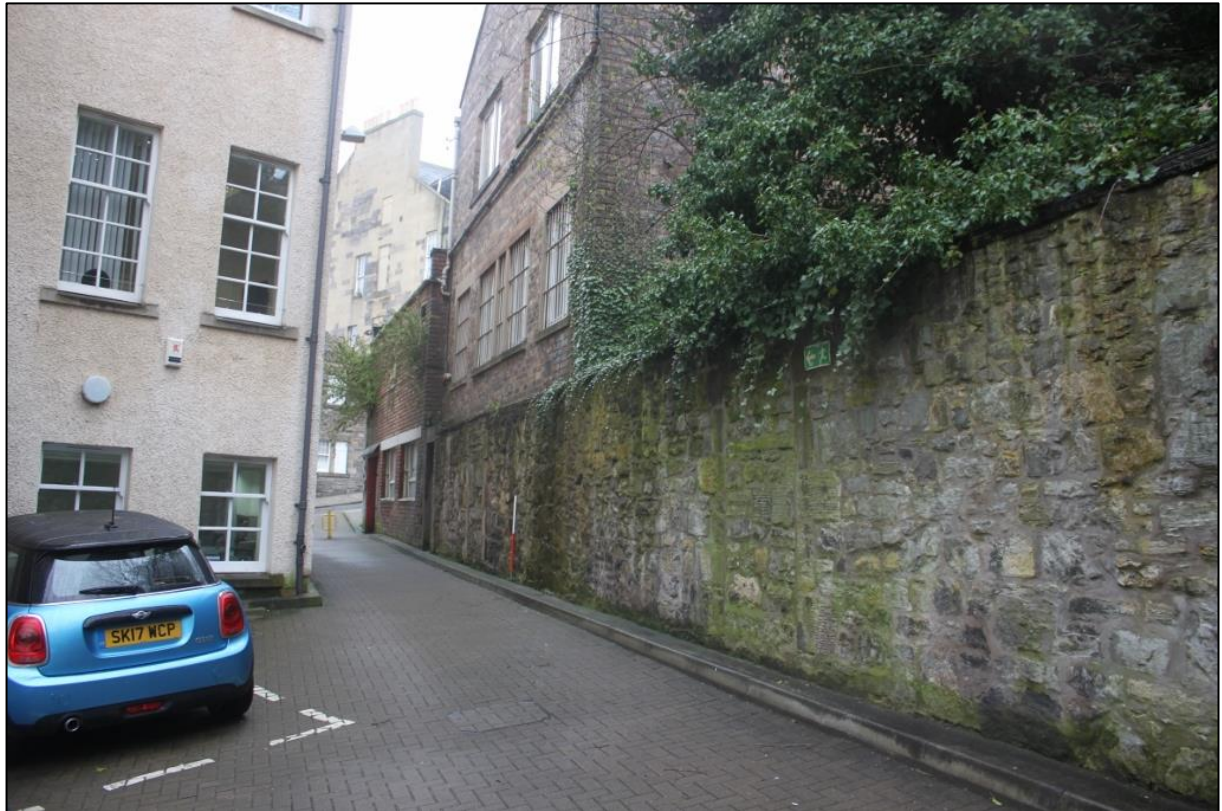
Figure 14a: View of the N lane showing N elevations of Buildings 3 and 4 (and early 19th century wall). From the WNW.

22. Building 3's footprint was located within the area encompassed originally by 24 Forth Street's garden plot, which measured 18m from north to south and 10 m from east to west. The building consisted of an attic (inaccessible), 1st floor, ground floor and a set of emergency stairs which may re-use previously-existing stairs and which cuts into a natural raised terrace which formed 24 Forth Street's garden. The emergency stairs exited out onto the North Lane through an early 19th century garden/retaining wall which marked the northern extent of the gardens behind Forth Street (Figure 14a and 15a).

- ❖ the early 19th century garden wall also lies beneath the base of Building 3 and within the building's emergency exit, which descends from the building's ground floor, exiting through a cut gap in the wall onto a lane off Union Street.

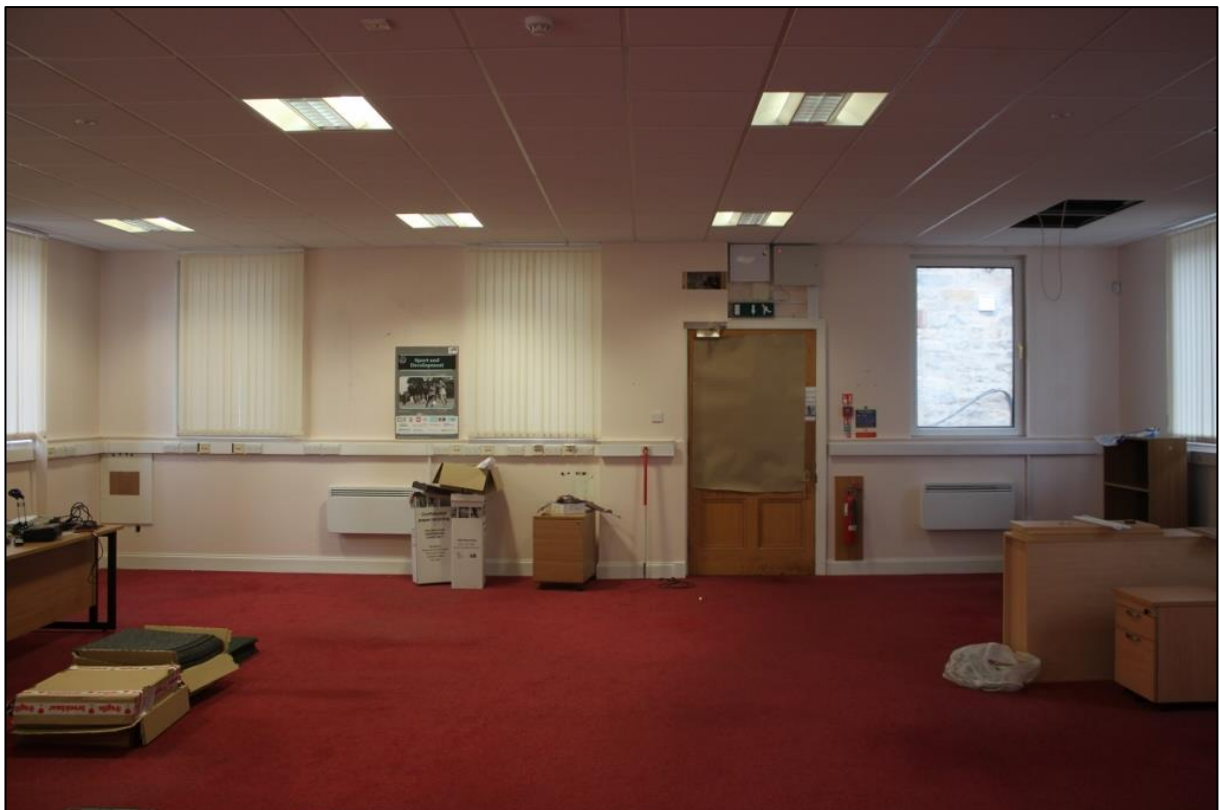
Figure 14b: Room 11a within Building 3. From the N.

26. The 1st floor of Building 3 consisted of one large open plan room, Room 11a (Figure 14b). Access to the room was via a doorway in the northeast corner leading to a stairwell (see below). The ceiling consisted of a suspended ceiling with integrated lighting panels. The walls appeared to have a modern painted plaster finish with four windows on the east and west facing walls, two on the south-facing wall and three on the north-facing wall. All of the windows had modern double glazing. A plastic covered conduit for internet and power sockets was located centrally along the walls to accommodate work stations or desks. The skirting board was plain and painted and the floor was carpeted. A door on the north-facing wall led into Room 11b which was a raised corridor leading to 24 Forth Street. The corridor was decorated in a similar fashion to Room 11a.

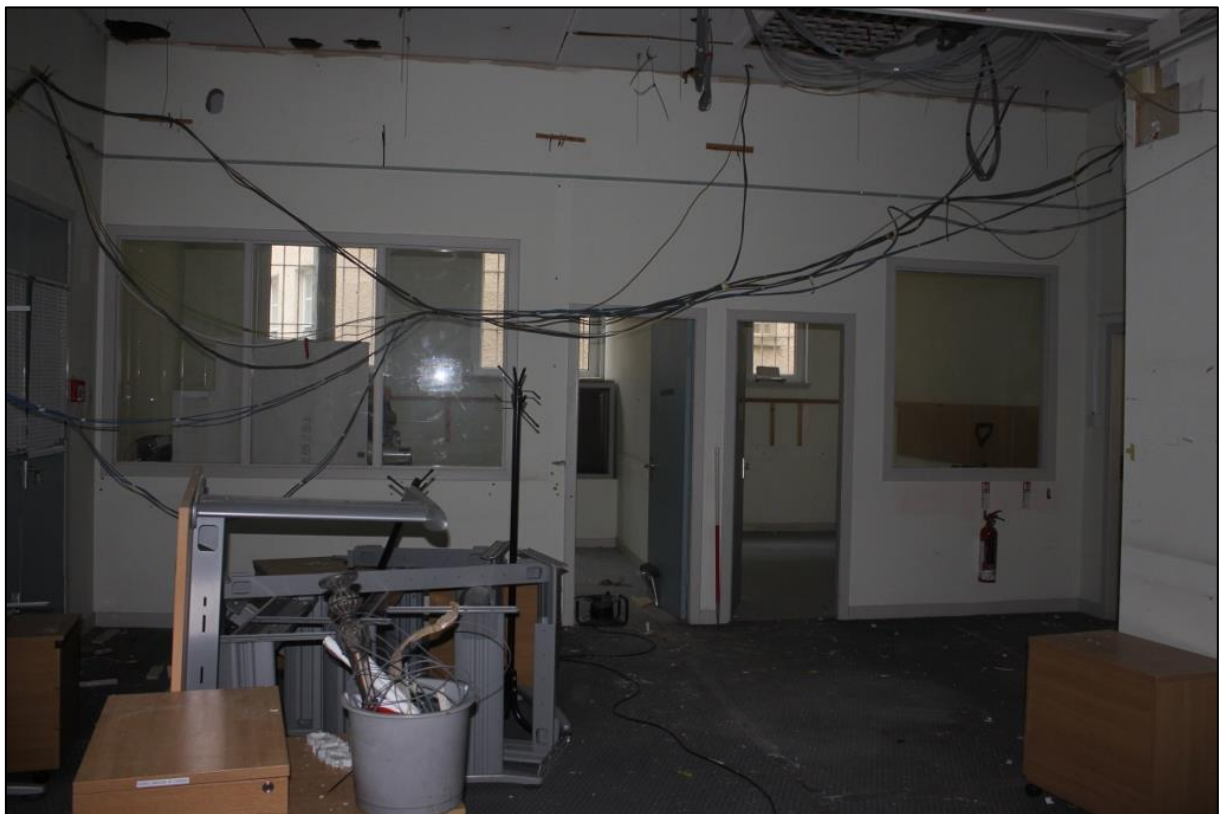
Figure 15b: View of Room 14 (with Rooms 12 and 13 in background) within Building 3. From the S.

27. The ground floor of Building 3 consisted of six rooms (Rooms 12-17). Rooms 12 and 13 (Figures 15b) were located at the northern end and had modern suspended ceilings and painted plastered walls. There were two windows on the south-facing walls in each room with Room 13 having a door accessing the garden on its east-facing wall. The north-facing walls of each room contained doors leading to Room 14 and also had internal windows. There were a number of power sockets in each room as well as fittings for shelving on the walls and fixed corner platforms for the placing of scientific equipment. The skirting was plain and painted with linoleum flooring. Room 14 and 15 (Figure 15b) were located centrally and at the southwest part of the building. They were decorated in a similar fashion to Room 11a on the 1st floor but the suspended ceiling had been removed and there were numerous cables hanging down within the rooms. Room 14 had an access corridor to the stairwell up to the 1st floor, one window and a set of double doors on its east facing wall. An open doorway in the room's north-facing wall led to Room 15. Room 15 had two windows on its east-facing wall, one on its north-facing wall and a doorway leading to Room 17 on its west-facing wall. Room 17 (Figure 16a) was accessed via a small recessed doorway off the lane to the south of Building 3 and a doorway entering this recess from Room 15. The room was decorated in a similar fashion to that found in Rooms 12 and 13 with the exception of the south facing wall which was covered with varnished wood panelling. There were no windows within the room which was lit by strip lighting attached to the suspended ceiling. There was fixed shelving on the rooms north and west facing walls and a fixed workstation in the northwest corner of the room above which was a metal panel which contained a series of sockets for cabling. A doorway on the south facing wall, which led into Room 16, was covered in wood panelling with the doorframe being steel. A small steel mesh panel was fixed to the door, possibly an observation window for viewing activities within Room 16 (Figure 16a). All of Room 16's walls and its ceilings were covered in a mix of wood panelling, similar to that found in Room 17, and panels covered with moulded foam obelisks (Figure 16b). The flooring within the room consisted of dark foam padding with a fixed workstation located in the centre of the room.

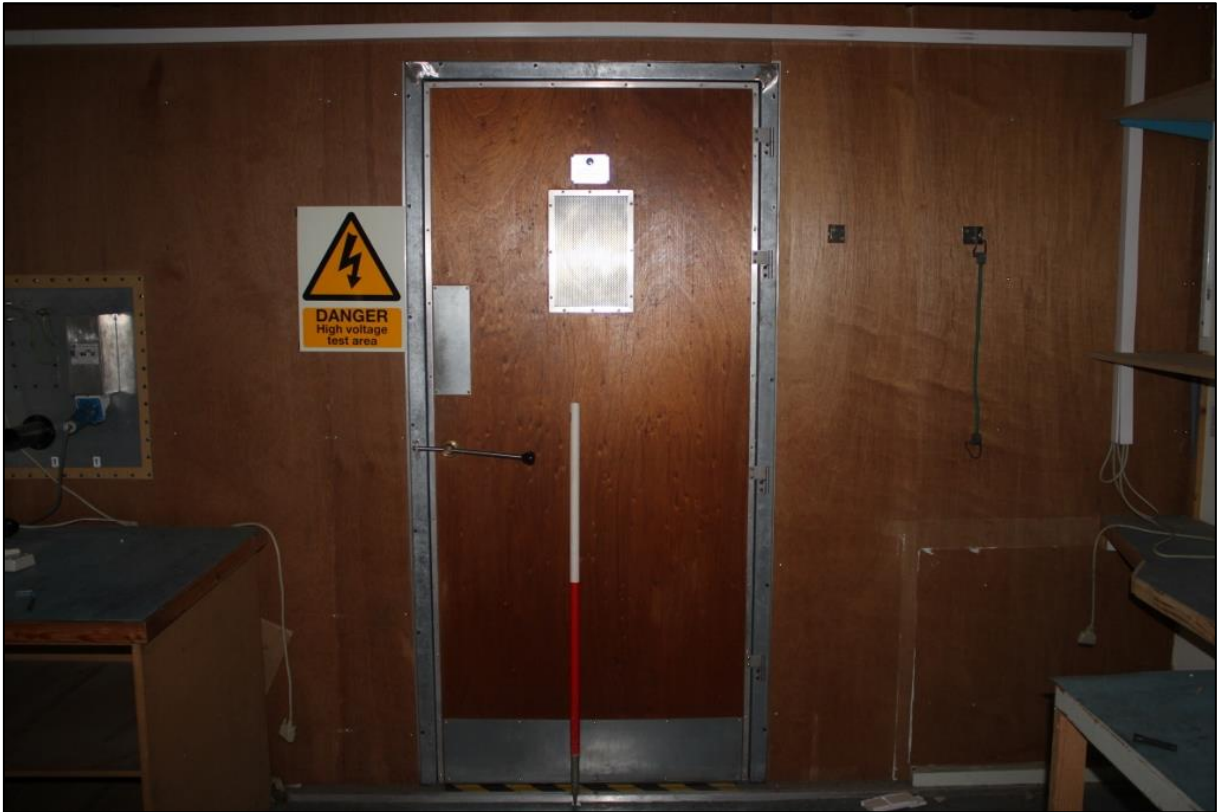
Figure 16a: View of S facing wall within Room 17, Building 3. From the S.
