14-16 Union Street, Edinburgh: Historic Building Recording

Data Structure Report

by Liam McKinstry

issued 9th May 2018

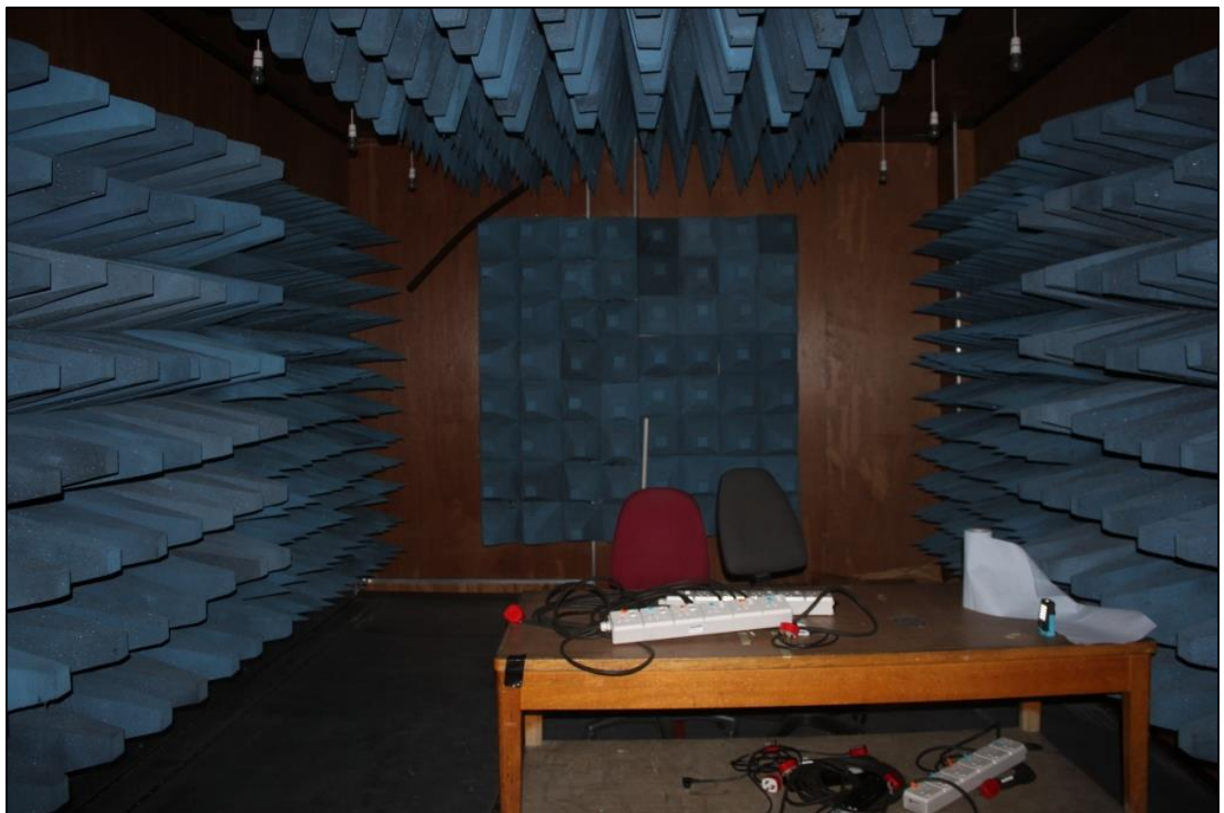
Figure 16b: View of Room 16, Building 3. From the S.

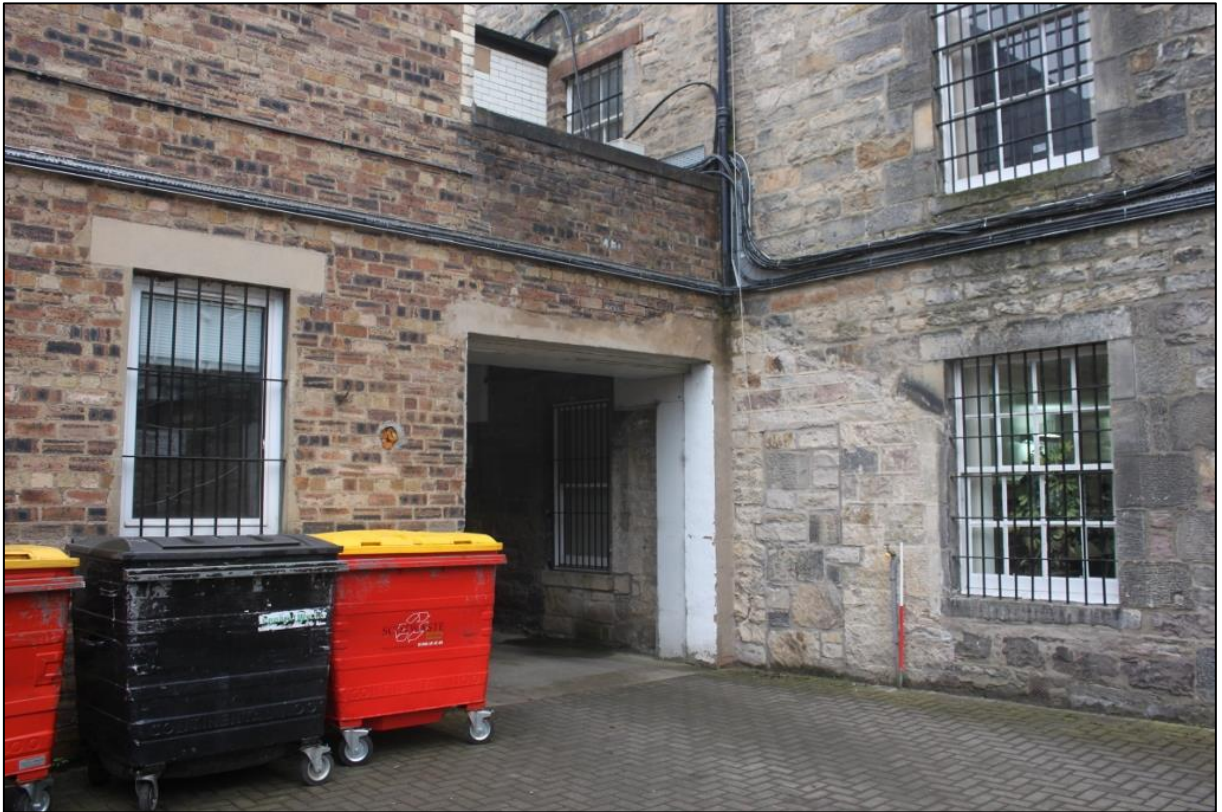
Figure 17a: View of raised corridor linking Building 3 to 24 Forth Street. From the NW.

24. The raised corridor (Room 11b) which joined the 1st floors of Buildings 3 and 24 Forth Street was located 2.5m from the west on Building 3's south facing elevation (Figures 17a). The raised corridor, which was faced with off white coloured glazed brick and had a width of 1.6m, rested upon a raised platform/roof, which had a width of 10m matching the east to west length of Building 3. At present there is one bay within the raised corridor with single modern windows on its west and east sides. A modern looking concrete lintel with a support under the raised platform on its west-facing side and the presence of two
