14-16 Union Street, Edinburgh: Archaeological Monitoring

Data Structure Report

| Event Type | Archaeological Monitoring | | |

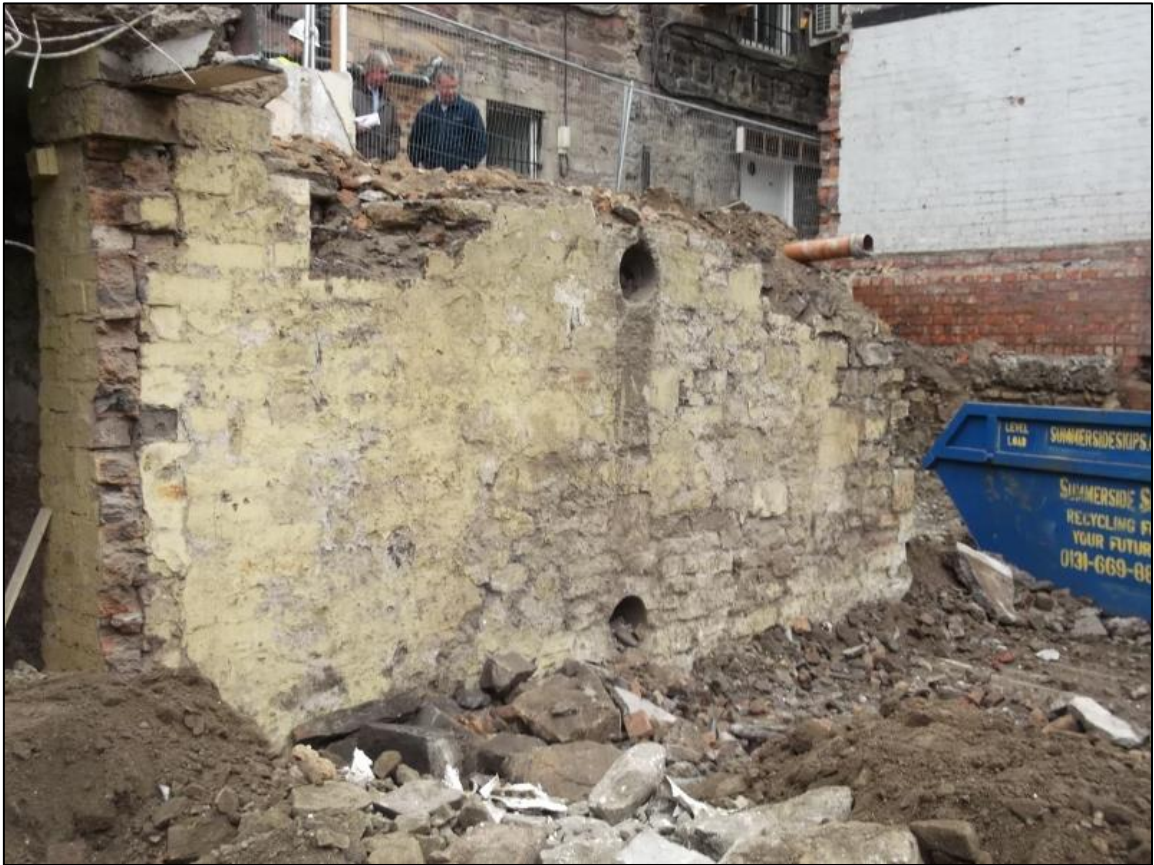
Figure 2a: Wall [101] in process of demolition (N-facing wall, Buildings 4/1a)

6. Wall [101], which comprised the extant N-facing basement wall of Building 4 (once part of Room 10a) was composed of snecked sandstone rubble, painted cream (Figure 2a). In section, it was 0.6m thick over its lowermost 1.6m (Figure 2b): here, it comprised an outer N-facing wall face which fronted onto the basement, with a less substantial face to the rear, which suggested that the wall had been built as a free-standing structure, with infilling of the void to the rear occurring after its construction.

7. For a depth of 1m below the upper surface of modern concrete slab [103], Wall [101] was broader, measuring 0.6m in thickness. Here it cut an earlier wall (Figure 2a), Wall [102], which formed the E-facing wall of Building 1 which had been identified as potentially representing an earlier structure during the historic building recording element of the works. Of interest within the fabric of Wall [101] were occasional squared blocks of sandstone, with distinctive horizontal broaching across one face. These are likely to represent displaced quoins or margins re-used from an earlier structure (or structures), which – judging by the character of the tool marks – is likely to have been late 18th or early 19th century in date. On one example the broached surface was covered with cream paint identical in shade to the rest of the basement wall, which confirmed its inclusion within the actual later wall fabric (Figure 3a).

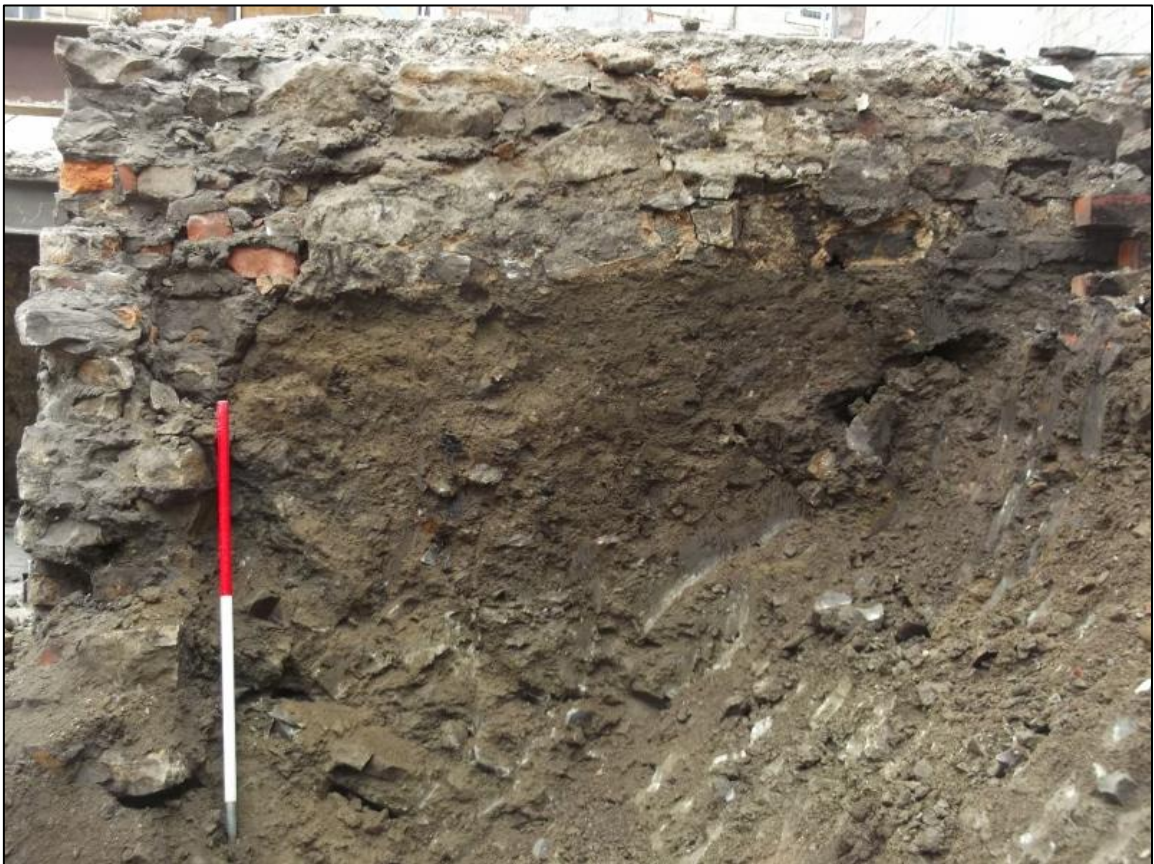
Figure 2b: W-Facing Section through area of interest, showing Wall [101] cutting through Wall [102]. Wall [101] in section, and sediments (009) and (010) over bedrock (002)

14. At least two, and potentially three, phases of wall-building were identified. Wall [102] - the E-facing wall of Building 1 - was the earliest structure, with the W-facing section clearly showing that it was cut by Wall [101], but Wall [102] was itself complex in nature, with the W-facing section and the E-facing elevation appearing entirely different in character. Viewed from the W, Wall [102] displayed a snecked rubble face 0.5m high (maximum 4 courses) which directly overlay made ground deposits (009) and (010). Viewed from the E, however, the sandstone element of Wall [101] formed only the upper part of a much deeper basement (Figure 4a) roughly 2.5m in depth, with the lowermost 2m composed of regular courses of handmade brick (characterised as Wall [102]a).

15. The differing character of these two fabrics, coupled with the fact that the character of the wall differed so markedly depending on which face was being viewed, indicated that the wall did not represent a single phase of building. Rather, it seems likely that the sandstone element [102] represented a pre-existing found which had been left in place while the sediments and bedrock below were dug away to create a basement which was then faced with handmade bricks to form [102]a.

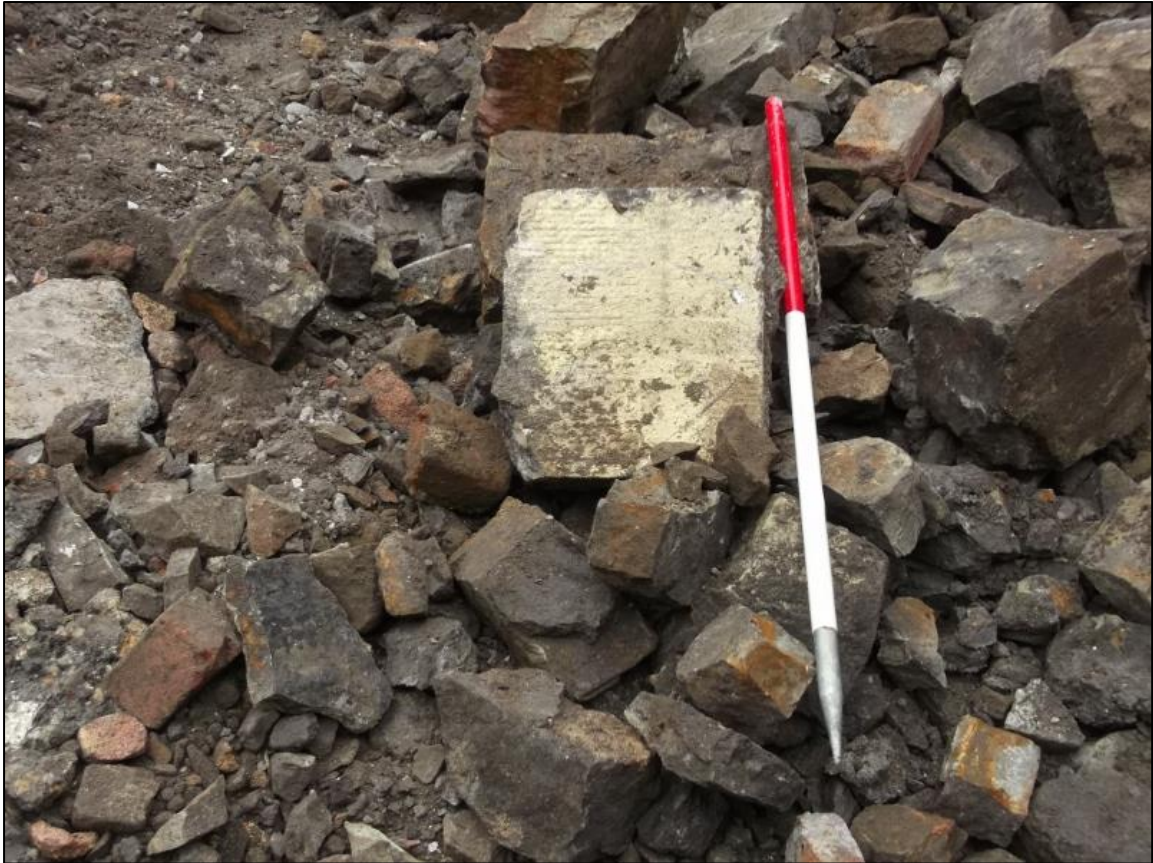
Figure 3a: Fragment of 18th century quoin or margin, incorporated into Wall [101]

17. The relationship between the various elements of walling has now been demonstrated, but it is hard to establish precise dates for the various elements, with the exception of Wall [101], which has fragments of late 18th/early 19th century character within its fabric. It is possible that the snecked rubble wall [101] represents the relict foundations of this earlier structure, but this cannot be confidently established with the evidence available. It is likely, however, that the brick element of Wall [102] - [102]a - represents a different phase of build to that of Wall [101] as the fabric is entirely different in composition.

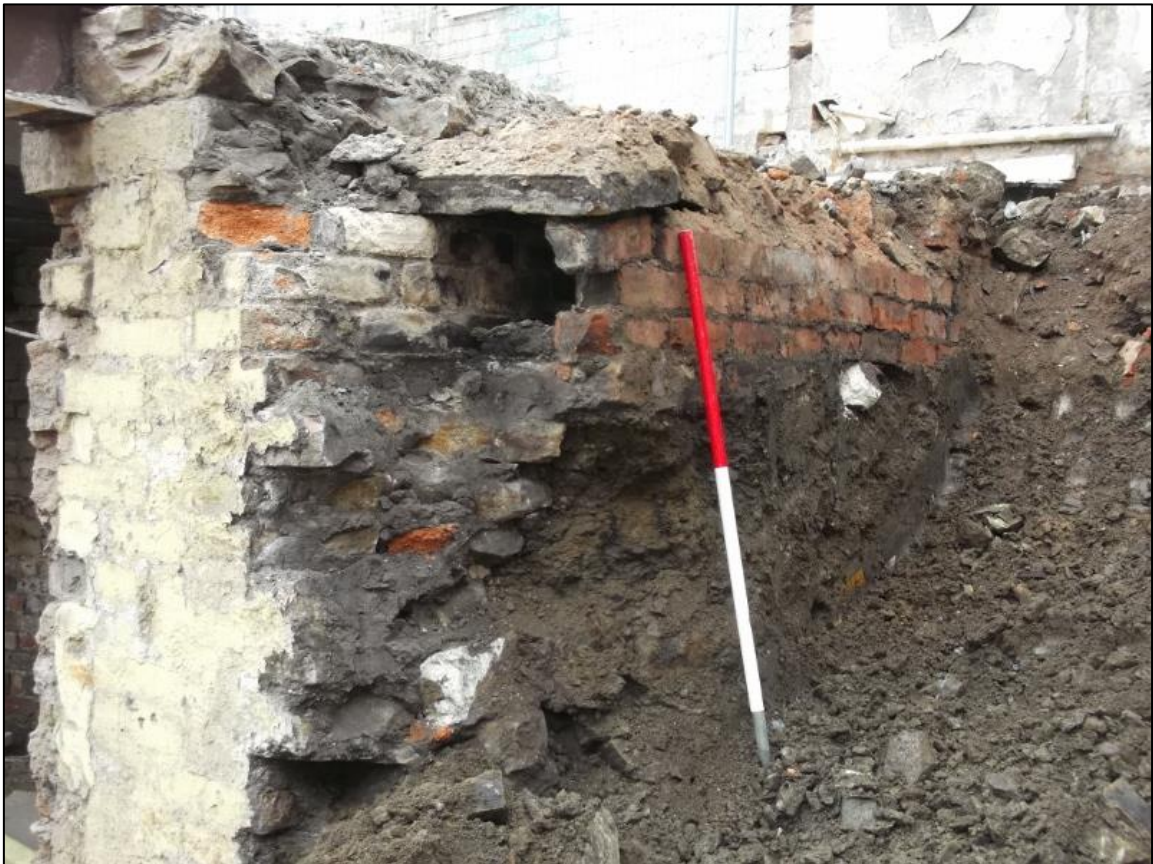
Figure 3b: Flue [006] revealed within made ground deposit (001)

10. Two features were noted within the sediments which occurred to the rear of Wall [101]. The first comprised a small flue of square section, Flue [003] (Figures 3b and 4a). This measured 0.2 x 0.2m in extent, and comprised a flat base of rectangular sandstone slabs [005], placed end-on, with sides comprising three courses of handmade brick [004], laid in stretcher bond, and capped with another row of rectangular sandstone slabs [006], again placed end-on. A small deposit of ash and soot (007) remained *in situ* over the base of the flue.

11. The flue was set at a high level within the basement wall, at a depth of 0.66m below the relict concrete slab [103]. It sat virtually flush on its eastern side with Wall [102]: the different character of the sediments to its immediate east supported the possibility - already inferred by the fact that Wall [101] cut the line of Wall [102] - that the creation of the basement area associated with Building 1a post-dated Wall [102]. This could then infer that (009) formed the fill of a foundation cut for [102], but this is by no means certain, as there is evidence that Wall [102] had itself been substantially modified during its history.

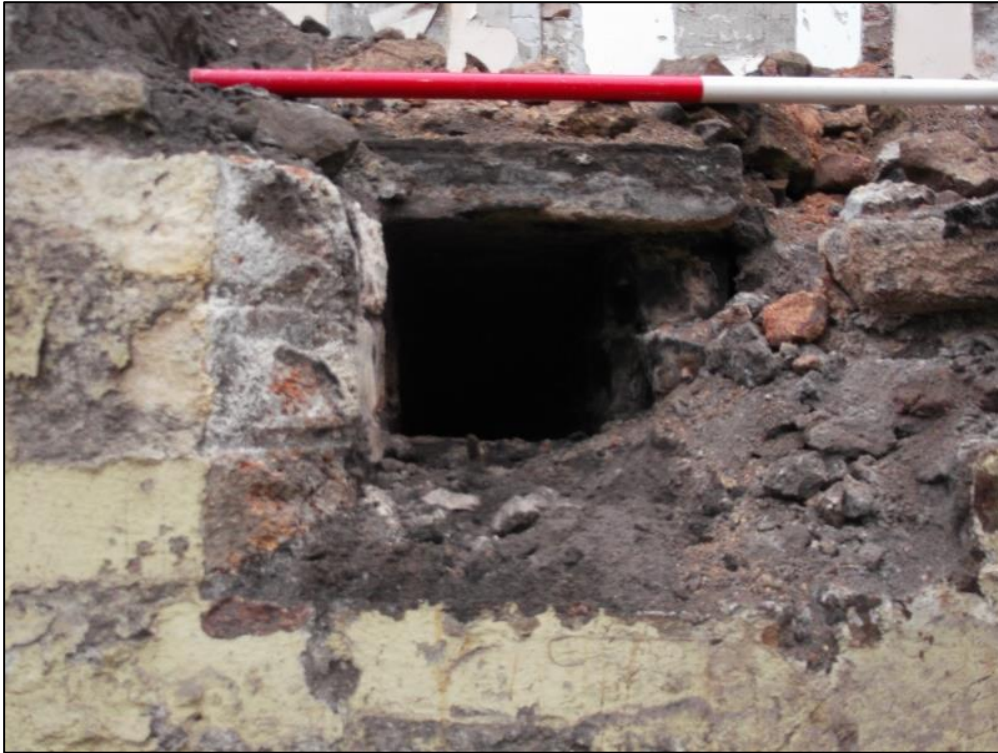
Figure 4a: Detail of Flue [006]

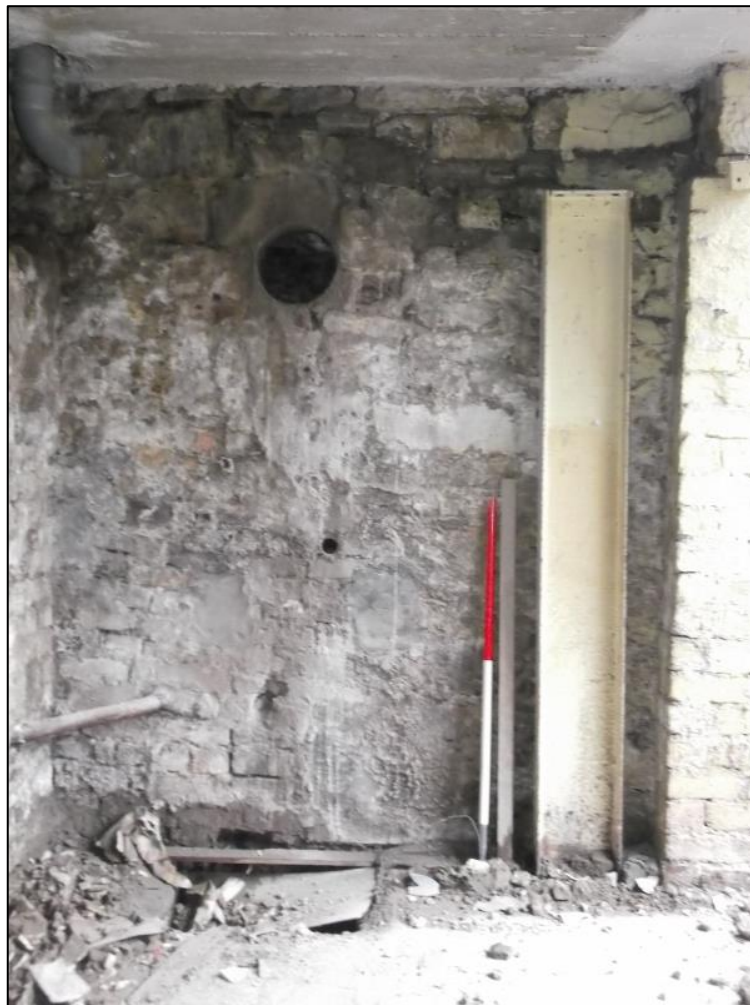
Figure 4b: Wall [101], E Elevation, showing snecked rubble upper section over brick below

16. The snecked sandstone rubble of [102] was consistent with early to mid-19th century construction, but it could conceivably have been earlier, with the brick basement inserted prior to 1850. At a later stage, the E-W aligned Wall [101] was added, cutting through the N end of [102] and potentially marking the initial consolidation of Building 1 and Building 1a into one conjoined structure. The incorporation of tooled ashlar blocks within the fabric of Wall [101] (though not within the fabric of Wall [102]) suggests that the fabric derived from the demolished remains of an earlier structure. From the nature of the tooling, which comprised horizontal broaching with contrasting broached margins, we can surmise that these blocks were derived from quoins and/or door/window margins of late 18th/early 19th century date, potentially representing an earlier building which once occupied the site.
