Craignavar, Perth & Kinross: Archaeological Mitigation

Data Structure Report

issued 31st May 2018

on behalf of West Glenalmond Estate

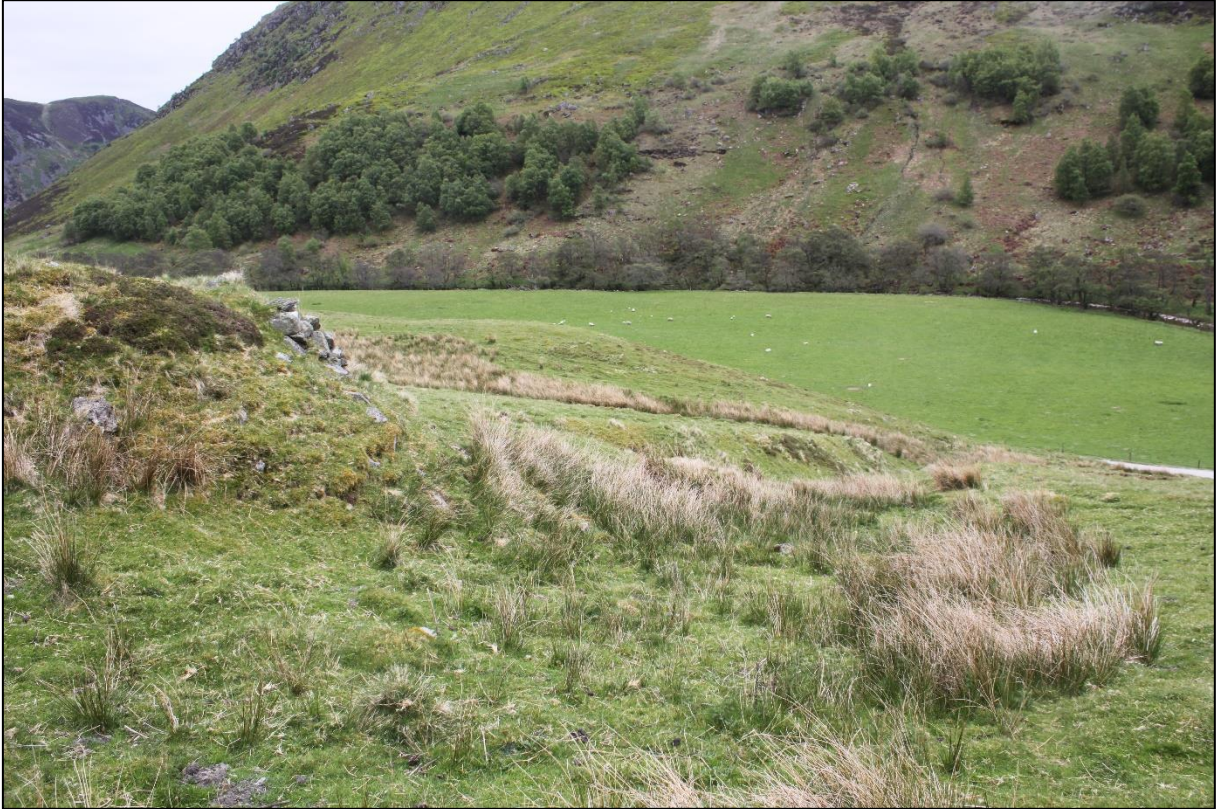
8. The scheduled area sits 240m above the northern bank of the River Almond. The deserted township is now situated on rough open pasture used for grazing livestock, with an access road running along its southern axis. The scheduled area is sub-rectangular in plan, running roughly east-west, measuring approximately 350m east-west and 80m north south (Figure 2-3a).

Figure 3a: General shot of rough pasture from the NNW facing into Glen Almond.

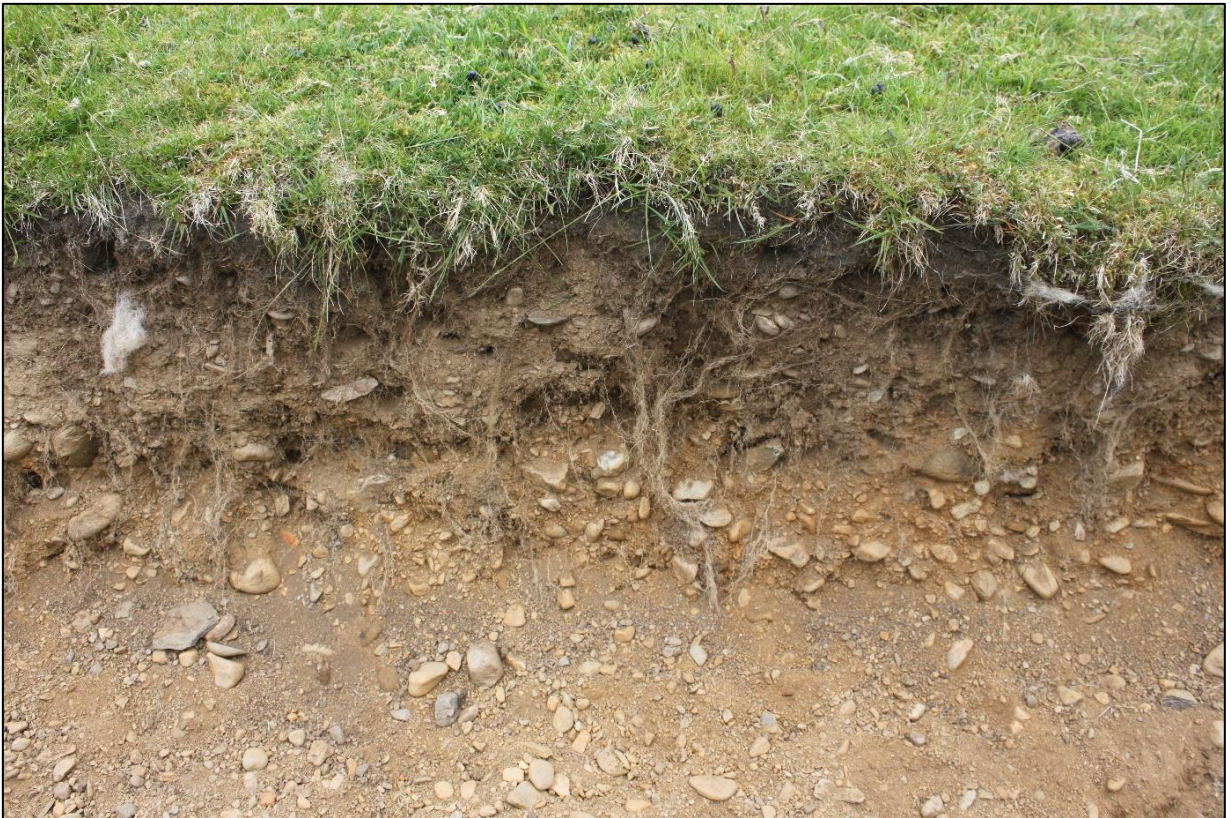
9. The topsoil, (001), which was identified in both areas of reinstatement was a, friable, mid-grey brown, silty sand with small to medium sub rounded stone inclusions. The topsoil had a depth range of between 0.1m to 0.27m. Beneath the topsoil layer was a natural subsoil layer, (002), which comprised a loosely compacted, light yellow orange, sand with small to medium sub rounded stone inclusions. This subsoil layer was identified in both of the reinstatement areas (Figure 3b).

Figure 3b: South facing section of [004].

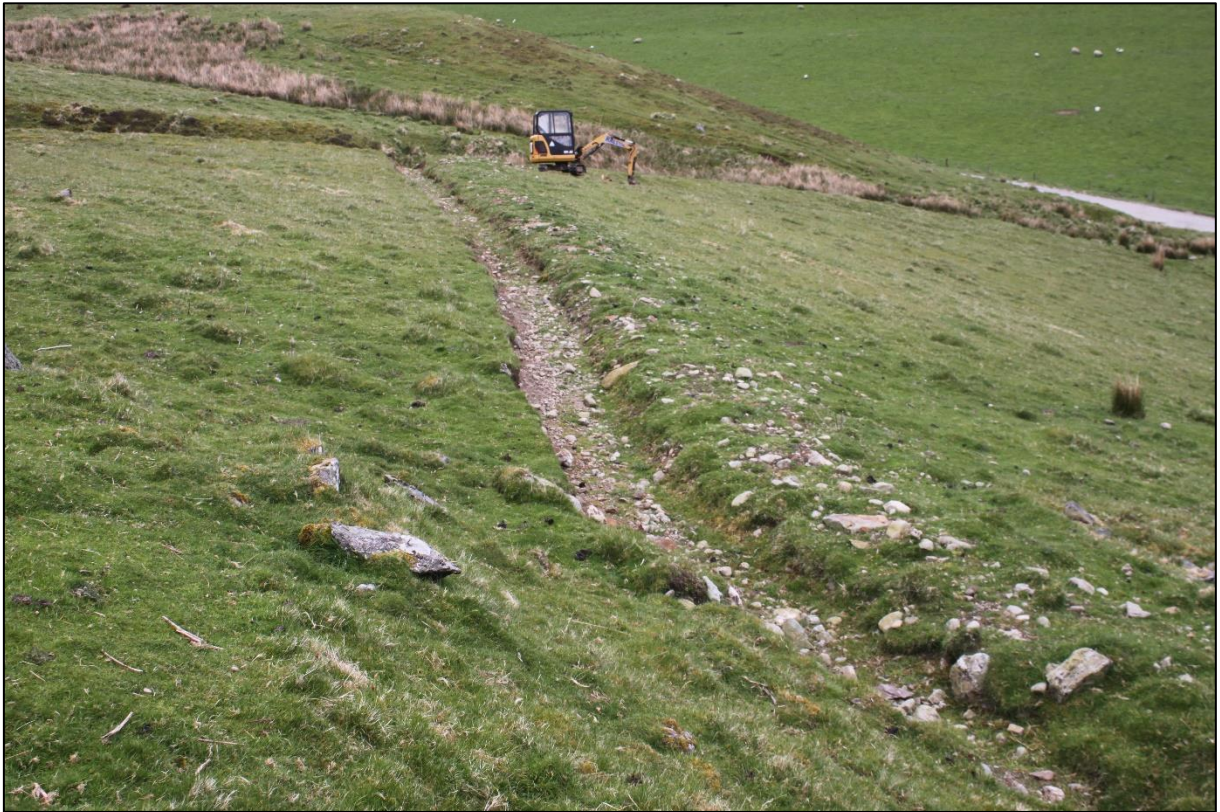
10. Prior to reinstatement, it was observed that along the southern edge of each drainage ditch ran a bund (005) from the initial excavation. These bunds were both a friable mix of (001) and (002) and contained small to large stone inclusions. The bunds measured 45m ditch and 125m long, 1m wide by 0.4m deep.

11. At the western extent of the site the first of the modern drainage ditches, [003], was observed running northwest-southeast. The ditch was linear in plan with gently sloping sides, a flat base with a gradual break of slope. The ditch measured 45m long, 1.20m wide and 0.55m deep. The ditch was reinstated using the pre-existing bund (005) (Figure 4a-4b).

Figure 4a: Pre-Reinstatement of ditch [003] from the east

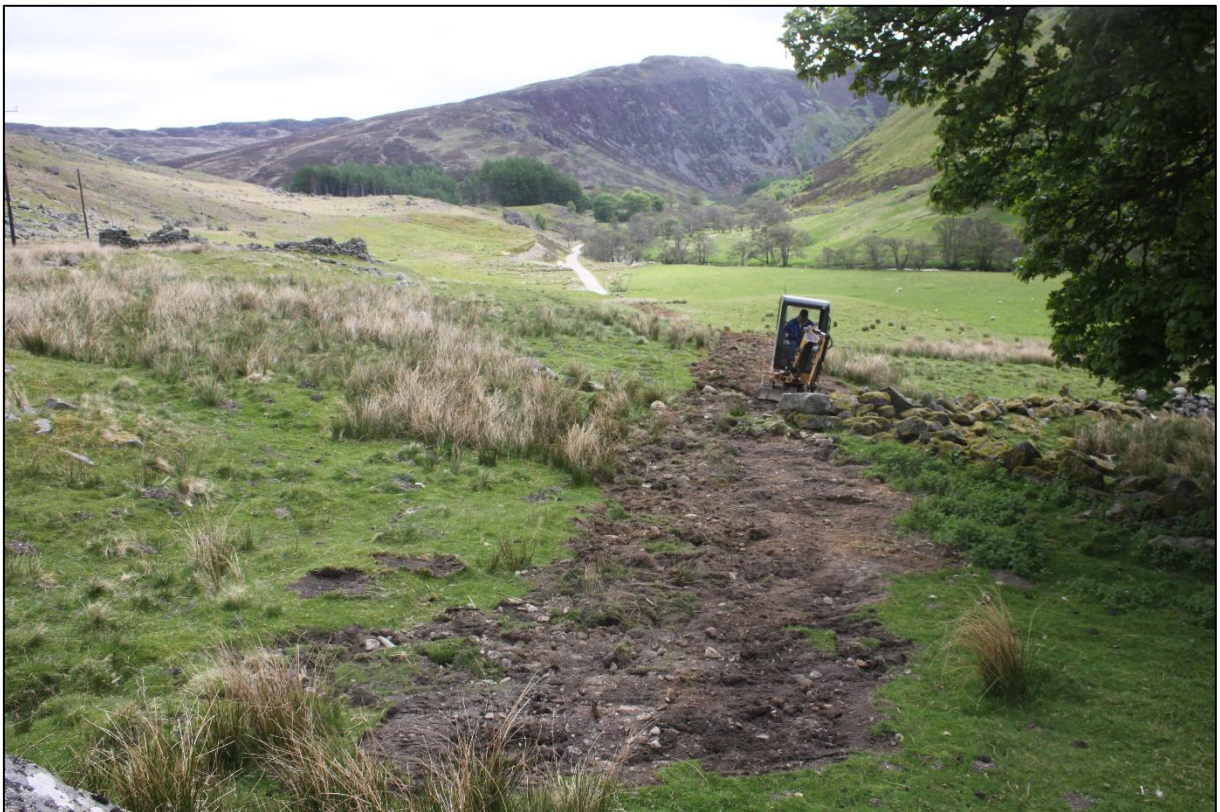
Figure 4b: Ditch [003] after reinstatement complete from the west

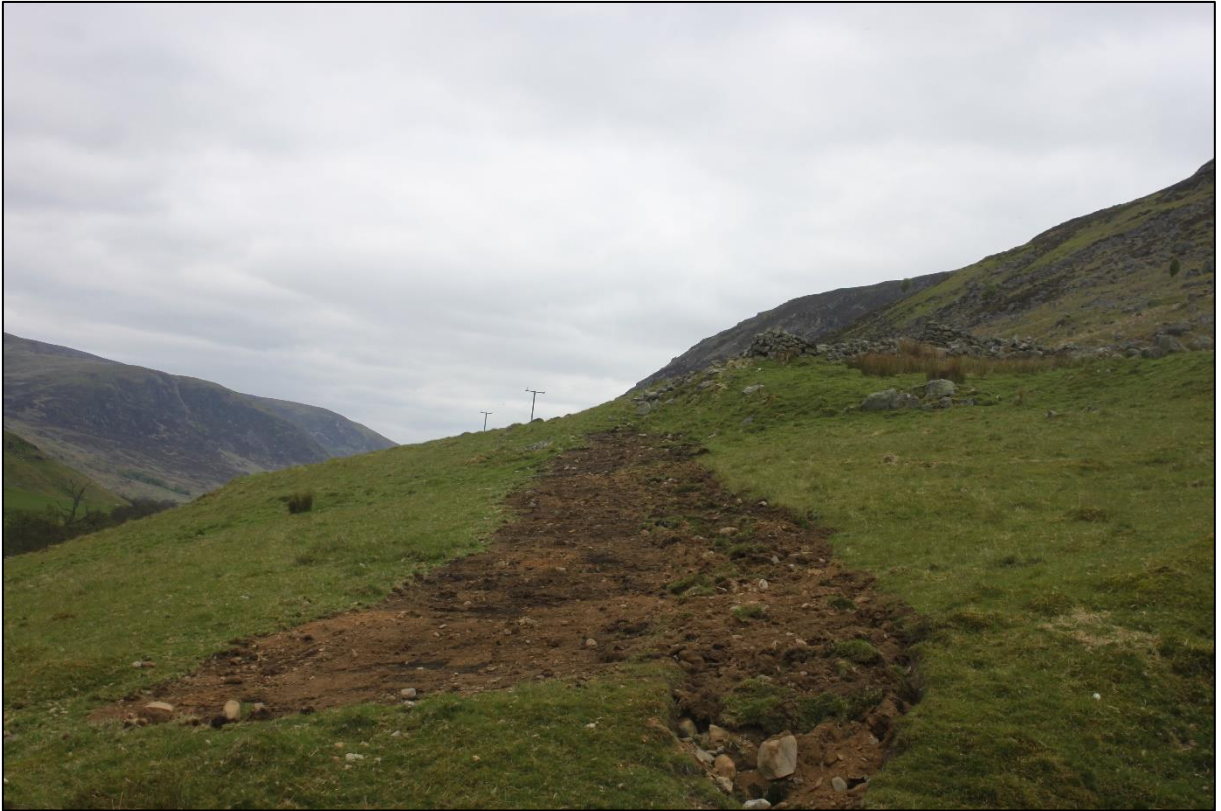
12. At the eastern extent of the site the second modern drainage ditch, [004], was observed running east-west. The ditch was linear in plan with vertical sides and a flat base with a sharp break of slope. The ditch measured 125m long 0.9m wide by 0.5m deep. The ditch was reinstated using the pre-existing bund (005) (Figure 5a-5b).

Figure 5a: Pre-Reinstatement of ditch [004] from the west.

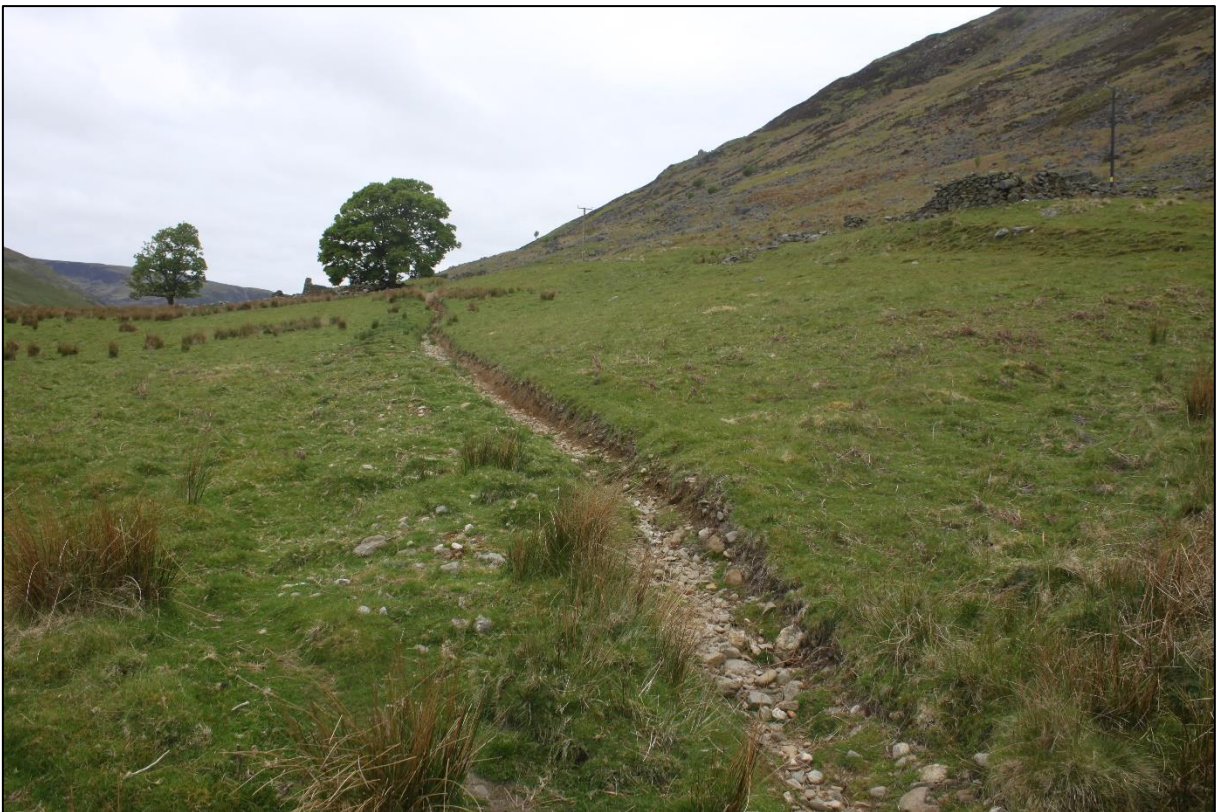
Figure 5b: Ditch [004] after reinstatement complete from the east.
