# **39 North Vennel, Lanark, South Lanarkshire: Archaeological Mitigation**

Data Structure Report

issued 30<sup>th</sup> August 2018

on behalf of Clydesdale Housing Association Ltd

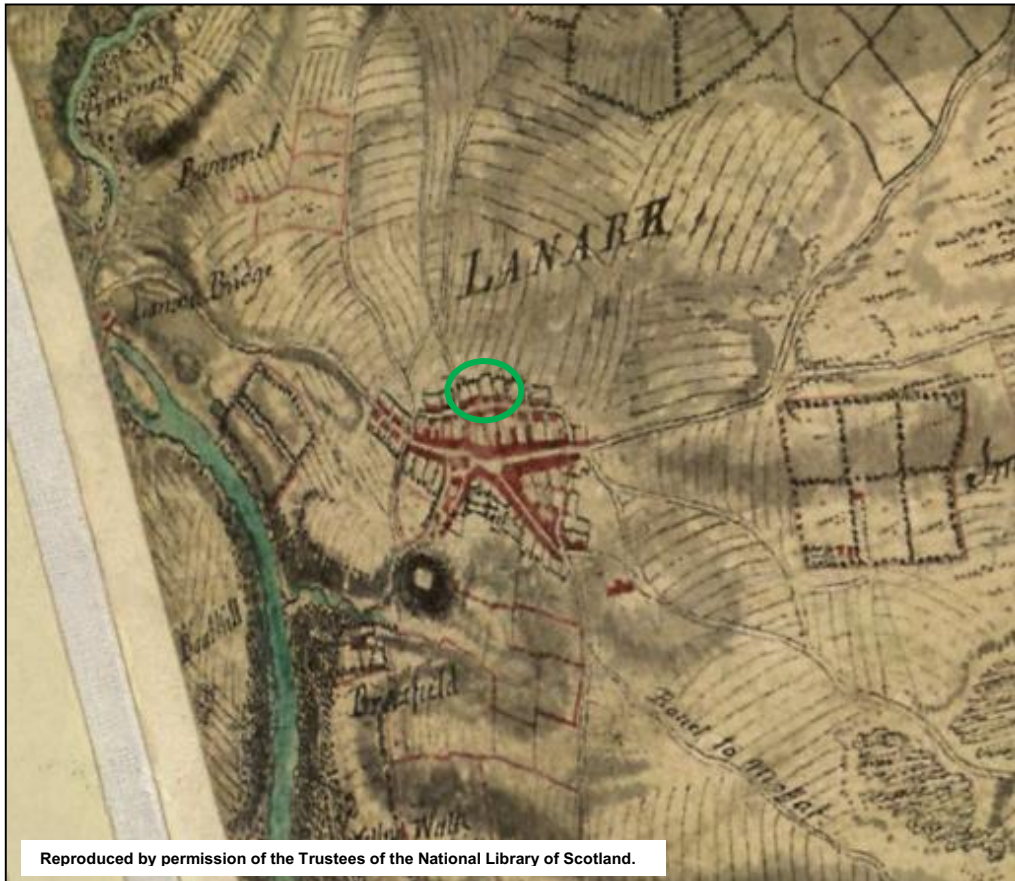
Figure 1a: Roy's Military Survey of Scotland, 1752-55

6. The burgh of Lanark is first shown on Timothy Pont's *Map of Scotland* in 1596 and again on John Blaeu's *Atlas of Scotland* in 1654. The first detailed depiction of its layout however, is provided by William Roy's *Military Survey of Scotland* in 1752-55 (Figure 1a) which enables us to identify the street layout. Roy's map clearly shows the line of the central High Street/Bloomgate running roughly east-west through the centre of the town, with North Vennel running parallel further to the north. By this time, we can see that the town has expanded and that properties are now present along the northern side of North Vennel. This places the development area as being within the extent of the town by the mid-18<sup>th</sup> century, although the date at which it was first occupied is not known. It is possible that activity may have occurred on this site from a fairly early date, such as ad hoc settlement or small-scale industrial processing undertaken immediately outwith the formal burgh boundaries. This suggested potential for archaeological remains to be present.

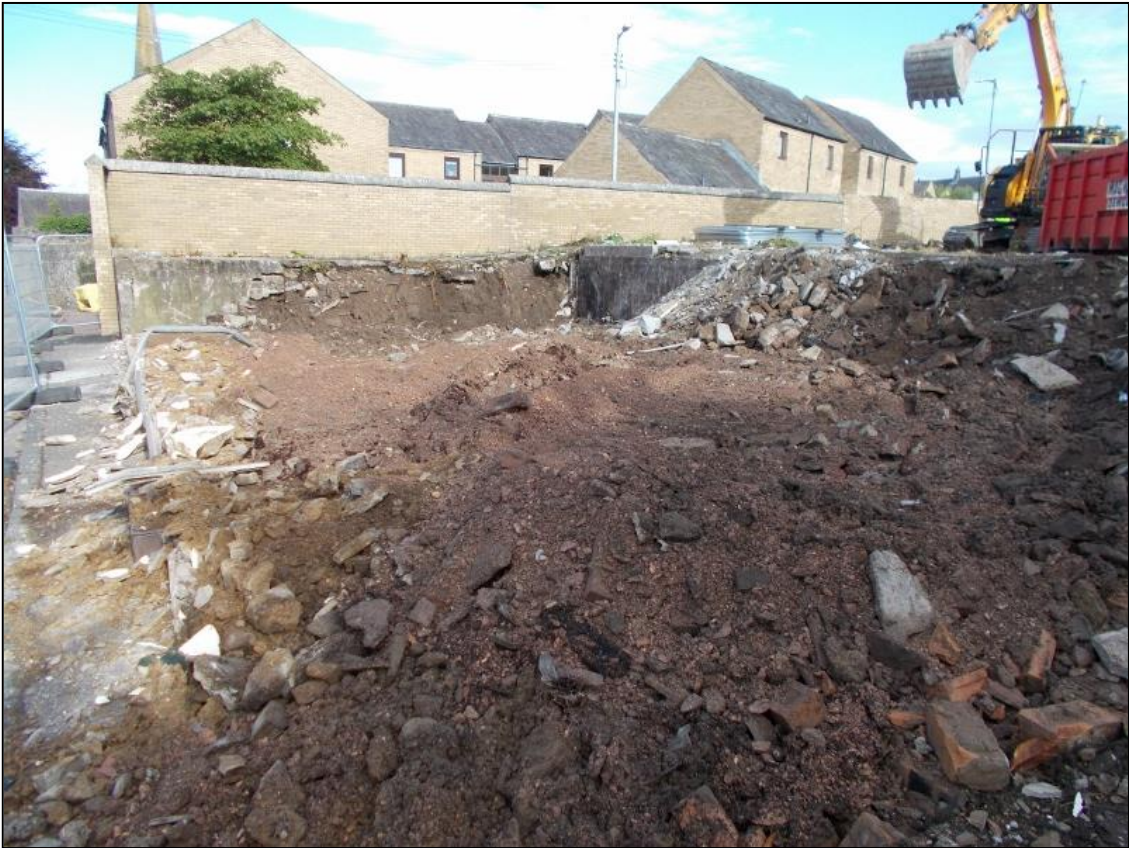
Figure 3a: Site of SW and SE buildings from the east-southeast after floors removed, raised surface (004) sits in front of boundary wall and machine sits on rear yard area

27. The surface of the yard sat higher than the floors, (001) and (003), of the southern buildings (see Figure 3a) with the northern walls of both structures acting as a retaining wall for the material sitting behind. More specifically, floor (003) sat approximately 1.6m below the surface of the yard. On removal of the northern wall of the SW building, a section through the deposits underlying the yard was revealed (Figure 3b). Underlying the raised yard surface (009), made ground (007) was shown to have a depth of 1m in this area before coming down on to subsoil (006).

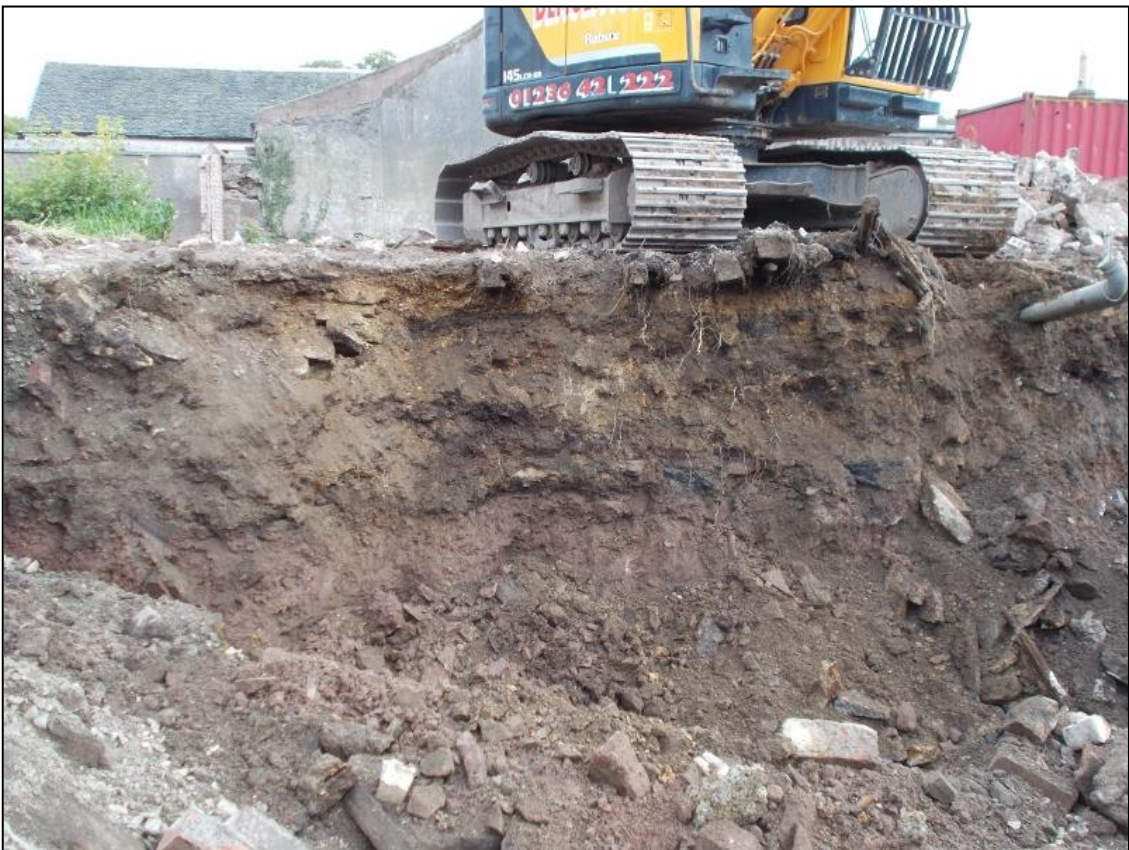
Figure 3b: South facing section along rear yard, after north wall of SW building removed

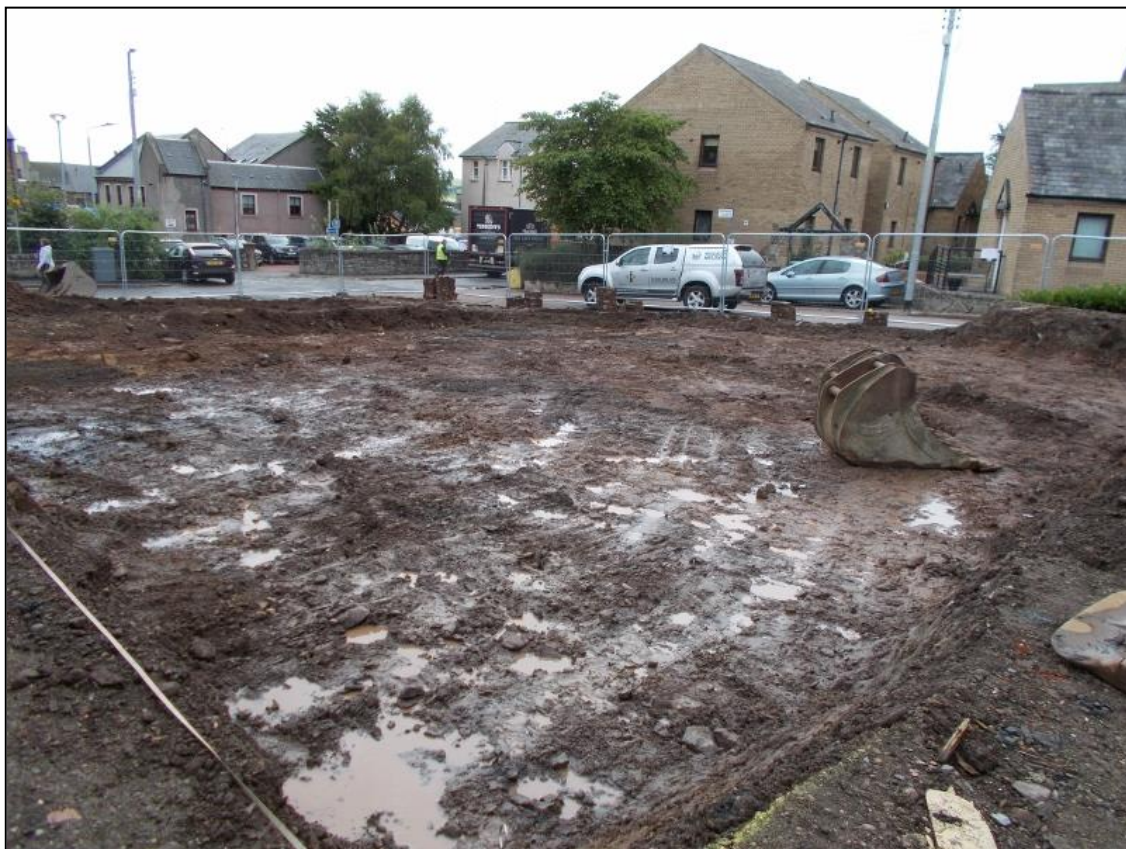
Figure 5a: General post-excavation shot of stripped area from the northeast

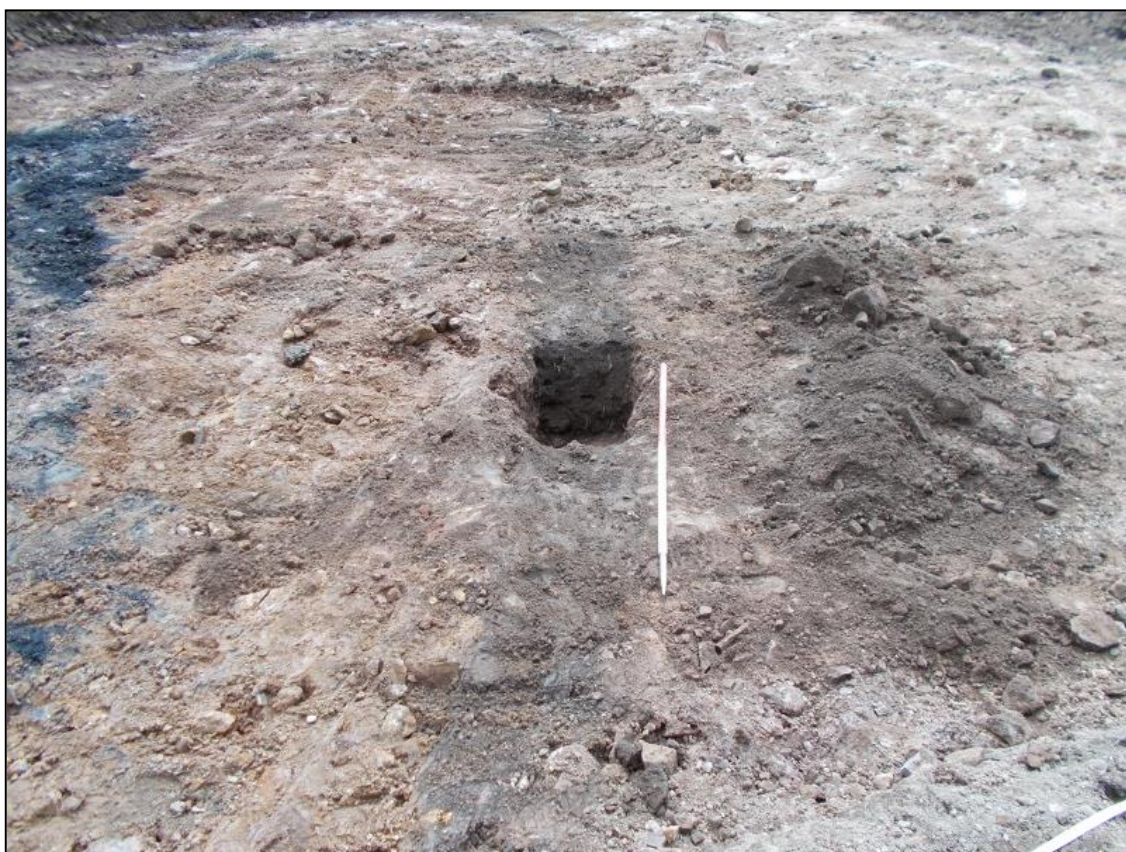
36. Cut into the upper surface of the natural subsoil, some spreads and features were exposed. In the northwestern corner of the area, linear feature [010] was revealed running northeast-southwest (Figure 5b). It had vertical sides and a flat base, measuring 0.4m wide and 400mm deep. It ran for a length of 9m continuing outwith the stripped area to the north. The feature was filled by (011), a loosely compacted dark grey brown silty clay with frequent small-medium sized stone inclusions. This contained sherds of white glazed white earthenware pottery dating to the late 19<sup>th</sup>/20<sup>th</sup> century.

Figure 5b: Linear feature [010] from the northeast

43. The presence of sherds of white glazed white earthenware within the fill of linear feature [010] indicates it as being late 19<sup>th</sup>/20<sup>th</sup> century in date. Although its function remains unclear, this date places it as contemporary with the use of this area for buildings and
