**Church Lane, Riccarton,
East Ayrshire:
Archaeological Mitigation**

Data Structure Report

issued 14th August 2018

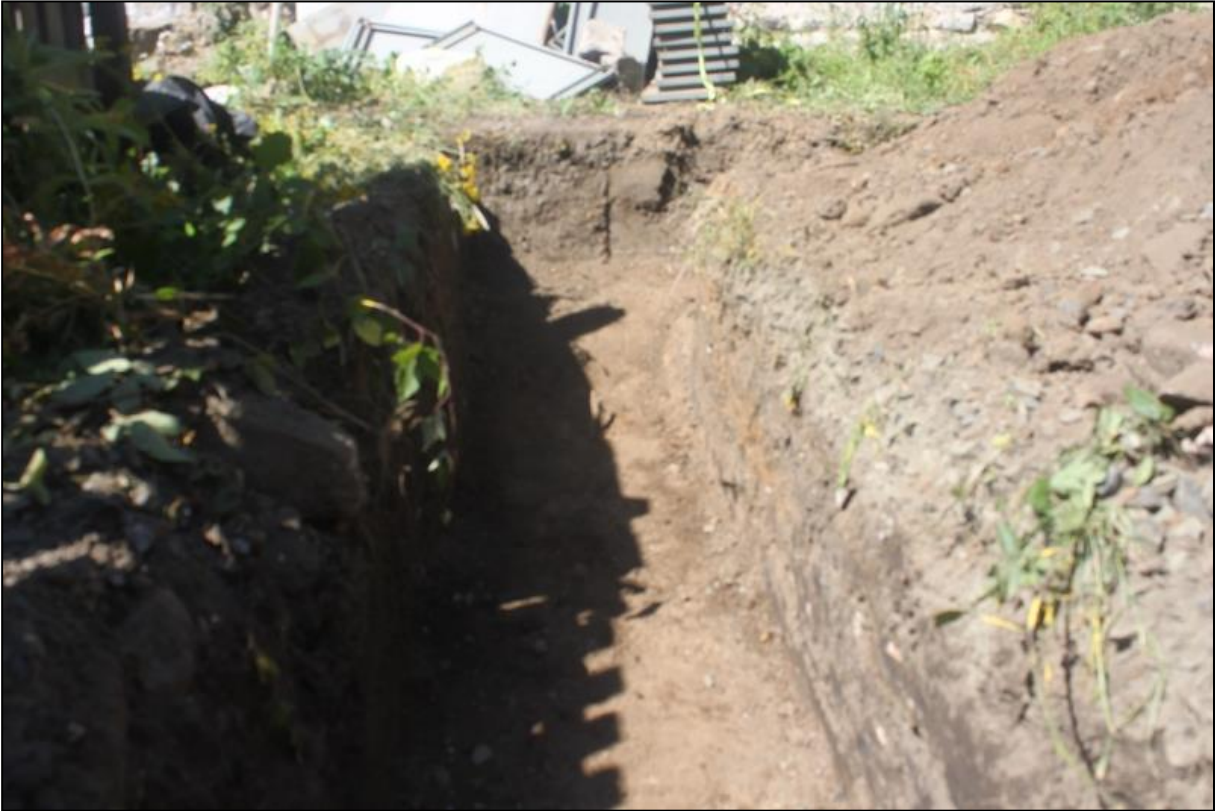
Figure 3a: Post-excitation shot of Trench 2 from the southeast.

13. Trench 2 ran northwest-southeast at the western end of the development area parallel to the wooden garden fence which formed the boundary on this side. It ran perpendicular to Trench 1. The trench was 9.4m long and 0.8m wide. The northwestern third of the trench was excavated to a depth of 0.6m, while the remainder of the trench was excavated to 1.5m.
14. Trench 2 was dug through (001) and loose whitish grey small sub-angular Type 1 gravel (007) with frequent brick and concrete slab inclusions. (001) was only present in the northern 1.5m of the trench. Made ground (006) underlay (001) and (007) at a depth of 0.25m for the entire length of the trench (Figure 3a). The natural subsoil (002) was not exposed in this trench.
15. No significant archaeological features were revealed within Trench 2.

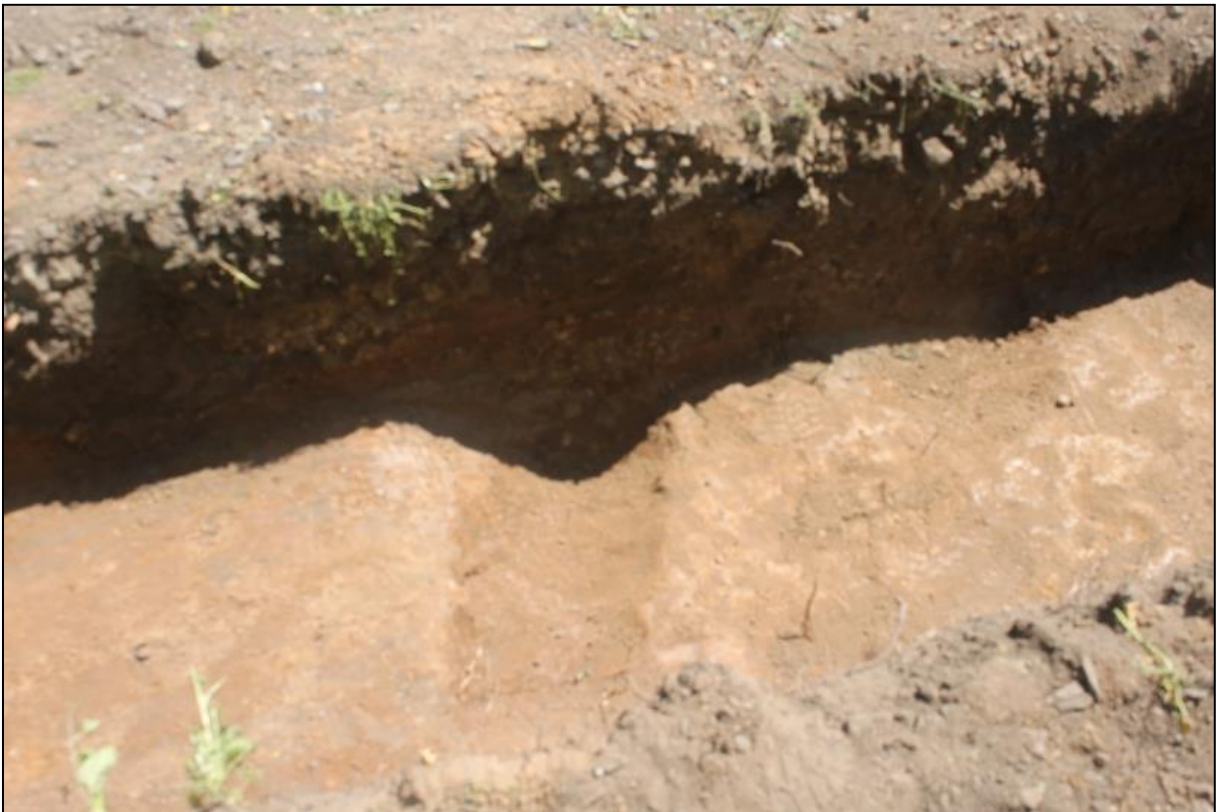
Figure 3b: Linear feature [005] in Trench 1, taken from the southeast.

11. In the southwestern 7.6m of Trench 1, (001) was underlain by made ground (006), a moderately compact dark blackish brown clay with frequent brick and stone inclusions. This made ground had a thickness of 0.25m and overlay natural subsoil (002). Sat 5.4m from the southwestern end of Trench 1, a small linear feature [005] running north-south was revealed cut into the surface of (002). The linear was U-shaped with steep sides and a rounded base (Figure 3b). It had a width of 0.32m and was 0.19m deep. A length of 0.8m was exposed within the trench and it extended outwith the trench in both directions. The linear was filled by (004), a loose mid blackish-orange clayey sand with small stone inclusions that was the same as the overlying deposit (006).

30. The linear feature found running north-south within Trench 1 is likely to be modern in date. It is incredibly shallow and the fill (004) is the same as the overlying made ground deposit (006). It is likely that this linear feature is an old service trench or drain. It is also possible that this linear feature may have related to the small structure shown within the development area on the 1st and 2nd edition Ordnance Survey maps (Figures 1a and b).

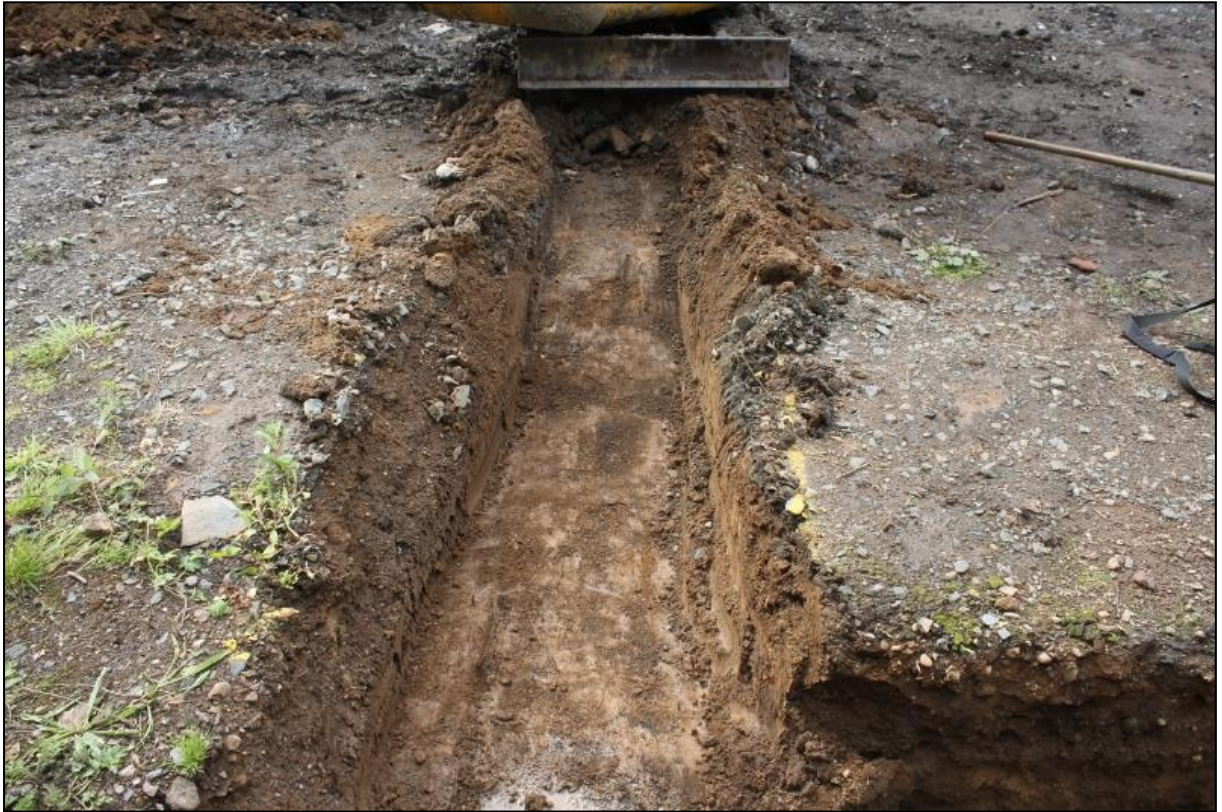
Figure 4a: Post-excavation shot of the northwest half of Trench 4 from the northwest.

20. Trench 4 ran southeast from the northeastern end of Trench 1. It was 8.9m long and 0.8m wide, and had a maximum depth of 0.8m.
21. The trench was cut into hardstanding (001) which measured 0.15m thick. In the northwestern half of the trench (001) was underlain by topsoil (008). Underlying topsoil (008) at a depth of 0.34m sat natural subsoil (002). The subsoil was cut into for 0.2m (Figure 4a).
22. In the southeastern half of Trench 4, (001) was underlain by Type 1 gravel (007) at a depth of 0.15m. (007) was in turn underlain by made ground (006) at a depth of 0.45m. The full extent of the made ground is not known in this section but it was excavated to a maximum depth of 0.8m (Figure 4b), and the base of the trench did not go beyond it.
23. No significant archaeological features were revealed within Trench 4.

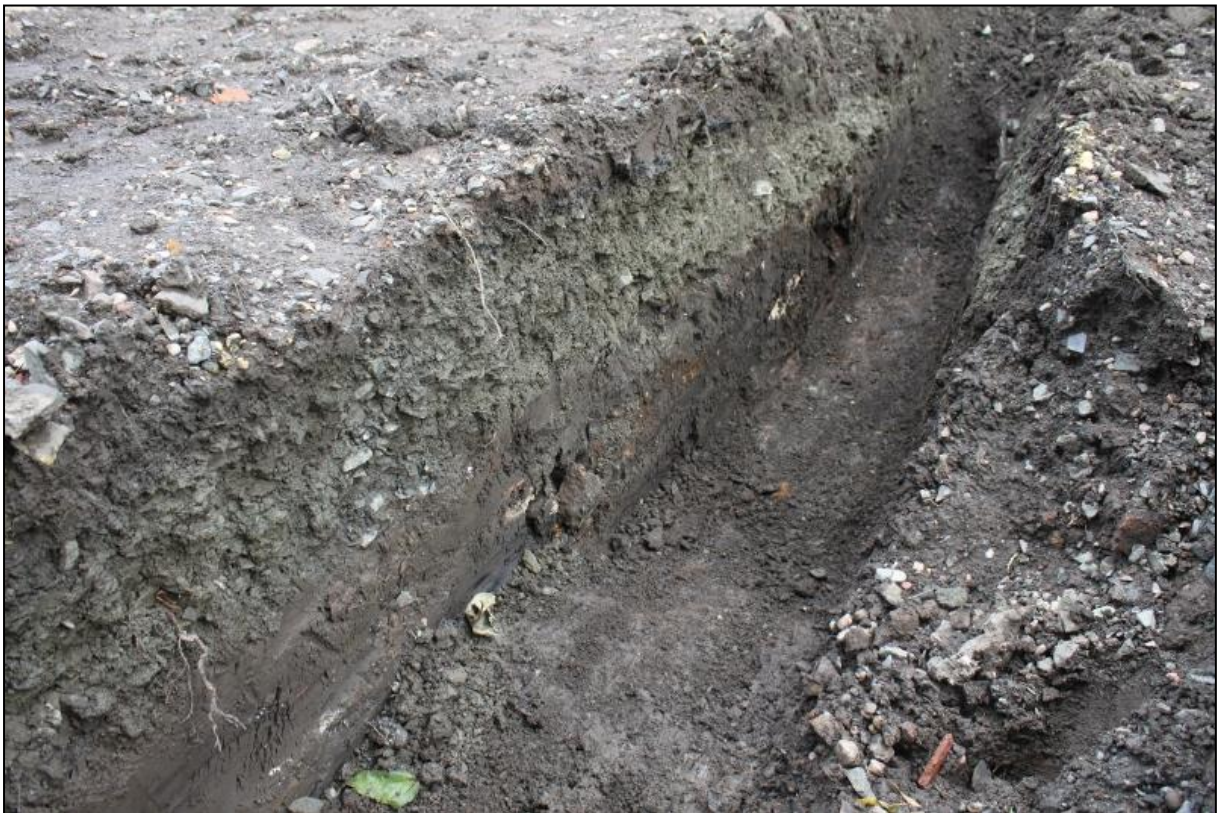
Figure 4b: Post-excavation shot of the southeast half of Trench 4 showing northeast facing section, taken from the east.

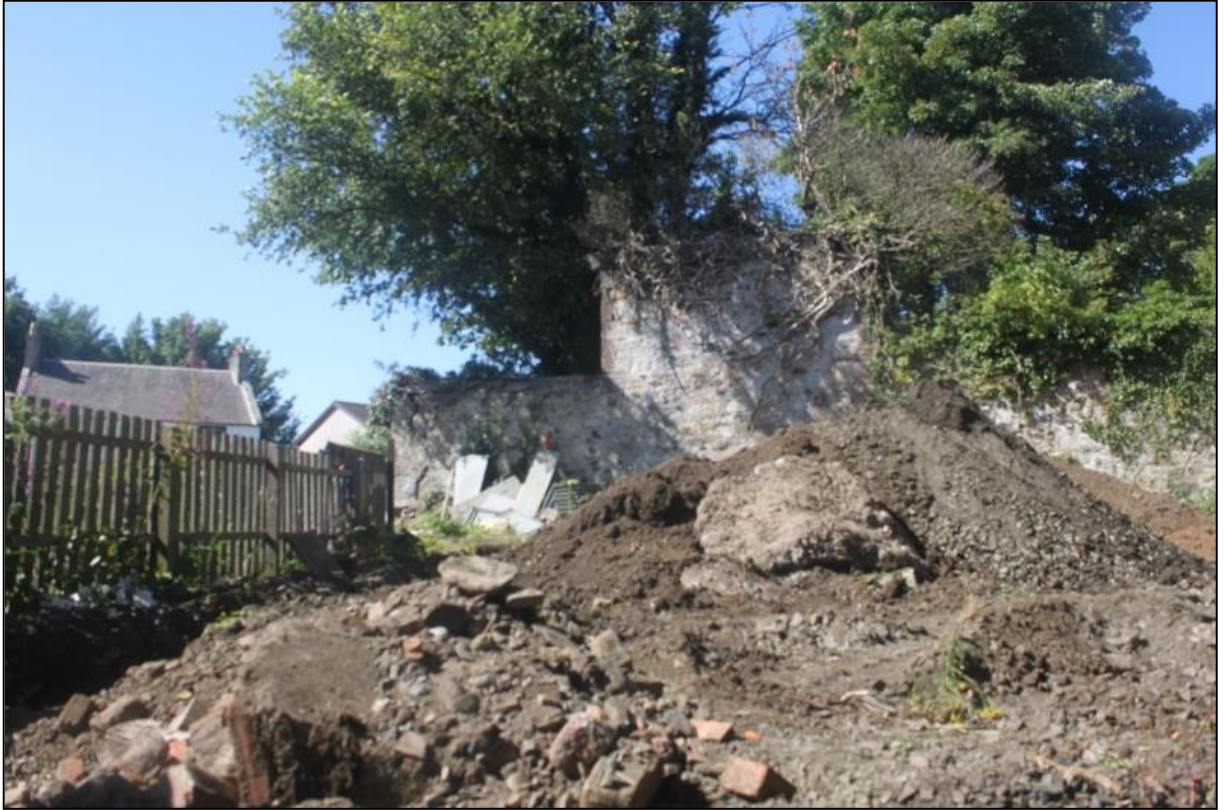
Figure 5a: General shot of site taken from the south.

6. The programme of works comprised the archaeological monitoring of ground breaking works immediately to the south of the old graveyard of Riccarton Parish Church along Church Lane (Figure 2; Figure 5a). As already agreed in the Method Statement, works that did not extend beyond the depth of the hardstanding did not require monitoring (Krischer 2018). As a result, the southern portion of Trench 3 was not monitored.

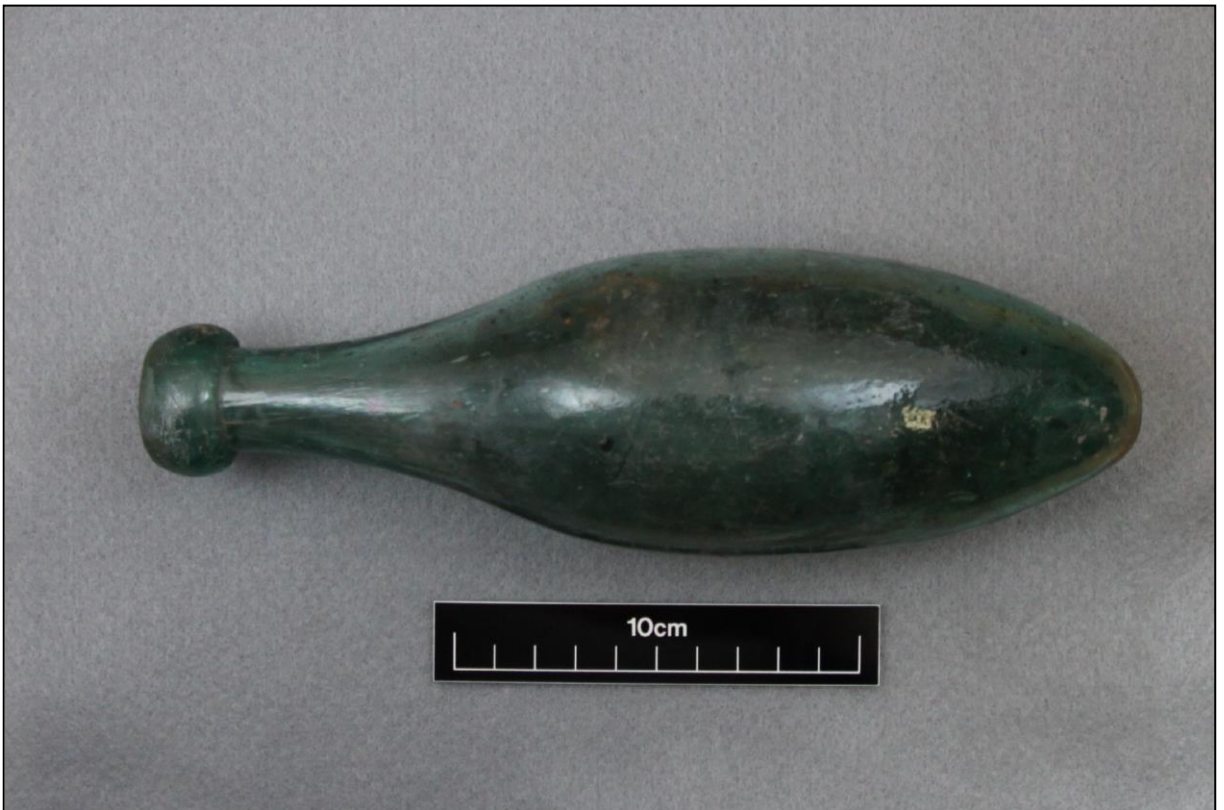
Figure 5b: Torpedo bottle from (006) in Trench 4.

27. A glass bottle (Find no. 3; Figure 5b) was found in made ground (006) in Trench 4. It was a moulded blue green torpedo bottle with a rolled lip. The bottle was 0.24m long and had a maximum diameter of 0.075m. The bottle had no decorations or embossed lettering. This form of bottle was used to hold aerated mineral water. They first appeared in England around 1809, but was most common between the 1870s and 1910.
28. In addition, (006), which was found across the majority of the site, contained a large amount of ceramic sherds that were late 19th century in date.
