**Linwood Community Hub,  
Renfrewshire:  
Archaeological Evaluation**

Data Structure Report

issued 10<sup>th</sup> October 2018

on behalf of Linwood Community Development Trust

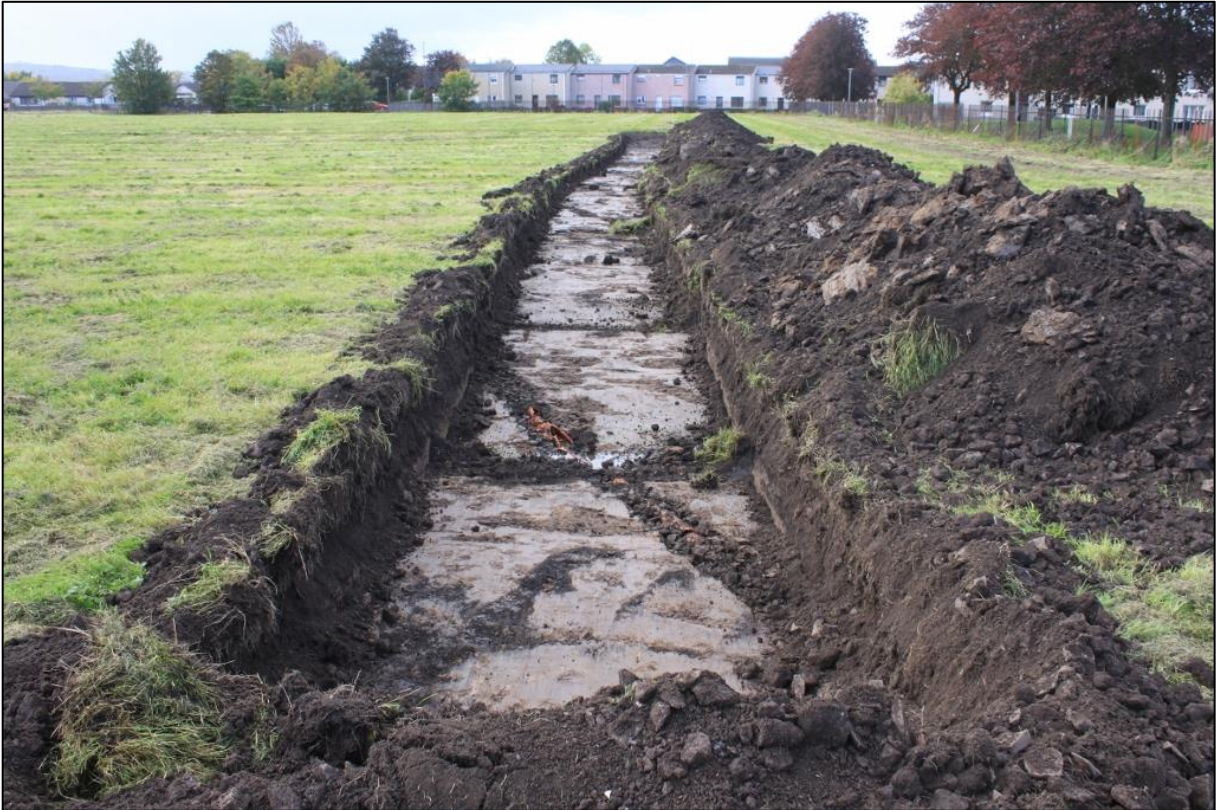
11. There were two main layers of naturally occurring subsoil which were identified within all of the excavated trenches (Figures 3a and 4a). The first of these subsoil layers, (002), consisted of moderate to firmly compacted, mid grey-brown silty clay with very frequent small to medium sandstone and grey gravel inclusions (possibly related to disturbance). The layer had an excavated depth within the trenches of between 0.09m to 0.22m. The second of these subsoil layers, (003), consisted of firmly compacted, light to mid orange-brown/grey-brown clay with occasional small stone and gravel inclusions. The layer had an excavated depth within the trenches of between 0.09m to 0.2m.

12. A series of parallel and associated linear cuts were identified within all of the excavated trenches (Figures 3a and 3b). These cuts had a width range of between 0.38m to 0.43m and a depth range of between 0.48m to 0.54m. They were orientated predominantly in a northeast to southwest direction, spaced 3m to 5m apart, and were connected to a series of east to west orientated cuts (of a similar size and form). All of the cuts were filled with a mid grey gravel which surrounded a buff/orange coloured ceramic pipe which had a diameter of 0.3m. All of these linear features cut into the natural subsoil layers, (002) and (003), within the site.

Figure 3a Post excavation view of T2 from the NW.

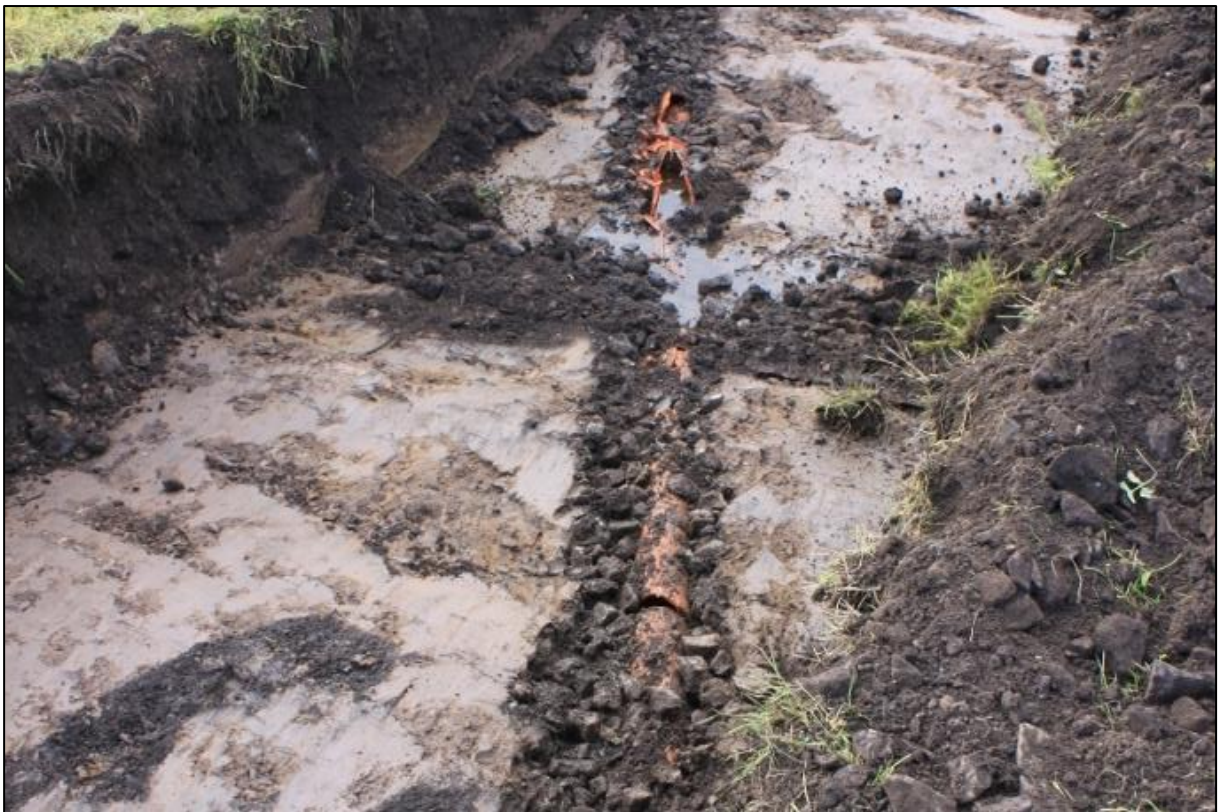
Figure 3b View of ceramic drain (004) within T2 from the N.

15. The topsoil, (001), and subsoil, (002) and (003), layers identified within the site were all quite sterile with no artefacts being recovered, though grey gravel within (002) may be the result of modern disturbance. This and the presence of the series of linear drains, (004), may suggest that the site had been landscaped, quite recently, in the past (most likely the 20th century). The presence of the recently demolished Clippens School on the site may explain this as the landscaping and drainage was most likely associated with the school's sports fields.

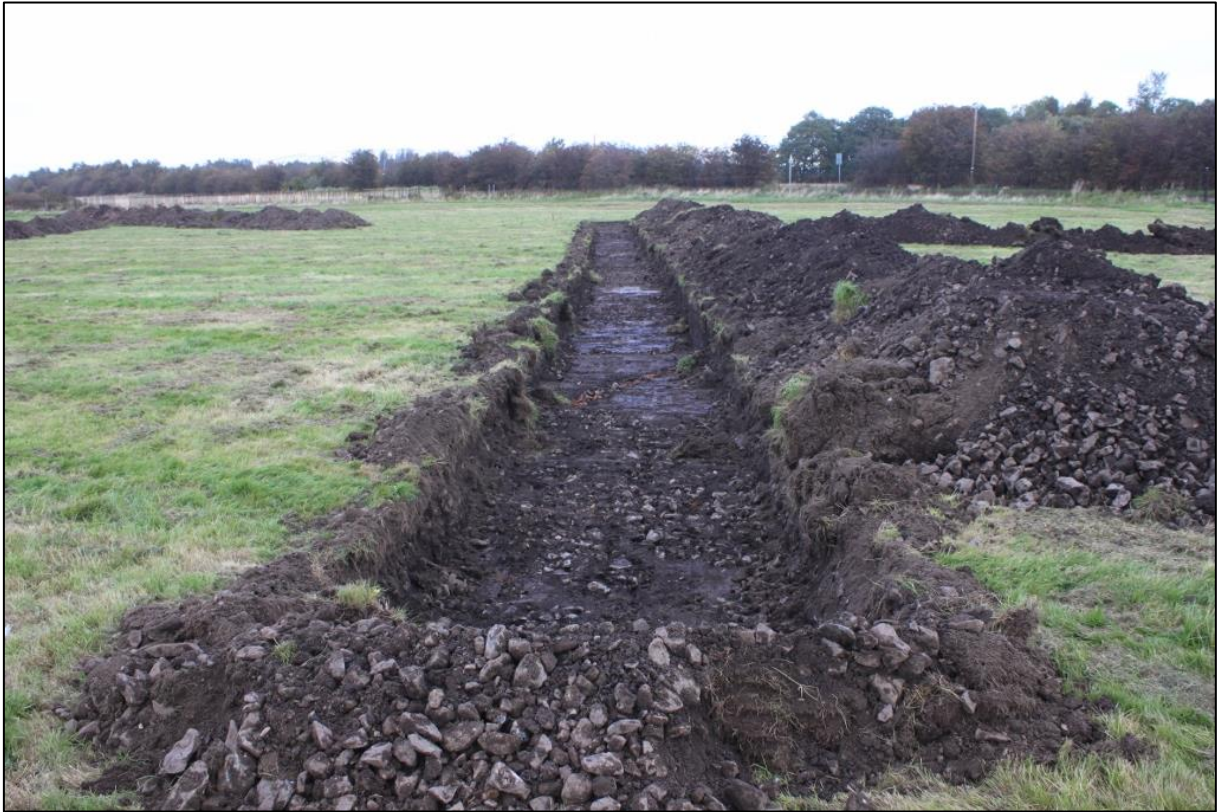
Figure 4a Post excavation view of T6 from the N.

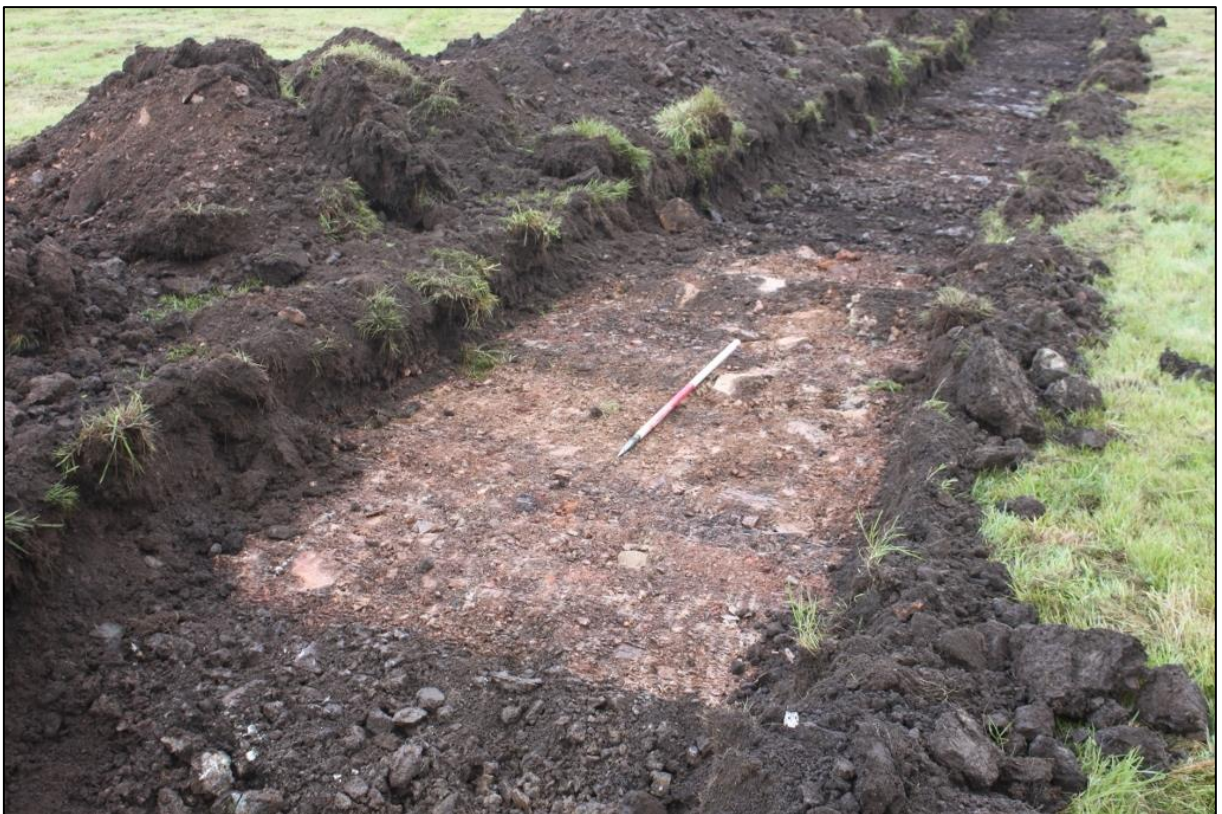
13. A large linear spread or deposit, which was orientated in a west southwest to east northeast direction, was identified within the southern ends of trenches T8 and T9 (Figure 4b). The layer consisted of moderate to firmly compacted, orange-brown silty clay with very frequent inclusions of small to moderate sized, irregular shaped sandstone fragments. The layer had a width range of 5m to 6m and a thickness range of between 0.18m to 0.19m. It directly overlay the naturally occurring subsoil layers, (002) and (003), and was cut by one of the linear features (004). The spread or deposit was located at 3.6m from the southeast end of trench T8 and 16.7m from the southeast end of trench T9.

17. The remains of another site S2, a tramway (005), was identified in the southern parts of trenches T8 and T9 (Figure 2). The feature, which was first depicted in the Ordnance Survey of 1898 (Figure 1b), ran in a west southwest to east northeast direction across the southern part of the site and consisted a thick layer of silty clay with a very high sandstone content. This material (Figure 4b) most likely formed a foundation base for the tramway's tracks and supporting sleepers.

Figure 4b View of tramway deposit (005) within T9 from the S.

19. All of the features identified through the programme of test trenching were either modern drainage features associated with the recently demolished school or from the remains of the late 19<sup>th</sup> century tramway. No other significant features or artefacts were identified within the site hence Rathmell Archaeology Ltd recommends that no further archaeological works should be carried with regards to the development area.
20. The acceptability of these recommendations needs to be confirmed with WoSAS and Renfrewshire Council.
