# **Brathwic Terrace, Brodick: Archaeological Mitigation**

Data Structure Report

by Claire Williamson  
issued 12<sup>th</sup> October 2018  
on behalf of Ashleigh (Scotland) Ltd

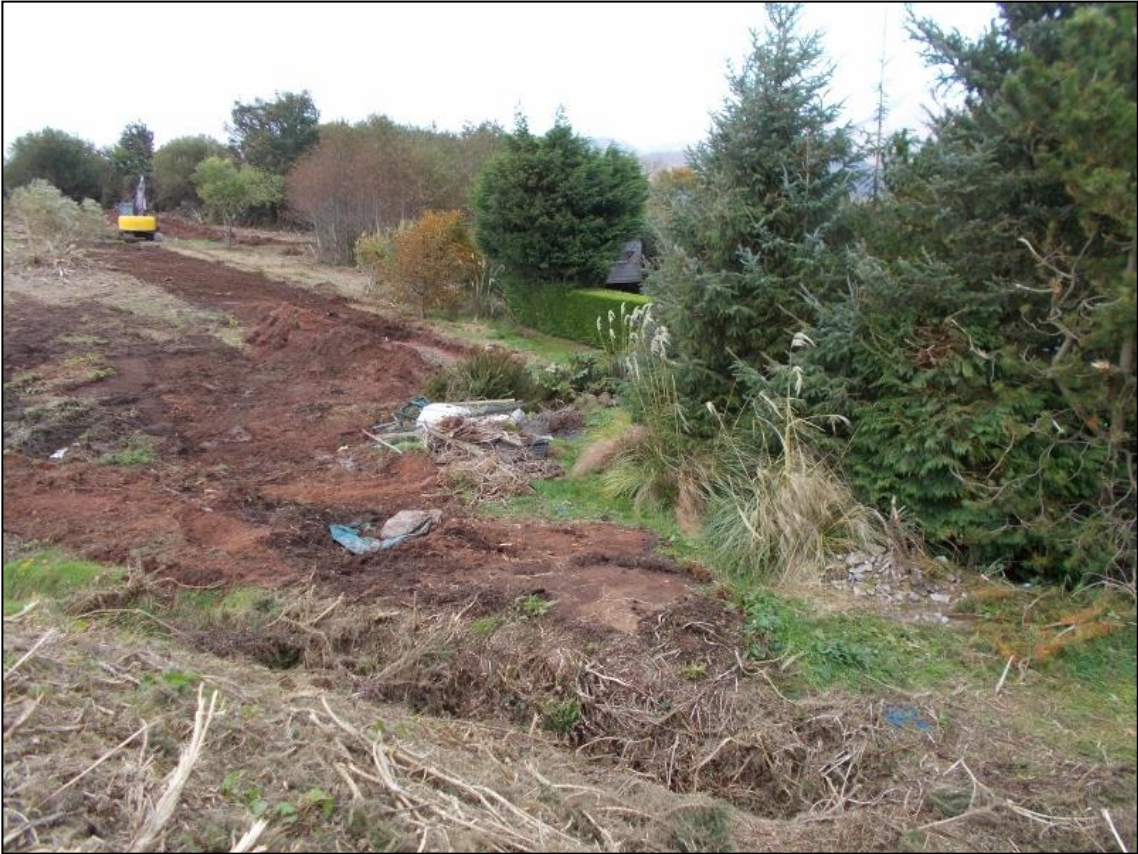
Figure 2a: General shot along northern edge of site from the southeast

9. The presence of upstanding trees and a garden along the northern edge of the area (Figures 2a and 2b) limited the amount of available ground at this end, meaning that some of the intended meterage was lost in this area. Trenches 1 and 4 had to be shortened, while Trench 3 was split into two smaller trenches (Trenches 3a and 3b) to fit within breaks in the upstanding trees (Figure 3a). Trench 2 was also shuffled slightly to the south to be able to fit in its full length.

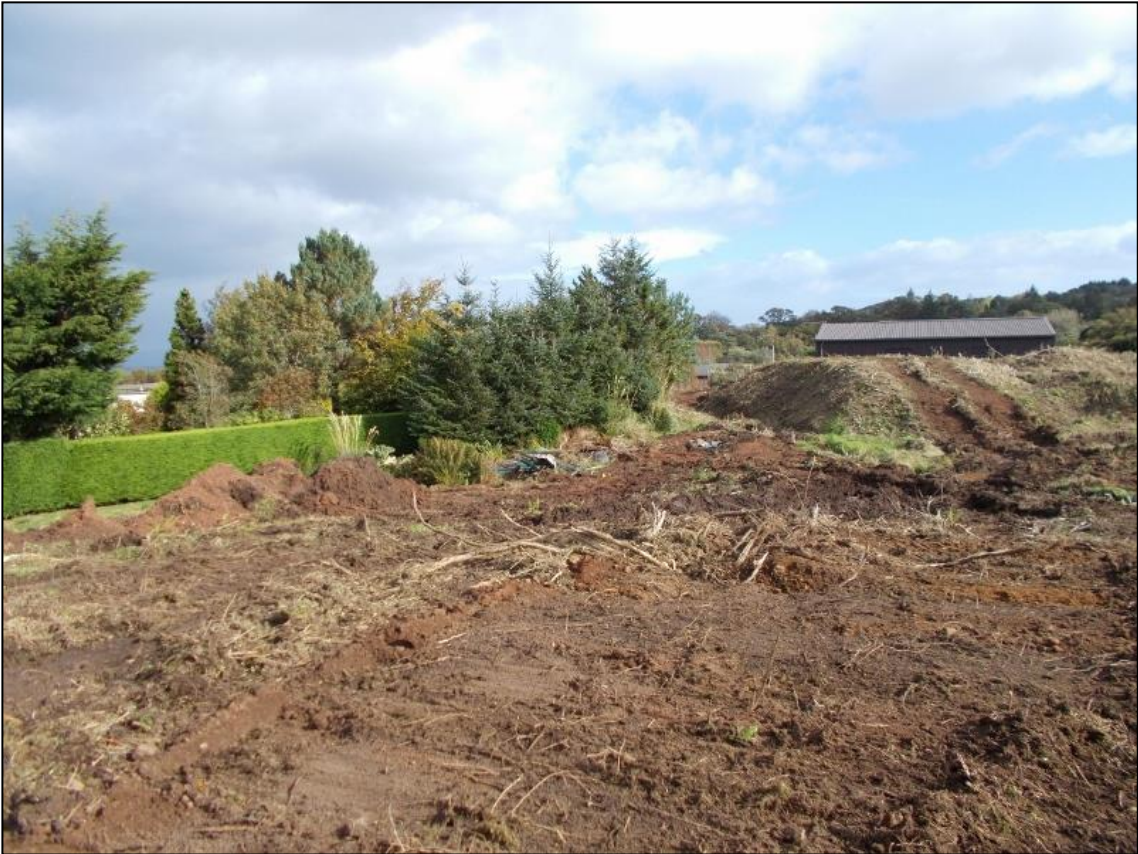
Figure 2b: View of the garden at the northern edge of site from the southwest

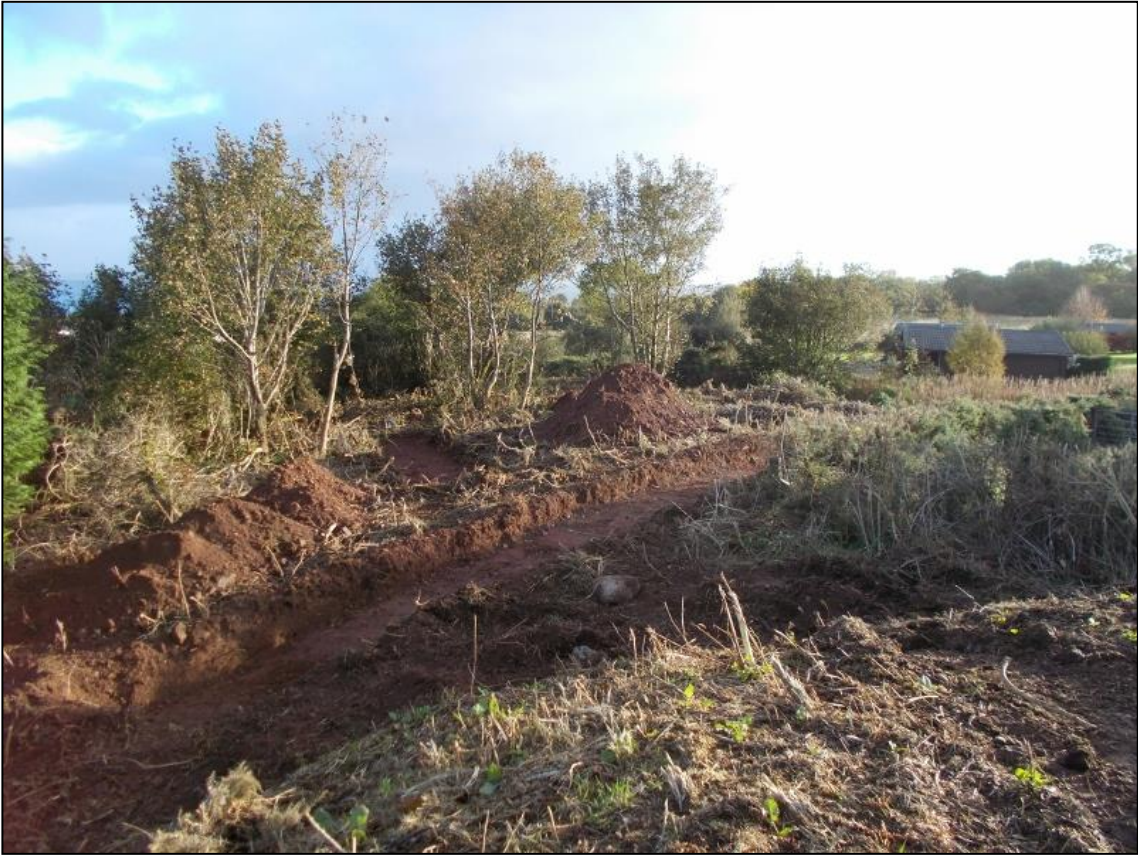
Figure 3a: General shot of Trenches 3a, 3b and 4 from the southwest

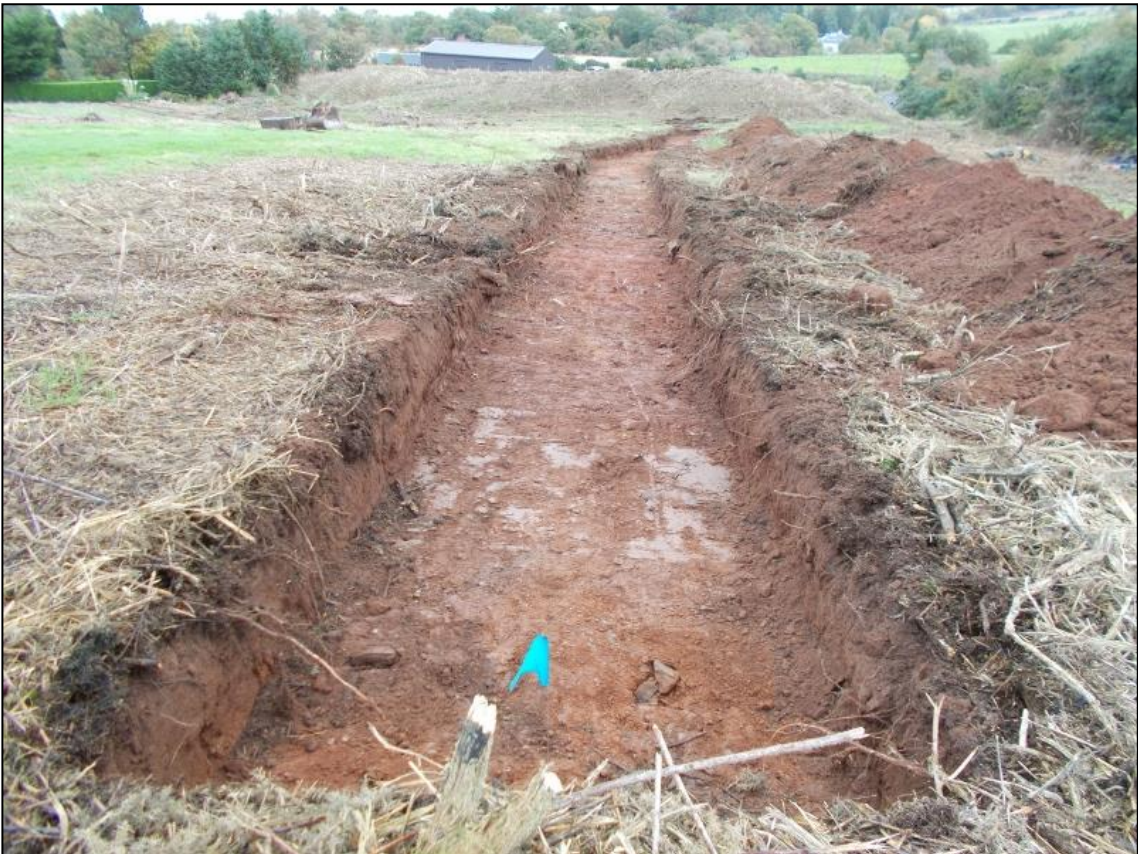
14. Natural subsoil was encountered at depths of between 200 to 600mm below the ground surface level. The subsoil consisted predominantly of firmly compacted dark pinkish red clay with frequent gravel inclusions (002) (Figure 3b), although natural variations in the subsoil appeared across the area. Within the southern portions of the site, patches of very compact mottled mid- red/orange/yellow silty clay with moderate stone inclusions (003) were present, as well as a very compact light grey clayey silt with moderate small stone inclusions (004). Within Trench 7, there was also an area of (007): a moderately compacted light grey (mottled with orange flecks) silty clay with frequent medium sized stones. Towards the northern end of the area, a small area of bedrock (009) was also revealed within Trench 2.

Figure 3b: Trench 8 from the west showing natural subsoil (002)

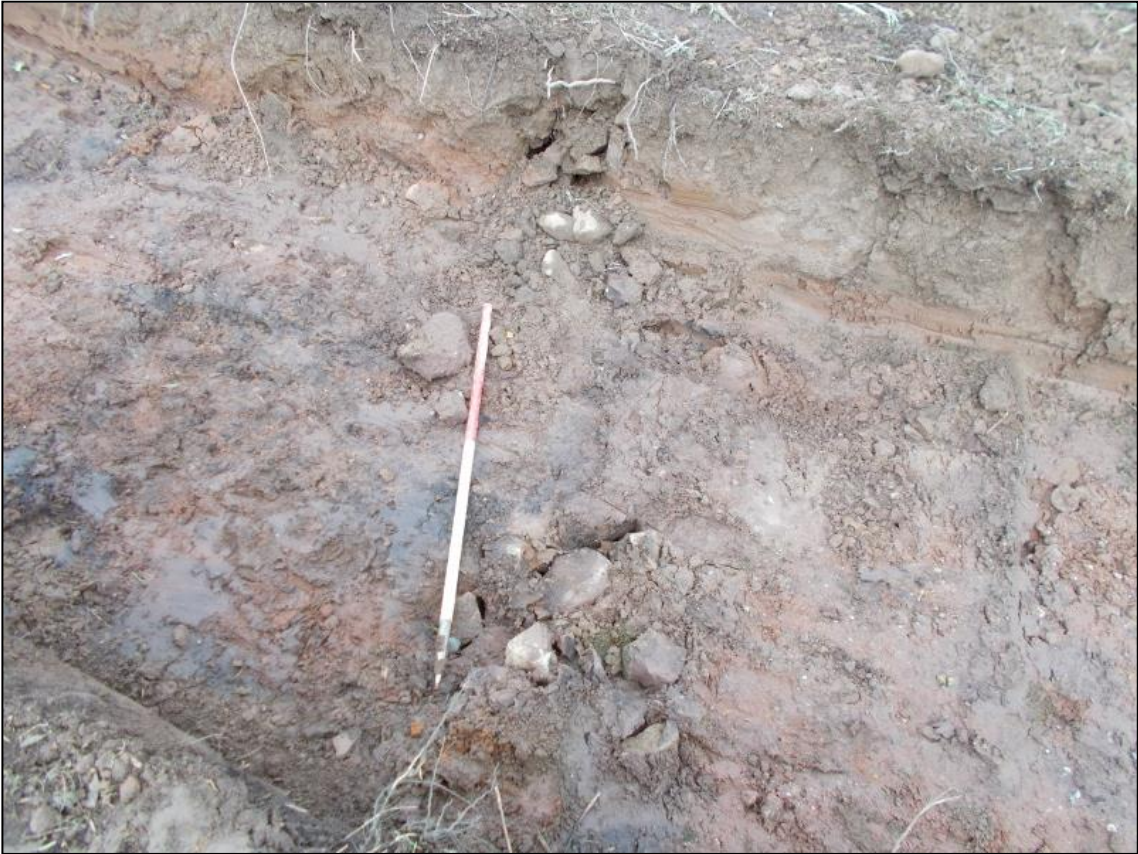
15. The majority of the trenches revealed modern disturbance in the form of drains (005), (006) and (008). Both (005) and (008) represented rubble drains which varied in the size of stone used. (005) appeared to represent one drain which ran N-S through the western ends of Trenches 5-8. It measured 0.5m wide and was filled by sub-angular and sub-rounded stones measuring an average size of 0.29m by 0.26m by 0.2m. Rubble drains (008) were recorded within Trenches 6 and 7, although it is possible that they existed within some of the other trenches where small patches of waterlogging – often caused by meeting the drains themselves – may have obscured their presence. Drains (008) were orientated SSE-NNW, measured 0.4m wide and were filled by sub-angular and sub-rounded stones measuring an average size of 0.2m by 0.07m by 0.16m (Figure 4a).

Figure 4a: Rubble drain (008) in Trench 8 from the south-southeast

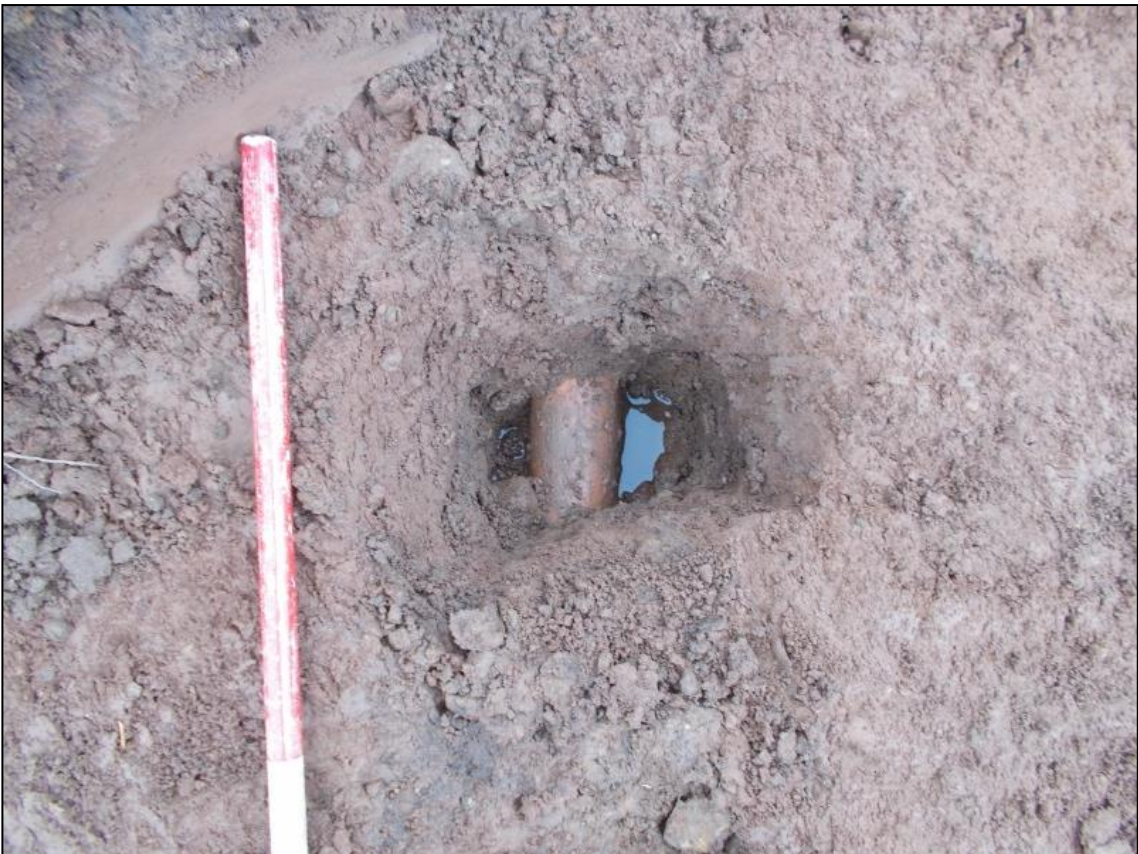
16. (006) represented red tile drains. These were the most frequent and appeared within a number of the trenches across the western half of the site. They were mainly orientated SSW-NNE, although one example within Trench 5 ran WNW-ESE. The cut for these drains measured 0.3m wide and 350mm deep and they were filled by a mixture of re-deposited natural subsoil and topsoil. They contained a horseshoe shaped red tile drain (0.1m wide) which sat at a depth of 200mm (Figure 4b).

Figure 4b: Red tile drain (006) in Trench 7 from the north-northeast

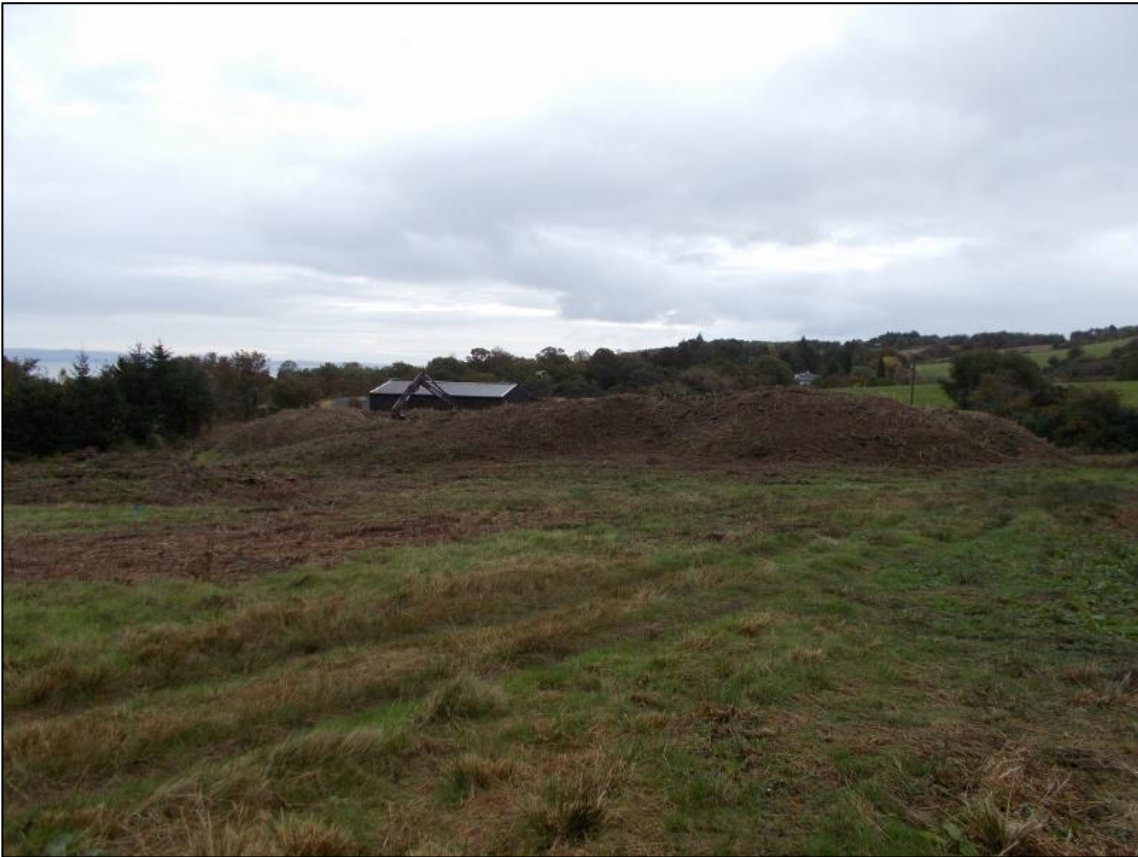
17. The site of the substation in the southeastern corner of the area was surrounded by a substantial bund of material along its western and northern edges (Figure 5a). Trenches 10, 11 and 12 were all placed so that their eastern ends ran into the edge of this bund. As might be expected, this revealed the bund itself to have been formed by (010): re-deposited natural subsoil (mainly (002)) which represented the material excavated during the installation of the substation and its surrounding structures. (010) was exposed to a thickness of 1.2m within the trenches, although will be much thicker within the main body of the bund, and sat directly overlying the topsoil (001) (Figure 5b).

Figure 5a: Shot towards bund around substation from the west

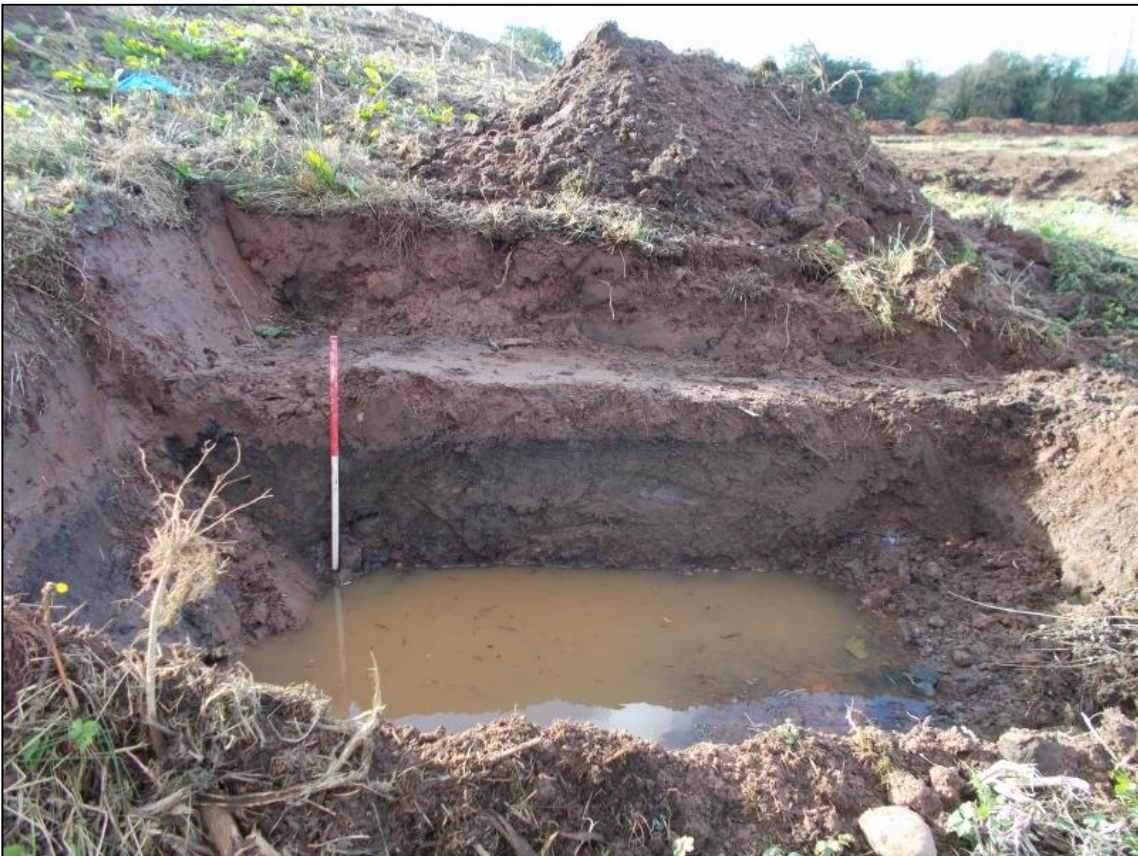
Figure 5b: North facing section through bund at eastern end of Trench 10 showing (010) overlying topsoil (001)

21. Aside from the presence of the field drains, the only other archaeological activity revealed within the trenches was that represented by the bund surrounding the substation to the east. As might be expected, this bund was revealed to be re-deposited natural subsoil from reducing and levelling the ground to the east which was simply banded directly on top of the ground surface to the side.
