Chattan Works, Bonnybridge: Archaeological Evaluation

Data Structure Report

issued 9th October 2018

on behalf of Central Demolition Limited

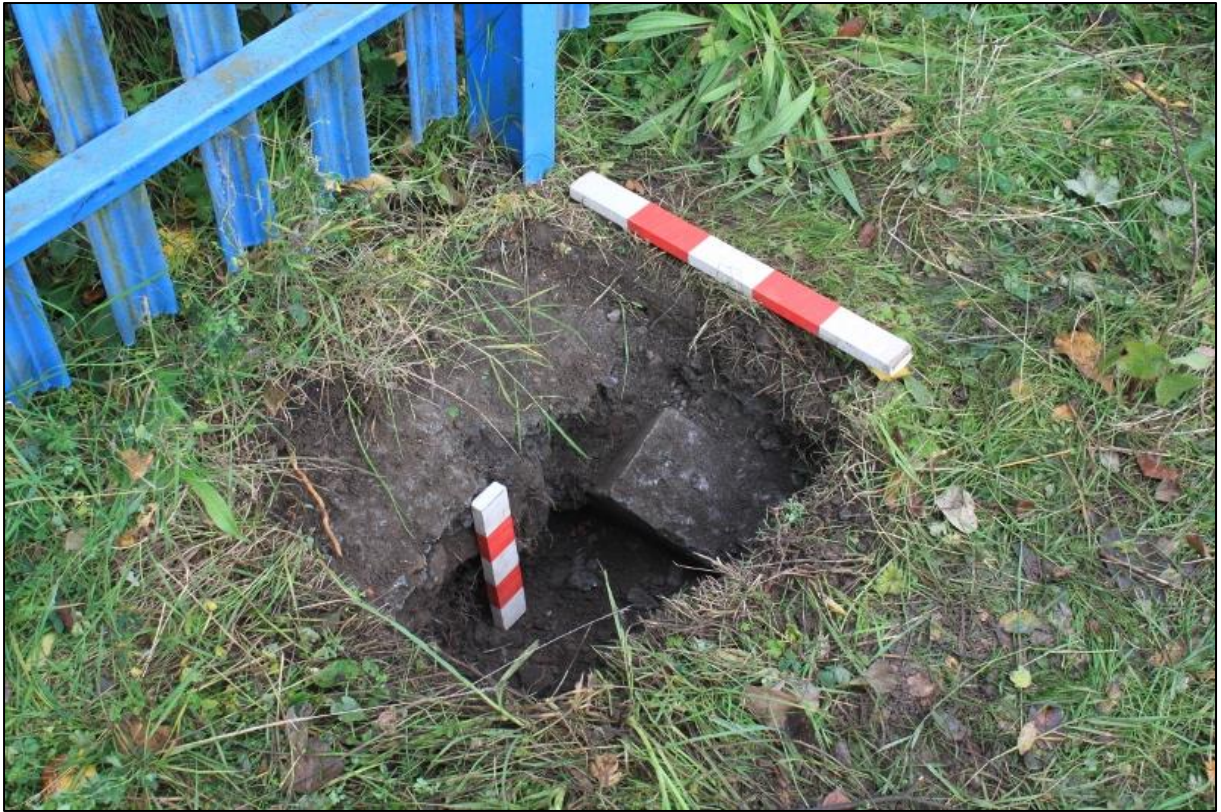
16. Test Pit A was the northwestern test pit on the fence located approximately 22.0m northwest of the southern corner of the former playing field. The western third of the test pit exposed the concrete packing (001) for the fence post that extended down some 300mm below ground surface. This packing was set wholly within topsoil (002) that contained modern detritus including a section of precast concrete beam.

Figure 3a: Post excavation shot of TPA showing concrete packing (001)

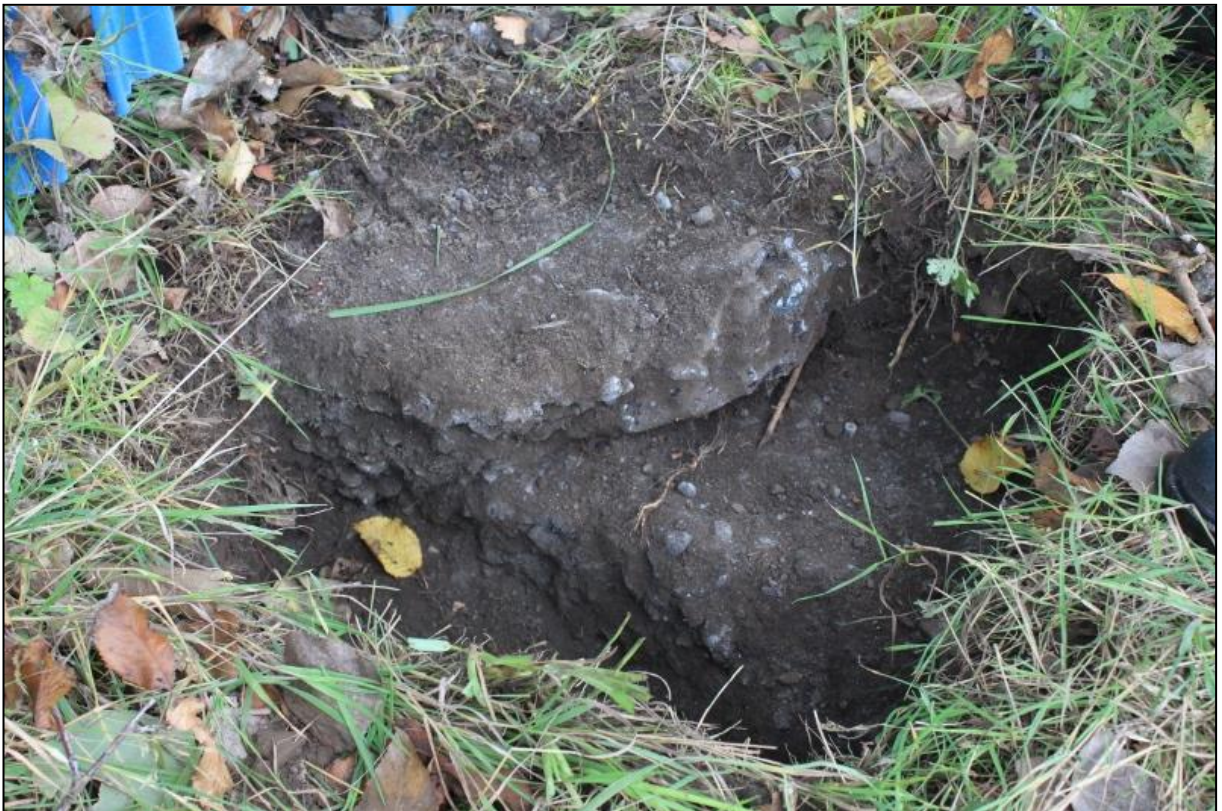
17. Test Pit B was on the fence located approximately 11.1m northwest of the southern corner of the former playing field. The northwest corner of the test pit exposed the concrete packing (003) for the fence post that extended down some 180mm. This packing was set onto an earlier concrete pad (004) that extended outwith the test pit to west, north and east. The full depth of this earlier pad (004) was not confirmed as it was only exposed to 120mm in depth to ensure that this was not packing for the post. The packing (003) and underlying pad (004) were both set wholly within topsoil (005) that contained modern detritus.

Figure 3b: Detail of TPB showing concrete (003) over pad (004)

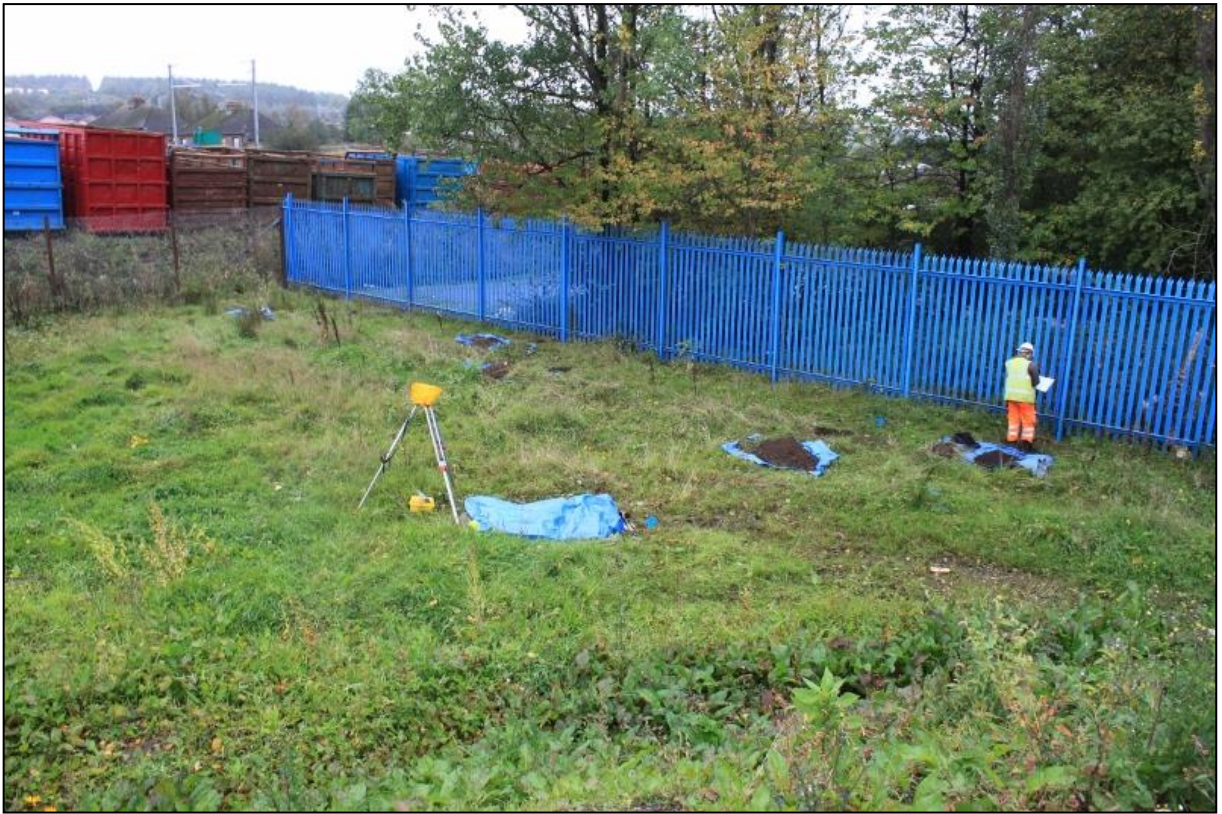
Figure 4a: TP array from N and palisade fence

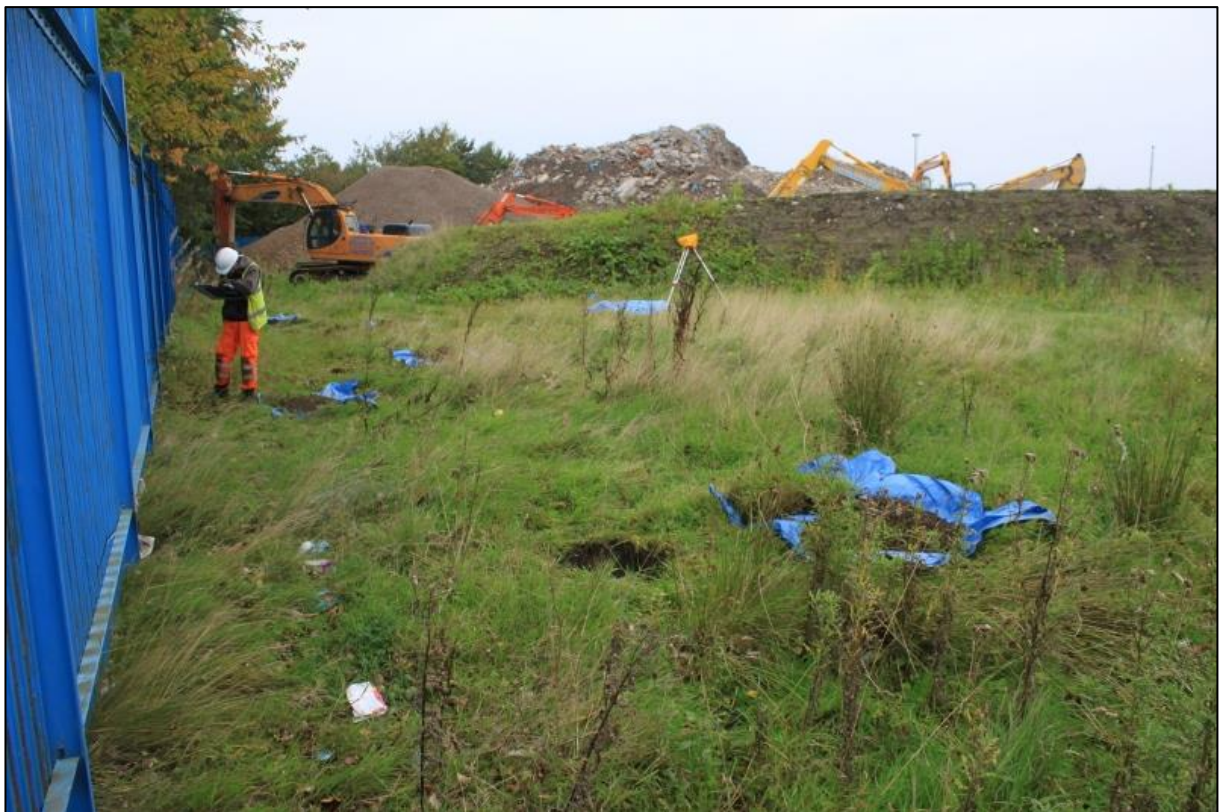
Figure 4b: TP array from SW, palisade fence and bund

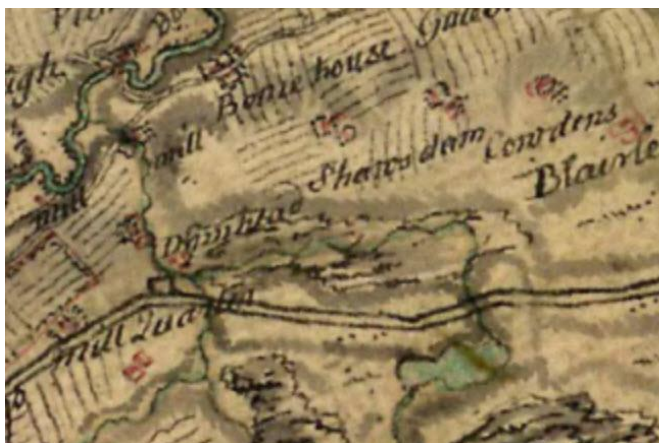
Map

- 1752** Roy's *Military Survey of Scotland*, 1752 – 1755 showing the line of the Antonine Wall marked including the fortification near Milnquarter. The area between Dennyloanhead (marked as Dhinhead) and St Helen's Loch (not named). The area is marked as unenclosed moorland, not under agricultural use.

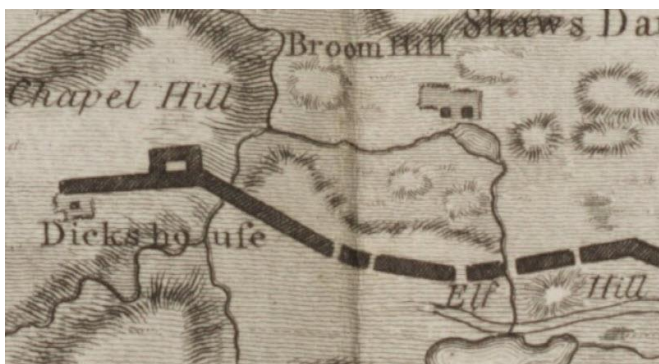
Map

- 1793** Roy's *Military Antiquities of the Romans in North Britain* – showing the line of the Antonine Wall between Chapel Hill and St Helen's Loch (not named). The fortification near Milnquarter is marked. The line of the wall is frequently broken. The Area is shown as open moorland.

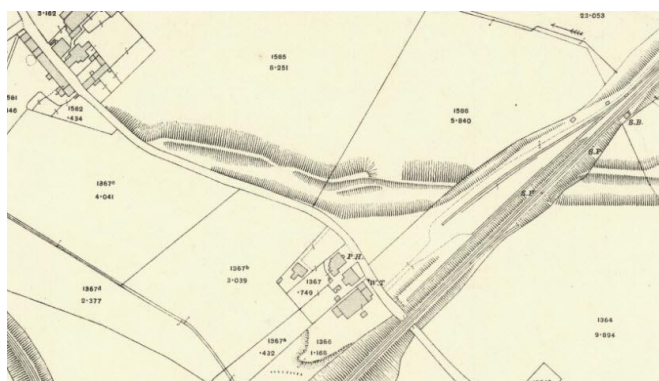
1913 *Ordnance Survey, Stirlingshire*, (published 1918) showing the railway siding sloping down to a fence and the area. Topography is marked which presumably shows the Antonine Wall passing through the south-west of the area. No trees or structures are marked.

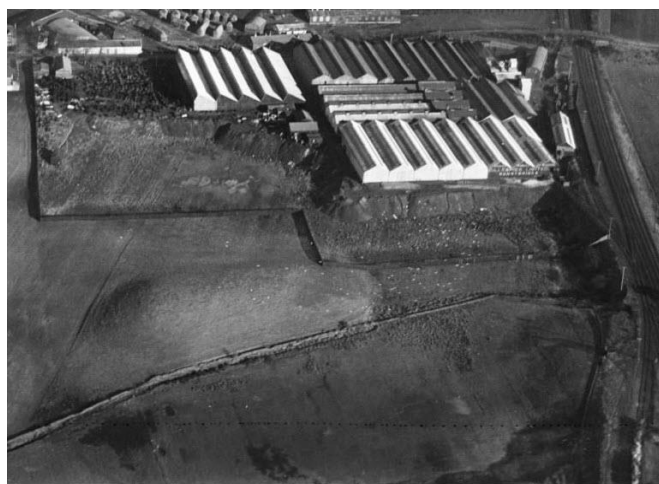
1928 February 4th – AP *AFL2013 Aerofilms* showing the build-up of material under Chattan Works in the north-east of the area. Another possible bund of material beyond the fence in the centre of the area. Some scrub to the south-west and ground appears to begin sloping down relative to the railway tracks.

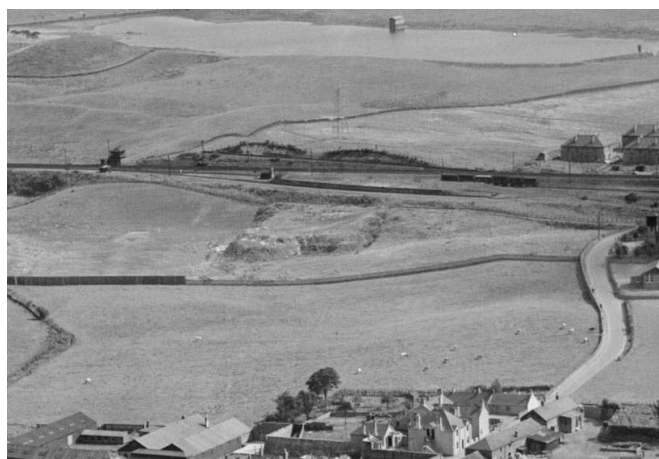
1934 August 1st – AP *SPW045880 Aerofilms* showing steep sided dump of material in centre of area. Some scrub vegetation. Boundary fence against railway sidings and access road for dumping are visible. No trees visible. Access road appears raised close to main road. Broomhill farm visible bottom right.

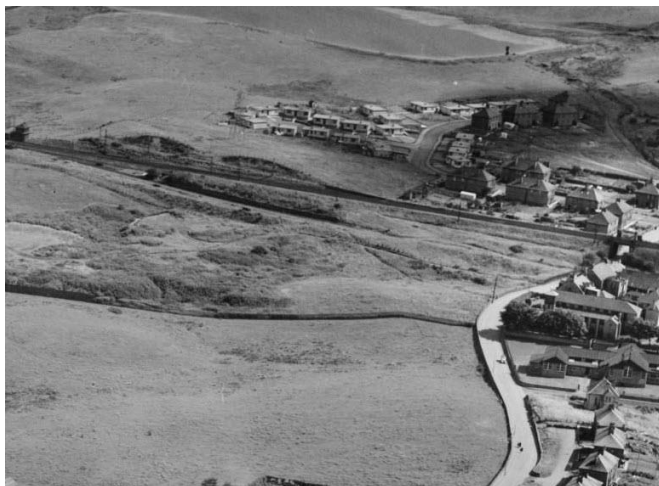
1951 August 17th - AP AFL2145
 AP
Aerofilms showing scrub vegetation over core of area. No trees visible. SE boundary fence against railway sidings clear - railway sidings now appear not in regular use. Earlier dump and access road less distinct - possibly added to and spread since last AP.

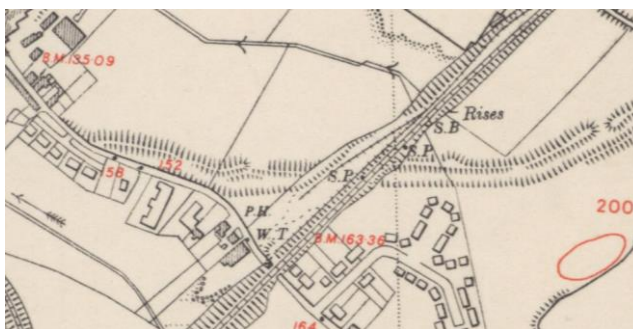
1946 Ordnance Survey,
 Map
 (published 1951) showing the area as enclosed land. The railway siding is present and slopes down to the area. No trees or buildings are marked. The topography of the Antonine wall is marked as in 1913. No dumped material is shown.

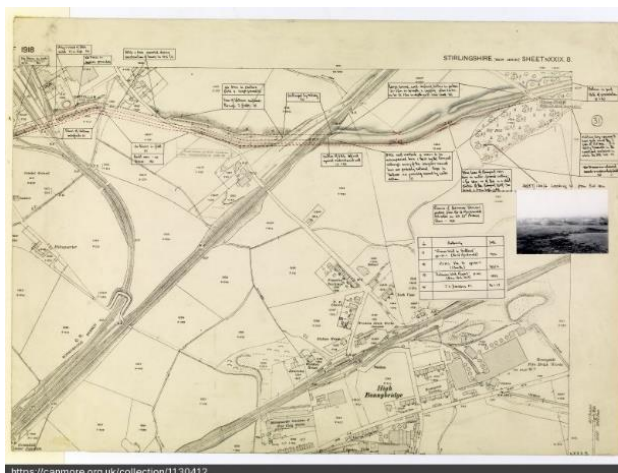
1957 Ordnance Survey
 Event Archaeology Division
 Antonine Wall 1954-57
 working sheets (map sheet
 31). Survey uses the 1913
 Ordnance survey map as a
 base and identify for this
 section 'No trace in pasture
 ...'. The base mapping of
 the Antonine Wall has not
 changed since the 1898
 map (see above).

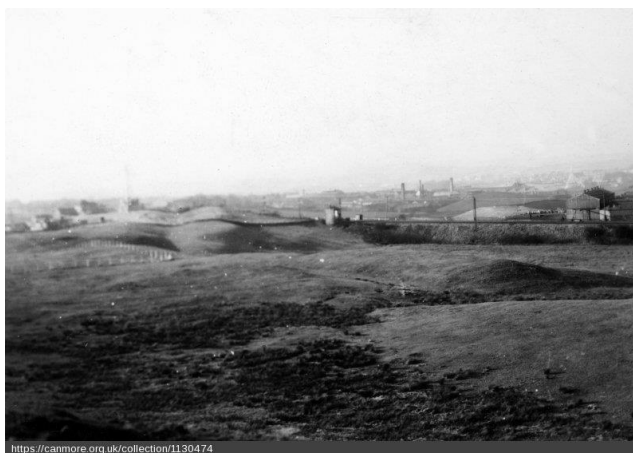
1957 Ordnance Survey
 Event Archaeology Division
 Antonine Wall 1954-57
 photo, taken approximately
 500m to the east and
 looking towards the area. It
 shows the line of the
 railway and the topography
 of the Antonine Wall in the
 mid-ground. Chattan works
 in right of image.

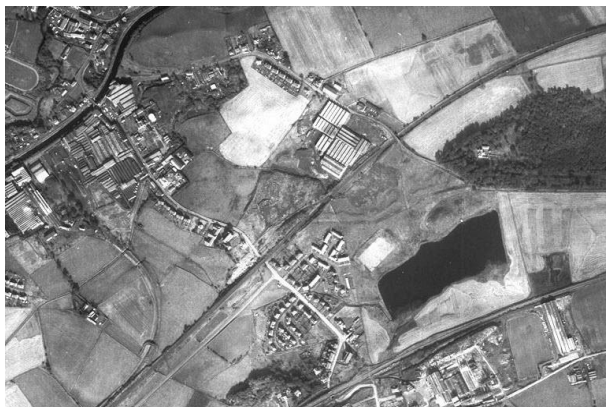
1970 October 9th MER08070
 AP *Meridian Airmaps* showing
 the area as disturbed
 industrial land. The railway
 siding is visible along with
 an access road for
 dumping. Other vehicle
 tracks are visible in the
 area along with dumped
 material. The area appears
 raised in comparison to the
 land to the north and west.

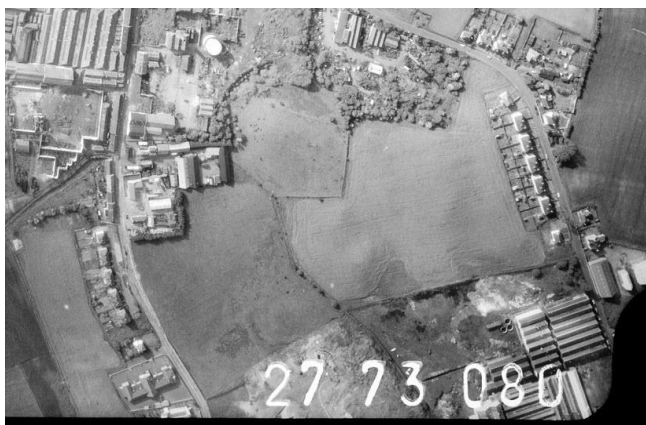
1973 June 7th - AP MER02773
 AP *Meridian Airmaps* showing
 the area as disturbed
 industrial ground. Evidence
 of dumped material is
 visible along with vehicle
 tracks. The area appears to
 be raised in relation to the
 surrounding land.

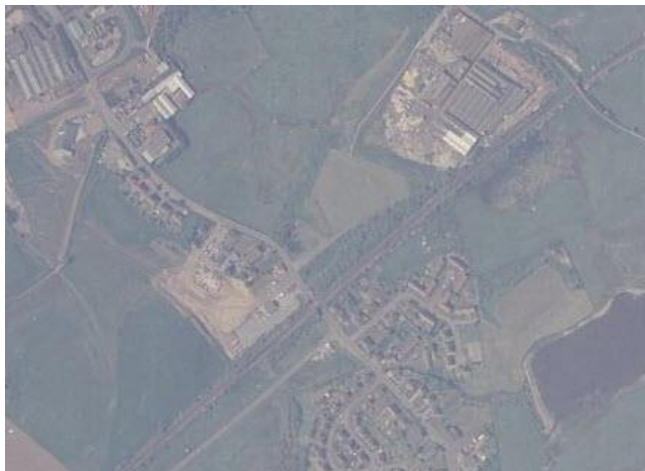
1988 June 7th – ASS51988
AP
JAStory showing the area bounded by established foliage/trees. The central part of the area is landscaped. The railway siding is overgrown. Established industrial works are to the north-east and south-west of the area.

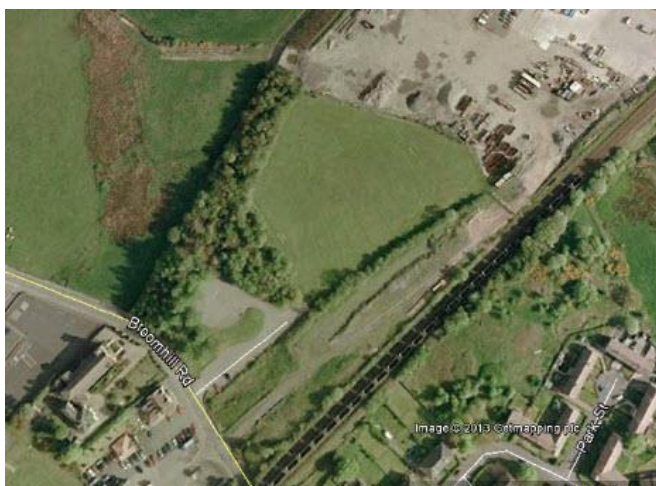
2005 Google AP showing amenity carpark, woodland blocks and playing field with railway sidings disused.

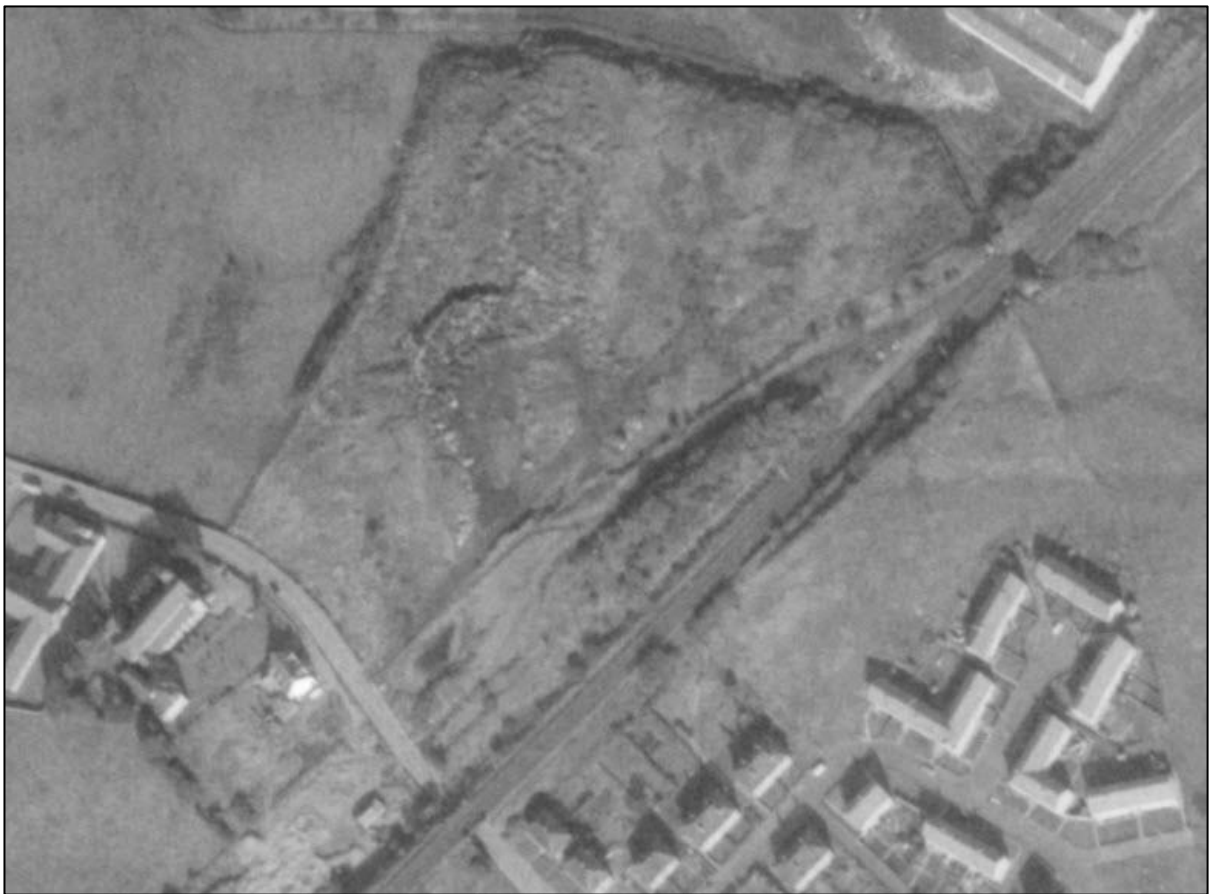
Figure 5: Aerial Photograph (1970 - MER08070) showing active refuse disposal site
