**North of Lakin Farm,
Isle of Arran:
Archaeological Evaluation**

Data Structure Report

by Jack Portwood

issued 29th January 2019

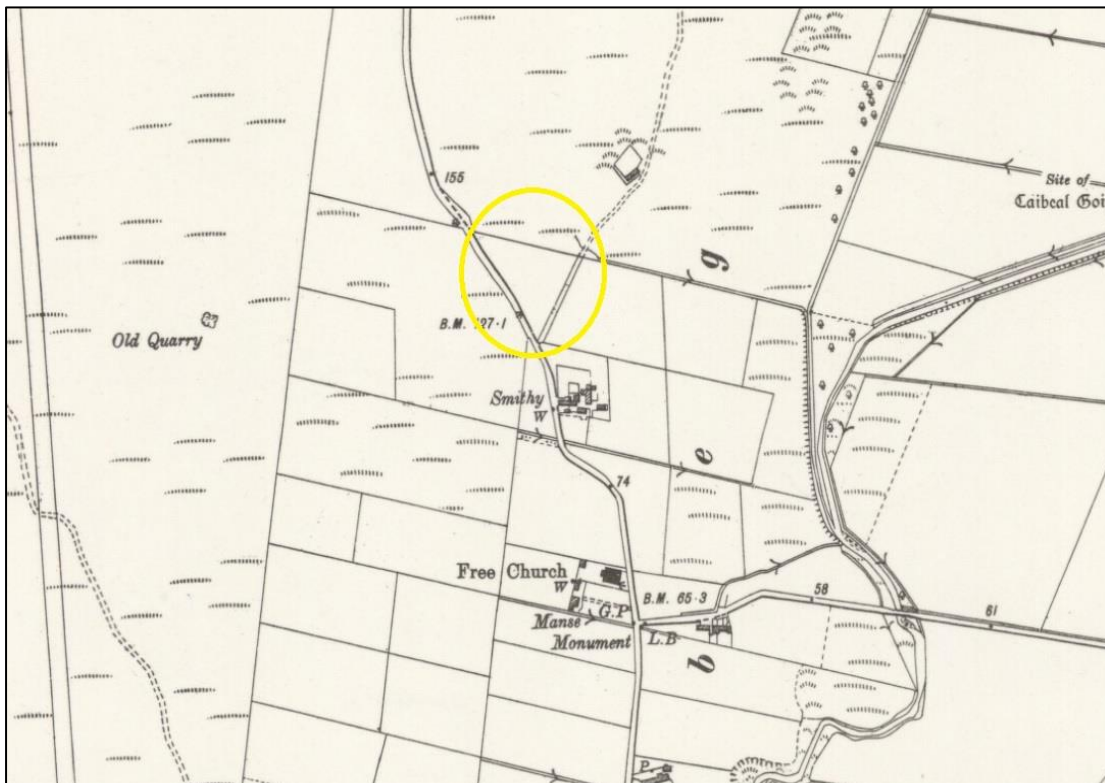
20. The WSI (Williamson 2018) established that no known archaeological sites were located within the evaluation area. The 1st edition Ordnance Survey map of 1869 (Figure 2a), shows the development area much as it is seen today, while the later 2nd edition Ordnance Survey map of 1924 (Figure 2b) attests to land use in the development area remaining consistent, possibly being used as rough grazing for livestock.

Figure 2b: 1924 6-inch 2nd edition and later Ordnance Survey.

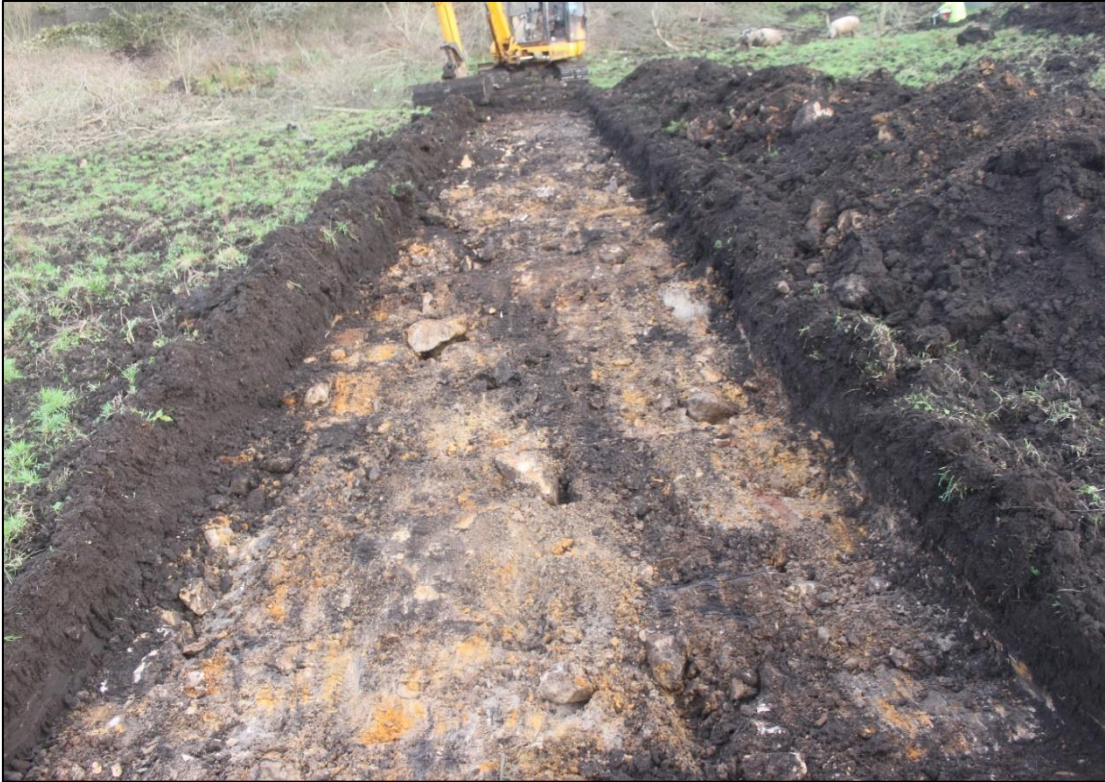
17. Within T1 a linear cut was identified [009] (Figure 3a) orientated northeast – southwest and running into the area of denser vegetation to the north. Measuring 8.5m by 0.55m by 0.3m deep this feature was filled with a mid-grey brown silt sand with frequent small to medium stone inclusions. The feature cut into subsoil (003): upon inspection water rose to the surface suggesting it was a live field drain.

21. No artefacts were recovered from topsoil (001), the presence of a linear drain, [009], may suggest that the site was landscaped quite recently, most likely during the 20th century. The presence of [009] on the site may indicate efforts to improve drainage in the northern part of the site which has dense levels of upstanding vegetation.

Figure 3a: Post excavation view of T1 from the W with (003) subsoil and [009] field drain.

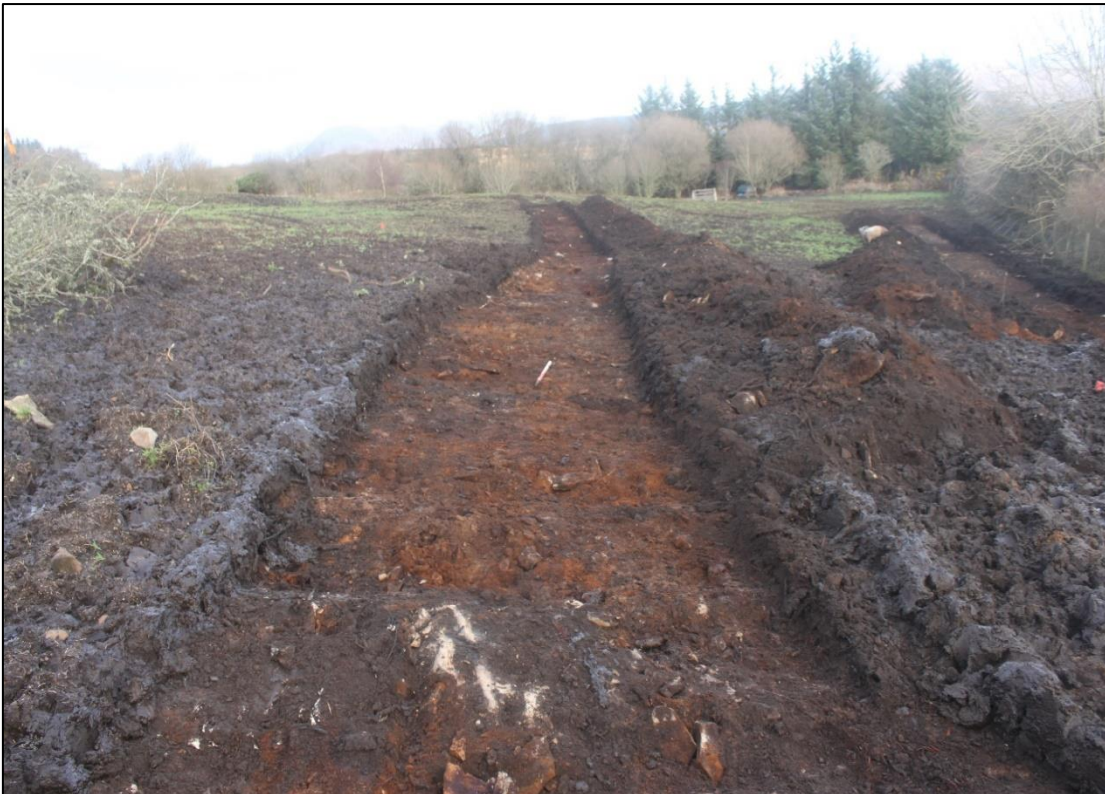
16. There were two main layers of naturally occurring subsoil which were identified within the excavated trenches (Figures 3a and 3b). The first of these subsoil layers, (002), consisted of moderately compact mid brown orange silty-sand with very frequent small to large natural sandstone inclusions. The layer had an excavated depth within the trenches of between 0.19m to 0.5m. The second of these subsoil layers, (003), comprised a compact mid yellow brown clay-sand with frequent small to large stone inclusions. The layer had an excavated depth within the trenches of between 0.09m to 0.2m.

Figure 3b: Post excavation view of T1 from the SSE with (002) subsoil.

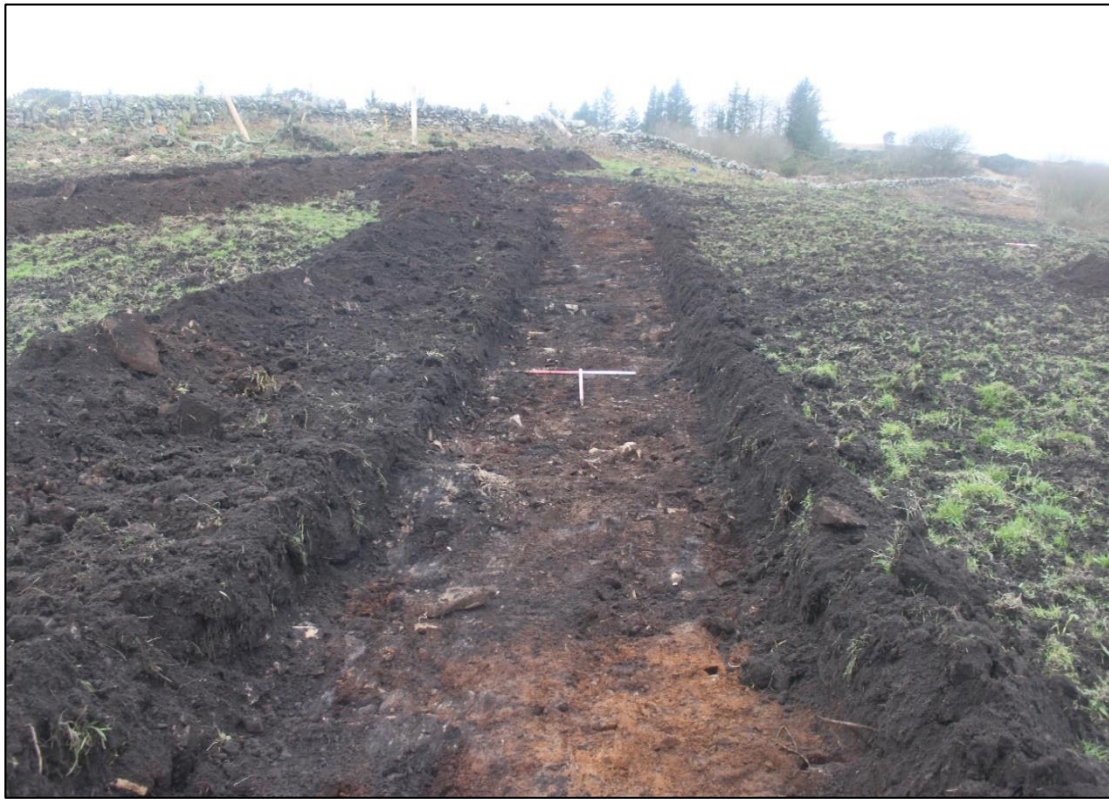
18. A large spread or deposit, which was orientated east-west was identified in the middle of T4 (Figure 4a), approximately 13.5m from the eastern end. The layer (006) consisted of a moderately compact dark grey brown sandy-silt with occasional small to large stone inclusions measuring 6.5m x 3m x 0.1m. It directly overlay the naturally occurring subsoil (002) at the eastern limit of the spread and (005) at the western limit.

22. The deposit / spread (006) uncovered in T4 measured 0.1m deep and overlay the naturally occurring subsoil (002) and (005). (006) appeared isolated within this area and did not extend to the north. It is possible that (006) is a deposit of hill wash.

Figure 4a: Post excavation view of T4 and hill wash deposit (006) from the SE.

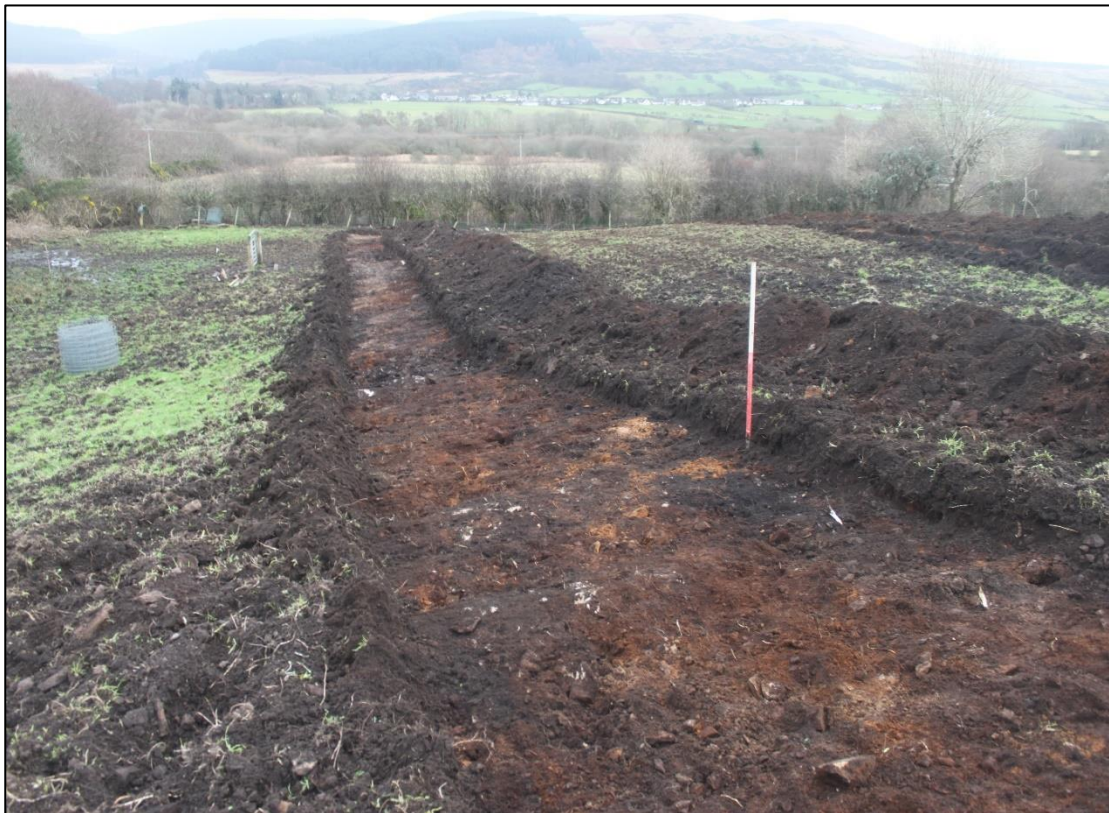
Figure 4b: Post excavation view of T2 from the WNW.
