Ayr Grammar Project – Demolition Works: Archaeological Watching Brief

Data Structure Report

issued 28th February 2019

on behalf of Morrison Construction Scotland

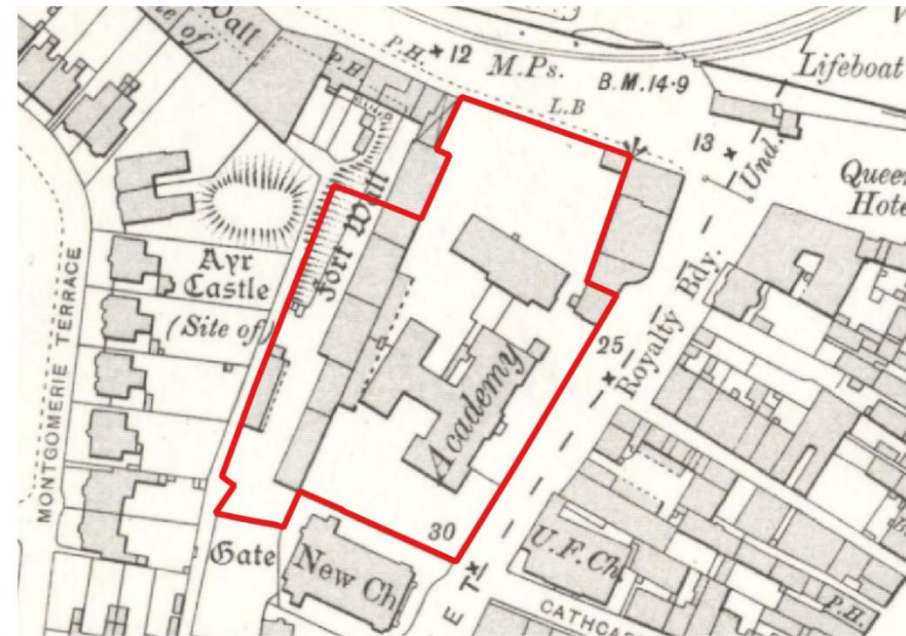
Figure 1: Historic Ordnance Survey sequence

- A 1855 Ordnance Survey
- B 1860 Ordnance Survey
- C 1909 Ordnance Survey
- D 1937 Ordnance Survey

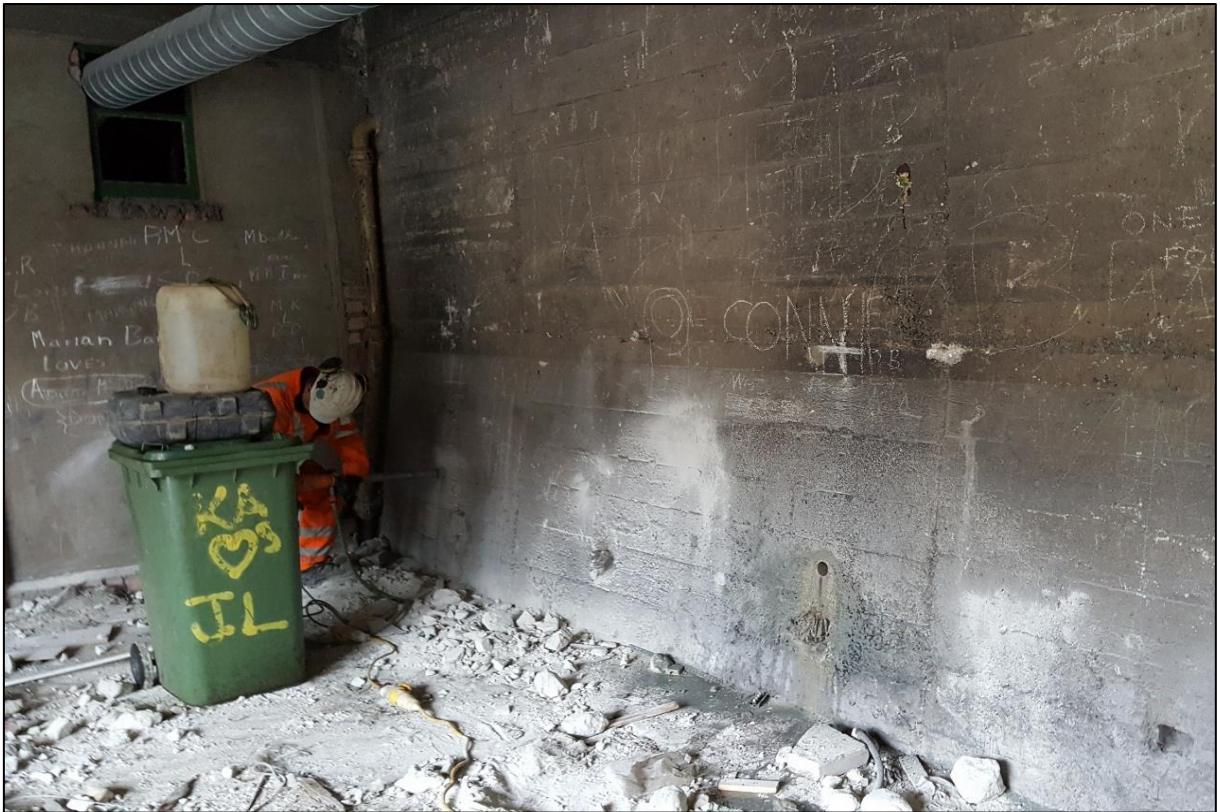
11. The line of the moat wall in the southwest of the site from the Citadel Lane playground appears as a shuttered concrete retaining structure underneath the pedestrian ramp and to the rear of the garages. Two cores were drilled through this retaining structure: these showed it to comprise shuttered, reinforced concrete to a thickness of 230mm to 300mm (the variation reflecting the kickout of the lower section of the concrete face). Behind the concrete had to be some 400mm to 515mm of lime-mortared wall composed of blond sandstone, red sandstone and whinstone (Figures 3a and 3b).

Figure 3a: Coring through shuttered concrete finish in garages on line of Moat Wall.

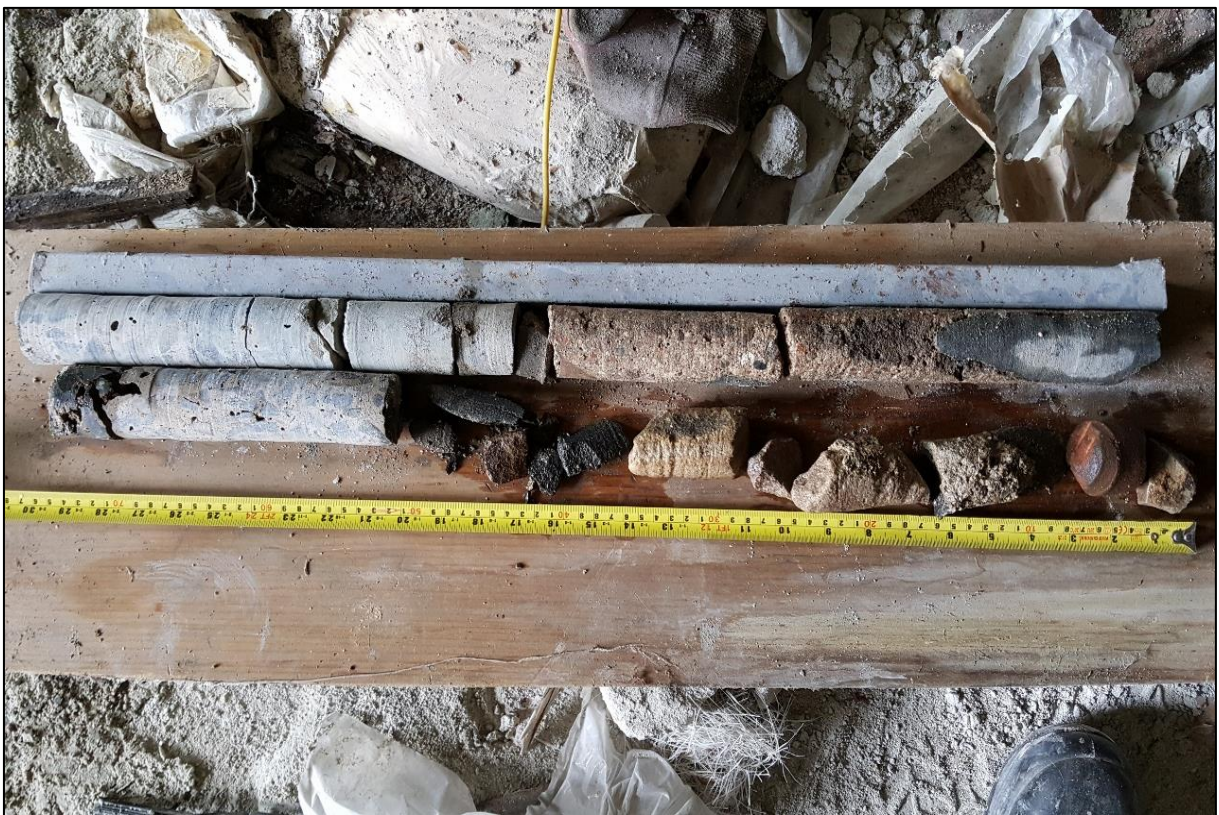
Figure 3b: Two full depth cores through retaining structure, existing surface left of image.

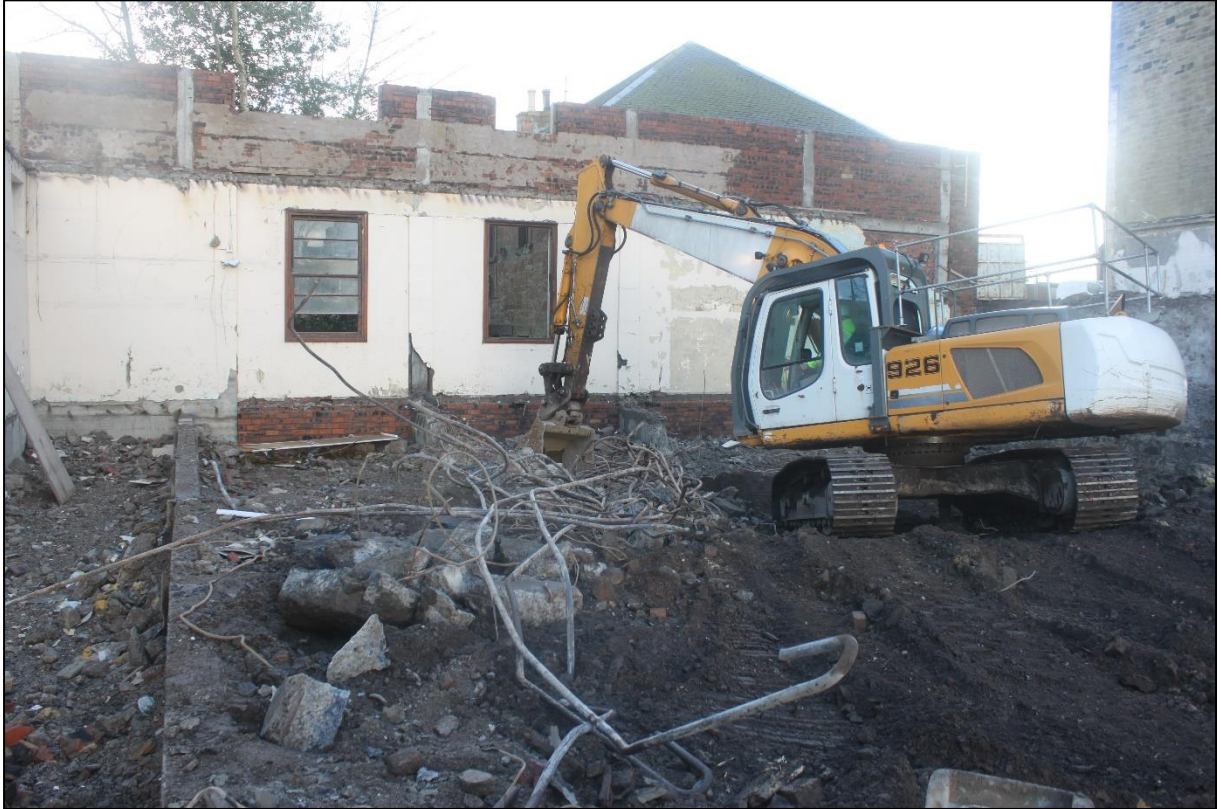
15. The second area of foundations was located within the footprint of moat **S2.2**, to the rear of the main Ayr Academy building. The foundation was a remnant of the extension, representing the most southerly part of the structure. The foundations were overlain by demolition layer (001), a loose, dark grey brown sand with very frequent medium to large sized inclusions of demolition material such as brick, concrete and re-bar. Underlying (001) was [004], which comprised concrete ground beam foundations running NNE-SSW by WNW-ESE in a grid pattern. These abutted the most westerly limit of the site and the retaining wall for the Academy, covering an area that measured approximately 21m by 18m in extent and which reached a depth of 800mm below the previous floor level of the extension. [004] overlay subsoil (005), a loose, mid-brown yellow sand with small to medium sized stone inclusions (Figures 4a and 4b).

Figure 4a: Northern area post excavation.

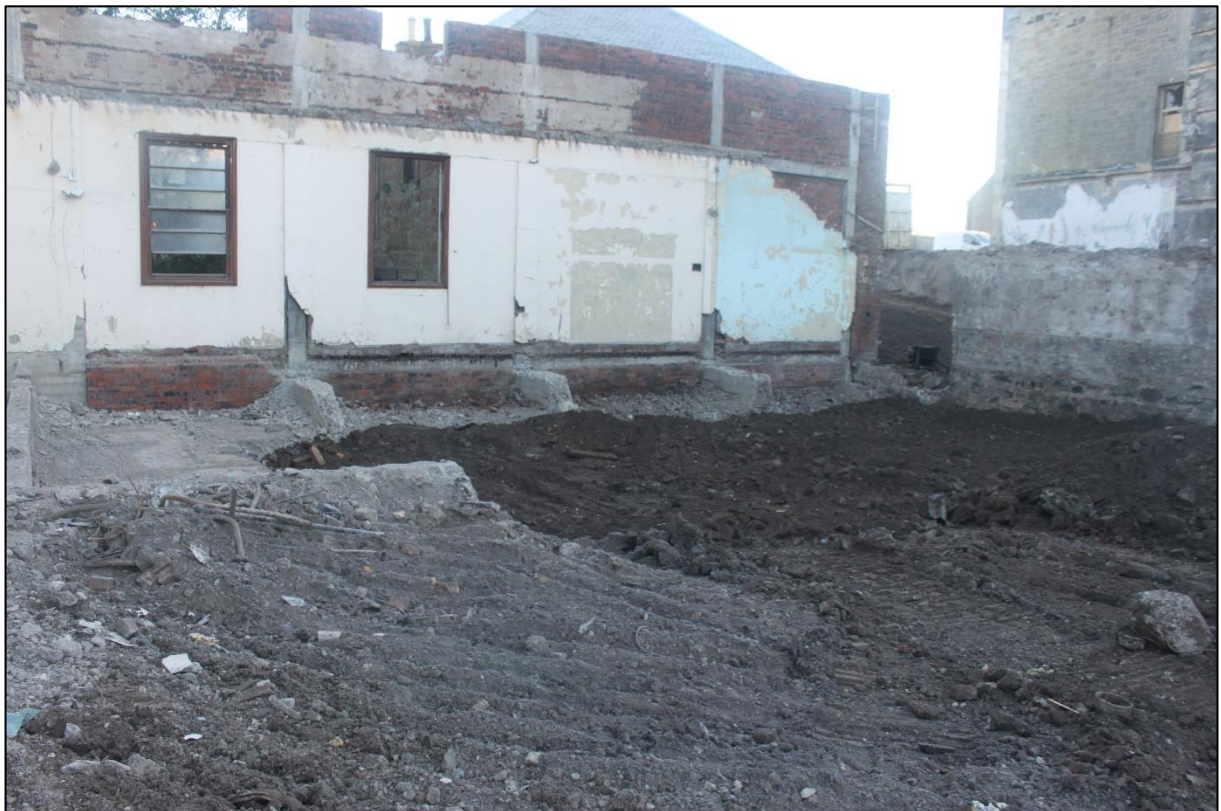
Figure 4b: Removal of foundation to the north of the development area.

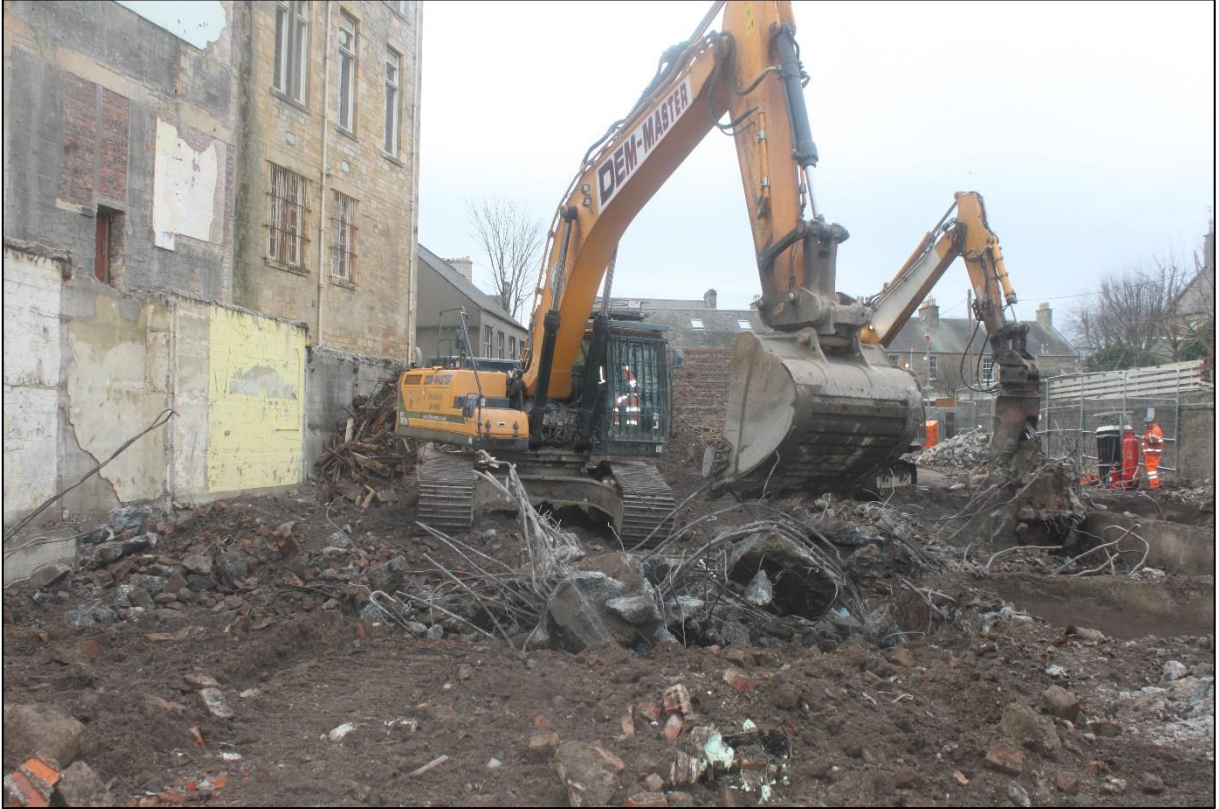
16. The final area of foundations were located within the footprint of the moat and represented the northernmost part of the extension which abuts the 19th century warehouse to the north. The foundations were overlain by (001) a loose, dark grey brown sand with very frequent inclusions of medium to large sized demolition materials such as brick, concrete and re-bar. Underlying (001) was another section of [004], which comprised concrete ground beam foundations running NNE-SSW by WNW-ESE in a grid pattern, covering an area measuring approximately 10m by 11m in extent, and reaching a depth of 800mm below the previous internal floor level of the extension. [004] in turn overlay deposit (005): a loose, mid-brown yellow sand with small to medium sized stone inclusions (Figures 5a and 5b).

Figure 5a: Removal of foundation to the south of the development area.

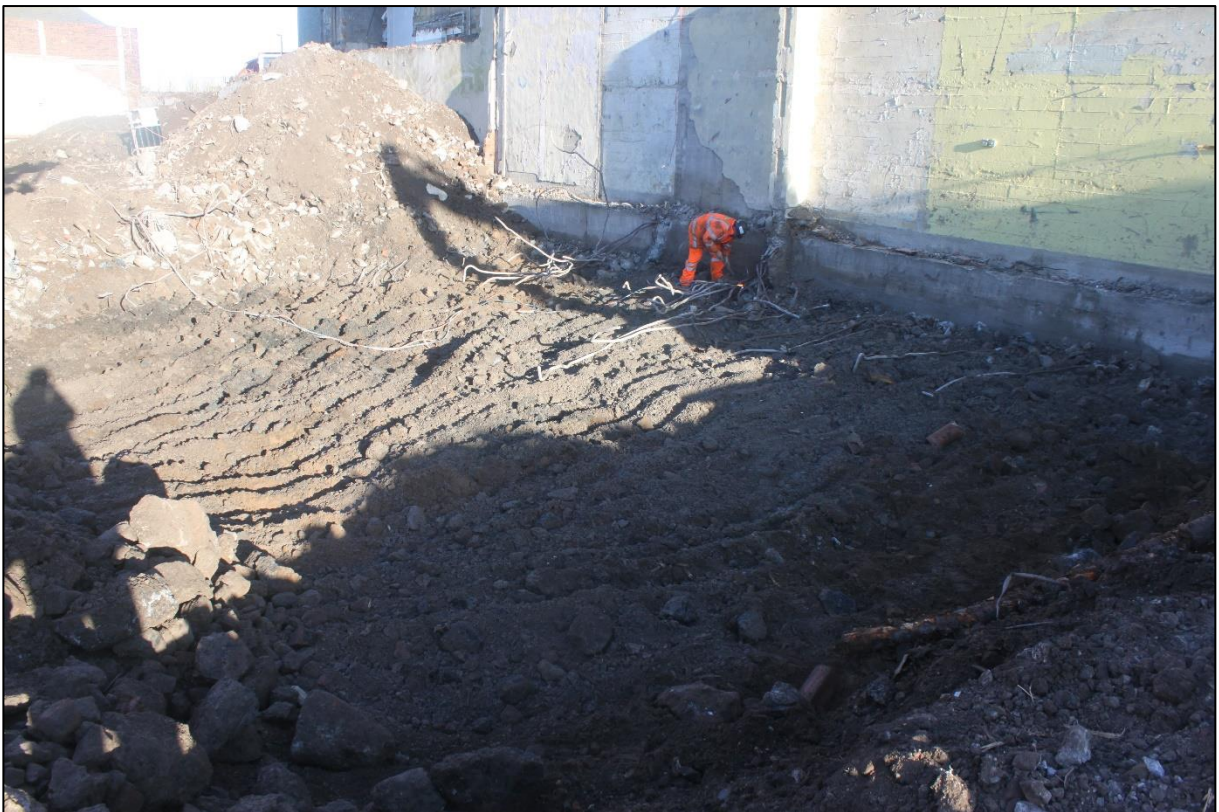
Figure 5b: Southern area post-excitation.

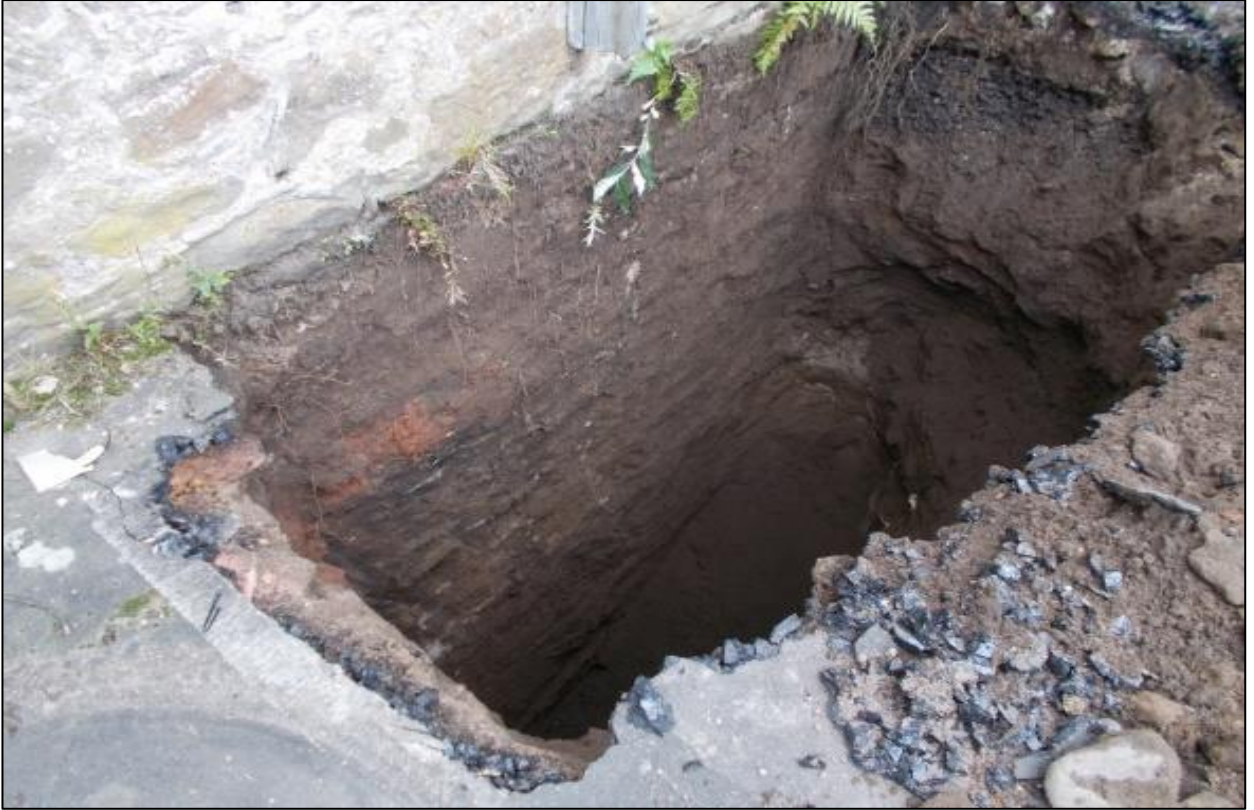
(006). TP B and TP C sat directly against the eastern walls of the buildings which bounded the western side of the playground, and revealed that the wall faces of these buildings continued to the full depth of the trial pits, that is 4.19m and 3.95m respectively. These were mostly constructed of blond sandstone, but occasional red sandstone and whinstone blocks were also visible within the fabric.

17. The presence of a wall face continuing to such a depth within TP B (Figure 2), a location that had the potential to encounter the original moat wall **S2.4**, suggests that there may have been more disruption from 19th century building work in this area than had previously been suspected. While it is uncertain what form the original mid-17th century wall would have taken, it seems unlikely that there would have been any need for a finished wall face here, on the side of the wall which sat directly against the retained material to the outside of the moat. The fabric of the wall face itself was also not inconsistent with 19th century construction, and was of similar character to the fabric of surviving 19th century walls located elsewhere upon the site. The presence of the wall face at this depth might therefore imply that, at one time, this represented a freestanding structure, the remains of which have since been obscured by the raising of the ground level for the playground. Further supporting this was the fact that all three pits identified that the deposits underlying the playground represented made ground for their full depth, indicating an infilling of this area to raise it to its current level (Figures 6a and 6b).

Figure 6a: TP B from the south showing east facing wall face.

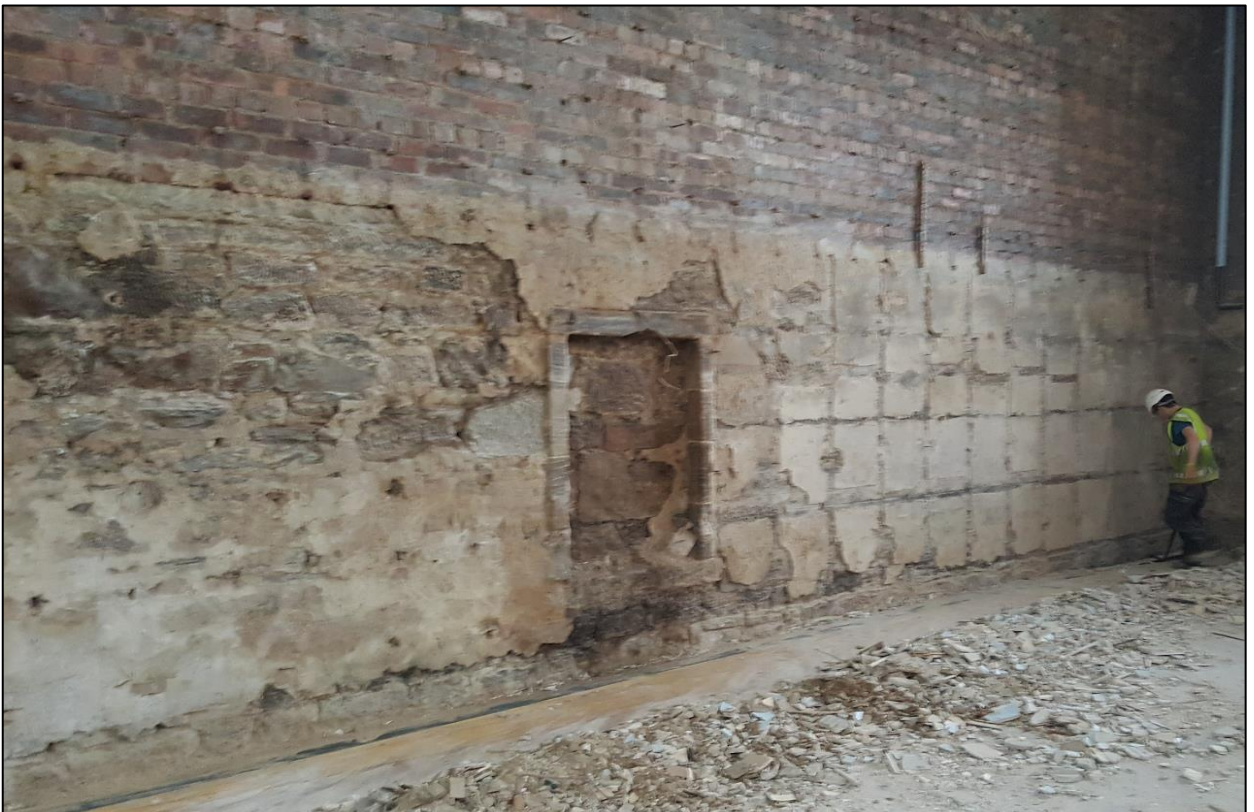
12. On the same visit, inspection of the soft strip underway within the main school buildings identified a fragment of 19th century fabric on the line of the moat wall. The western wall of the Boys Gymnasium proved to be of mixed construction, with one storey of predominantly coursed sandstone rubble surmounted by regular brick construction. Rybats and lintels for two openings were identified within this sandstone fabric, which was interpreted as the east facing upper storey wall of the 19th century warehouses running along the moat.

Figure 6b: Relict one-storey 19th century wall on Moat Wall line in Boys Gymnasium.
