**Old Church Site,  
Fountainblue Terrace,  
Wigtown,  
Dumfries and Galloway  
Archaeological Mitigation:**

Data Structure Report

issued 18<sup>th</sup> April 2019

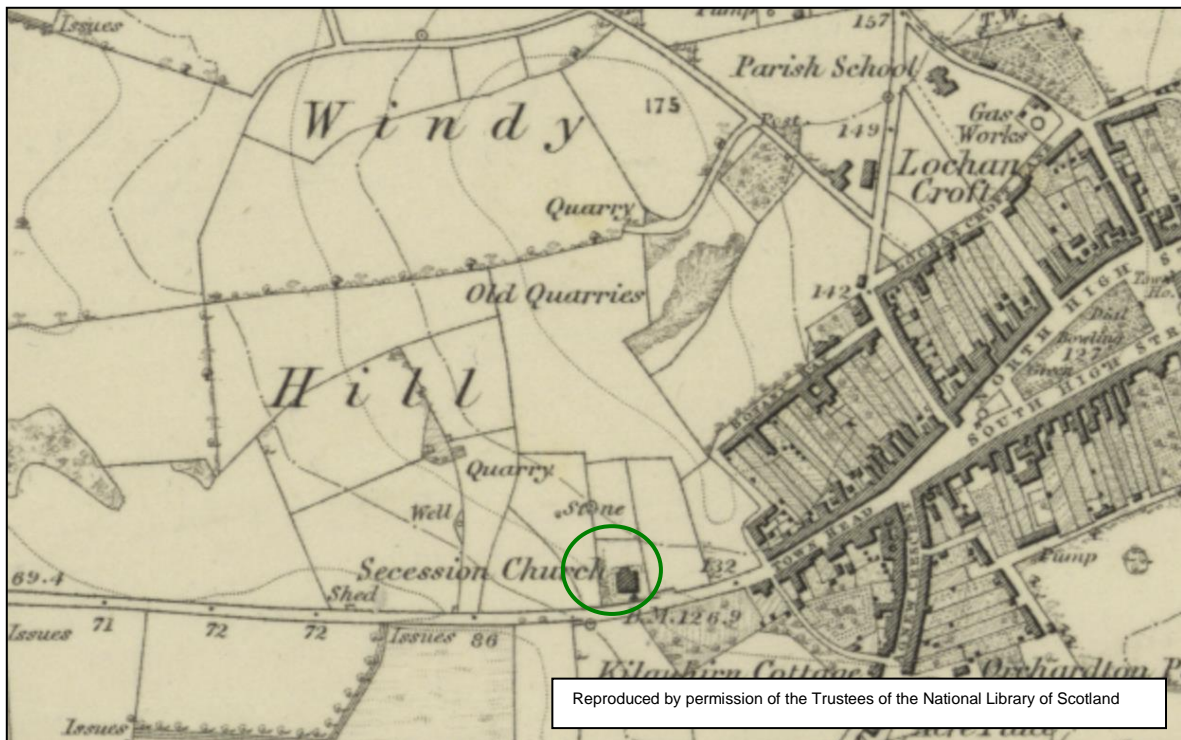
5. There is no other mapping evidence which shows occupation on the site prior to the construction of a church in the 1840s. This church was initially constructed as a Relief Church, however, it was not finished and was sold to the congregation of Wigtown Free Church in 1843. It is shown on the 1<sup>st</sup> Edition Ordnance Survey of 1847-8 as a "Secession Church" (Figure 1b). It was known as the Free Church of Wigtown until 1900 when it was renamed the Wigtown United Free Church following the union of the Free Church and the United Presbyterians. In 1929 it was renamed yet again to the Wigtown West Church of Scotland after the United Free Church joined with the Church of Scotland. In 1948 Wigtown West church joined with Wigtown Laigh to become Wigtown Church of Scotland. At this point the old Wigtown West church was sold and the structure was demolished at some later date (Dawson 2011).

Figure 1b: 1850 Ordnance Survey 1<sup>st</sup> edition map. The green circle denotes the development area.

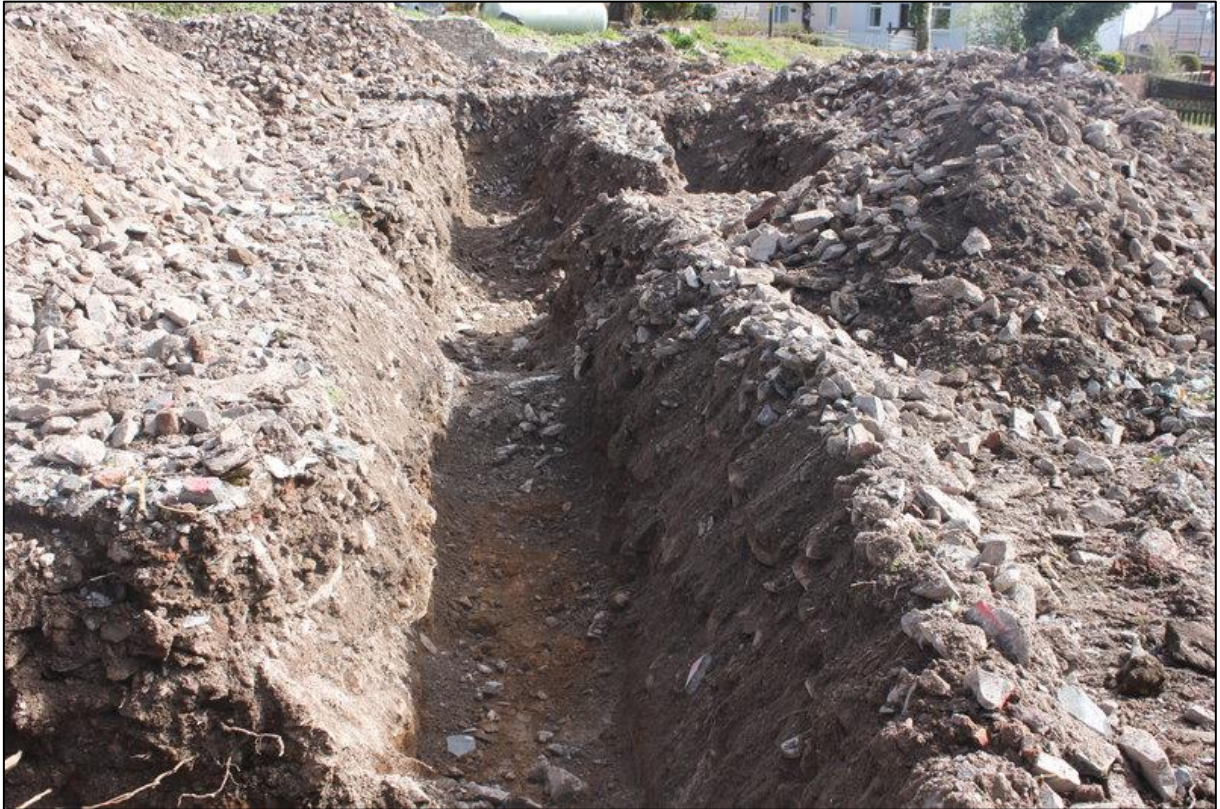
12. Trench 2 ran perpendicular to Trench 1 at its southern end (Figure 2). It measured 14.5m long by 1.2m wide and had a maximum depth of 1.3m. The trench was excavated through an existing demolition layer, (001), to a depth of 0.68m at the eastern end of the trench where it overlay subsoil deposit (004) and to a depth of 0.72m in the western part of the trench where it overlay subsoil deposit (003). Subsoil deposit (003) consisted of a moderate to loosely compacted, mid-orange sand with occasional sub angular stone inclusions (Figure 3a). A linear shaped stone foundation wall, [005], was identified 5.4m from the western end of Trench 2 at a depth of 0.85m. It measured 0.4m wide and ran across the entire 1.3m of the trench. Its thickness was unknown but it was constructed in a similar fashion to foundation wall [006].

Figure 3a: Post-excavation shot of Trench 2 from the west.

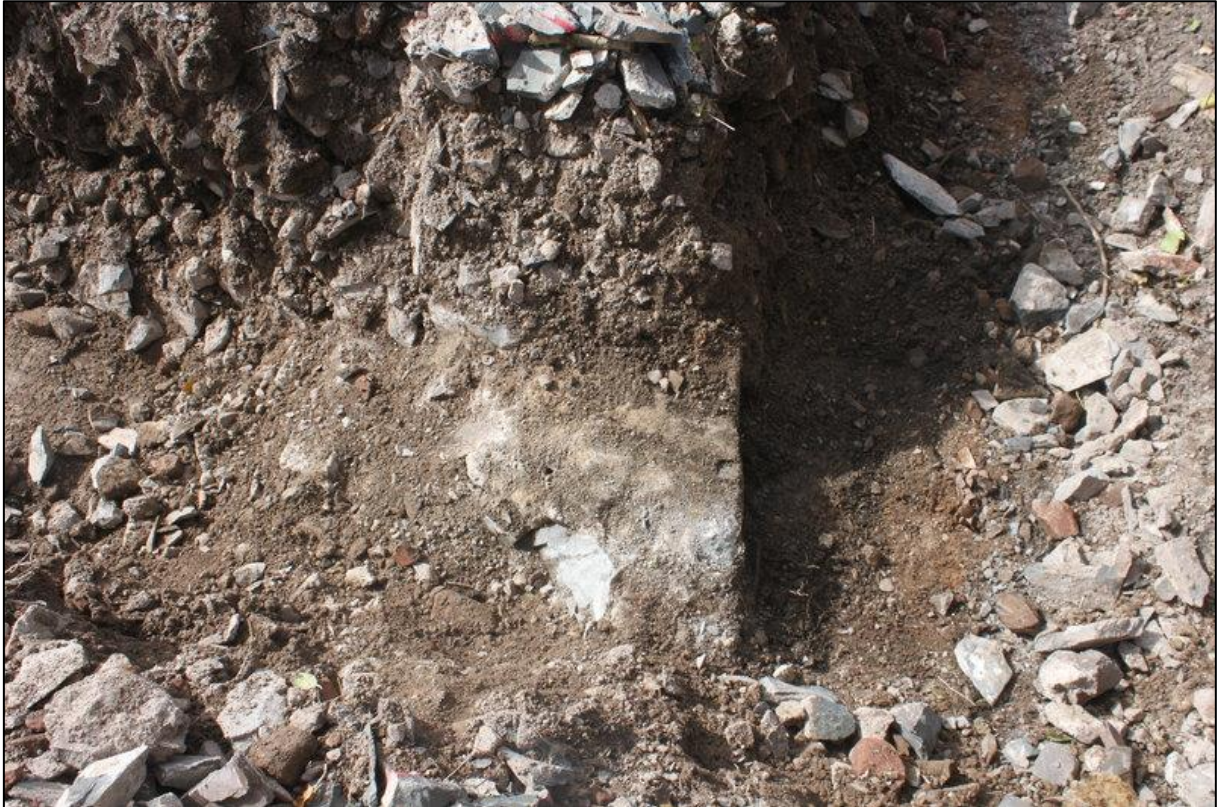
11. Trench 1 ran in a north-south direction to the immediate west of the eastern edge of the development area (Figure 2). It measured 11.5m long, 1.3m wide and had a maximum depth of 1.2m. The trench excavated through an existing demolition layer, (001), which consisted of a very loosely compacted, crushed grey stone rubble within a brown sand matrix. The demolition layer had a thickness of 0.7m and overlay subsoil deposit (004) which consisted of a moderate to loosely compacted, pale yellowish-white sand with small stone inclusions. Subsoil deposit (004) had a maximum excavated thickness of 0.5m within Trench 1. A linear shaped stone foundation wall of the demolished church, [006], was identified 1.2m from the northern end of Trench 1 and at a depth of 0.6m from the existing ground level. The foundation wall measured 0.6m long by 0.9m wide and had a maximum excavated thickness of 0.1m (Figure 3b). The visible section of foundation wall was constructed from a single block of angular grey stone.

Figure 3b: Post-excavation shot of Foundation [006] in Trench 1 from the east.

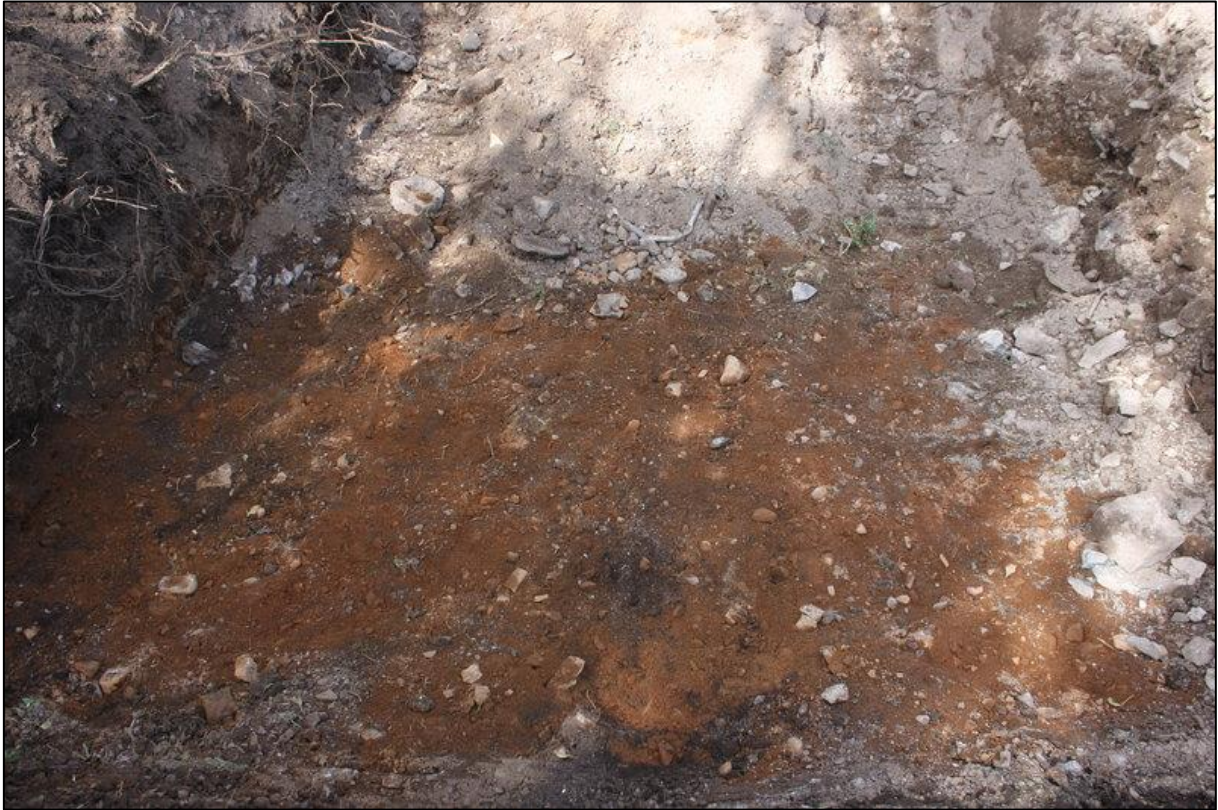
17. A rectangular Septic Tank Pit was excavated 2m to the west of the foundation trenches. It measured 4.4m from east-west and 3m from north-south and had a depth of 1.2m (Figure 2). The pit was excavated through a made ground layer, (002), which consisted of a moderate to loosely compacted, dark brown sand with occasional stone and root inclusions

Figure 4a: Post-excavation shot of Septic Tank Pit from the south.

(Figure 4a). The made ground layer had a depth of 1m and overlay subsoil deposit (003). No significant archaeological features or artefacts were identified within the Septic Tank Pit.

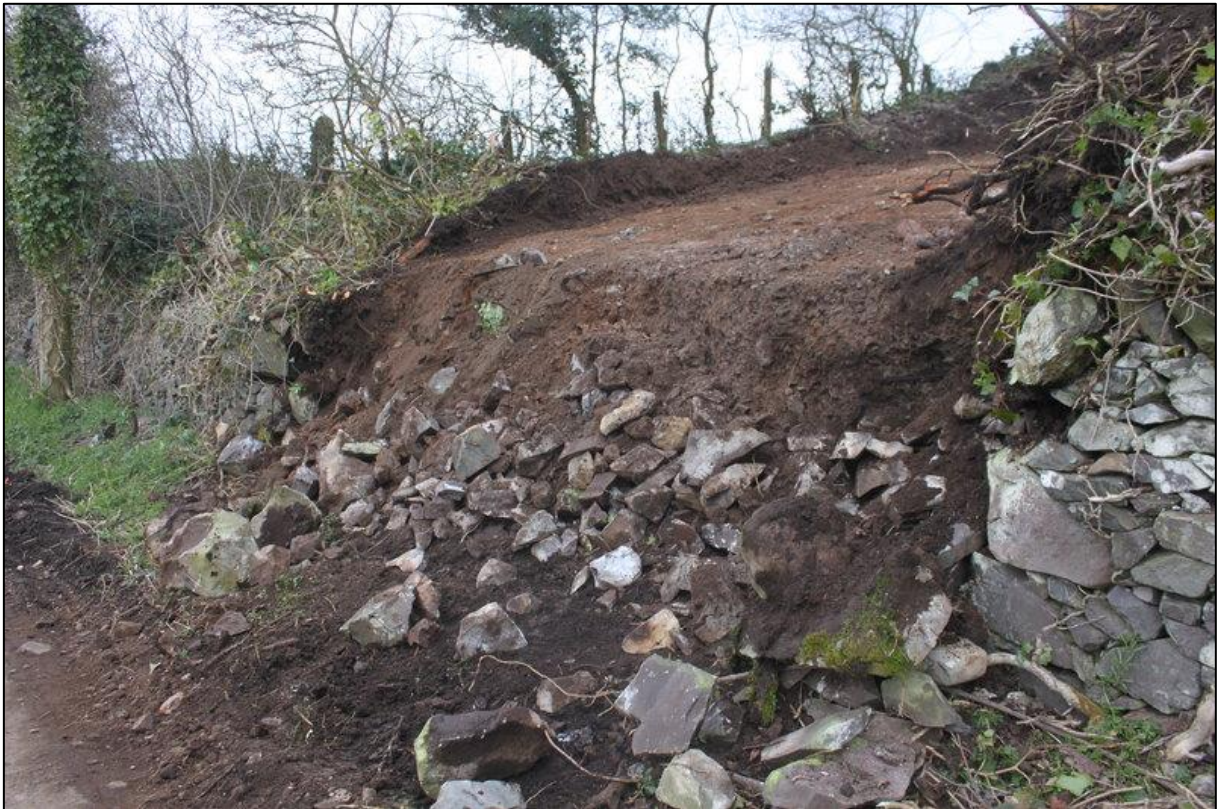
Figure 4b: Post-excavation shot of access track showing made ground (002) and retaining wall [007]. Photo from the southeast.

18. The access track had a length of 23m a width of 4.9m and ran in a north-south direction from Fountainblue Terrace to the main part of the development area (Figure 2). The track was excavated through made ground layer, (002), which consisted of a moderate to loosely compacted, dark brown sand which contained inclusions of 19<sup>th</sup> century or later glass bottle fragments and ceramic sherds (though none of these were retained). Evidence of large tree roots and other organic disturbance were also noted within the made ground layer. The made ground had a maximum thickness of 0.7m and overlay subsoil deposit, (003), a moderate to loosely compacted, mid orange sand with occasional sub angular stone inclusions. At the southernmost end of the access track it cut through the stone retaining wall, [007], which bounded the pavement running along Fountainblue Terrace. The retaining wall was of drystone construction made using rough grey stone which measured approximately 0.3m by 0.3 by 0.2m thick. The wall was badly overgrown in places and had a height of 1.4m where it was cut by the access track (Figure 4b).
