Kinneil Woods, Falkirk: Archaeological Mitigation

Data Structure Report

issued 3rd October 2019

on behalf of Central Scotland Green Network Trust

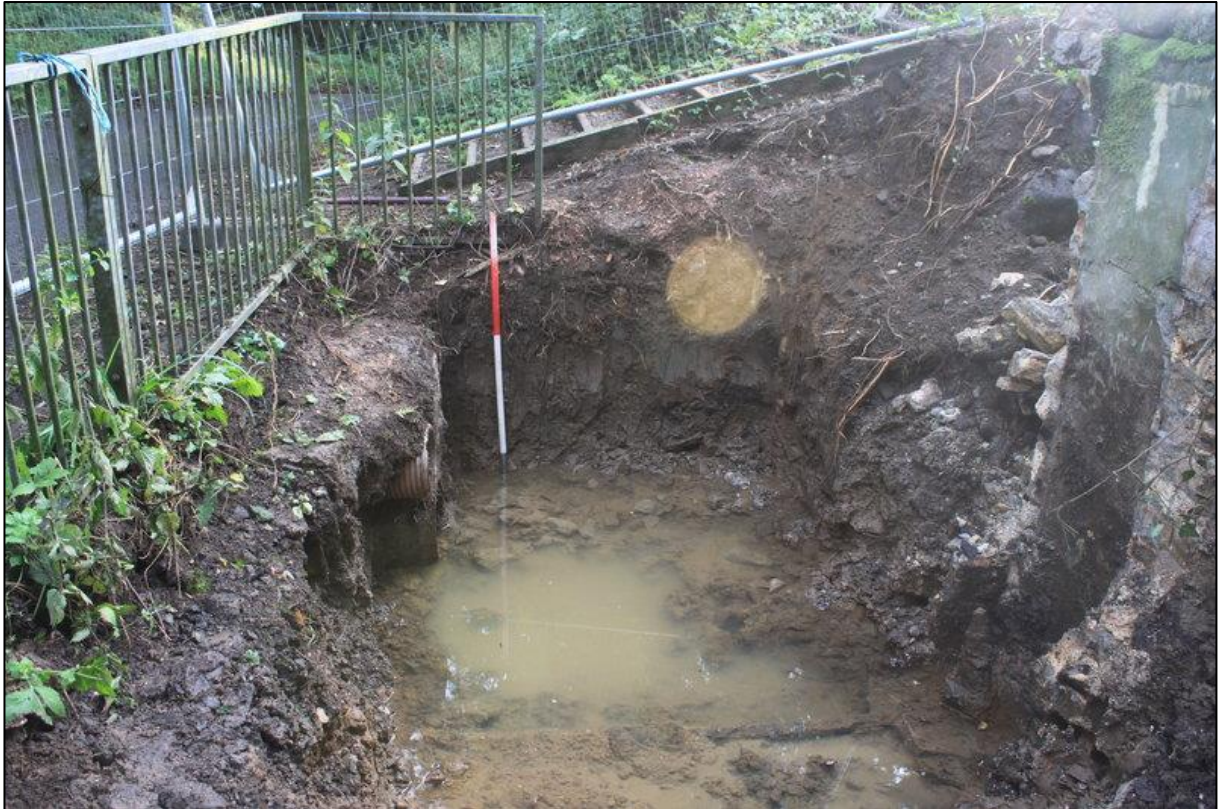
12. In the northeast corner of the site Manhole 1 was excavated in the same position as an existing concrete chamber [007]. Both the existing chamber and the new pit measured 1.65m by 1.15m. The chamber was filled with a deposit of made ground (006), comprising dark brownish grey clay with frequent stone inclusions. Both the fill of the chamber and its concrete lining were removed for Manhole 1. The pit was terminated at a depth of 1m.

Figure 2a: Post-excitation shot of Manhole 1 from the west.

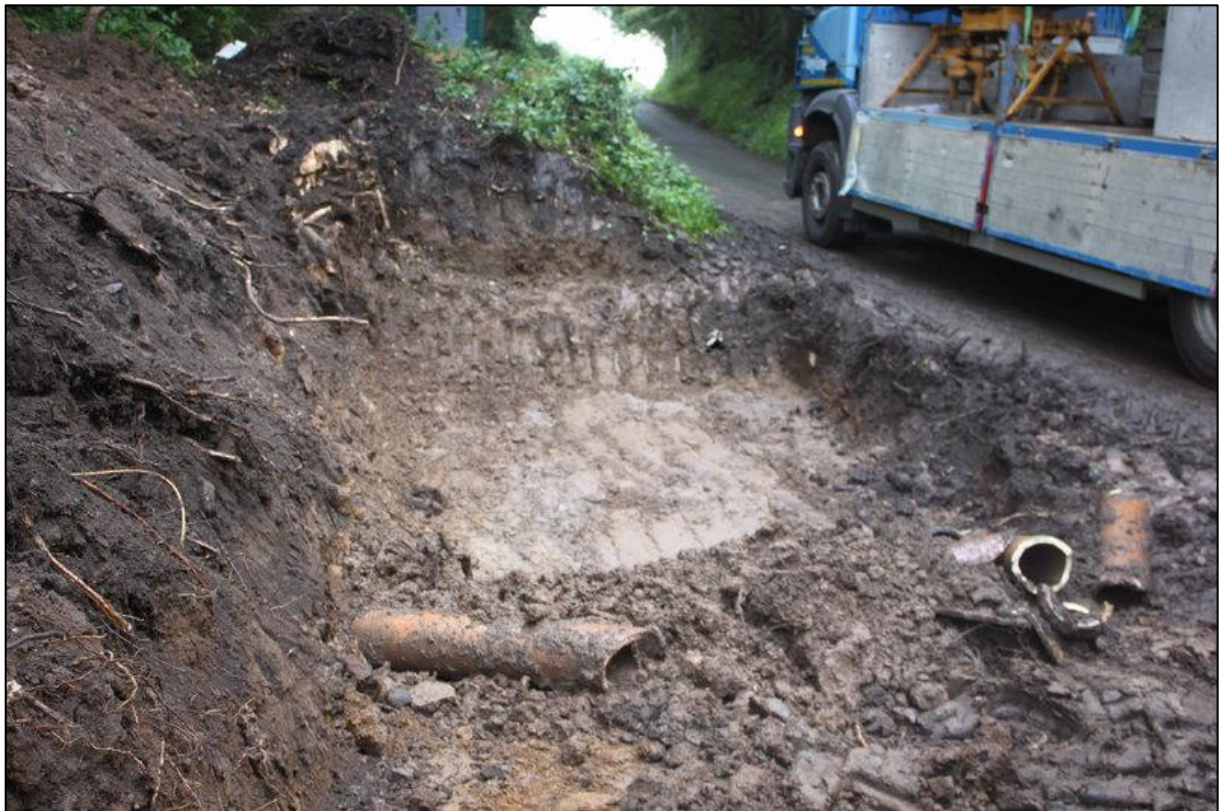
14. A further rectangular area measuring 4.8m by 2.8m (Tank 1) was opened to the north of the southeast drainage track, lying slightly northeast of centre in the widest portion of the excavation area. It had a maximum depth of 0.7m and was excavated through upper and lower layers of subsoil (002) and (004).

Figure 2b: General shot of Tank 1 from the east.

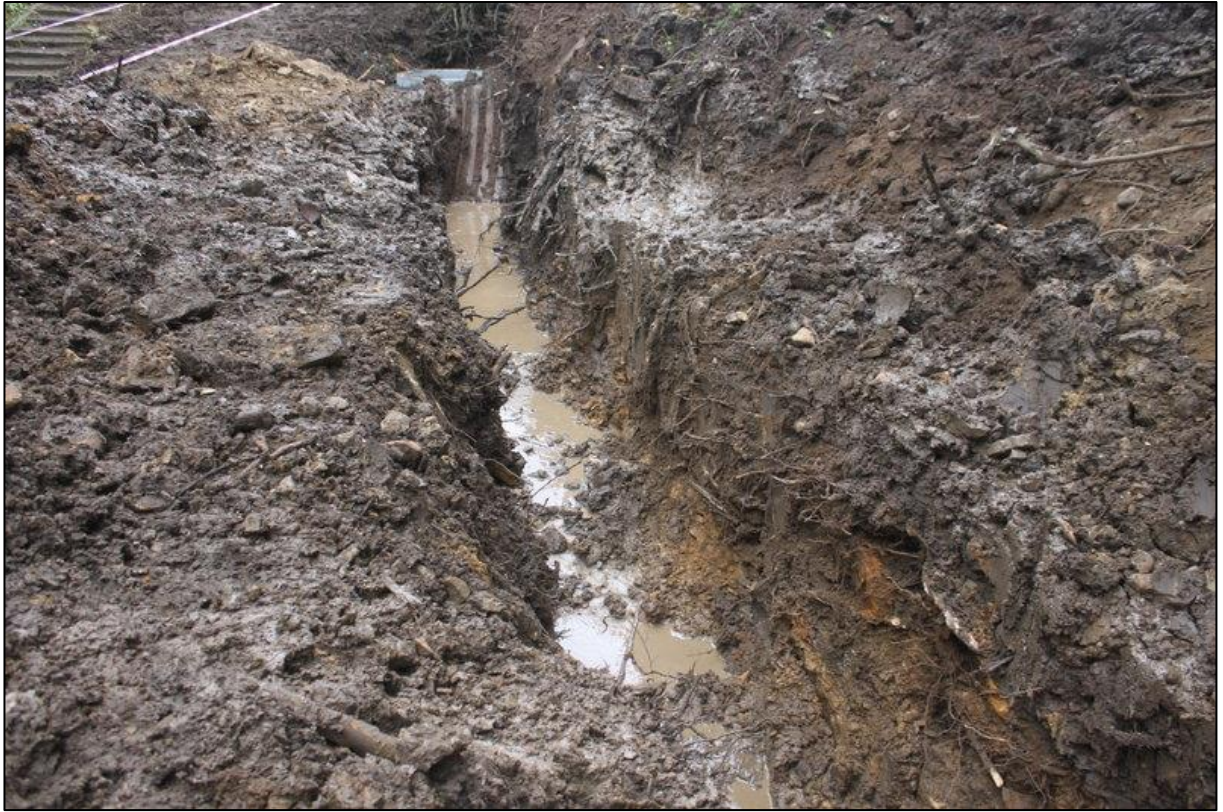
Figure 3a: Post-excitation shot of Drain 2 from the west.

16. Drains 2 and 3 followed a roughly northeast-southwest line running parallel with and slightly to the north of, the cycle path. Drain 2 connected Manholes 2 and 3. Drain 3 ran from Manhole 2 to the far western end of the study area. Both drains were 1m wide and 1m deep. Drain 2 was 7m long and Drain 3 was 8m long. Both drains were excavated through subsoil (002) and bedrock (008).
17. Drain 4 ran northwest-southeast from Manhole 2 to Drain 1. It was 7m in length and measured 1m wide by 1m deep. It was excavated through subsoil (002) that was underlain by subsoil (004) at a depth of 0.5m.
18. No artefacts or significant archaeological features were identified during these works.

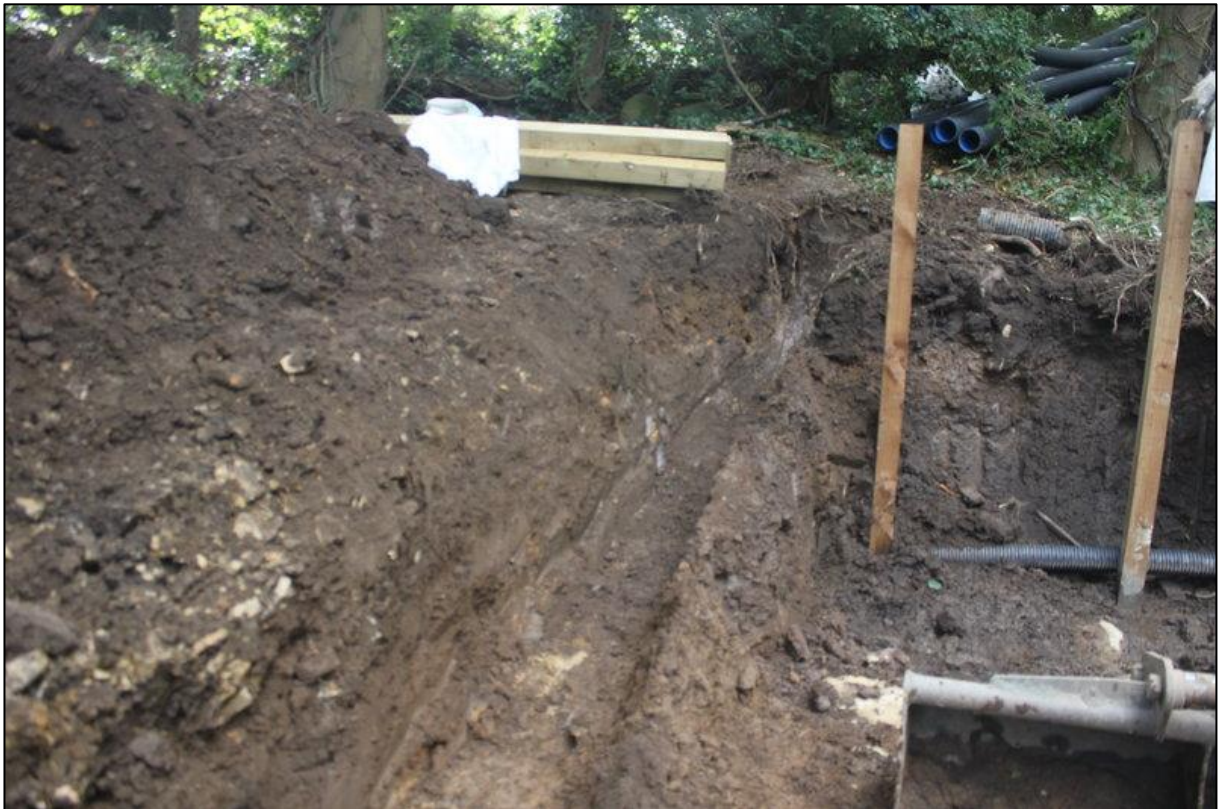
Figure 3b: Post-excitation shot of Drain 3 from the northwest.
