**Knockburnie, East Ayrshire:  
Historic Environment Assessment & Survey  
Appraisal**

on behalf of Mark Hamilton Landscape Services

**RATHMELL**    
ARCHAEOLOGY LTD

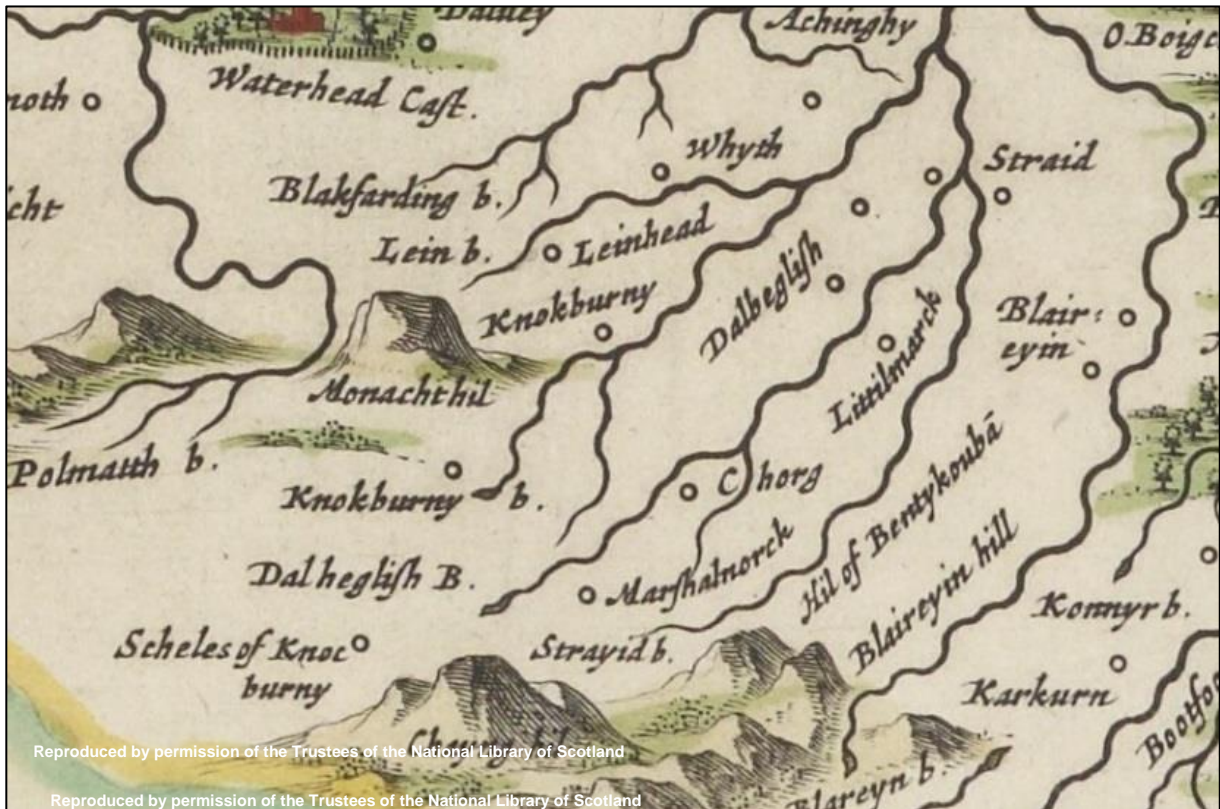
Figure 1a: Extract from Blaeu's map of 1654

18. Several farms are shown on Blaeu's map have equivalents in the modern landscape, including Lanehead ('Leinhead') and Dalleagles ('Dalbeglish'). Of particular interest in our case is, however, a farm or settlement named 'Knockburny,' located just west of the point where two branches of 'Knockburny Burn' converge to form a single watercourse (Canmore ID: 342232). This location, as shown, places the post-medieval site of Knockburny in the same location as that of modern Knockburnie farm. Whether its origins extend further back into the medieval period remains uncertain, with no available documentary sources confirming a medieval origin for the place name.

19. Of particular interest with regards to Blaeu's map is that 'Knockburny' settlement forms part of a much wider integrated landscape. It is often difficult to make comparisons between maps created by Blaeu or Pont and their modern equivalents, as the surveying was undertaken using different methods and to very different standards. In this case, however, common landscape features can be identified, in particular Maneight Hill and the Knockburnie Burn.

20. Blaeu's map shows two further sites - each potentially representing small settlements - lying to the south of 'Knockburny' itself. The first lies adjacent to the western branch of the Knockburnie burn: the place name 'Knockburny b.' (i.e. burn) may apply to the site, or the site may be unnamed with the appellation referring entirely to the watercourse. The site's location, as depicted on the map, places it close to the source of the Knockburnie Burn, close to Maneight Hill, and from this rough location, we can infer that it will probably lie outwith the study area. Even further to the south (or southwest) is another feature named 'Knockburny Schele.' This is likely to refer to shielings, i.e. an upland area where sheep and cattle were taken each year to graze throughout the summer months before returning to

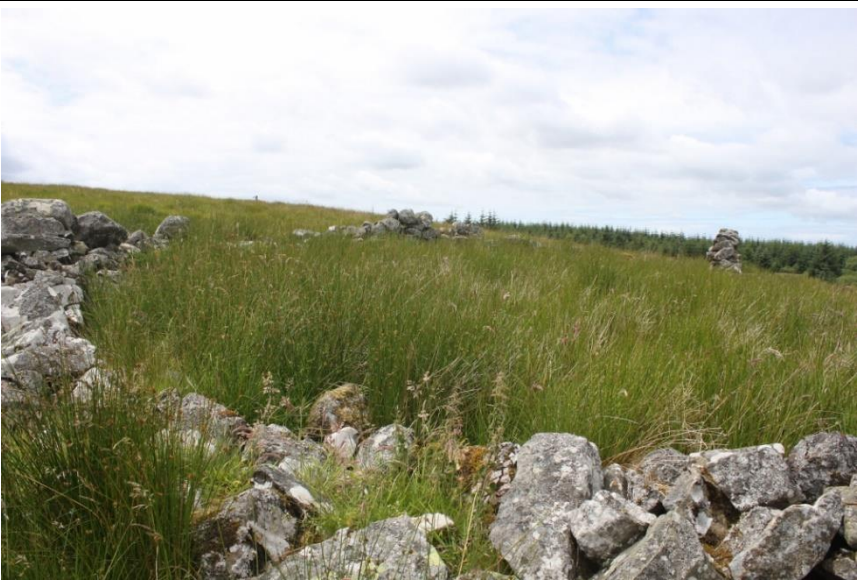
34. **S1** was located in the easternmost part of the study area and consisted of a sub-circular sheepfold of drystone construction and in poor repair with parts of the wall collapsed. No discernible entrance could be identified due to the poor repair of the structure. It survived to a height of 1.42m, was 0.6m thick and had an outer diameter of 13.5m. The sheepfold had two partial walls running off its WNW side (for 8m) and SSE side (for 4.4m). It was located 6.7m-6.8m to the NW of a small NE-SW running burn a tributary of Bow Burn located 480m to the E.

No	Site	HER Ref:	Description	NGR	Image from Site Inspection
S1	Craighouse: Sheepfold	-	<p><b>Desk Based Assessment</b></p> <p>A circular sheepfold is shown on the 1<sup>st</sup> edition Ordnance Survey map with two spurs, one running to the NW the other to the S. This sheepfold continues to be depicted on the current Ordnance Survey.</p> <p><b>Walk over survey</b></p> <p>The sub-circular sheepfold was of drystone construction and in poor repair at the time of the walkover with parts of the wall collapsed. No discernible entrance could be identified due to the poor repair of the structure. It survived to a height of 1.42m, was 0.6m thick and had an outer diameter of 13.5m. The sheepfold had two partial walls running off its WNW side (for 8m) and SSE side (for 4.4m). It was located 6.7m-6.8m to the NW of a small NE-SW running burn a tributary of Bow Burn located 480m to the E.</p>	NS 5478 1019

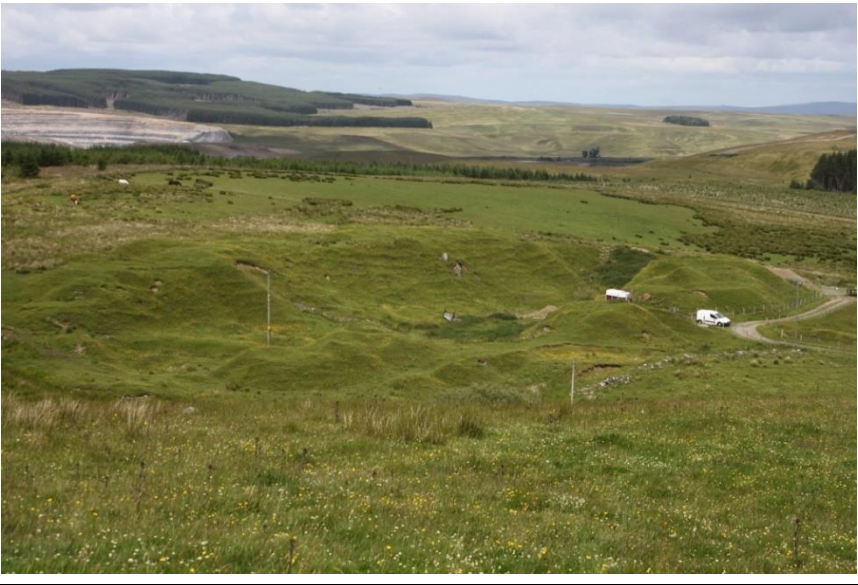
S2	Craighouse: Limestone Quarry	-	<p><b>Desk Based Assessment</b></p> <p>'Limestone Quarry' marked on Thomson 1832. An extensive 'Old Quarry (Limestone)' is depicted on the 1<sup>st</sup> edition Ordnance Survey map to the immediate W of Craighouse S3. Depicted as earthworks the quarry covers a rectangular area in plan some 200m NE/SW by 70m NW/SE. These earthworks continue to be depicted on the current Ordnance Survey.</p> <p><b>Walk over survey</b></p> <p>The remains of the quarry were located to the W and immediate NW of Craighouse Cottage S3. They took the form of a large sub-oval shaped depression which measured 172m-173m from NE-SW, 10m-22m from NW-SE and had a depth of 2m-4m from the existing ground level. Surrounding the sub-oval depression were irregular/linear shaped mounds (presumably bunds relating to the quarry workings) which had a width range of between 10m-25m to the NW and 11m-27m to the SE. These mounds had a height range of between 3m-4m.</p>	NS 5484 1041

46. The remains of Craighouse Limestone Quarry **S2** were located to the W and immediate NW of Craighouse Cottage **S3**. They took the form of a large sub-oval shaped depression which measured 172m-173m from NE-SW, 10m-22m from NW-SE and had a depth of 2m-4m from the existing ground level. Surrounding the sub-oval depression were irregular/linear shaped mounds (presumably bunds relating to the quarry workings) which had a width range of between 10m-25m to the NW and 11m-27m to the SE. These mounds had a height range of between 3m-4m.

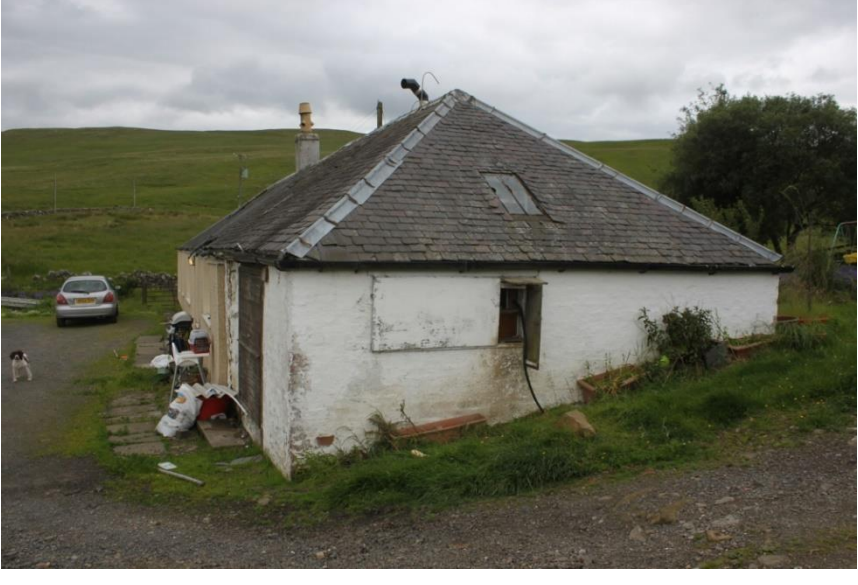
39. Craighouse Cottage **S3** was a single storey, rectangular shaped stone built structure with the outside of the building having been rendered and painted white. The building measured 25m from NNW-SSE, 7m from ENE-WSW and it had an approximate height of 4m-4.5m. The roofing, windows and doors for the cottage all looked to be recent suggesting that though the overall structure of the building was unchanged the building had been altered in a superficial manner after the 19<sup>th</sup> century.

40. The cottage was situated in a slightly off centre location within sub-rectangular shaped grounds which occupied an area of 1079m<sup>2</sup>. The grounds consisted of grass turf with an area of tarmac to the rear (NE side) of the building. The grounds were enclosed with a mix of tumbled drystone walling, wooden fencing and wire and post fencing. A small gravel farm track ran from the main B741 road to the S and entered the grounds from the SW where it joined the tarmac surface to the rear of the building. No elements relating to the cottage or its grounds were noted within the study area.

S3	Craighouse: Cottage	-	<p><b>Desk Based Assessment</b></p> <p>A cottage depicted on 1<sup>st</sup> edition Ordnance Survey as a NW/SE aligned building set to the N of the New Cumnock-Dalmellington road named 'Craighouse', accessed by tracks from the S. A small additional structure set to the NE with enclosure to the SW. Described in the Ordnance Survey Name Book as a 'cottage house occupied by William Nisbet'. By 2<sup>nd</sup> edition Ordnance Survey the structure appears to have been extended or rebuilt on a common alignment. This structure continues to be depicted on the current Ordnance Survey.</p> <p><b>Walk over survey</b></p> <p>Craighouse Cottage was a single storey, rectangular shaped stone built structure with the outside of the building having been rendered and painted white. The building measured 25m from NNW-SSE, 7m from ENE-WSW and it had an approximate height of 4m-4.5m. The roofing, windows and doors for the cottage all looked to be recent suggesting that though the overall structure of the building was unchanged the building had been altered in a superficial manner since the 19<sup>th</sup> century.</p> <p>The cottage was situated in a slightly off centre location within sub-rectangular shaped grounds which occupied an area of 1079m<sup>2</sup>. The grounds consisted of grass turf with an area of tarmac to the rear (NE) of the building. The grounds were enclosed with a mix of</p>	NS 5493 1043

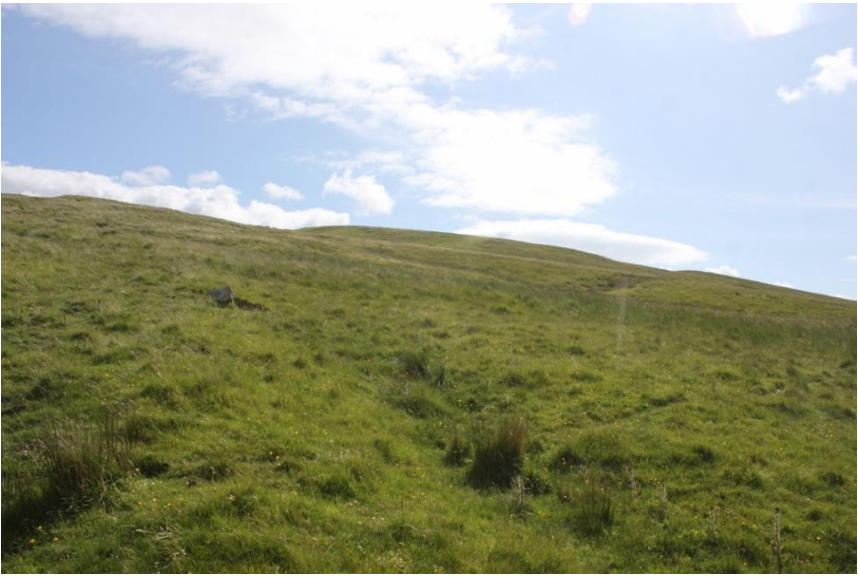
S5	Craighouse: Whinstone Quarry	-	<p><b>Desk Based Assessment</b></p> <p>A small 'Whinstone Quarry' is depicted on the 1<sup>st</sup> edition Ordnance Survey map to the immediate NE of sheepfold S1. The quarry continues to be mapped, but not described, on the 2<sup>nd</sup> edition Ordnance Survey with the suggestion of additional workings to the immediate S. Not depicted on the 3<sup>rd</sup> edition Ordnance Survey although a much larger depression including the original quarry is depicted on the 1962 Ordnance Survey.</p> <p><b>Survey</b></p> <p>The whinstone quarry was located on a moderate, N-S, slope which was 50m from the main B741 Road and 93m to the NE of Craighouse Sheepfold S1. The quarry was a sub-circular shaped depression which had a diameter of 10m-11m and a depth of 0.5m-1.5m from the existing ground level.</p>	NS 5486 1027

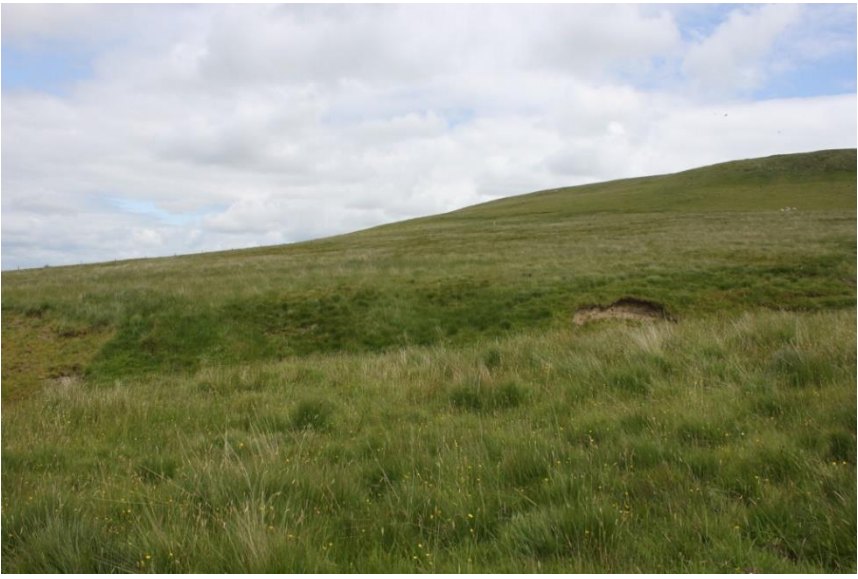
47. Craighouse Whinstone Quarry **S5** was located on a moderate, N-S, slope which was 50m from the main B741 Road and 93m to the NE of Craighouse Sheepfold **S1**. The quarry was a sub-circular shaped depression which had a diameter of 10m-11m and a depth of 0.5m-1.5m from the existing ground level.

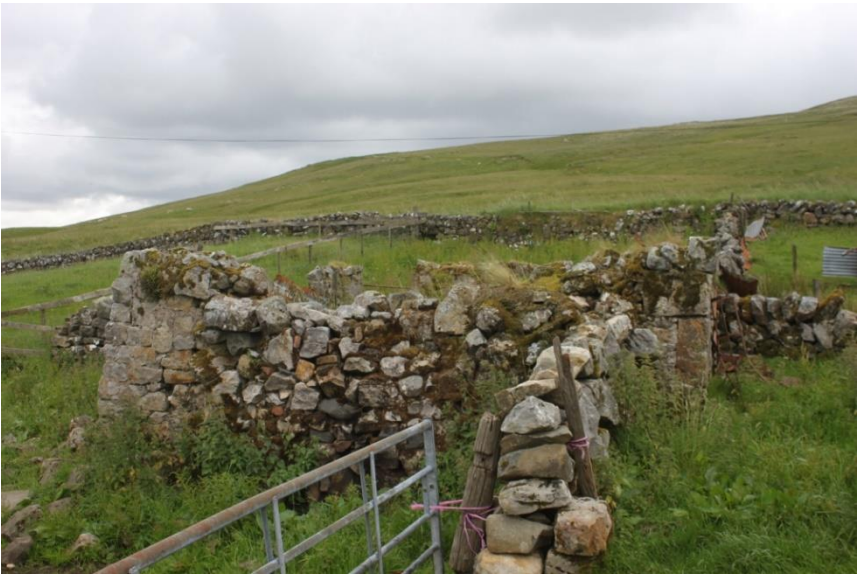
41. Stoneyknowes Cottage **S6** was a single storey, rectangular shaped drystone built structure. The structure was a partial ruin that consisted of two rooms. The ENE wall and part of the NNW wall were missing and no roofing survived. The building measured 6m from NNW-SSE, 11m from ENE-WSW and it had an approximate height of 1.5m. The structure's walls had a thickness range of 0.55m-0.65m. Some of the gaps in the NNW wall had been covered by corrugated iron sheets and there was an opening, located in a central position, in the SSE wall which may have been an original entrance. Two other entrances were observed on either side of the current entrance and both of these had been blocked up with drystone walling. A stone lintel still existed over the westernmost of these blocked entrances.

42. Grounds associated with the cottage were situated to the immediate SSE and were sub-rectangular shaped and occupied an area of 296m<sup>2</sup>. The grounds consisted of an area of rough grass turf which were enclosed with a mix of drystone walling (some of which was tumbled) and wire and post fencing.

No	Site	HER Ref:	Description	NGR	Image from Site Inspection
S6	Stonyknowes: Cottage	-	<p><b>Desk Based Assessment</b></p> <p>A Cottage depicted on 1<sup>st</sup> edition Ordnance Survey as a E/W aligned building set to the N of the New Cumnock-Dalmellington road named 'Stonyknowes'. A small enclosure to the S. Described in the Ordnance Survey Name Book as a 'small cottage house ... occupied by Robert Flemming'. By 2<sup>nd</sup> edition Ordnance Survey the structure appears to have become ruinous being depicted as an enclosure. At the same time additional enclosures have been formed abutting and to the W (<b>S10</b>). These enclosures continue to be depicted on the current Ordnance Survey.</p> <p><b>Walk over survey</b></p> <p>Stoneyknowes Cottage was a single storey, rectangular shaped drystone built structure. The structure is currently a partial ruin that consisted of two rooms. The ENE wall and part of the NNW wall were missing and no roofing survived. The building measured 6m from NNW-SSE, 11m from ENE-WSW and it had an approximate height of 1.5m. The structures walls had a thickness range of 0.55m-0.65m Some of the gaps in the NNW wall had been covered by corrugated iron sheets. There was an opening, located in a central position, in the SSE wall which may have been an original entrance. Two other entrances were observed on either side of the current entrance and both of these had been blocked up with drystone walling. A stone lintel still existed over the westernmost of these blocked entrances.</p> <p>Grounds associated with the cottage were situated to the immediate SSE. These grounds were sub-rectangular shaped and occupied an area of 296m<sup>2</sup>. The grounds consisted of an area of rough grass turf. The grounds were enclosed with a mix of drystone walling (some of which was tumbled) and wire and post fencing.</p>	NS 5556 1050

54. Two cottages with associated grounds, **S6** and **S8**, were identified within the study area (and one which was outwith it **S3**) were all depicted within the 1<sup>st</sup> edition Ordnance Survey showing them to be mid-19<sup>th</sup> century date though they may like the sheepfolds have originally have been constructed at an earlier time possibly the 18<sup>th</sup> century. As such they contribute to the historic character of the land and have been ascribed Local significance and should be protected by a 5m buffer. Each should be retained within a managed clearing that is maintained as an open space.

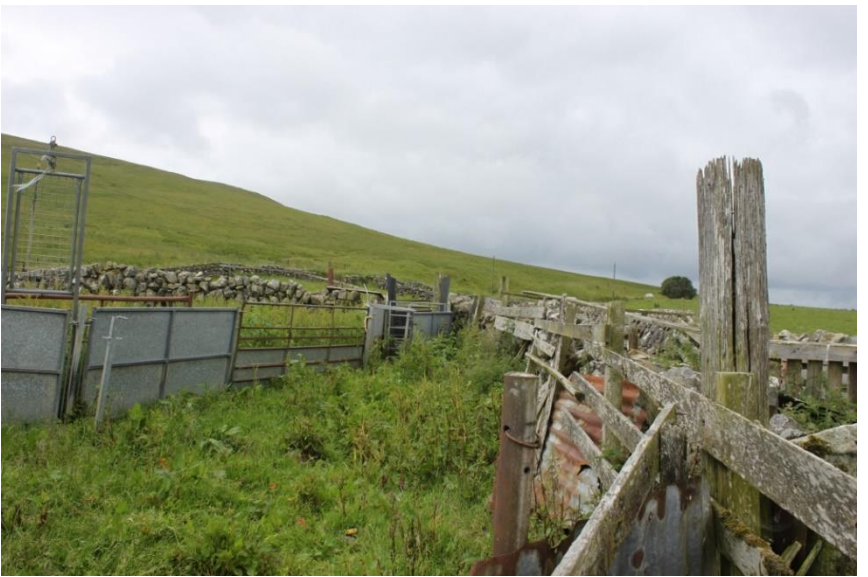
37. Sheepfolds **S7** and **S10** were located close or adjacent to the grounds of Stoneyknowes Cottage **S6**. Sheepfold **S7** consisted of a main square shaped enclosure divided along its NE-SW axis with two other smaller rectangular enclosures running off the SW side of the main enclosure and another irregular shaped enclosure running off its NW side. Overall the sheepfold occupied an area of 410m<sup>2</sup>. The walls making up the main enclosure were all of drystone construction with a width of 0.4m and a height of 1.4m. The adjacent enclosures running off the SW side of the main enclosure were a mix of wire and post/corrugated sheeting and a modern breeze block wall and the enclosure running off the main enclosure's NW side was enclosed by a similar breeze block wall. All of the gates within the sheepfold were made from modern galvanised steel. Sheepfold **S10** was located to the immediate WSW of Stoneyknowes Cottage and its associated grounds **S6** and NNW of the main B741 road. The sheepfold was square shaped in plan measuring 16.5m from ENE-WSW and 17m from NNW-SSE. The enclosing wall was of drystone construction with the SSE wall being part of a boundary wall running along the main road and the ENE wall being part of a field boundary wall which carried on further to the NNW. The wall was tumbled in places but generally in good repair with a thickness of 0.5m and height of 1.1m.

S7	Stonyknowes: Sheepfold	Canmore: 170148 WoSAS: 47342	<p><b>Desk Based Assessment</b></p> <p>A series of rectangular enclosures are depicted on the on 1<sup>st</sup> edition Ordnance Survey. While none are labelled as ruins, it is credible that there are two ruinous structures present. The larger is aligned NE/SW with the smaller appended to the SW gable, running to the SE to overall form an L-shaped structure. A large enclosure lies in the angle between the two proposed ruins, a smaller enclosure is appended to the SW of the complex. On the 2<sup>nd</sup> edition Ordnance Survey this complex has been expanded and is labelled 'Sheep Ree'. These enclosures continue to be depicted on the current Ordnance Survey.</p> <p><b>Walk over survey</b></p> <p>The sheepfold was of mainly drystone construction with some areas of corrugated iron sheeting and wire and post fencing. It consisted of a main square shaped enclosure divided along its NE-SW axis with two other smaller rectangular enclosures running off the SW side of the main enclosure and another irregular shaped enclosure running off its NW side. Overall the sheepfold occupied an area of 410m<sup>2</sup>. The walls making up the main enclosure were all of drystone construction with a width of 0.4m and a height of 1.4m. The adjacent enclosures running off the SW side of the main enclosure were a mix of wire and post/corrugated sheeting and a modern breeze block wall and the enclosure running off the main enclosures NW side was enclosed by a similar breeze block wall. All of the gates within the sheepfold were made from modern galvanised steel.</p>	NS 5561 1053

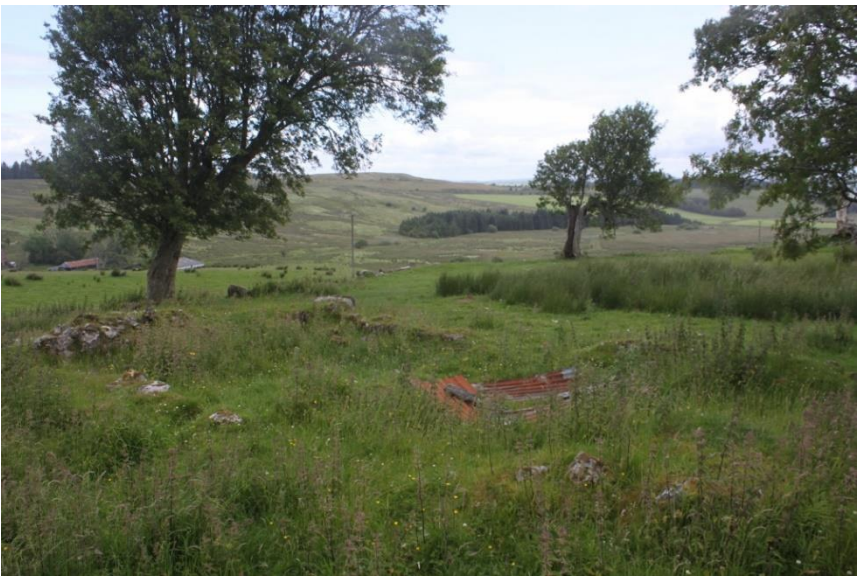
43. The remains of Knockburnie Cottage **S8** consisted of a rectangular shaped stone built structure which was overgrown with vegetation. It measured 7.4m from NNW-SSE and 5.4m from ENE-WSW. The surviving wall foundations had a width of 0.3m-0.5m and height

No	Site	HER Ref:	Description	NGR	Image from Site Inspection
S8	Knockburnie Cottage:	-	<p><b>Desk Based Assessment</b></p> <p>A Cottage depicted on 1<sup>st</sup> edition Ordnance Survey set on the northern edge of the New Cumnock-Dalmellington road named 'Knockburnie Cottage'. Described in the Ordnance Survey Name Book as a 'cottage on the public road ... occupied by William Gemmel, Gamekeeper'. By 2<sup>nd</sup> edition Ordnance Survey the structure lies within a larger enclosure, predominately extending to the E, also abutting the road. The cottage is depicted as roofed on the 3<sup>rd</sup> edition Ordnance Survey, with the ruin of the structure with larger enclosure depicted on the 1962 Ordnance Survey. The larger enclosure continue to be depicted on the current Ordnance Survey.</p> <p><b>Walk over survey</b></p> <p>The remains of Knockburnie Cottage consisted of a rectangular shaped stone built structure which was overgrown with vegetation. It measured 7.4m from NNW-SSE and 5.4m from ENE-WSW. The surviving wall foundations had a width of 0.3m-0.5m and height of 0.5m. A gap in the WSW wall may possibly have been the entrance into the structure.</p> <p>The cottage was located within sub-rectangular shaped grounds that occupied an area of 514m<sup>2</sup>. The only sign of the boundary which once enclosed the grounds was in the form of a low only just discernible bank on the line of which were a number of mature trees grew.</p>	NS 5575 1052

- of 0.5m. A gap in the WSW wall may possibly have been the entrance into the structure.
44. The cottage was located within sub-rectangular shaped grounds that occupied an area of 514m<sup>2</sup>. The only sign of the boundary which once enclosed the grounds was in the form of a low only just discernible bank of overgrown stone on the line of which were a number of mature trees grew.

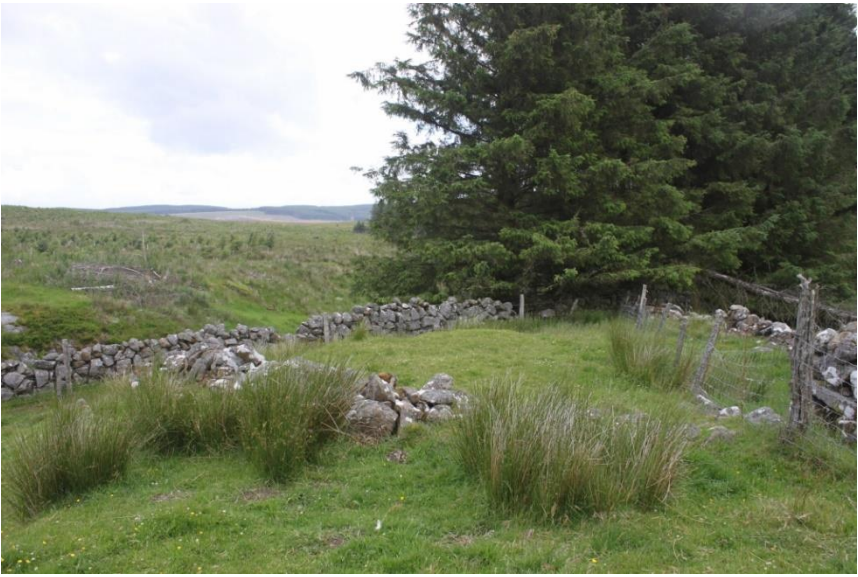
36. In the northern part of the study area the partial remains of the sheepfold **S9** were identified at the T junction of drystone field walling. It was semi-circular shaped in plan with a NE-SW length of 17.5m and a NW-SE length of 12.4m. Like the adjoining field walls it was of drystone construction though it had collapsed in places. The sheepfold's wall had a thickness of 0.4m and height of 0.8m-1.4m. There were two openings into the sheepfold, one on either side of the adjoining NNW-SSE field wall.

S9	Craighouse: Sheepfold	-	<p><b>Desk Based Assessment</b></p> <p>On the 2<sup>nd</sup> edition Ordnance Survey a Sheep Ree is shown formed by the remodelling of field boundaries at a T junction. This sheepfold continues to be depicted on the current Ordnance Survey.</p> <p><b>Walk over survey</b></p> <p>The partial remains of the sheepfold were identified at the T junction of drystone field walling. It was semi-circular shaped in plan with a NE-SW length of 17.5m and a NW-SE length of 12.4m. Like the adjoining field walls it was of drystone construction though it had collapsed in places. The sheepfolds wall had a thickness of 0.4m and height of 0.8m-1.4m. There were two openings into the sheepfold, one on either side of the adjoining NNW-SSE field wall.</p>	NS 5525 1056

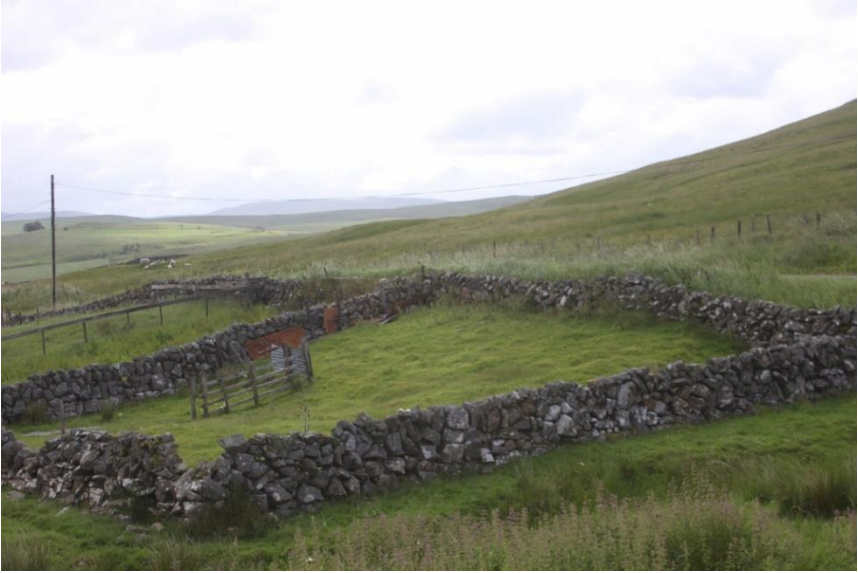
S10	Stonyknowes: Sheepfold	-	<p><b>Desk Based Assessment</b></p> <p>On the 2<sup>nd</sup> edition Ordnance Survey a rectangular Sheep Ree is shown formed to the immediate W, and abutting, the enclosures of Stonyknowes S6. This sheepfold continues to be depicted on the current Ordnance Survey.</p> <p><b>Walk over survey</b></p> <p>The Stonyknowes Sheepfold was located to the immediate WSW of Stonyknowes Cottage and its associated grounds S6 and NNW of the main B741 road. The sheepfold was square shaped in plan measuring 16.5m from ENE-WSW and 17m from NNW-SSE. The enclosing wall was of drystone construction with the SSE wall being part of a boundary wall running along the main road and the ENE wall being part of a field boundary wall which carried on further to the NNW. The wall was tumbled in places but generally in good repair with a thickness of 0.5m and height of 1.1m.</p>	NS 5555 1049

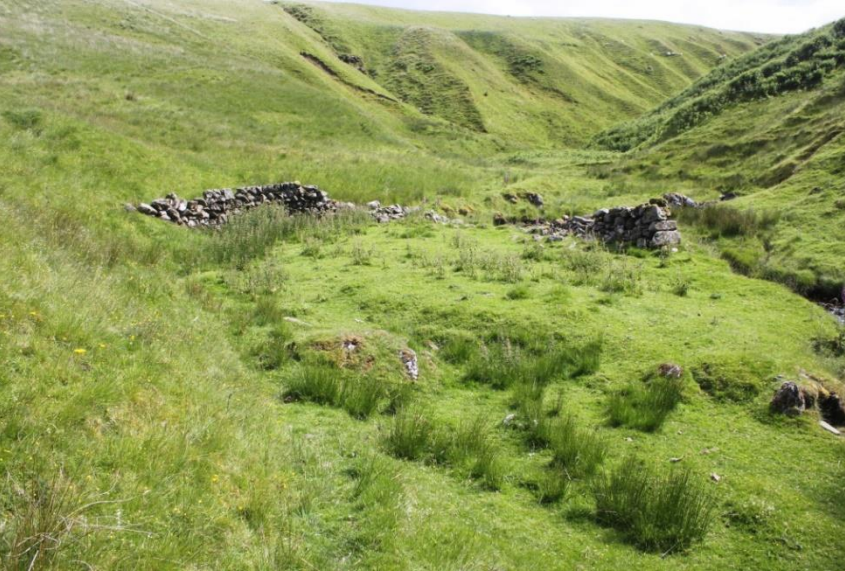
35. In the southern part of the study area two sheepfold sites, **S11** and **S14**, were identified. The partial remains of **S11**, what may have been a circular shaped drystone sheep fold, were located on the eastern bank of the burn running through Knockburnie Glen. The surviving remains measured 14m by 6m suggesting that the sheepfold had had a diameter of 14m-15m. The surviving walling had a thickness of 0.6m and a height of 0.65m-1.5m. Sheepfold **S14**, which was located on the NW bank of Spout Burn, was rectangular shaped in plan and in a poor state of repair. It was of drystone construction and overgrown with vegetation. It measured 10m from N-S, 7.8m from E-W and had a height of 0.3m. The sheepfolds walls were all tumbled and had a width range of 0.6m-0.7m.

No	Site	HER Ref:	Description	NGR	Image from Site Inspection
S11	Knockburnie Burn: Sheep Shelter	-	<p><b>Desk Based Assessment</b></p> <p>On the 2<sup>nd</sup> edition Ordnance Survey an arc of walling, open to the N, is depicted to the immediate E of Knockburnie Glen. This walling was labelled 'Sheep Shelter' and continued to be depicted on the 3<sup>rd</sup> edition Ordnance Survey. No longer depicted on Ordnance Survey mapping, but visible on aerial imagery.</p> <p><b>Walk over survey</b></p> <p>The partial remains of what may have been a circular shaped drystone sheep fold were located on the eastern bank of the burn running through Knockburnie Glen. The surviving remains measured 14m by 6m suggesting that the sheepfold had had a diameter of 14m-15m. The surviving walling had a thickness of 0.6m and a height of 0.65m-1.5m.</p>	NS 5633 1003

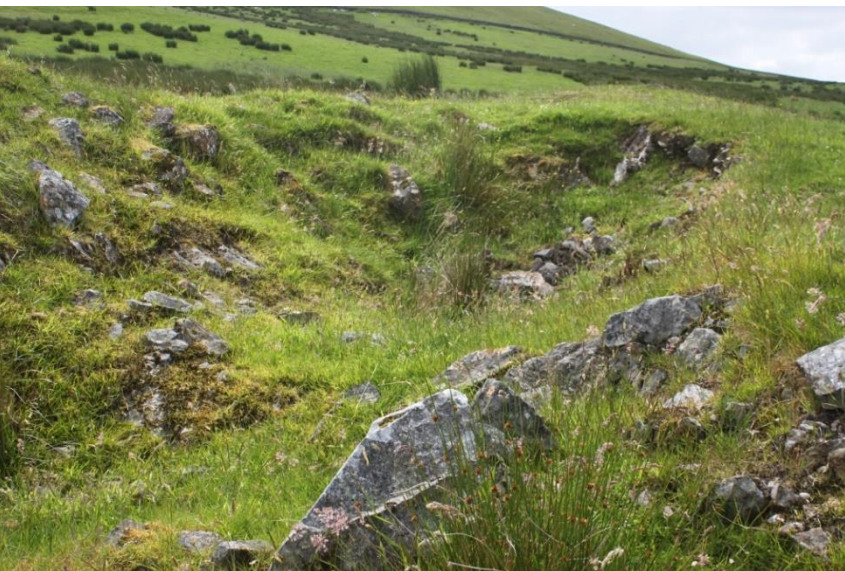
S12	Knockburnie: Quarry	-	<p><b>Desk Based Assessment</b></p> <p>A small probable quarry is depicted from the 3<sup>rd</sup> edition Ordnance Survey to the immediate west of Knockburnie farm, enclosed by a circular wall. No longer depicted on Ordnance Survey mapping.</p> <p><b>Walk over survey</b></p> <p>Irregular shaped depression represented the remains of the quarry and were noted almost adjacent to the W facing sides of one of the buildings at Knockburnie Farm. The quarry measured 23m from N-S, 22m from E-W and had a maximum depth of 2.5m-3m. To the E of the quarry were a number of both small and large mounds of spoil, some of which were overgrown.</p>	NS 5617 1046

48. Knockburnie Quarry **S12** was an irregular shaped depression noted almost adjacent to the W facing sides of one of the buildings at current Knockburnie Farm. The quarry measured 23m from N-S, 22m from E-W and had a maximum depth of 2.5m-3m. To the E of the quarry were a number of both small and large mounds of spoil, some of which were overgrown.

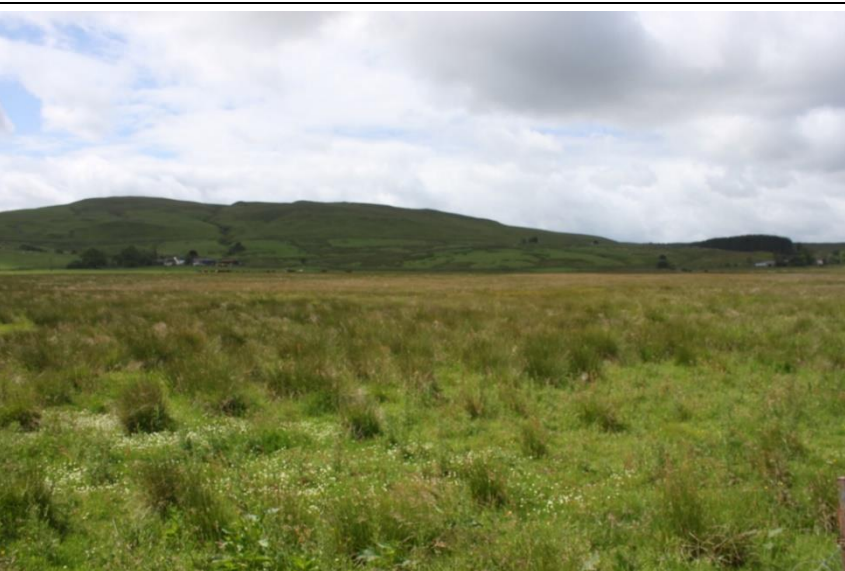
S13	Knockburnie Burn: Mineral Line	-	<p><b>Desk Based Assessment</b></p> <p>A section of a mineral line running from New Cumnock Iron Works (at Bank) to Ironstone and Coal Pits (at Beoch) is depicted on the 1<sup>st</sup> edition Ordnance Survey. It does not appear on subsequent editions.</p> <p><b>Walk over survey</b></p> <p>No definitive trace of the mineral line could be identified. Where it would have entered the study area is now covered with a later 20<sup>th</sup> century farm track. This farm track had no metaling or gravel hard standing within its makeup consisting of just a rough track over plough soil which had been compacted by agricultural machinery over recent years.</p>	NS 5654 1102

49. No definitive trace of the mineral line at Knockburnie Burn **S13** could be identified. Where it would have entered the study area was covered with a later 20th century farm track. This farm track had no metaling or gravel hard standing within its makeup consisting of just a rough track over plough soil which had been compacted by agricultural machinery over recent years.

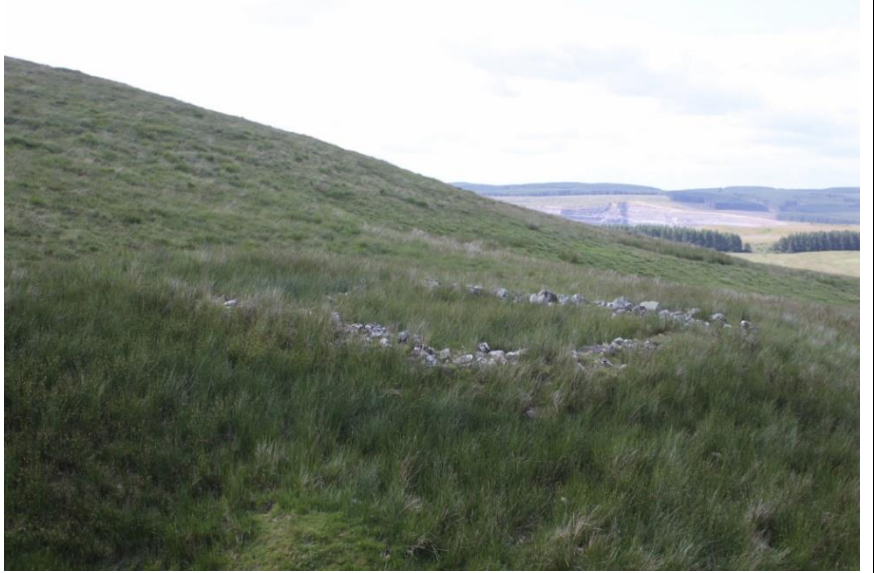
No	Site	HER Ref:	Description	NGR	Image from Site Inspection
S14	Spout Burn Sheepfold	-	<p><b>Desk Based Assessment</b></p> <p>A square shaped enclosure of probable stone construction was identified using modern aerial imagery. The structure, which is most likely a sheepfold or pen, is not shown on any historic mapping.</p> <p><b>Walk over survey</b></p> <p>The sheepfold, which was located on the NW bank of Spout Burn, was rectangular shaped in plan and in a poor state of repair. It was of drystone construction and overgrown with vegetation. It measured 10m from N-S, 7.8m from E-W and had a height of 0.3m. The sheepfolds walls were all tumbled and had a width range of 0.6m-0.7m.</p>	NS 5589 1005

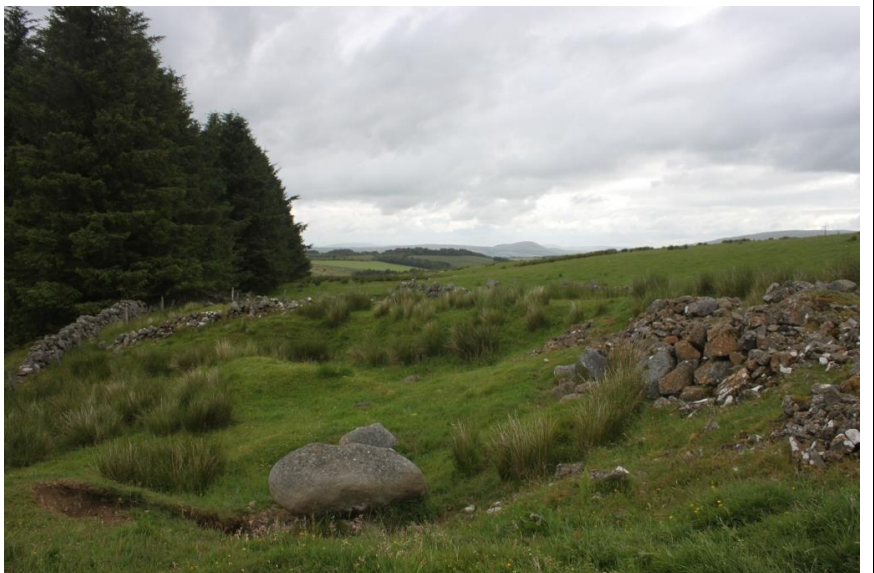
S15	Craighouse Quarry	-	<p><b>Desk Based Assessment</b></p> <p>The kidney shaped quarry is not shown on any historic mapping was located to the immediate SW of sheepfold <b>S9</b>. It was identified through aerial imagery.</p> <p><b>Walk over survey</b></p> <p>The kidney shaped quarry was 3m-4m SW of <b>S9</b>. It was 22m from NE-SW, 9m-11m from NW-SE and had a depth of 1m-2m. Low mounds of loose boulders were located to the immediate SE and SW of the quarry. These mounds of boulders were not grown over with vegetation suggesting they had been placed there relatively recently possibly stockpiling stone for repairs to nearby stone wall and sheepfolds like <b>S9</b>.</p>	NS 5524 1054

50. Kidney shaped quarry **S15** was 3m-4m to the SW of sheepfold **S9**. It was 22m from NE-SW, 9m-11m from NW-SE and had a depth of 1m-2m. Low mounds of loose boulders were located to the immediate SE and SW of the quarry. These mounds of boulders were not grown over with vegetation suggesting they had been placed there relatively recently possibly stockpiling stone for repairs to nearby stone wall and sheepfolds like **S9**.
