**Ballinnie Farm, Dumfries and Galloway:
Historic Environment Assessment & Survey
Appraisal**

issued 16th July 2019

on behalf of Mark Hamilton Landscape Services

RATHMELL  
ARCHAEOLOGY LTD

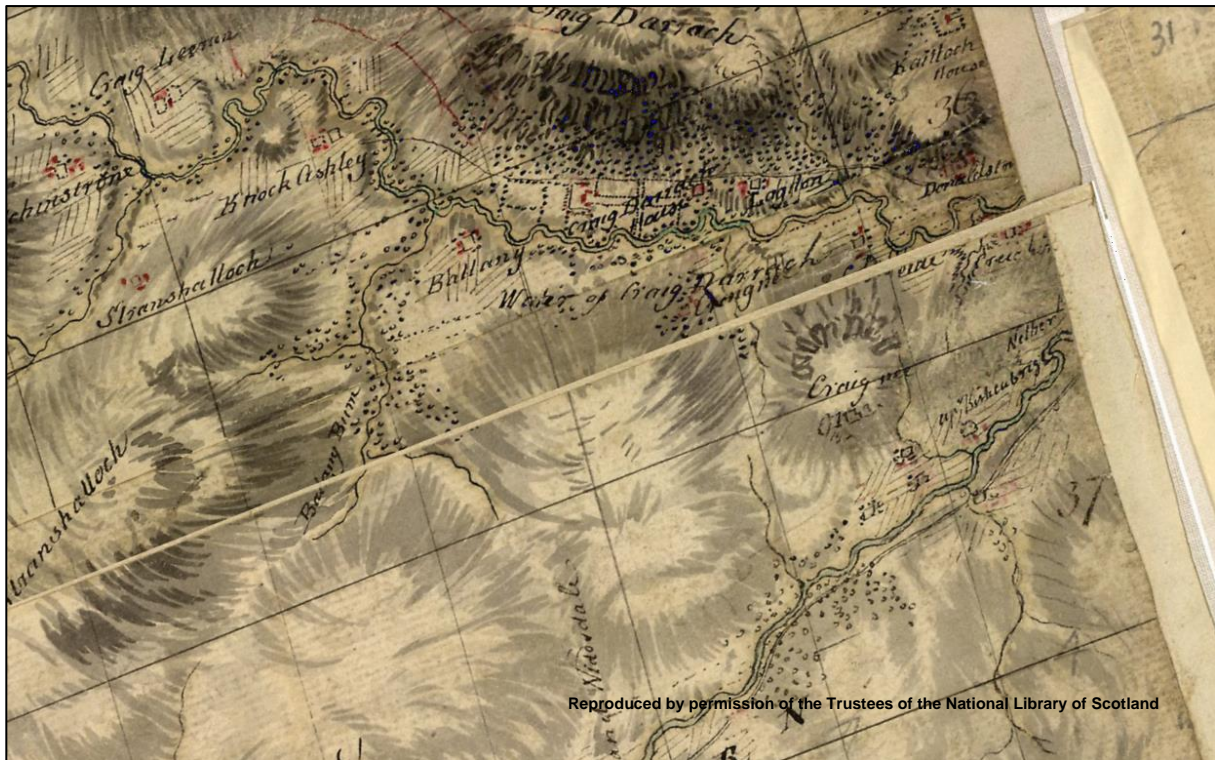
Figure 1a: Extract from Roy's Military Survey of 1752-5.

20. No sites are shown within the study area on Roy's map of 1752-55 (Figure 1a). The farm of Ballinnie is, however, depicted by this time, occupying a location which closely corresponds to that of the modern farm buildings. The farm itself is shown as four rectangular structures, arranged around a central, square enclosure which is itself surrounded by land which – although shown as cultivated – is unenclosed. Roy's map also shows Craigdarroch, denoted here as 'Craig Darroch House,' which suggests an elevation in status. The high status of this property is further indicated by its association with a deigned landscape: the house is approached from the east by a tree-lined avenue, and flanked on its east and west sides by a series of large rectilinear fields, lined by woodland planting which presumably functions as shelter belts.

21. The line of a road is also shown for the first time on Roy's map, running east-west along the same line as that followed by the modern B739. This suggests that the landscape as we see it today had in this area been established by at least the mid-18th century, although it is possible that it was already present in a rudimentary form much earlier, during the post-medieval period.

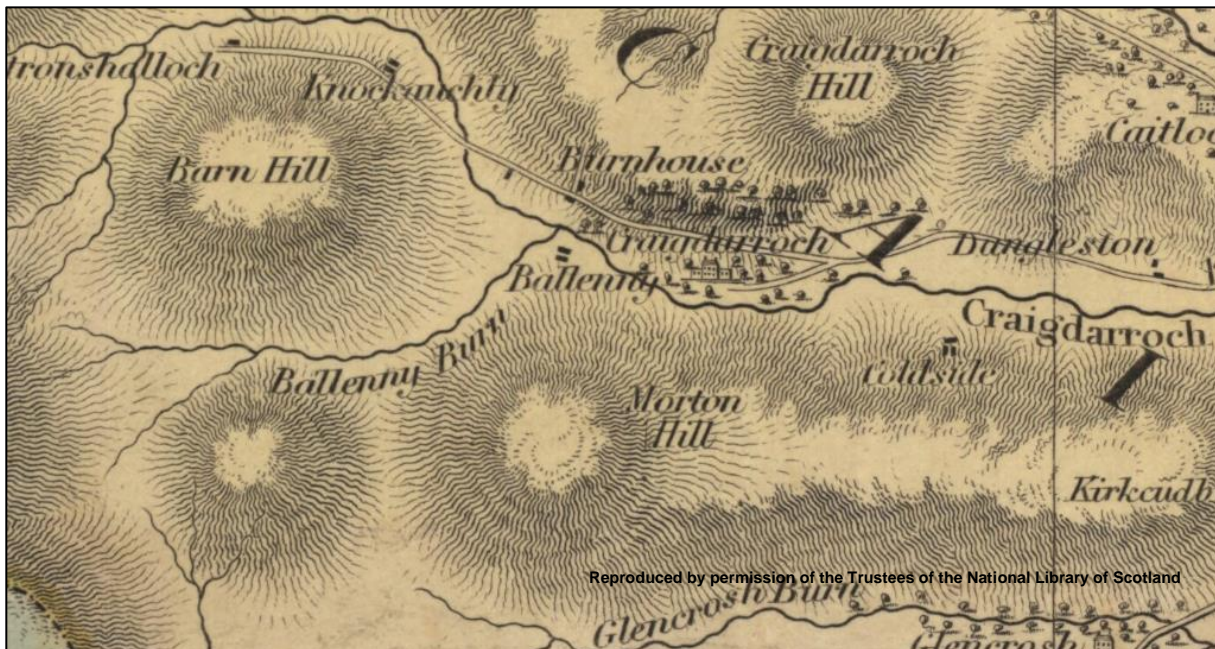
Figure 1b: Extract from Thomson 1834.

22. Thomson's 1828 map (Figure 1b) shows a very similar picture to Roy's, with the low-lying ground adjacent to the Craigdarroch Water now occupied by the farms of Ballinnie and Burnhouse which lie, respectively, on the south and north sides of the road.

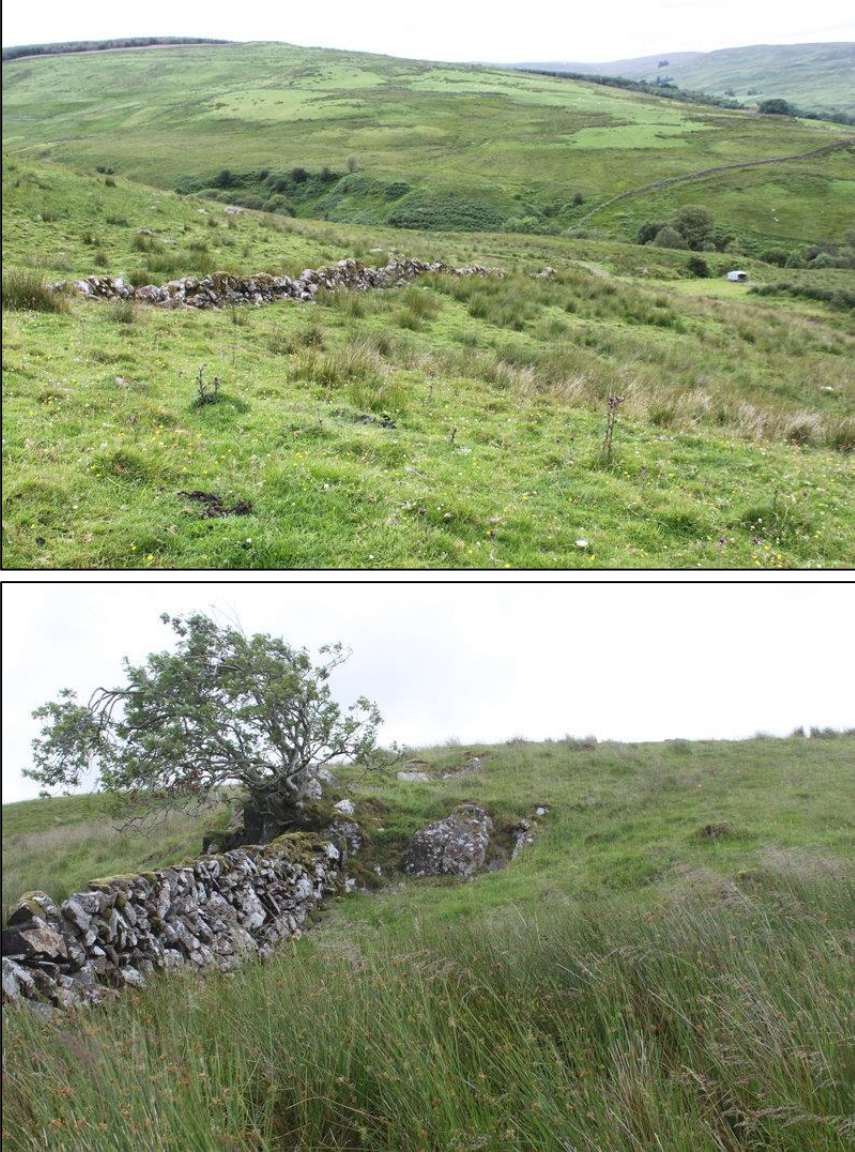
27. Sites **S1.1** to **1.4** were identified on modern aerial imagery as possible sheep shelters. They were located during field survey as lengths of drystone walls running down the slope of Big Morton Hill. Some were slightly curved in nature, while others incorporated areas of rock outcrop to create shelter for stock. The walls had a maximum height of 1.6m and a maximum width of 0.6m and measured between 12 and 37m in length.

No	Site	HER Ref:	Description	NGR	Image from Site Inspection
S1	Ballinnie Hill Sheep Shelters	-	<p>Desk Based Assessment</p> <p>Four stone walls are shown running north-south (i.e. downslope) on the lower slopes of Ballinnie Hill on modern Ordnance Survey mapping. They are visible on modern aerial imagery as small stone walls.</p> <p>These sites are not depicted on historical mapping.</p> <p>Walkover survey</p> <p>All four sheep shelters were located as drystone walls running down the slope of Big Morton Hill. The walls had a maximum height of 1.6m and a width of 0.55m and were composed of medium to large sub-angular blocks.</p> <p>S1.1 was located to the far western end of the study area. It was 12m long and aligned northwest-southeast. It was located in a slight dip along the hillside.</p> <p>S1.2 was also aligned northwest-southeast. It was 25m long, terminating at the southeast end in a natural rock outcropping that created a T-shaped sheltered area around the wall.</p> <p>S1.3 was a curved wall 37m in length which ran northwest-southeast along the slope of the hill. As with S1.1 it was located in a natural dip in the hillside.</p> <p>S1.4 was also slightly curved and measured 30m in length. It ran southwest-northeast, abutting a rocky outcrop at its southwest end. An additional rocky outcrop was incorporated into the wall.</p>	<p>S1.1 – N 72454 90086</p> <p>S1.2 – NX 72860 90311</p> <p>S1.3 – NX 73140 90403</p> <p>S1.4 – NX 73256 90348</p>

33. Sheep shelters **S1.1** to **S1.4** are not shown on historic mapping. However, due to their somewhat ephemeral nature there is a chance that they are relatively early in date, originating perhaps in the 19th century. Though none are listed in Canmore they contribute to the historic character of the landscape and they have therefore been ascribed Local significance and should be protected by a 5m buffer. Each should be retained within a managed clearing that is maintained as an open space.

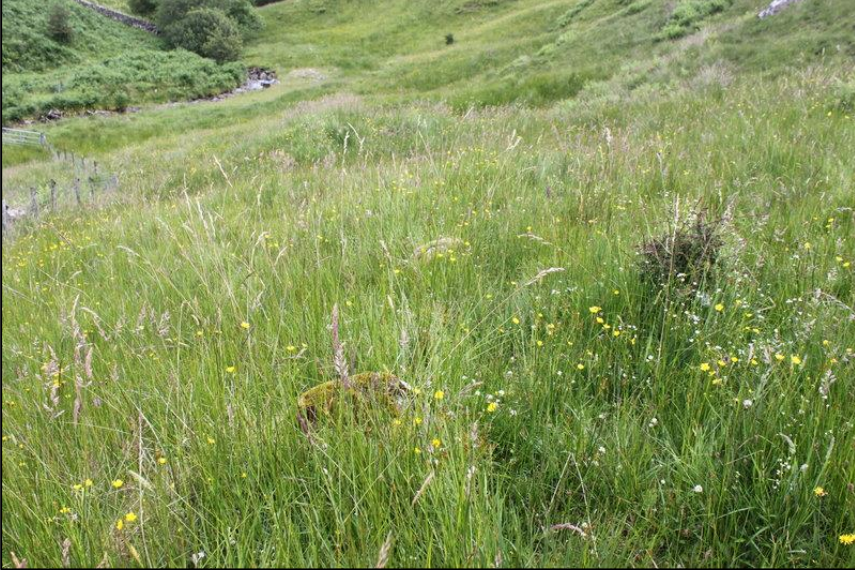
28. **Site 2** was identified on historical mapping as a section of relict wall running northeast-southwest. It was located during field survey as a low overgrown wall 0.2m high and approximately 0.6m wide. It was not possible to measure the length of the wall due to its poor state of preservation.

S2	Ballinnie Burn Field boundary	-	<p>Desk Based Assessment</p> <p>A relict field boundary is visible on modern aerial imagery running northeast - southwest. It appears to correspond with a field boundary shown on the 1st edition Ordnance Survey map. However, by the 2nd edition Ordnance Survey map of 1900 this field boundary had fallen out of use. It is not shown on modern mapping.</p> <p>Walkover survey</p> <p>The boundary was located during field survey as a very low, heavily overgrown stone bank. The bank was 0.2m high and approximately 0.6m wide. Due to the poor condition of the site it was impossible to measure the length of the wall or make any observations about its condition.</p>	NX 72916 90445

34. Relict field boundaries **S2** and **S3** are both shown on the 1st and 2nd edition Ordnance Survey. They are likely to represent a 19th century boundary, although they have the potential to date back to the 18th century. **S2** is very poorly preserved and as such has been ascribed Other significance with **no** action recommended. **S3** is better preserved, but has once again been ascribed Other significance with **no** action recommended. Unnecessary damage to both sites should, however, be avoided if at all possible.

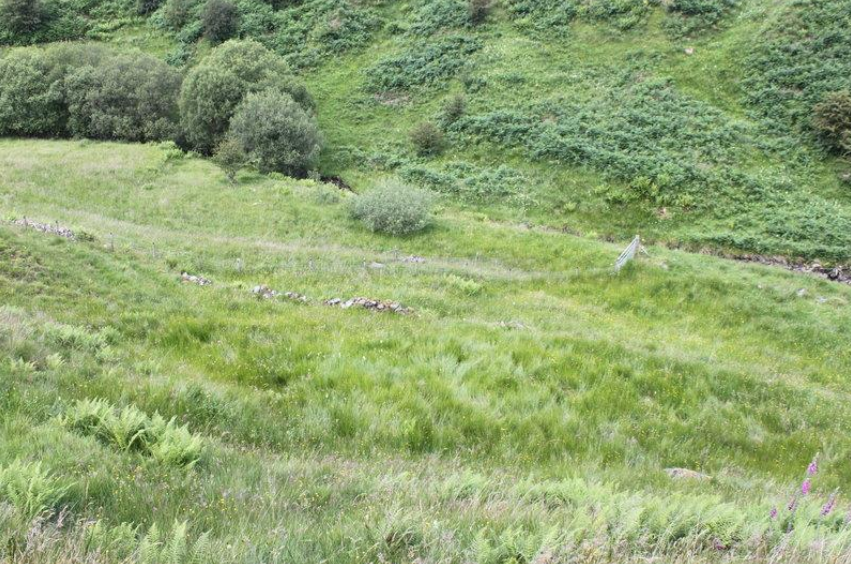
29. **S3** was a linear relict field boundary visible on both the 1st and 2nd editions of Ordnance Survey mapping. It was identified during the field survey as a drystone wall running northeast-southwest. The wall was 30m long, 0.65m wide and had a maximum height of 0.6m.

No	Site	HER Ref:	Description	NGR	Image from Site Inspection
S3	Ballinnie Burn Relict Wall	-	<p>Desk Based Assessment</p> <p>A stretch of relict field boundary is visible on modern aerial imagery. It matches a field boundary shown on the 1st and 2nd Editions of Ordnance Survey mapping. It is not shown on modern mapping.</p> <p>Walkover survey</p> <p>The site was located as a drystone wall running northeast-southwest. It was 30m long, 0.65m wide and had a maximum height of 0.6m. It was composed of sub-angular blocks with an average size of 0.5m by 0.3m by 0.2m.</p>	NX 72951 90473

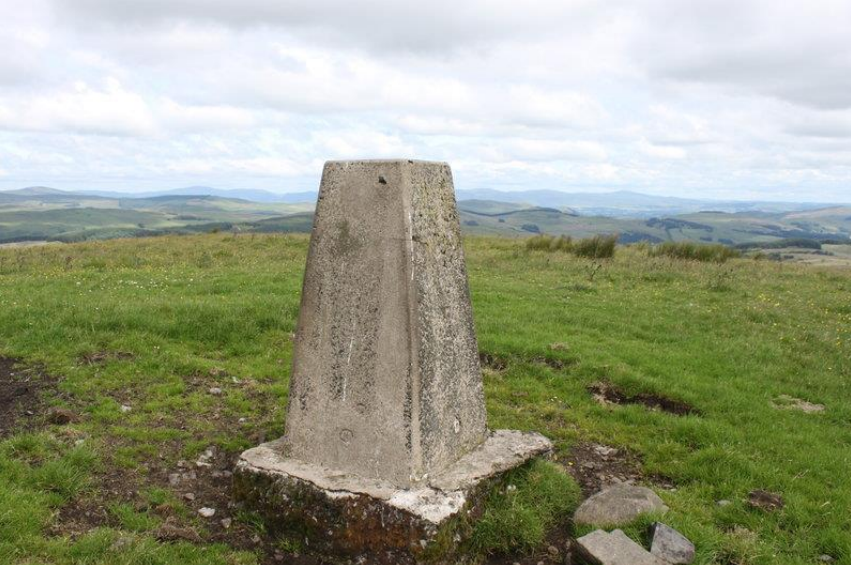
30. Big Morton Hill trig point **S4** was located on modern mapping . During field survey it was located as a concrete pillar on an asphalt base.
31. A fifth site was identified during the field survey which had not previously been identified during the desk-based assessment. This was small cairn **S5**, located in the northern portion of the study area and measuring 2.1 x 1.9m in extent and upstanding to a height of 0.3m. The form and dimensions of this cairn suggest that this feature represents a pile of field-cleared stone (as opposed to a formal structure, such as a Bronze Age funerary cairn), and while small cairns of similar character can be associated with later prehistoric or medieval field systems, the isolated character of this particular example – with no known field systems or roundhouse structures identified nearby – suggests a relatively recent date and an association with more recent agricultural activities.

S4	Big Morton Hill Triangulation Point	-	<p>Desk Based Assessment</p> <p>The triangulation point on Big Morton Hill was completed in 1954. It is a pillar type triangulation point with the name NX99/2. It is visible on modern aerial imagery and appears on the current Ordnance Survey map.</p> <p>Walkover survey</p> <p>The triangulation point was located as a rectangular concrete column on an asphalt base. The base measured 0.9m square and was 0.3m in height. The base had been eroded out in places, particularly on the southern side.</p> <p>The concrete column was square in section and measured 0.6m wide at its base. It was 1.2m high.</p>	NX 73111 89665

35. The Big Morton Hill triangulation point **S4** dates to 1954 and forms part of a wider network of trig points distributed throughout the United Kingdom. It therefore contributes to the historic character of the landscape and has hence been ascribed Local significance. It should be protected with a 5m buffer and should be retained within a managed clearing that is maintained as an open space. It would, however, be beneficial in this particular instance if the buffer could be extended to allow wider views across the landscape to be retained from this particular monument.
36. Clearance cairn **S5** was located during field survey. It is not shown on any historic mapping, is likely to be relatively recent in date and does not contribute to the historical character of the landscape. Therefore it has been ascribed Other significance and **no** action is recommended.

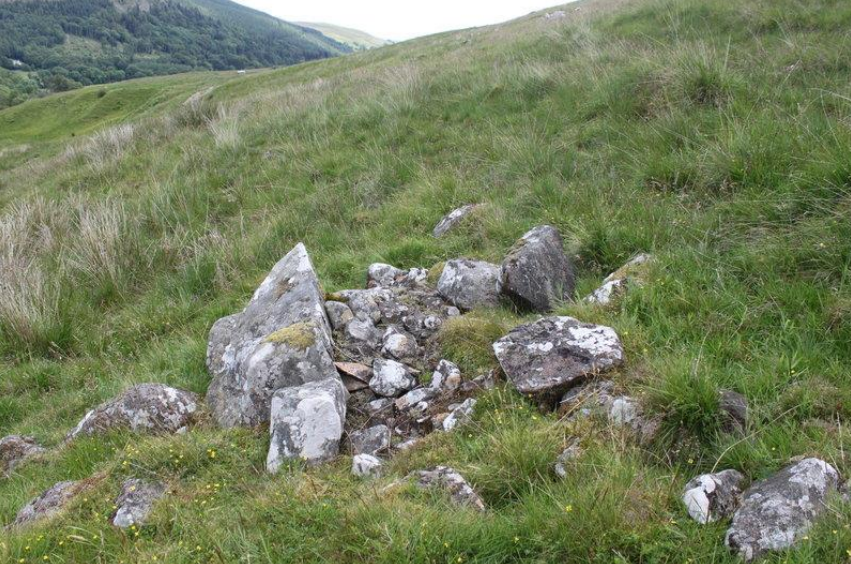
S5	Ballinnie Hill Clearance Cairn	-	<p>Desk Based Assessment</p> <p>Identified at a later stage during the field survey, the clearance cairn was not visible on modern aerial photos or mapping. It is also not shown on historic mapping.</p> <p>Walkover Survey</p> <p>The clearance cairn was first identified during field survey. It consisted of a sub-circular collection of stones at the northern side of the study area. It measured 1.9m by 2.1m and was 0.3m high.</p>	NX 72842 90371

S5	Ballinnie Hill Clearance	Other	The clearance cairn is a small and isolated feature that does not tie into a wider historic	-

Cairn		landscape. As such it has been ascribed Other significance. No action is recommended.	
--	-------	--	---	--
