# **Corserig Crescent, Kirkconnel Overland Sewer, Dumfries & Galloway: Archaeological Mitigation**

## **Data Structure Report**

issued 27<sup>th</sup> March 2020

on behalf of Scottish Water Specialist Services

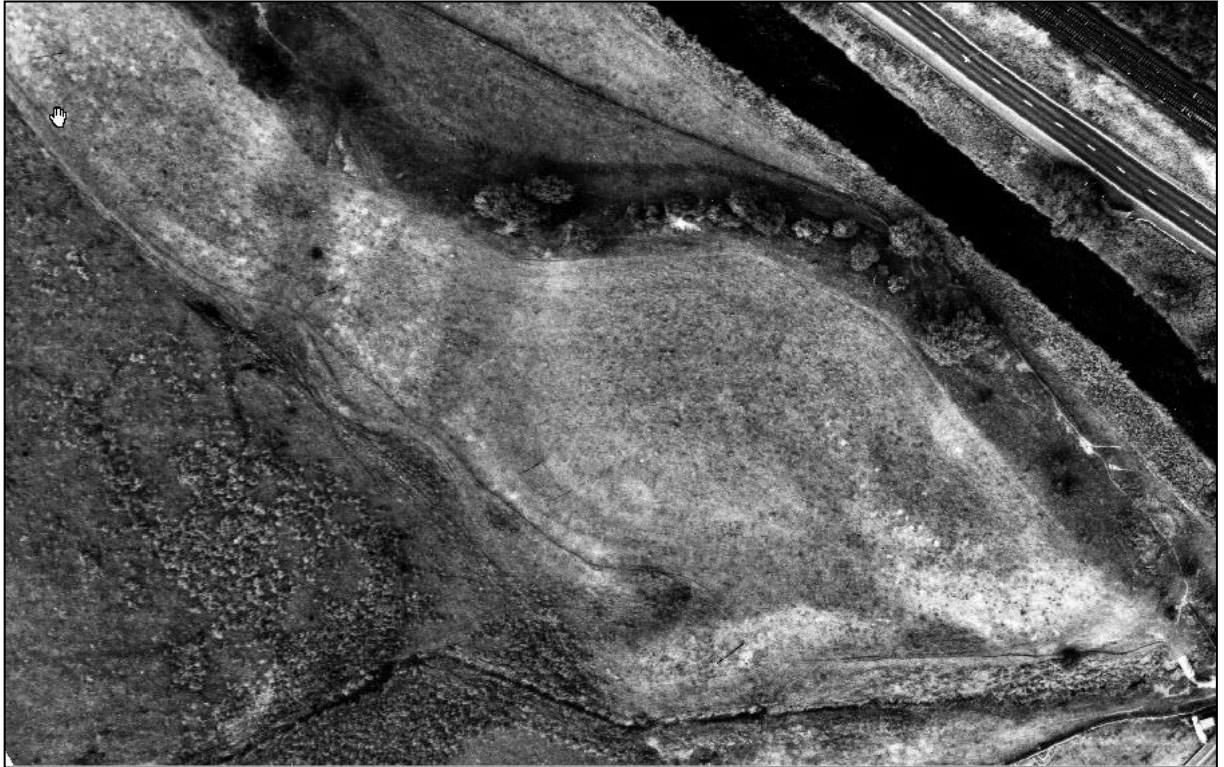
Figure 1a: Rectified Aerial Photograph of S1.

6. The focus of these works was the enclosure, S1 at Mill Knowe (Rees 2018). Oblique aerial photography in 1995 identified cropmarks of a possible settlement S1 on the summit of Mill Knowe, a low knoll immediately north of Kelloholm on the west bank of River Nith. A reinterpretation of the image proposes a concentric defensive system around the western and southern sides of the knoll comprising two ditches (each in the order of 20m broad, the outer ditch passing into Marr Moss) and a palisade. Three possible round houses are visible on the northwest and southern edges of the interior. Low level imagery shows Mill Knowe be a marked landscape feature with a level summit, the northern and eastern side of the knoll being the brae falling to the River Nith.

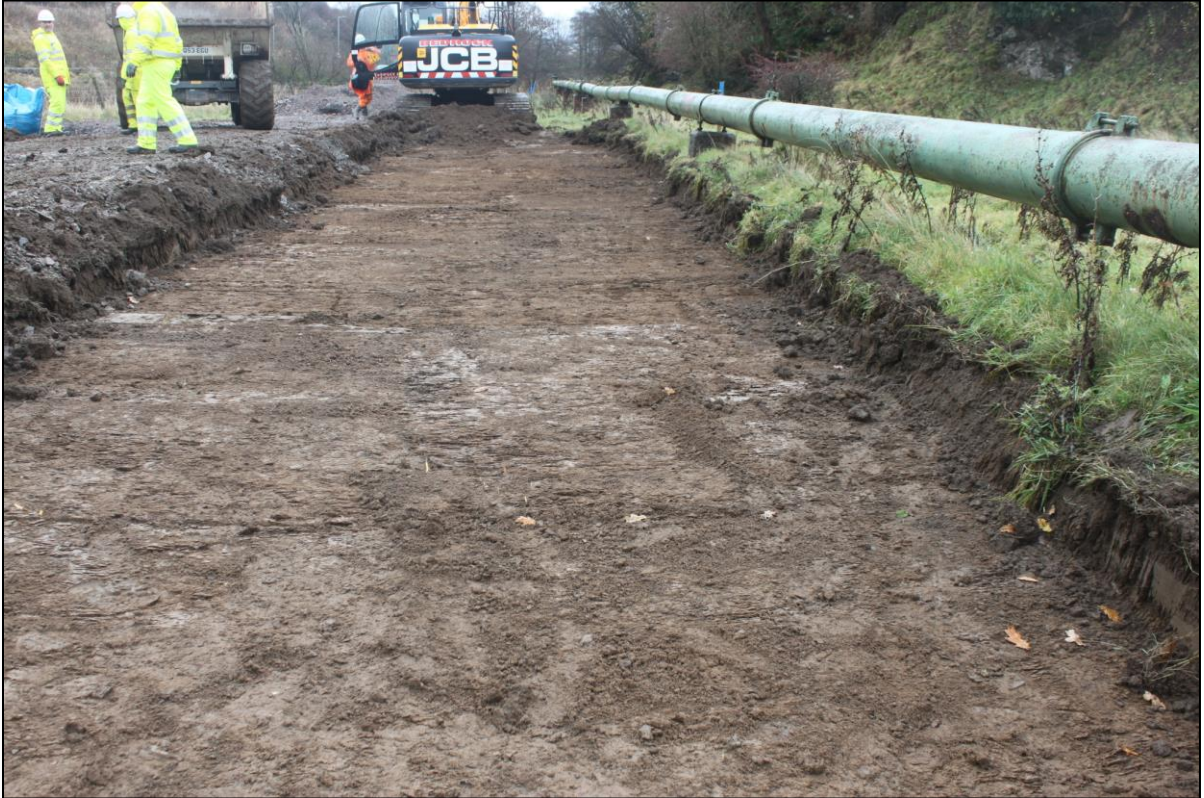
Figure 3a: Post-excavation shot of the western track. From NW.

14. Piers 1 to 15 were located within the large excavated track on the southern bank of the River Nith with the track itself lying to the immediate north of the existing overland sewer pipe (Figures 2 & 3a). The track measured approximately 3m to 4m in width, approximately 120m in length and was excavated to a depth of 400mm. The track excavated through the topsoil (001) which consisted of friable mid-yellow brown silty sand with frequent root inclusions and occasional small stones. The topsoil layer had a thickness of 100mm within the western area. This topsoil was present throughout the western track and the eastern Piers, excluding Pier 28 and abutment 2. Underlying the topsoil (001) within the western area was a naturally occurring subsoil (002) which consisted of friable light-yellow brown silty sand with occasional stone inclusions. This deposit had an excavated thickness of 300mm and was only identified within the western area.

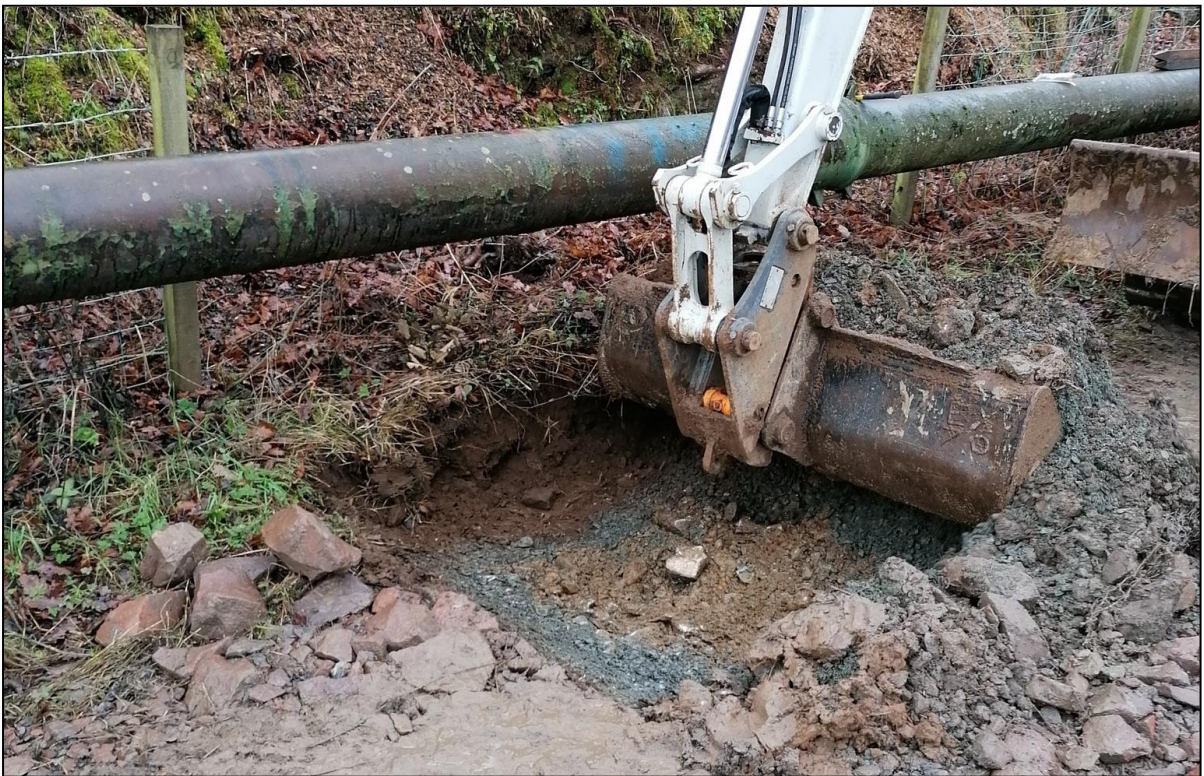
Figure 3b: Working shot of Pier 20 showing excavation through the access road. From E.

28. No artefacts associated with enclosure atop Mill Knowe (see Background) were identified within any of the identified deposits in the development area. However, within Pier 20, metal fragments were identified. These were interpreted as the fragmented remains of a modern metal fence included within hill wash (004).

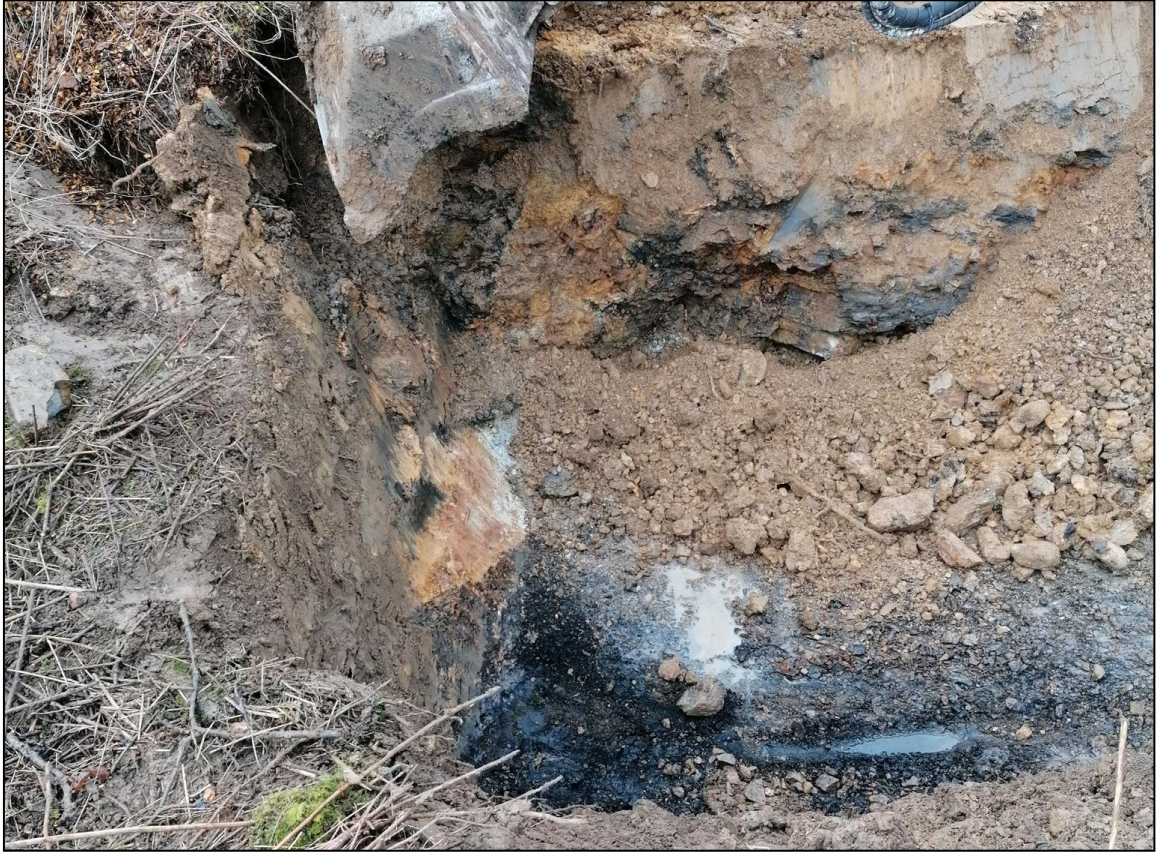
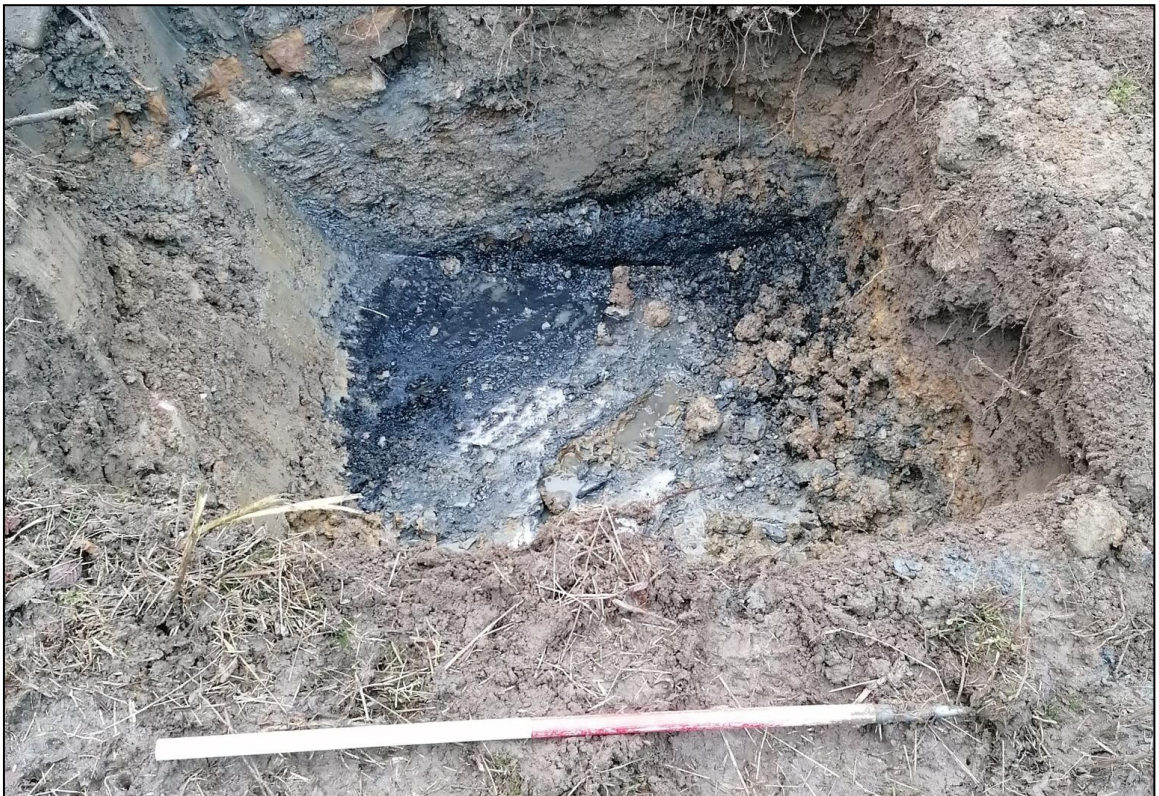
Figure 4a: Deposit (007) appearing in the base of Pier 27. From ENE.

Figure 4b: Deposit (007) at the base of Pier 28. From SE.

20. A possible alluvial or coal residue deposit (007) was identified overlying subsoil (006) within Piers 27 and 28 (Figure 4a & 4b). It comprised of friable black gravel and was identified at a depth of 800mm to 1.3m below the current ground surface. It had an excavated thickness of 300mm to 400mm although the deposits full thickness was not identified.

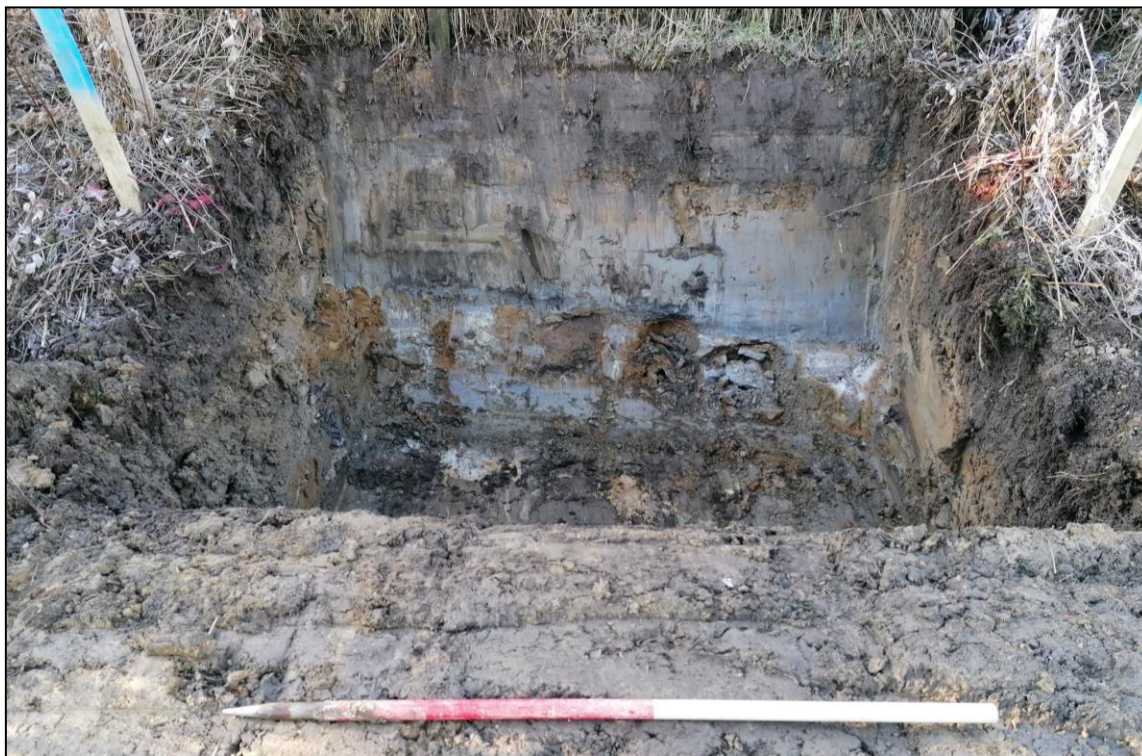
Figure 5a: Exposed bedrock at the base of Pier 25. From ESE.

21. A layer of natural bedrock (003) was identified which comprised a grey slate-like sedimentary rock (Figure 5a). The bedrock was identified within Piers 18, 21-24 and 26-28. The bedrock was encountered at a depth range of between 700mm and 1.6m from the current ground surface.
