Hollywood Hall, Dumfries: Archaeological Mitigation

Data Structure Report

issued 12th February 2021

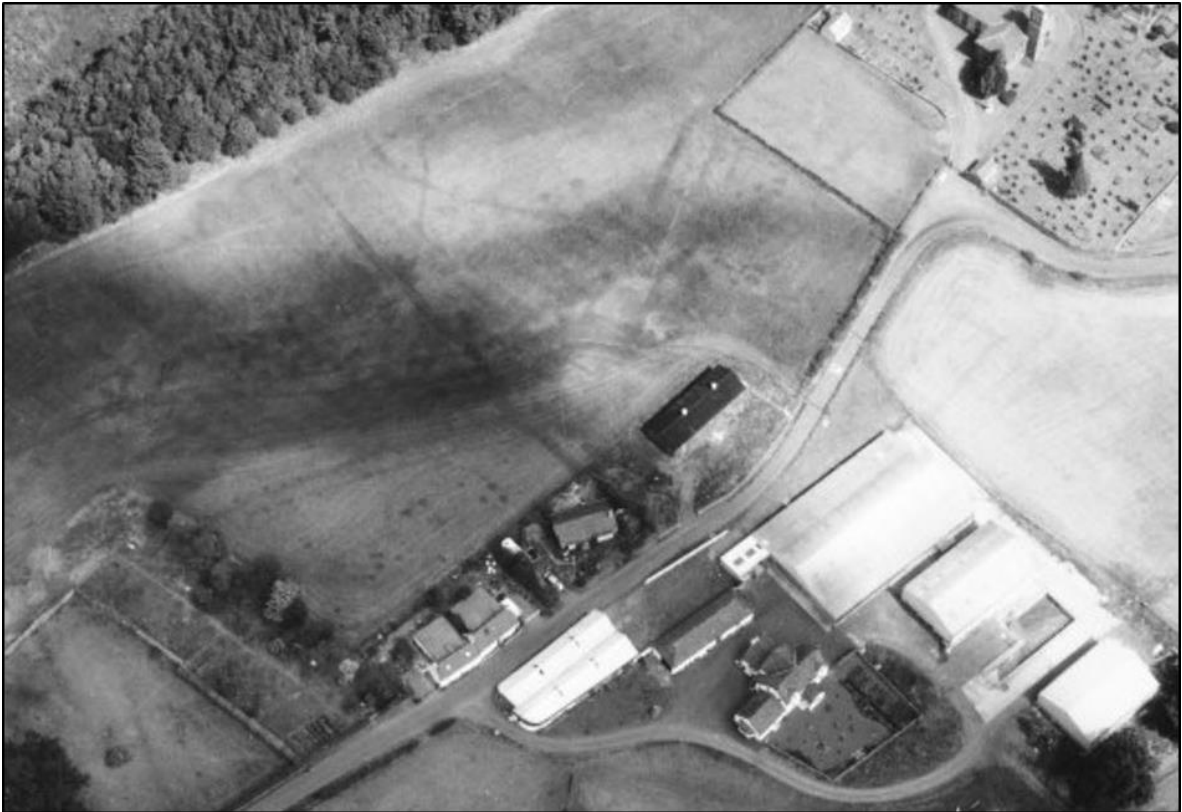
Figure 1a: Oblique aerial images of cropmarks from 1984 ©HER

9. Historic aerial imagery (e.g., Figure 1a) shows the presence of features that are reasonably interpreted as timber-built structures to the immediate northeast of the proposed development area. The transcription of these cropmark features overlain onto a modern aerial image (Figure 1b, provided by the Dumfries & Galloway Council Archaeologist) shows other structural elements, landscape boundaries and possible routeways in proximity to the proposed development area. These features are all of a character that could reasonably derive from the early medieval or medieval period.

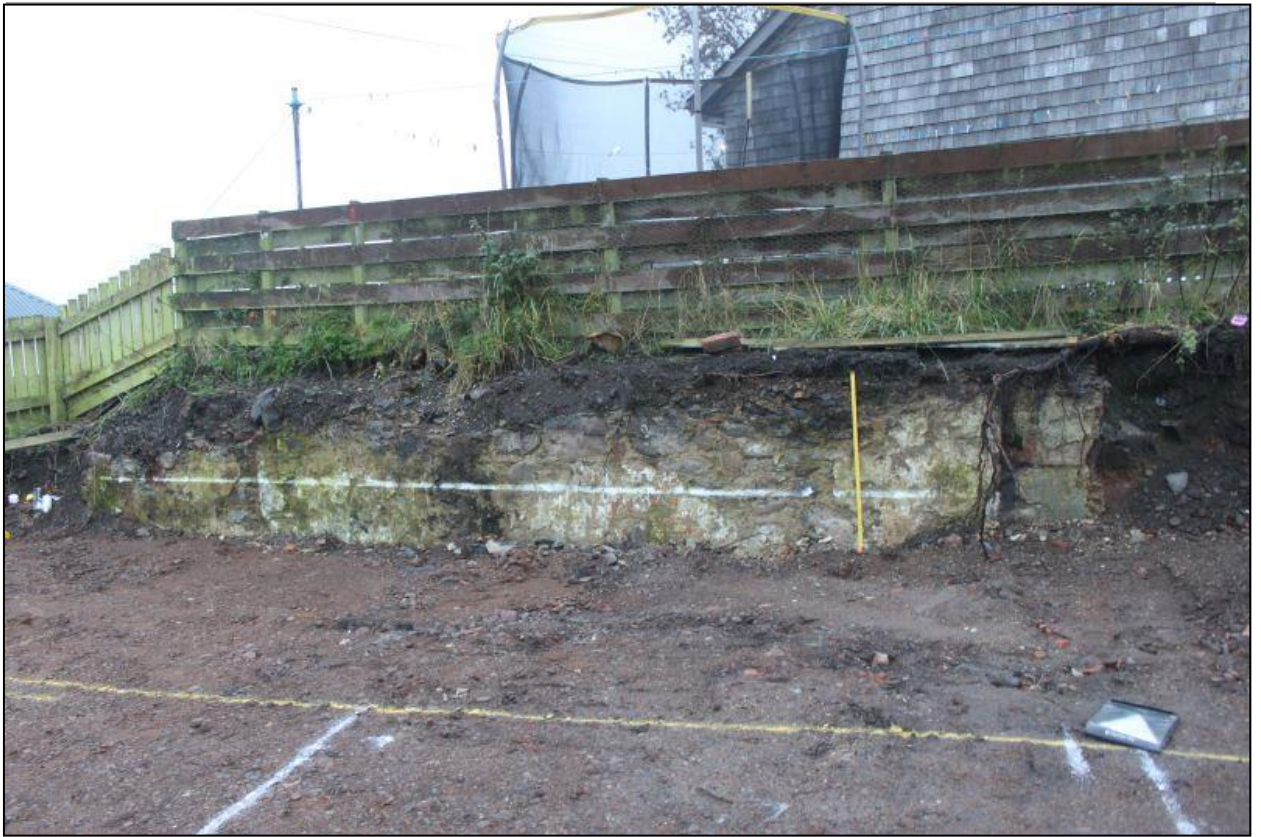
Figure 5a: (003) identified out with the development area. From E.

22. A mortared rubble wall was identified (003) outwith the development areas in the southwest portion of the site (Figure 5a). This wall was originally concealed beneath a mound of soil and was revealed during the levelling of the area. The wall measured a minimum surviving height of 0.65m and a maximum width of 1.15m with an excavated length of 7.5m. The wall may represent an external wall derived from one of the Church Houses' shown on the 1st Edition Ordnance Survey map. The wall is located beyond the limits of the development and will ultimately be re-covered by landscaping.

34. A possible original wall (003) from the "Church Houses" that were represented on the 1st edition Ordnance Survey map was located in the SW area of the site. The wall is outwith the development area and will ultimately be obscured through landscaping for the house's gardens.

003	Area 1.	Structure	A mortared rubble wall was identified in the south-western area of the site. The wall measured a maximum height of 1.15m and a minimum height of 650mm. It was excavated over a length of 7.5m.	May represent an original wall from the 19 th century "Church Houses".
