**White Cart Flood Prevention Scheme 2004
Contract 1, Kirkland Bridge,
South Lanarkshire and East Renfrewshire:
Archaeological Mitigation**

Data Structure Report

issued 10th November 2008

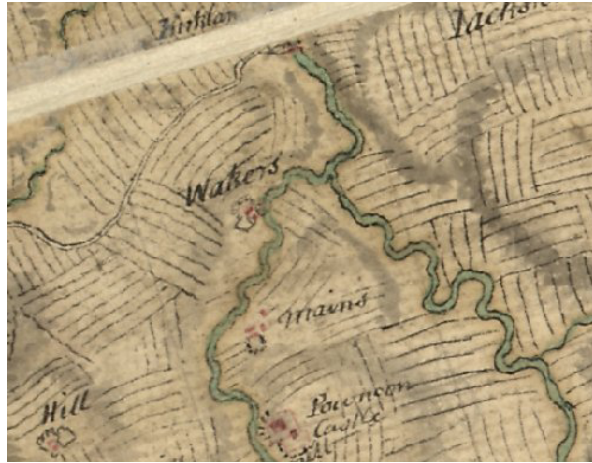
Fig. 5a: Roy's Military Map of 1747-55

- 5.1.5 The earliest map of the area is Blaeu's revision of Pont's map of the Shire of Renfrew (1548-1601). This map pre-dates the founding of the planned village of Eaglesham by several hundred years: Polnoon Castle is shown, and while no road systems are depicted, a predecessor of the current Kirkland Road Bridge is clearly shown to exist. By the time Roy's military map of 1747-55 was surveyed, a road is clearly shown heading up to the site of the Kirkland Road Bridge (Fig. 5a). Once again, there is no sign of the planned village of Eaglesham, the founding of which post-dates the date of the mapping. Mains Farm is, however, shown, as a cluster of four buildings lying to the north of Polnoon Castle. This seemingly random arrangement of buildings suggests that the farmsteading pre-dates the agricultural improvements, where farm layouts were more carefully planned.

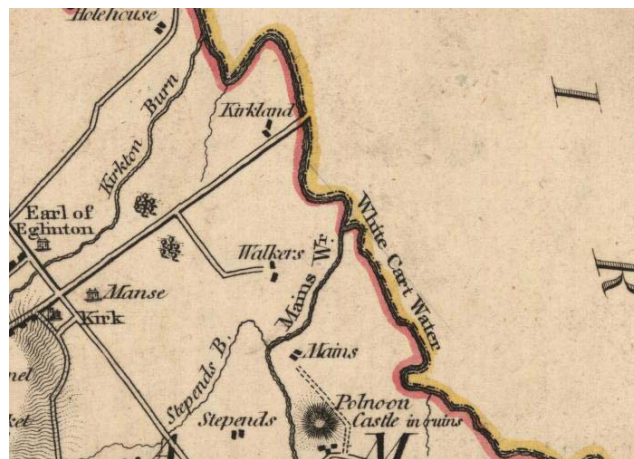
Fig. 5b: John Ainslie's Map of Renfrewshire (1796)

- 5.1.6 By the time John Ainslie surveyed his map of Renfrewshire in 1796, the planned village of Eaglesham had been established (Fig. 5b). As in the Roy map of 50 years earlier, a road runs to the Kirkland Road Bridge, this time leading directly from the newly founded village. Mains Farm is now shown as two rectangular structures in a roughly similar location to the four structures depicted on Roy's map. The increasing regularisation of the landscape, demonstrated by the canalisation of the Polnoon Water, the appearance of a more complex road network and the creation of new farms such as Stepends implies that the process of agricultural improvement has started in the area around Eaglesham. It should be noted, however, that at this time Mains Farm is accessed only from the SE. The SW to NE access road carried by the Mains Farm bridge has not yet been built.

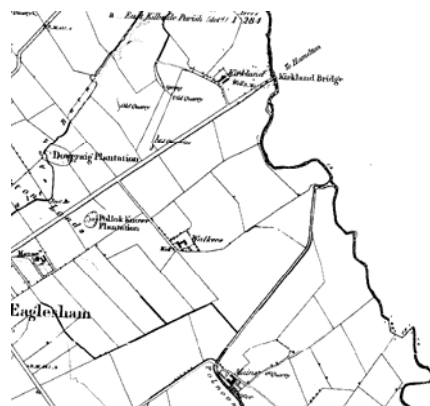
- 5.1.7. The Mains Farm bridge makes its first appearance on the 1st Edition Ordnance Survey map of Renfrewshire of 1863 (Fig. 5c). There are also significant differences evident in the layout of the farmsteading between these two successive phases of mapping. The informal group of buildings depicted on Roy and Ainslie is replaced by a 'u'-shaped courtyard arrangement located further to the W, in a site overlooking the E bank of the Polnoon Water. This substantial building programme took place at some point in the early 19th century, which in turn suggests a significant investment in the Eaglesham estate's holdings by its then-tenant or landowner. Whether this took place at the behest of the Earls of Eglinton or under the auspices of the Gilmour family cannot be determined; it was hoped that the architectural details of the bridge itself might yield an insight into the wider issues which led to its creation. However, it is clear that a significant amount of money was involved in its construction; Hay and Stell note that 'arched masonry bridges of single or multiple spans constitute the most substantial monuments in the country's early road system' (Hay and Stell, 1986, 183).

Fig. 5c: 1st Edition Ordnance Survey Map (1863)

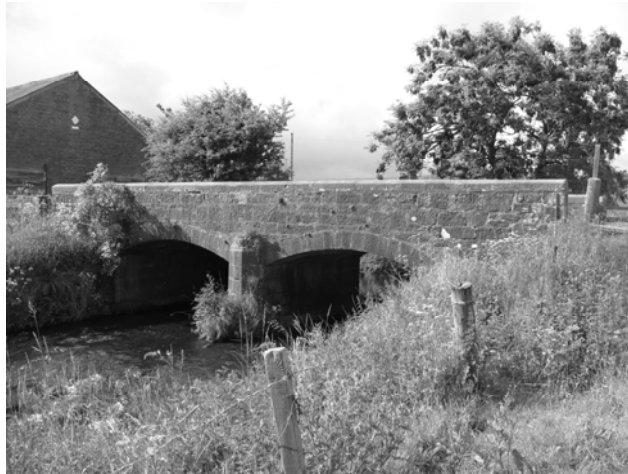
- 5.2.1 The structure in question comprised an unnamed road bridge at Mains Farm, near Eaglesham (NS 5833 5166). It carries a single track farm access road across the Polnoon Water; prior to its construction in the 19th century, access to the farm was by a much more indirect route. The bridge measures 13.0m in length and comprises two segmental arches (2005) and (2006) each spanning 3.65m, which are supported by a central pier (2004). It reaches a height of 3.22m above the base of the river bed (to the top of the parapet wall), and measures 4.60m in width (Fig. 6a).

Fig. 6a: The Mains Farm Bridge – General View from N

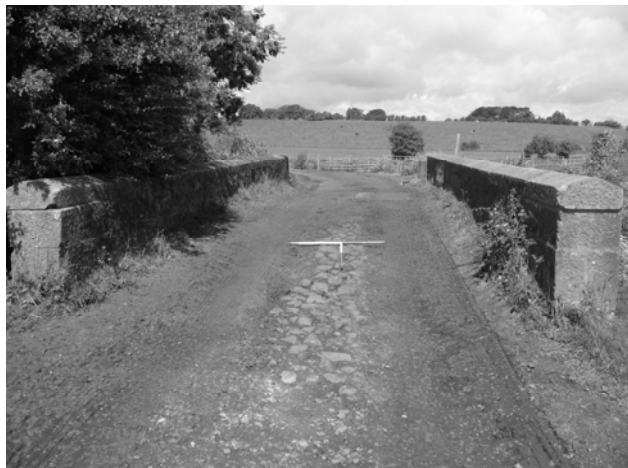
- 5.2.2 The associated roadway is largely modern in character – where it crosses the actual bridge, there is much evidence of re-surfacing, with areas of tarmac and even concrete apparent. However, on the E side of the bridge, a spread of cobble stones is evident in the centre (2009). This appears to be the surviving remains of an original surface, in an area which would not have been subject to excessive wear from the passage of iron-rimmed cartwheels (Fig. 6b).

Fig. 6b: Mains Farm Bridge - Surviving Remnants of Cobbled Surface

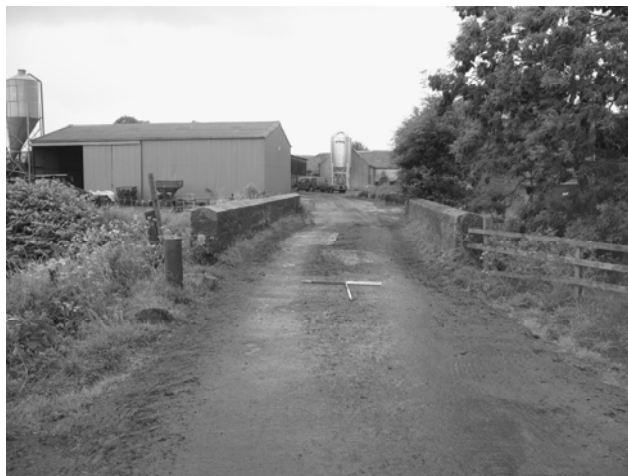
- 5.2.3 The presence of bollards on the N side of the W approach road is another interesting feature which should be noted. Two phases of bollard construction are evident (Fig 6c). The first phase, which probably dates back to the construction of the bridge itself, is evidenced by the presence of two substantial boulders, 2011, unworked but earthfast, which have been laid in a NW-SE line 1m apart at the N edge of the W approach road. These have a twofold purpose. Firstly, they provide both a means of guidance for those navigating the curve in the road that approaches the bridge, and an obstruction which prevents damage to the N parapet wall of the bridge structure. Secondly, they prevent laden carts from slipping down the steep embankment on the N side of the approach road. The second phase, which is much later in date (perhaps mid- to late 20th century), is represented by a concrete bollard (Fig. 6c)

Fig. 6c: Mains Farm Bridge - Bollards on N Side of Approach Road (to left of picture)

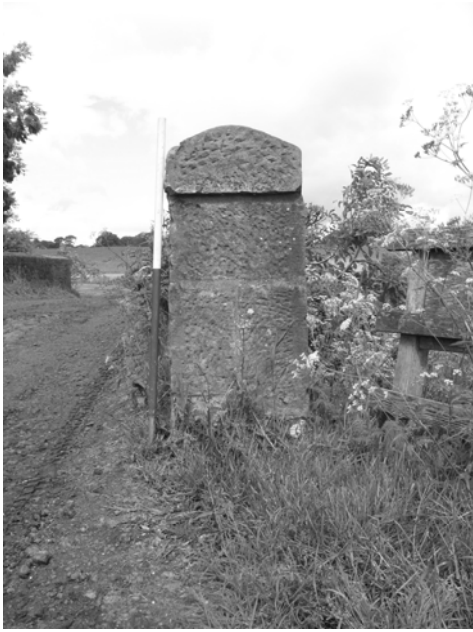
- 5.2.4 Much of the bridge structure is composed of squared and stugged red sandstone rubble, in particular the main portion of the parapet walls (2007, 2008). However, a significant amount of ashlar has been used. The abutments on either bank, the voussoirs and the facing stones of central pier (2004) are all stugged ashlar, and the quoins of the parapet are also stugged ashlar. The abutments on either bank also consist of stugged ashlar, though here the contrasting margins are absent, while parapets (2007) and (2008) are surmounted by stugged triangular-sectioned coping-stones, with a flattened apex (Fig. 7a). The central pier (2004) features a cutwater on the upstream and downstream sides (Fig. 7b); again this is fashioned from stugged red sandstone ashlar. The ashlar blocks used in the quoins, voussoirs and cutwaters also show the use of contrasting margins (Fig. 7c), presumably as a decorative feature. Finally, there is a projecting stone block (2018) centrally located above the cutwater on the S side of the bridge – this appears to be a datestone, which was unfortunately never inscribed (Fig. 7b).

Fig. 7a: Mains Farm Bridge - Detail of Parapet Wall

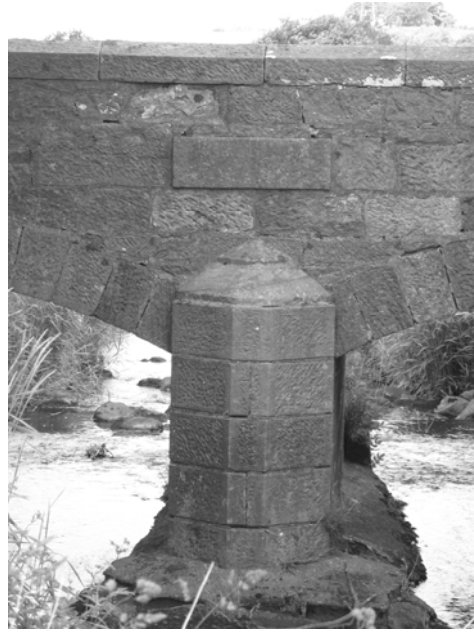
Fig. 7b: Mains Farm Bridge – Cutwater and Blank Datestone

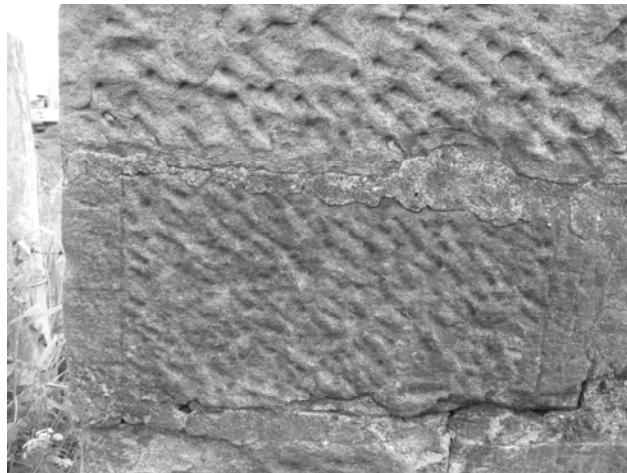
Fig. 7c: Detail of Stugged Ashlar Quoin with Contrasting Margin

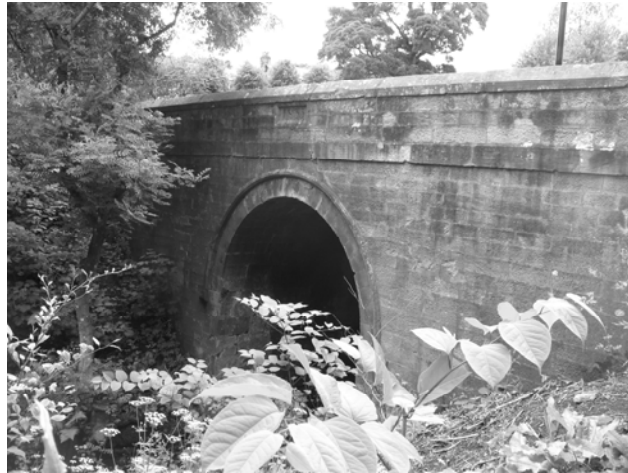
Fig. 8a: Mid Bridge, Eaglesham – General View

6.3.3 One example of a closely comparable bridge did, however, stand out. This was the Mid Bridge, located within the centre of Eaglesham on the Mid Road (Fig. 8a). There were, however, some marked differences. The bridge was built from a mixture of red and blond

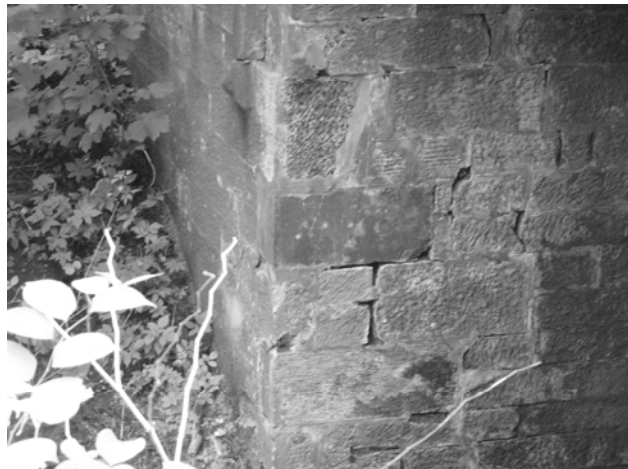
Fig. 8b: Mid Bridge, Eaglesham – Detail of Masonry in Abutment

sandstone, and had a single semicircular arch as opposed to two segmental arches. It was also made entirely of ashlar. However, the ashlar was stugged throughout, with the abutments and voussoirs showing similar contrasting margins to those seen on the Mains Farm bridge (Fig 8b).

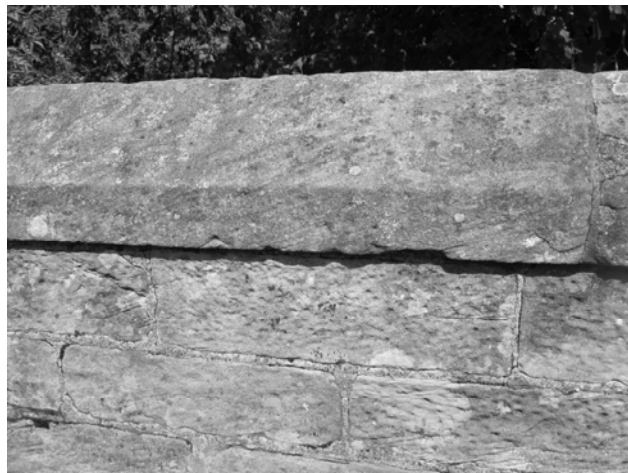
Fig. 8c: Mid Bridge, Eaglesham – Detail of Parapet

- 6.3.4 Also worthy of note was the treatment of the parapet; once again, the parapet wall was surmounted by a stugged, triangular-sectioned coping which provided both a close match to the Mains Farm bridge itself (Fig. 8c), and a marked contrast to other comparable bridges visited in the Eaglesham area. Of even greater importance was the fact that the Mid Bridge was furnished with a datestone, which gave the date of construction as '1835'. A further study of various house structures in the village revealed the use of stugged squared rubble with droved margins in one of the cottages in Cheapside (where one of the buildings bears a datestone again marked '1835') – the presence of stugged ashlar quoins with a contrasting droved margin in the same cottage again provides a parallel with the Mains Farm Bridge.
