**White Cart Flood Prevention Scheme 2004
Contract 1, Kittoch Bridge,
South Lanarkshire and East Renfrewshire:
Archaeological Mitigation**

Data Structure Report

by Douglas Gordon

issued 29th January 2009

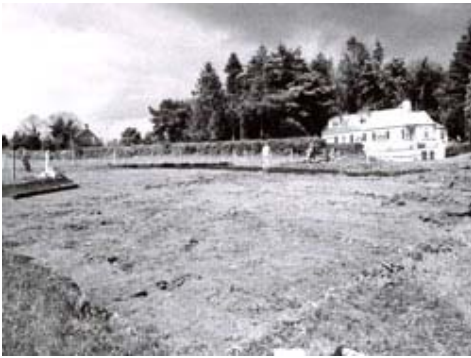
3a: Compound 1

- 3.2 Within Compound 1 the subsoil (002) was a pale orange brown sandy clay. No archaeological features were uncovered during the strip, map and sample, however a series of stone filled linears (003) were present. These linears either ran northwest to southeast at 10m apart or southwest to northeast at 5m apart, both sets were 300mm wide with a fill of small to medium angular stones. Four finds were recovered from the topsoil (001) of compound 1; Find (001) comprised two pieces of flint, one of which was burnt, Find (002) was piece of clay pipe stem, Find (003) was a piece of brunt bone and Find (004) was a coiled iron object.

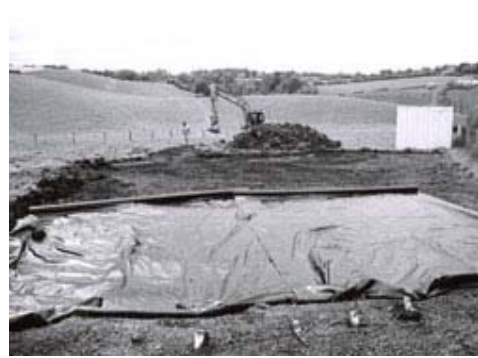
3b: Compound 2

- 3.5 Compound 2, which was situated at the north eastern corner of the site, had a subsoil (019) that was a compact red brown clay sand with frequent sub angular stones and occasional flecks of coal.

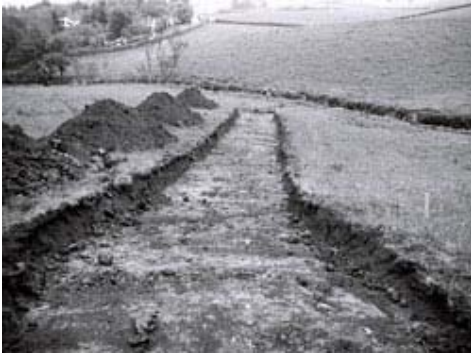
3c: Haul Road 1

- 3.3 Haul Road 1 which ran southeast to northwest from Compound 1 to the Kittoch Water, had two subsoils; (004) was a very compact mottled pale red/white/dark grey gravel in clay, while (005) was a very compact mottled yellow, grey/orange clay gravel. The series of stone filled linears (003) running northeast to southwest was also present.

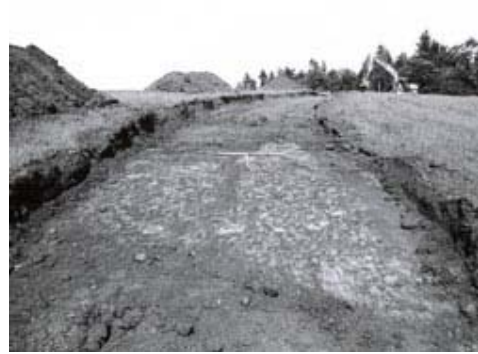
3d: Haul Road 2

- 3.4 Haul Road 2 ran northwest to southeast from Compound 1 to the Kittoch Water and had a subsoil of very compact dark grey/blue clay with very occasional small to medium sized stones. No archaeological features or artefacts were noted.

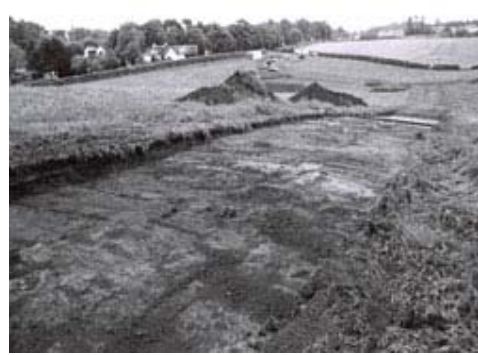
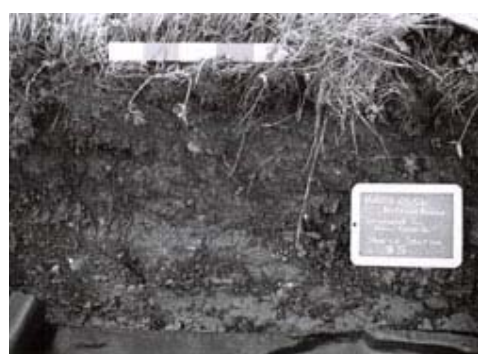
3f: Haul Road 4

- 3.7 Within Haul Road 4 the subsoil varied as it went from east to west; (009) was a medium compact grey brown silty sand, (017) was a compact orange grey silty clay then (018) was a very compact dark bluish grey silty clay. No archaeological features or artefacts were noted within Haul Road 4.

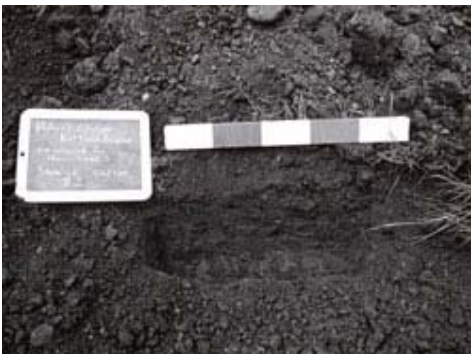
3e: Haul Road3

- 3.6 Haul Road 3 ran south from Compound 2. The subsoil here was the same as that identified in Compound 2 (019). Several linears were recorded; (020, 022,024, and 026) were aligned northwest to southeast, with vertical sides and a stone fill with gray matrix (021,023,025,027). Several artefacts were also recovered, consisting of flint Finds (06-09) and modern ceramics Find (010) and glass Find (011).

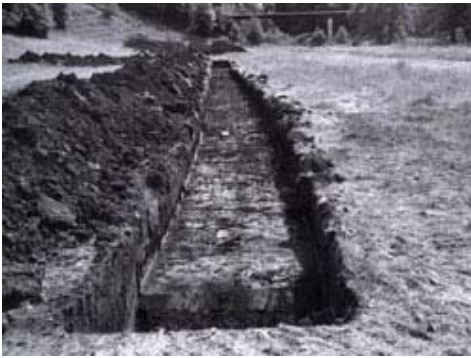
Figure 4a: Trench 4

- 4.5 *Drainage features*
- 4.5.1 Field drains were recorded within Trenches 1-4 and 6. Trenches 1-3 contained stone rubble drains (1011, 1015 and 1016 respectively), with a fill of small, sub-angular stones. Trenches 4 and 6 contained red ceramic tile drains (1003 and 1005 respectively), both measuring 250mm wide with a mixed topsoil and subsoil fill. The common alignment for both types of drains was northwest to southeast.

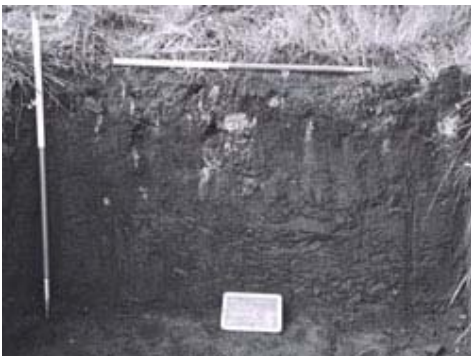
Figure 4e: Trench 5 Section

- 4.4 *Midden*
- 4.4.1 Within Trench 5 were two midden deposits, (1006) and (1008), which were present at +2.5m and +42.2m respectively. (1006) was 8.5m long and up to 200mm deep, while (1008) was 6.6m long and up to 250mm deep. Both contained modern material, including ceramic building material, glass, slate, polystyrene and charred timber.
