**Land to the south of Church Cottage
Townhead, Rothesay:
Archaeological Watching Brief**

Data Structure Report

by Alan Matthews

issued 6th October 2008

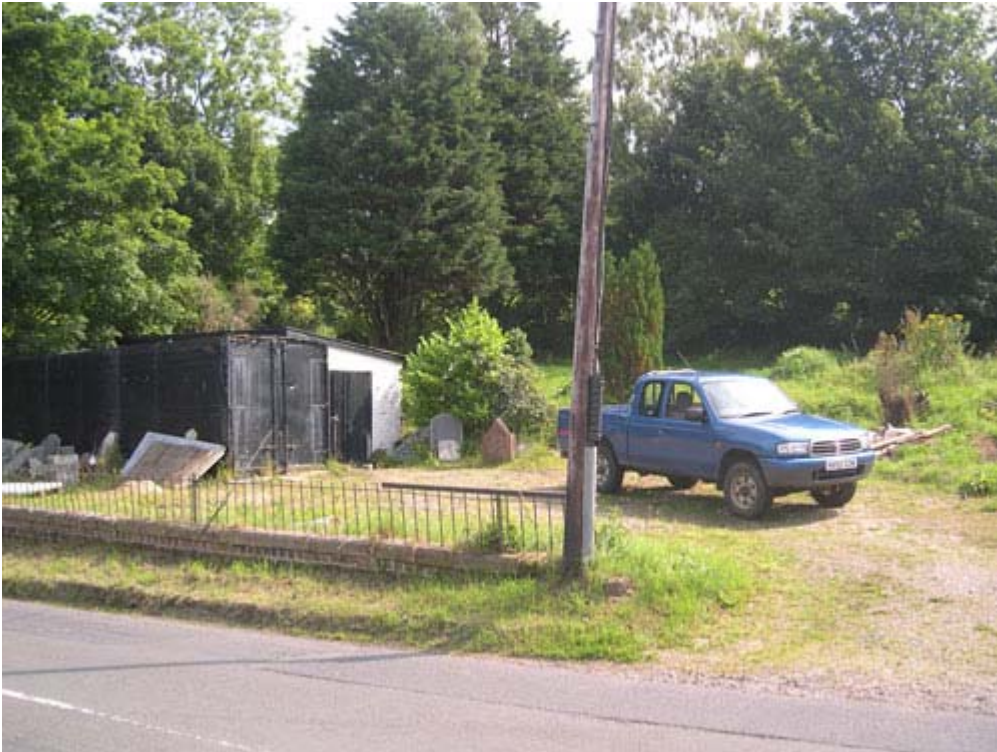
Figure 1a: Pre-excitation, north end of development area.

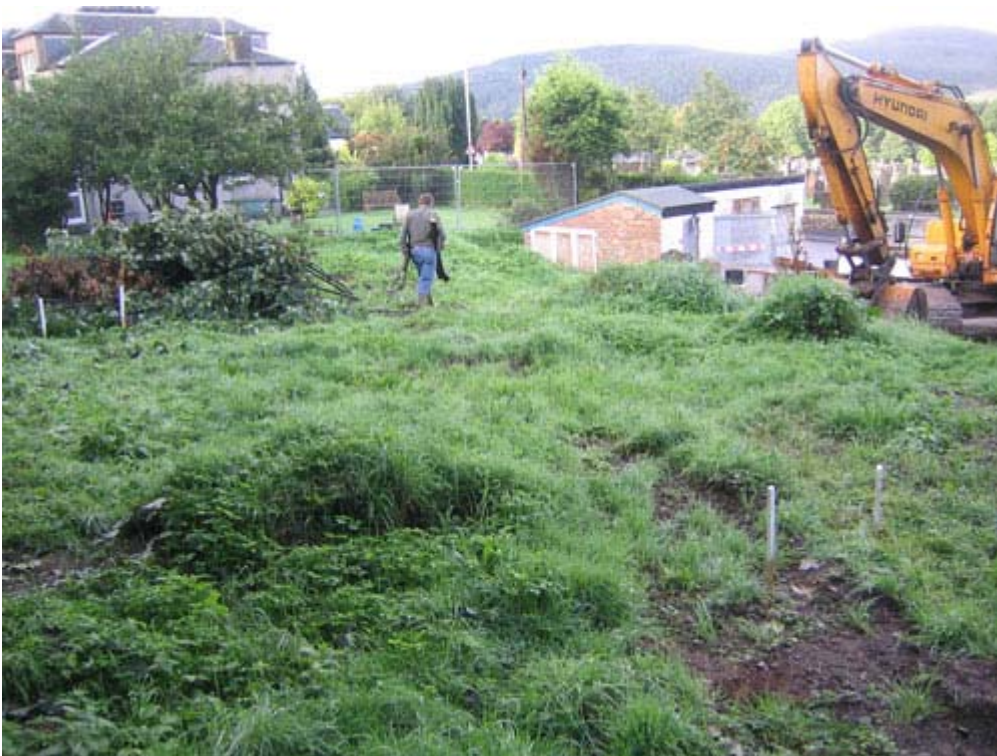
Figure 1b: Pre-excitation, south end of development area.

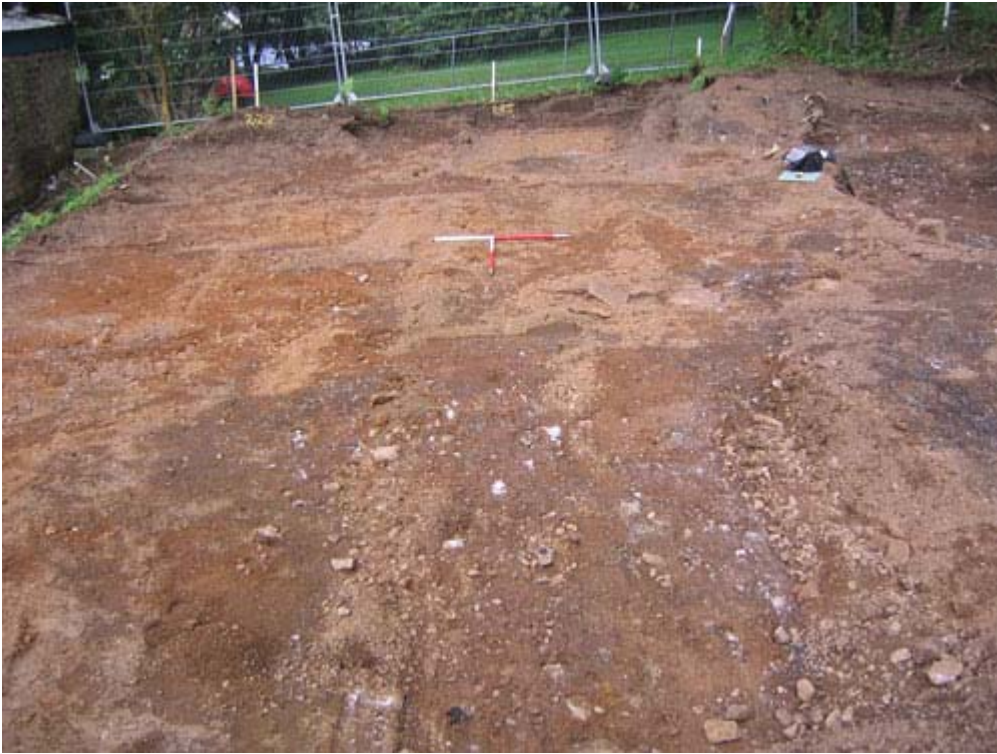
- 4.5 The subsoil appeared to be archaeologically sterile and the consistency of the slope towards the road suggest that there has been little disturbance or landscaping of the site other than in modern times.

Figure 3a: Excavation area cleared to natural subsoil and bedrock.

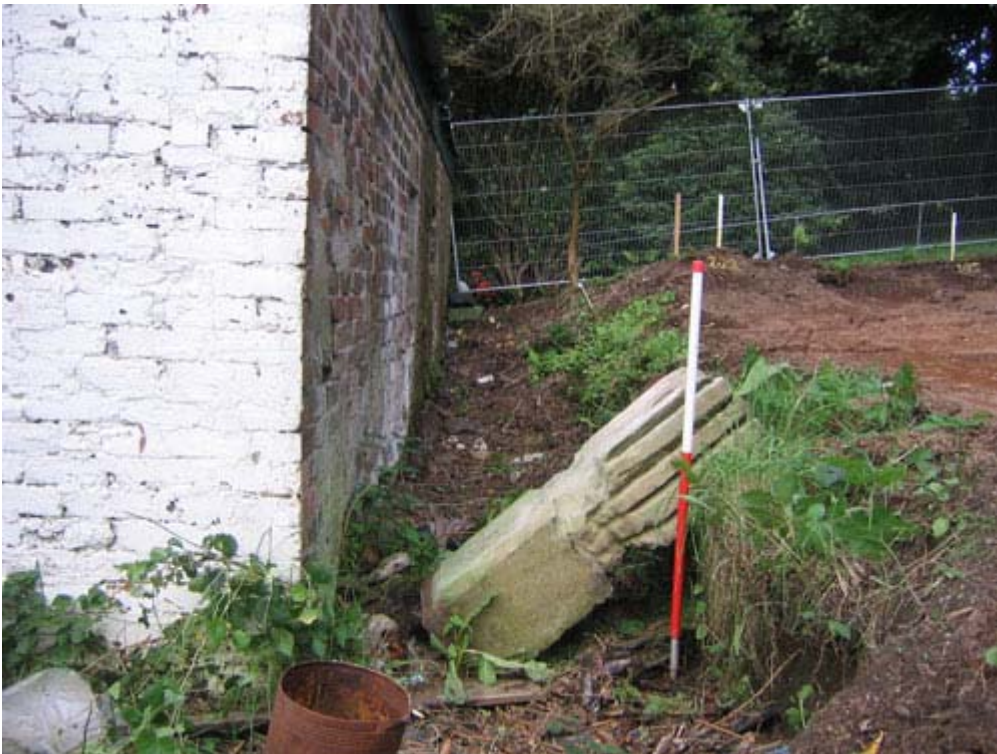
- 4.4 The two structures remaining on site and due to be demolished have been recessed into the slope of the natural subsoil in order to provide level ground for their construction. To the northern end of the development area the depth of this recess can be as much as 900mm. There is therefore no reasonable possibility of significant archaeological deposits surviving beneath the two structures. After consultation with West of Scotland Archaeology Service we were able to conclude that the development area could be considered archaeologically sterile and no further on site works were required.

Figure 3b: Showing reduction of natural subsoil for structures.
