**Sornhill, Galston:  
Archaeological Watching Brief**

Data Structure Report

issued 21<sup>st</sup> April 2011

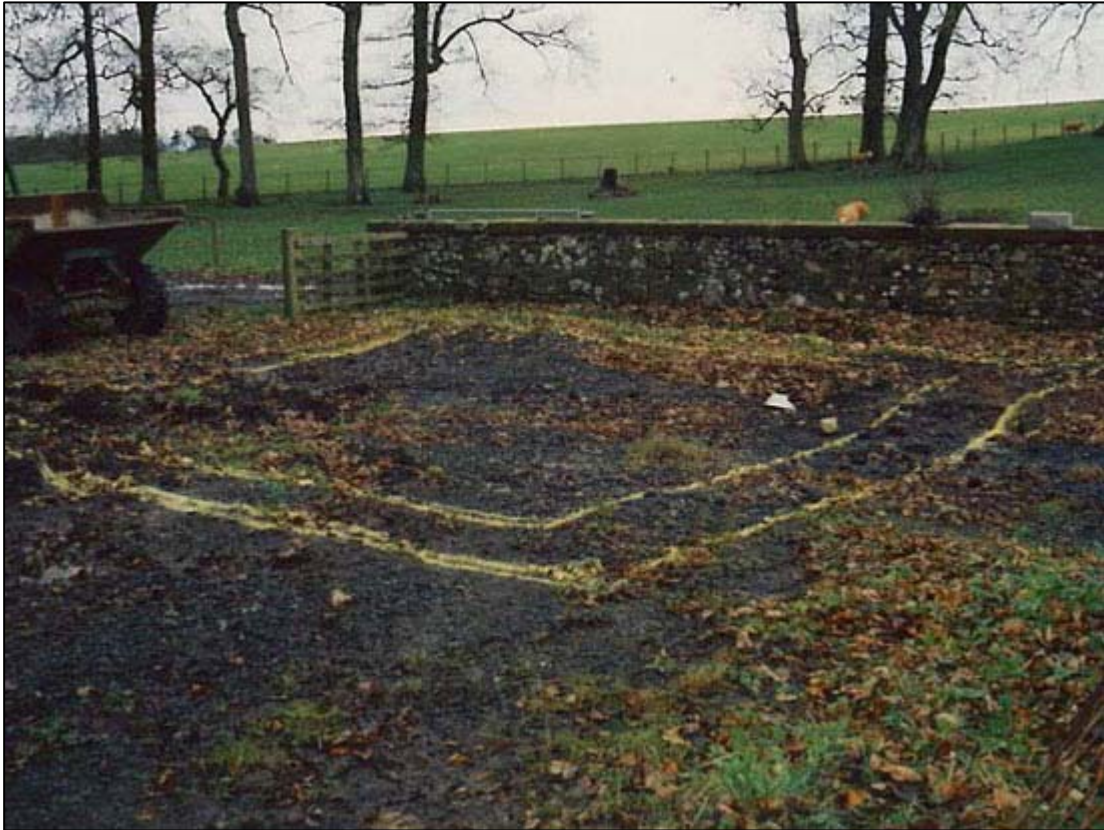
Figure 3a: Layout of garage foundations

11. Excavation of the foundation for the garage involved excavation of a trench approximately 1.2m wide and 450mm to 700mm deep (Figure 3a). The internal area of which was left unexcavated due to the plans for the garage requiring the floor to be elevated above the current ground level by at least 200mm. This work exposed a variety of sediments. Subsoil, (004) and (005), was reached in all parts of the excavation for the garage foundations (Figure 3b). However, the subsoil to the south, west and north appeared disturbed at the uppermost layers and may have been redeposited. The possibility of disturbance of this type is emphasised by the existence of a modern field drain running east-west across the excavated area.

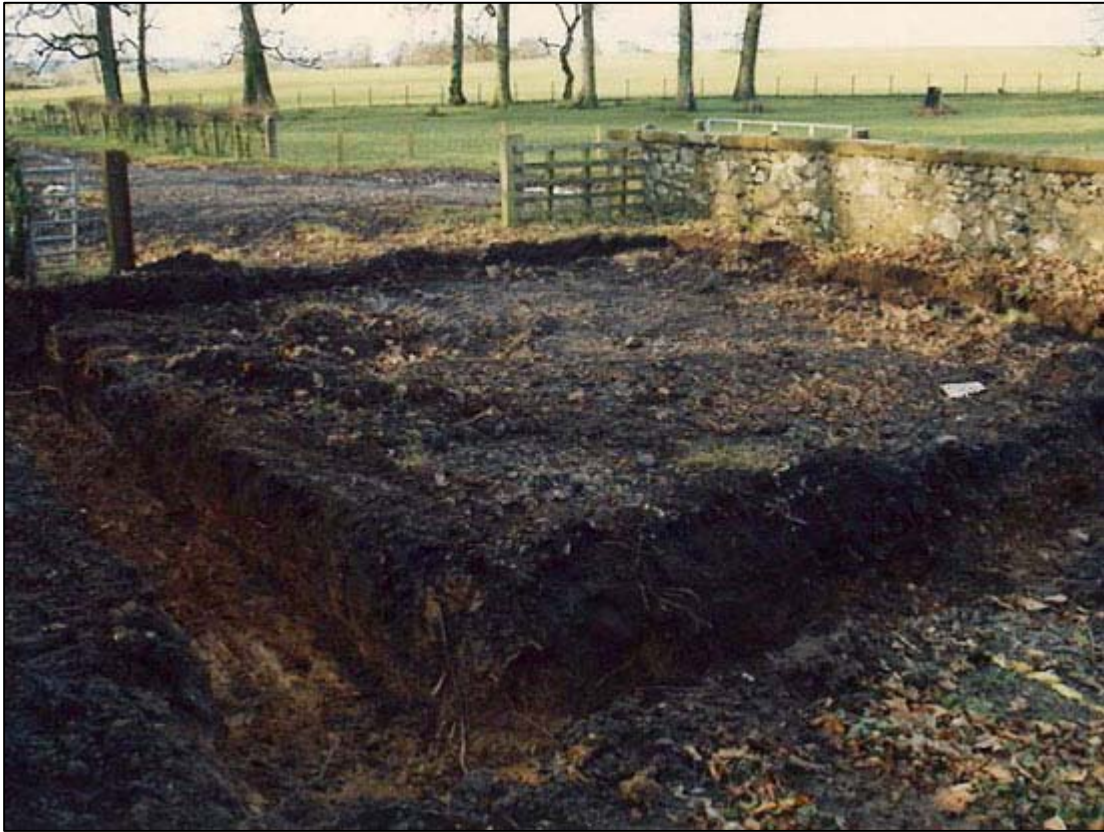
Figure 4a: Foundations of garage excavated

12. The remaining sediments in the area of the garage were made ground containing modern (19<sup>th</sup> or 20<sup>th</sup> century) material. Some modern ceramic was recovered from the topsoil (001). Additional fragments of mortar and ceramic were recovered from the build up of made ground (003). Additional made ground (002) took the form of levelling material and imported gravel, Type 1. All of the material recovered from the area of the garage was modern (19<sup>th</sup> or 20<sup>th</sup> century) in origin this includes the build up of made ground and the placement of modern drainage. Any potentially significant archaeological features were investigated and none were found (Figure 4a).

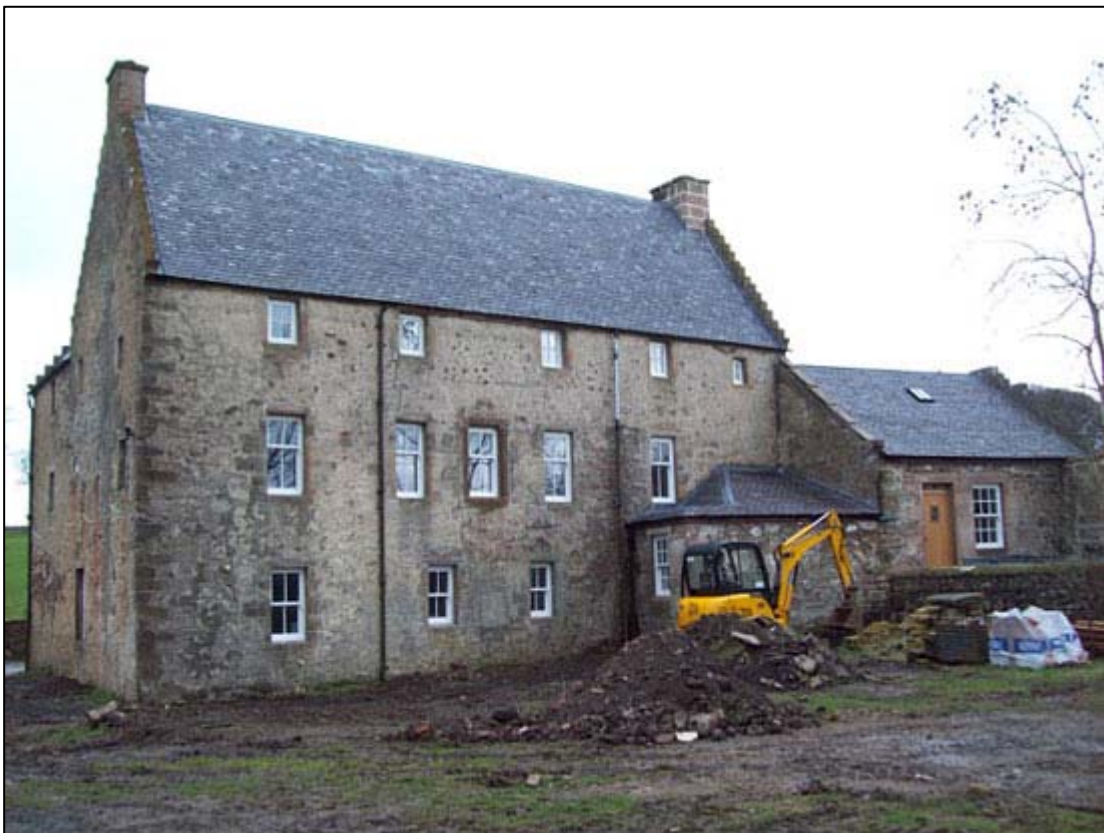
Figure 4b: Main house of Sornhill Farm

13. The archaeological monitoring of the excavation for rainwater drainage surrounding the main house (Figure 4b) took place more than two years later when the majority of the refurbishment work had been completed. The excavation for services surrounding the house was the only remaining ground breaking work requiring archaeological monitoring. The work was carried out using a 3 ton 360° mini-digger with a small toothed bucket (Figure 5a). The toothed bucket was required in order to break through the high bedrock which was frequently reached during the excavation works. The excavation was carried out in spits in order to achieve a trench approximately 500mm wide, 1.2m deep and around the north (Figure 5b), west and south of the main house approximately 1m from the building. The distance from the building varied depending on the location of the trench and where it had to tie in to outflow pipes.

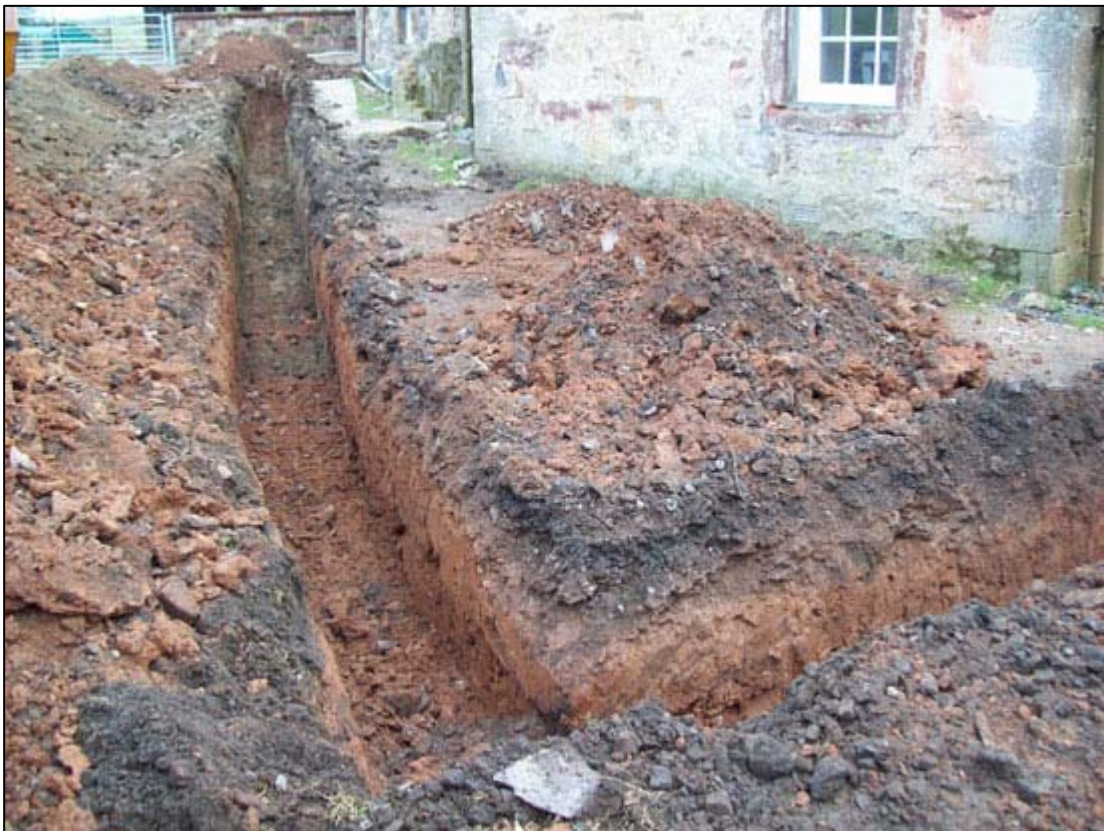
Figure 6b: North-western corner of service track

15. Archaeological monitoring was carried out during the removal of some of the bedrock to the north and south of the main house but typically monitoring ceased when the surface of the bedrock was reached. After the completion of the excavation for this track the only work remaining to be carried out was to join the new drainage track into the existing outflow pipes from the house (Figure 6a). After consultation with West of Scotland Archaeology Service it was agreed that this work did not require archaeological monitoring given that; length of area to be excavated was no more than 500mm, the excavation was to be carried out through previously disturbed made ground and that the area of the excavation had already been seen in section (Figure 6b).
