A9 Loaninghead Junction: Archaeological Evaluation

Data Structure Report

issued 7th November 2008

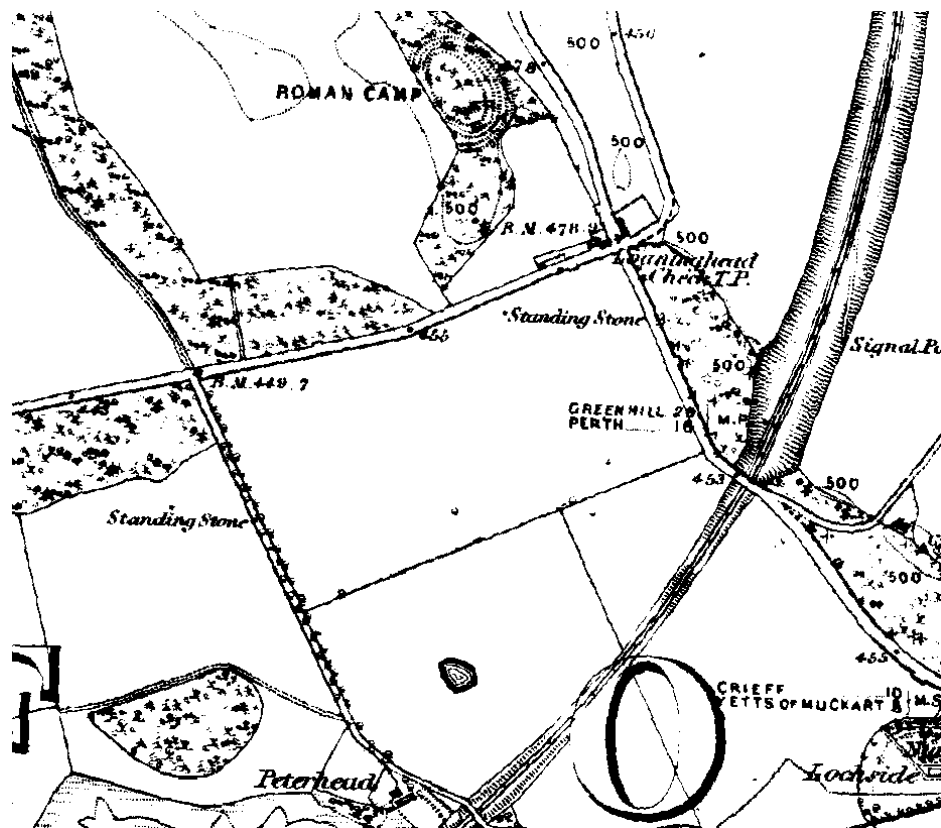
Figure 1b: 1st edition Ordnance Survey

- 3.1.2 The only known archaeology within the development area are three buildings (NMRS NN90NW.39 & NN90NW41) which are depicted on the First Edition Ordnance Survey map of 1866 as three roofed buildings.(Figure 1b). However, the location of these structures is now

overlain by the modern road network, suggesting the wholesale loss of these structures.

- 5.3.1 The demolition material uncovered within Trench 5 (Figure 3b) may be a spread of material that relates to the demolition of the more western of the two buildings (NMRS NN90NW.39) depicted on the 1st Edition Ordnance Survey map of 1866 (Figure 1b).

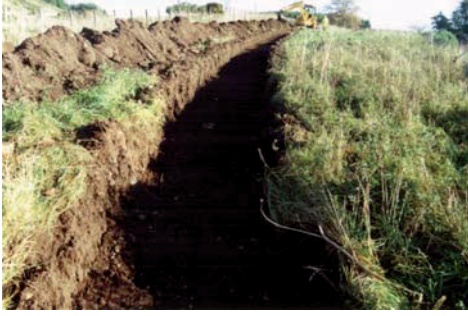
Figure 3a: Trench 1

- 4.6 *Modern Disturbance*
 - 4.6.1 Within Trenches 1-4 there were several features which were identified as modern (late nineteenth and twentieth century) based either through their form or inclusions. These were

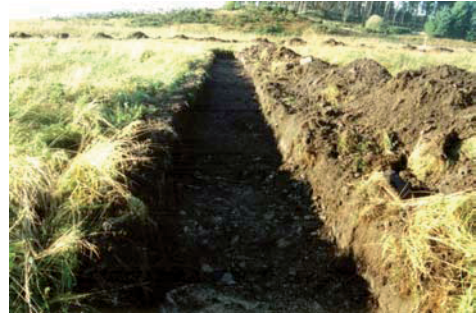
Figure 3b: Trench 5

- 4.6.2 Within Trench 5 there was also evidence of modern disturbance from +14.2m to +19.9m, this appeared to be demolition rubble for the most part which contained concrete and slate (505).

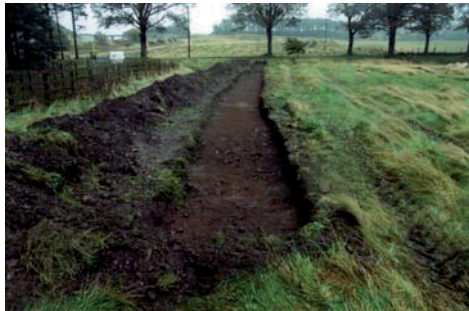
Figure 3e: Trench 11

- 4.3 *Linear features*
 - 4.3.1 Two trenches (Trenches 11 & 12) contained potentially significant archaeological features. Within Trench 11 (Figure 3e) a linear feature [1103] was noted at +6.6m, which measured 0.4m and 0.2m deep, with a grey brown silty clay fill [1104], it was aligned roughly NE-SW with steep sloping sides and a rounded base. A second linear [1105], was also present at +13.2m, with a compact light greyish brown sandy clay upper fill [1106] and a pale grey brown sandy clay lower fill. [1105] was aligned NNW-SSE and measured 2.2m by 0.46m deep (Figure 3g).

- 5.1.1 A series of linear features were uncovered within Trenches 11 and 12. Of particular note was feature [1105], which appears to be a ditch that was allowed to silt up, unfortunately no datable material was recovered from the fills of the feature (1106), (1107). However given its form and its location in proximity to the Peterhead Standing Stone (AMH 4061) it has the potential to be prehistoric in origin. Indeed this may be part of an enclosure or other landscape division designed in association with the adjacent standing stone. Clearly, without further archaeological investigation this is inference and potential.

- 5.1.2 [1103] which was also within Trench 11, this linear was only 0.4m wide by 0.2m deep and within seven metres of [1105]. This feature is quite ephemeral, and while appears to be of antiquity, no dateable material was recovered and without further archaeological investigation it would be impossible to give any firm date.

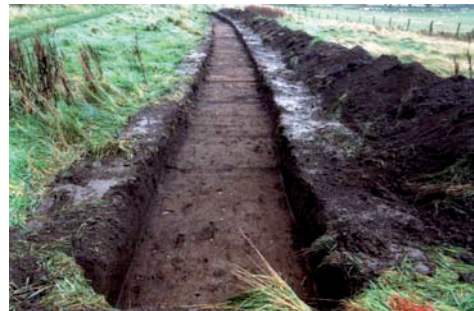
Figure 3f: Trench 12

- 4.3.2 Trench 12 (Figure 3f) revealed a further two linear features [1204] at +31.6m and [1207] at +43.9m. [1204] was aligned NNW-SSE and measured 0.39m wide and 0.12m deep, with a reddish brown sand fill [1205]. While [1207] was aligned NW-SE and measured 0.37m wide and 0.13m deep, with a reddish brown silty sand fill [1208].

- 5.1.3 [1204] and [1207] which are the remaining two linear features, were similar in form being 0.39m by 0.12m in depth and 0.37m by 0.13m in depth, respectively, with U shaped sections. As with [1103] and [1105] no datable material was recovered.

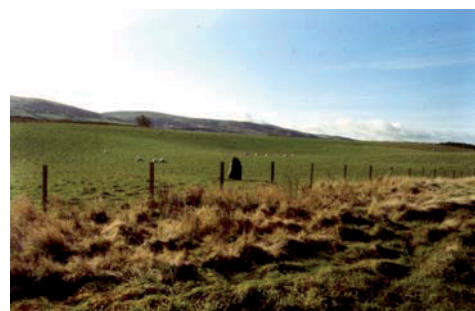
Figure 3h: Peterhead Standing Stone

- 7.2 A series of four negative linear features of potential archaeological significance were recorded during in the course of the evaluation to the immediate north of Peterhead Standing Stone, at the western end of the evaluation area. These linear features were generally aligned N-S and appears to have been open ditches. Elsewhere, modern features and plough scrapes were noted but no features of potential significance.
