Whinhill Farm, Greenock: Archaeological Mitigation

Data Structure Report (Revised)

by Alan Matthews

issued 4th February 2009

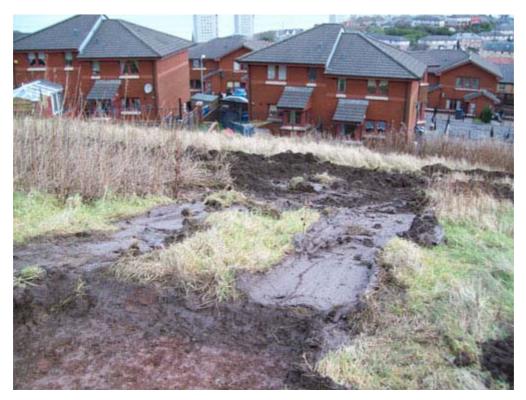
Figure 1: Digger slide due to saturated topsoil

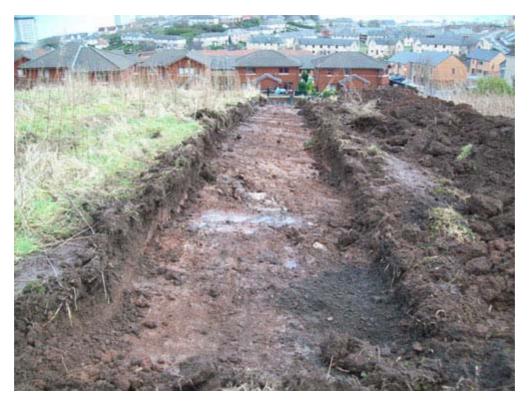
Figure 2: Trench 27

- 4.2 The topsoil across the site (001) ranged between 100mm to 400mm in depth, though typically it was no deeper than 300mm. The natural subsoil was predominantly pink-orange compact clay (Figure 2) with occasional areas of grey clay at the north-western end of the site. There was very little evidence of bioturbation or disturbance of the subsoil. Where such evidence did occur it was mainly as a result of modern activity or tree roots. In several places large trees made access for the evaluation work impossible (Figure 4).

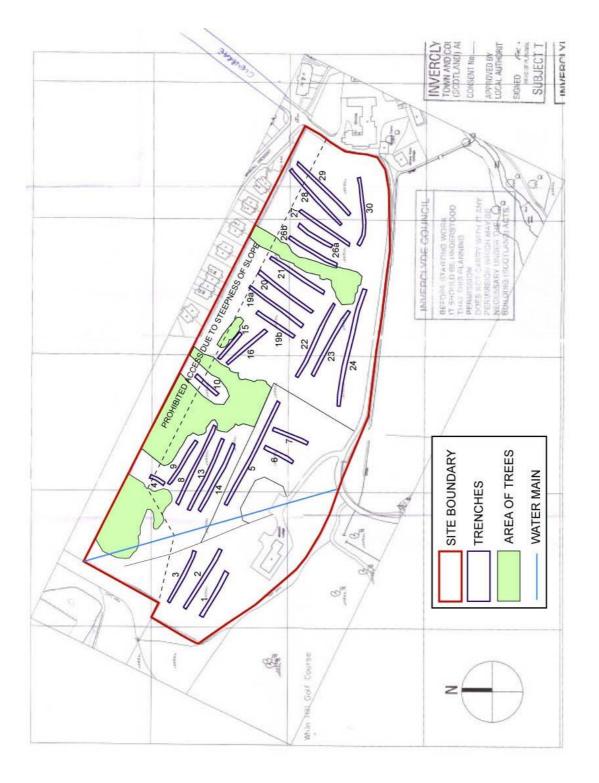
Figure 3: Trench Layout

- 4.1 Twenty-seven evaluation trenches were opened across the development area. Full descriptions of each are contained in the appendices at the end of this report. Included below is a synthesis of the findings and interpretation from these trenches. The numbering of trenches was originally intended to reflect their location as shown in the trench layout included in the Written Scheme of Investigation. However, in the course of the investigative works, these numbers had to be altered and adapted to suit the needs of the project. As a result there are no Trenches 11, 12, 17, 18 and 25 (Figure 3).

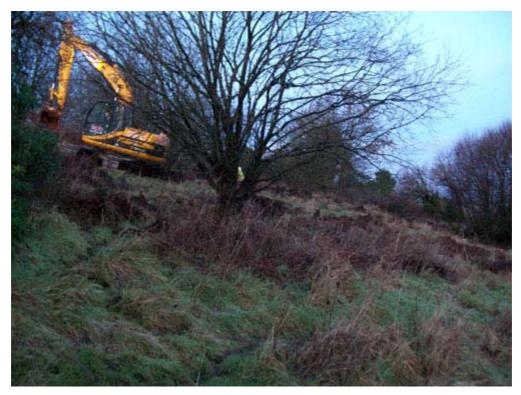
Figure 4: Digger among trees
