Margnaheglish, Lamlash, Isle of Arran: Archaeological Evaluation

Data Structure Report

by Douglas Gordon

issued 22nd April 2009

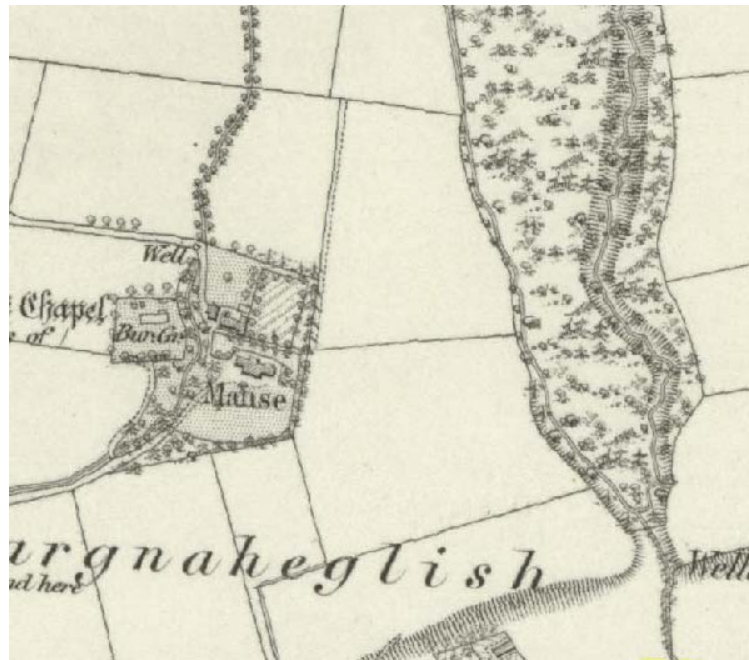
Figure 1: First Edition Ordnance Survey 1869

- 3.2.1 The first viable mapping comes from the 1st Edition Ordnance Survey 1869 which shows the site as a field with a boundary running east-west through its centre. The site remains an open field on all mapping to the present day.

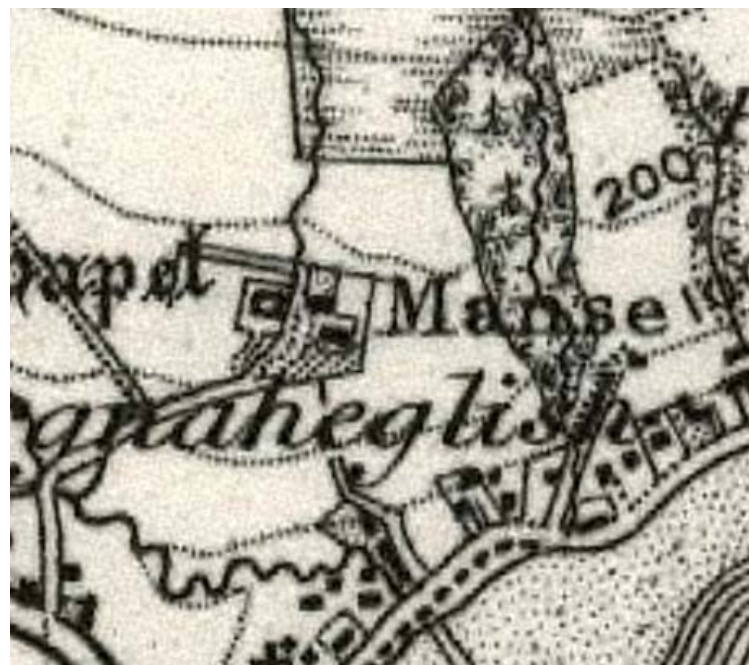
Figure 1b: Third Edition Ordnance Survey 1905

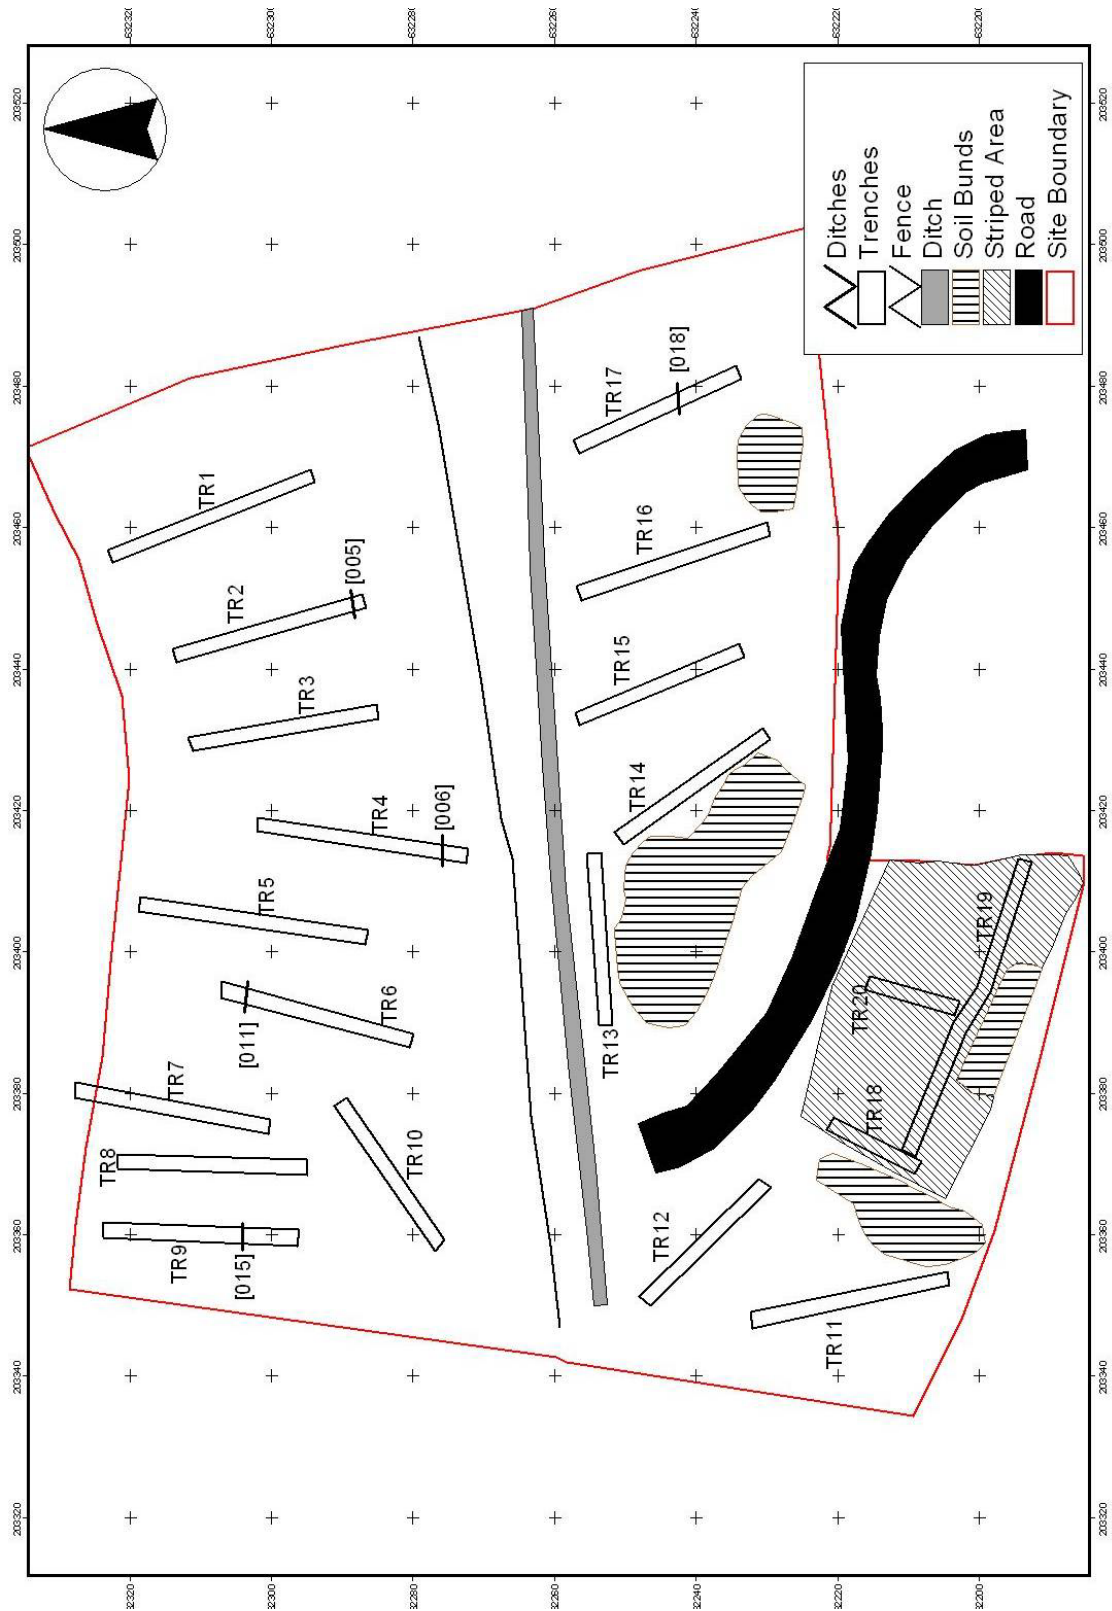
Figure 2: Trench Plan

All measurement distances quoted along the trench measure based on the quoted orientation of the trench. See Figure 2 for trench locations.

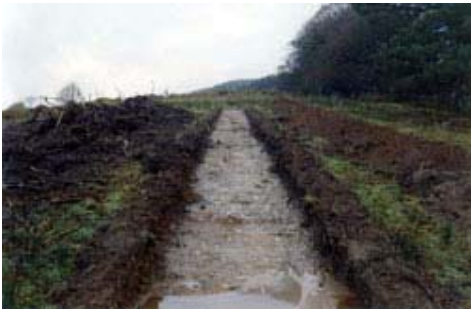
Figure 3a: Trench 1

- 4.3.2 Linear group [003] were thin, ephemeral features measuring 50-80mm wide and up to 50mm deep. These were present in Trenches 1, 4-7, 9 and 11. They varied in alignment from ENE-WSW to SW-NE to E-W, the alignment differing from trench to trench. Linear group [004] were approximately 500mm wide and up to 40mm deep with a near vertical slope on the uphill side and a gently sloping side on the downhill side. They were present within Trenches 1, 6, 11, 14, 15 and 17. Again, they varied in alignment across the trenches, running SW-NE and SE-NW in Trench 1; E-W in Trenches 6, 11, 14; ESE-WNW in Trench 15 and E-W and NNE-SSW in Trench 17.

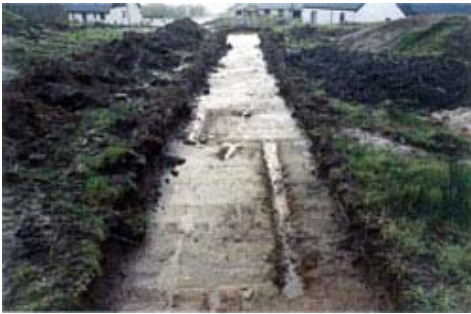
Figure 3c: Trench 16

- 4.3.5 [017] was the final linear feature that was recorded during the evaluation, it was present within Trenches 15 and 16 measuring 300mm wide and aligned NW-SE. Each was filled by re-deposited natural and contained a red ceramic drain.

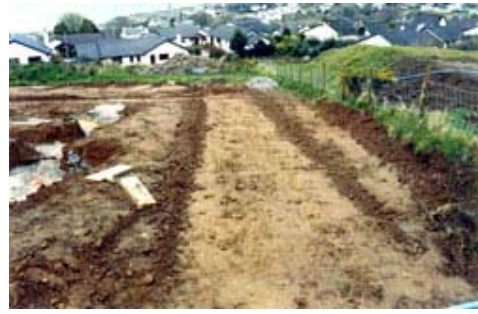
Figure 3d: Trench 18

- 4.3.3 Linear features [005], [006], [011], [015] and [018] were a series of features that were all aligned E-W and which measured from 500mm-1.6m wide and from 90mm-260mm deep. They were located within Trenches 2, 4, 6, 9 and 18 respectively, and all had a hillwash fill (008), [005], [006] and [011] had gentle sloping sides and irregular bases, while [015] and [018] had a near vertical side cut into the upper slope and with a gentle slope on the lower, down-slope, side.

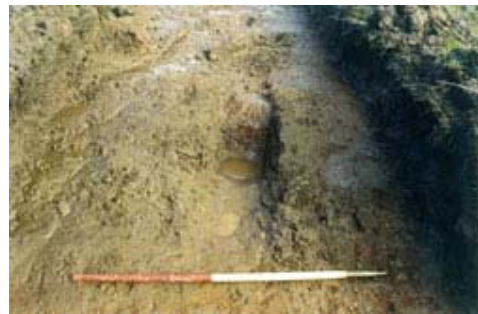
Figure 3f: Ditch [008]

- 5.1 Most of the linear features recorded during the evaluation works are interpreted as being agricultural in origin and nature. Five of these features ([005], [006], [011], [015] and [018]) were all generally orientated W-E and had the characteristics indicative of open drains or ditches, with shallow scooped sections. Given their discontinuous nature (Figure 2) and their W-E alignment across the steep slope, as well as no evidence of rig and furrow, it is likely that these open ditches were used to manage the ground for pastoral rather than arable purposes by acting as catch ditches for surface runoff. No evidence for their date was recovered during the evaluation, making it impossible to say if they predate the other drainage features recorded or were in fact associated with them.

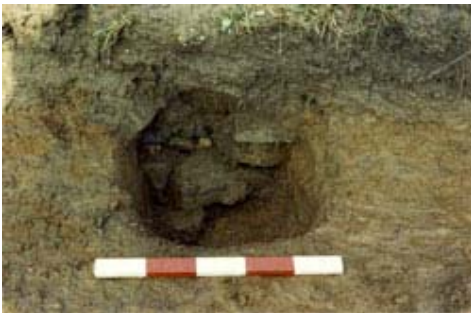
Figure 3g: Rubble Drain [009]

010	5	Fill	Large sub-rounded and angular stones $\leq 290\text{mm} \times 250\text{mm} \times 90\text{mm}$ sitting in a matrix of light grey brown clayey silt (similar to hillwash (008)). Extent measures 0.5m x 0.45m x 400mm deep. Fill of [009].	Fill of possible rubble drain
011	6	Cut	Linear shaped cut in plan orientated E-W. Measures 1.05m wide and 170mm deep. Irregular gently sloping sides and irregular base. Filled by hillwash (008).	Linear ditch, possibly agricultural
012	6	Feature	Linear shaped cut in plan orientated NW-SE. Measures 0.5m wide. Filled by sub-angular, angular and sub-rounded medium to large stones.	Rubble drain
013	-	-	Void	Void
014	-	-	Void	Void
015	9	Cut	Linear shaped cut in plan orientated E-W. Measures 1.6m wide and 260mm deep. U-shaped cut in section with near vertical sides in centre which spread and get shallower towards the outer edges. The southern side is shallower than the northern side. Filled by hillwash (008).	Linear ditch, possibly agricultural

- 5.3 [012], [016] and [017] all appear to be field drains, with [012] and [016] being rubble drains and [017] being a ceramic one. The rubble drains are of unknown date though most are likely to be 18th century in origin, while the ceramic drains were of middle to late 19th century date, being of factory manufacture.

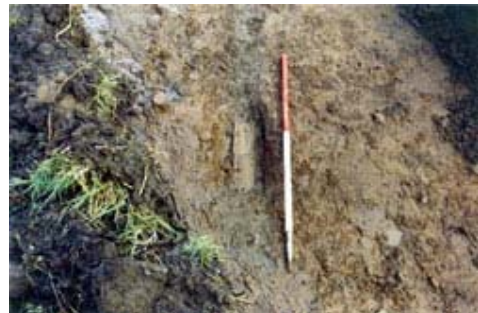
Figure 3h: Ceramic Field Drain [017]
