**Campbeltown Rising Main Installation:
Archaeological Monitoring**

Data Structure Report

by Douglas Gordon

issued 31st July 2009

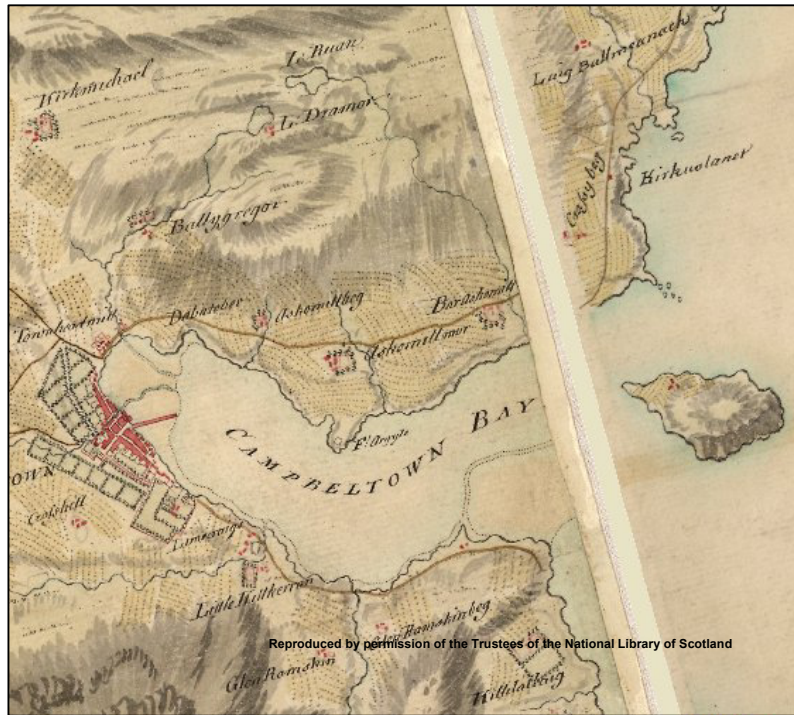
4. The first viable mapping evidence for the area between Trench Point and Slaty Farlan comes from Roy's Military Survey of Scotland 1747-55 (Figure 1a). Roy's map depicts an open area of arable fields, with the actual line of the rising main being in open, uncultivated ground. Of note is Fort Argyle marked in the centre of the tip of Trench Point.

Figure 1a: Roy's Military Map 1747-55

7. Also on Trench Point was a seventeenth century battery (NMRS NR72SW 20) known as 'The Trench' which is depicted on Roy's Military Map as 'Fort Argyle' and on the 1st edition Ordnance Survey as 'The Trench'. The battery was erected by the 8th Earl of Argyll in 1639 to defend Campbeltown from a threaten invasion by the Earl of Antrim during the Bishops' Wars.

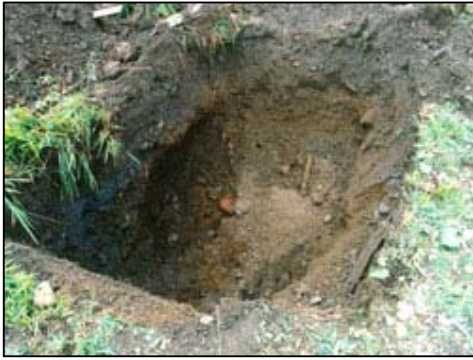
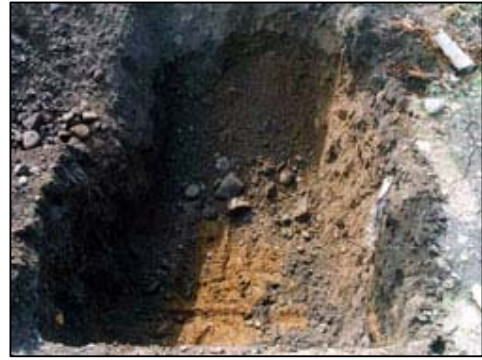
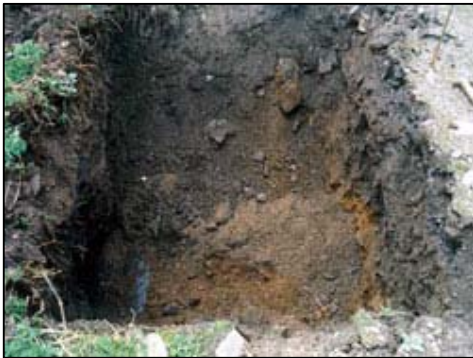
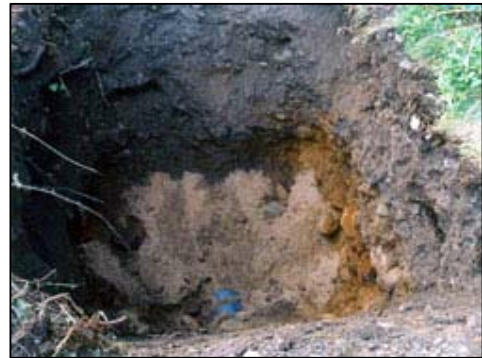
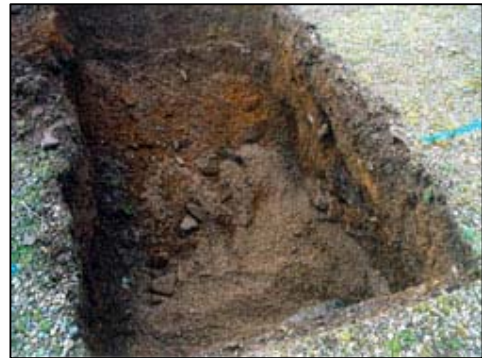
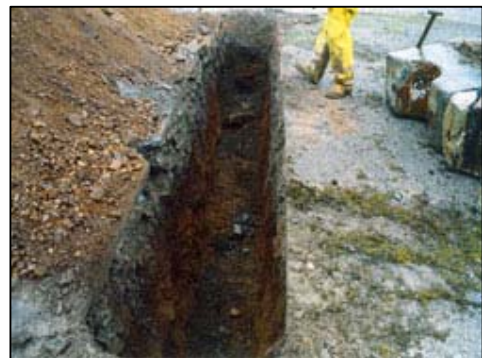
Figure 3a: Test Pit 1

Figure 3b: Test Pit 2

Figure 3c: Test Pit 3

Figure 3d: Test Pit 4

Figure 3f: Test Pit 8

Figure 3h: Test Pit 10

14. All the pits demonstrated a stratigraphy that lacked any evidence of topsoil but was dominated by made ground (101). This, in the majority of the area consisted of mixed brown and black silt sand with inclusions of plastic, textiles, metal wire and fishing nets. This commonly directly overlay a orange brown sand gravel subsoil (103), which had a plastic waste water pipe [102] within a narrow trench filled with pea gravel.

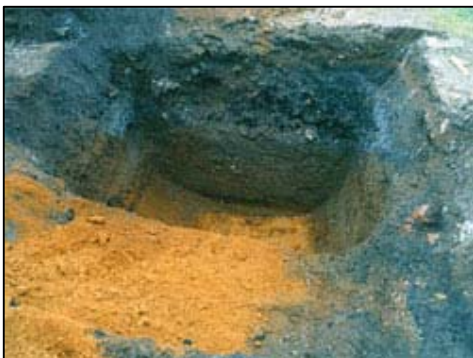
Figure 3g: Test Pit 9

15. Within Test Pit 9 the made ground varied from that observed in the other pits (105), was 2.5m deep and consisted of black mottled modern industrial waste, ash and slag like material being present with inclusions of rope, wire, textile, polystyrene and plastic. (105) directly lay over subsoil (106) which was a orange brown sandy gravel.

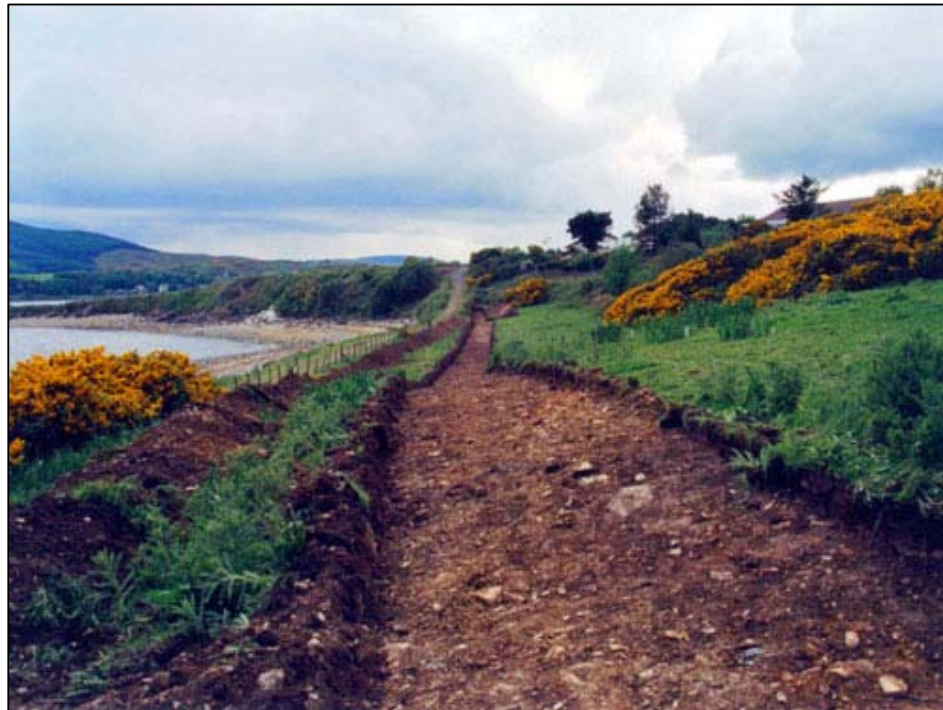
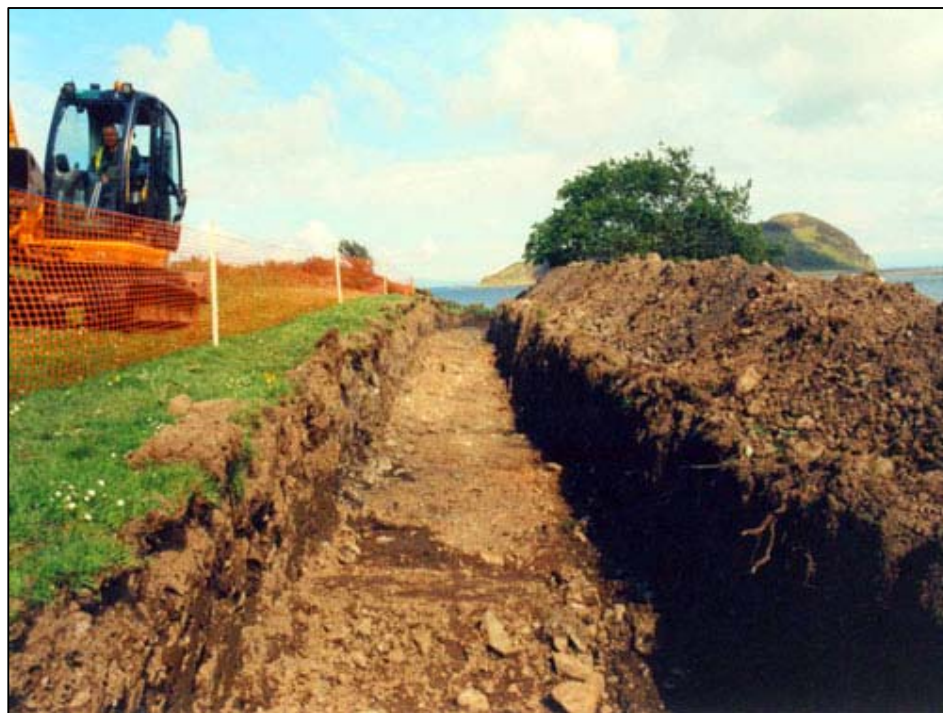
Figure 4a: Beginning of the pipe trench looking to Trench Point

Figure 4b: Pipe Trench

16. The trench for the new rising main, which was approximately 800m long, was excavated in advance of the main works. The trench in general measured 2.5m wide and was excavated either down to the upper surface of the underlying subsoil or to a depth of 1.5m. The line of the new trench was to fall between the two existing pipes (110) and (111).
17. The monitoring started at NGR NR7383 2059, which is the most eastern part of Trench point, here the topsoil (106) was a mid brown silt sand over a orange and light brown sand with small to medium size rounded stones (107). The character of the topsoil did not change along the length of the trench and measured from 100mm to 370mm in depth.
18. After about 100m along the trench the subsoil changed to a light brown and orange substratum of bedrock (108). At NGR NR73790 20576 a layer of made ground (109) was

observed, measuring 450mm to 600mm In depth appeared to consist of blue grey clay with very frequent modern detritus of netting, rope, plastic and ceramic building material.

19. After a further 260m along the trench a burn was crossed, to the east of the burn the made ground continued along the majority of the trench, varying in depth from 900mm to 1.6m deep. With the (108) being the main subsoil evident along the trench bed, with the two service trenches intermittingly evident, (110) being the water main and (111) an older waste water pipe.
20. Field drains were also evident within the trench at various points (112) was a modern yellow plastic pipe within a trench filled with pea gravel and (113) was a trench just filled with pea gravel.
21. For approximately the last 100m of the trench the subsoil changed from mid brown silty grit/coarse sand (116) to mid brown silty clay (115) with occasional medium stone inclusions. Towards the end of the trench at NGR NR 7418 2066

22. No significant archaeological features or artefacts were recovered from the archaeological monitoring. The made ground which the majority of the pipe trench cut through appears to be relatively modern, and it may relate in part or wholly to the demolition of the ship building yard on Trench Point.
23. The lack of archaeologically significant features is most likely due to the fact the line of the trench for the most part fell between the two pre-existing pipelines, which meant that the ground had previously been disturbed by the excavation for the earlier pipe trenches, which would have removed the presence of any archaeology that may have been present.
