**Main Street, Kilwinning, Ayrshire:
Archaeological Watching Brief**

Data Structure Report: Phases 1 and 2

by Louise Turner and Alan Matthews

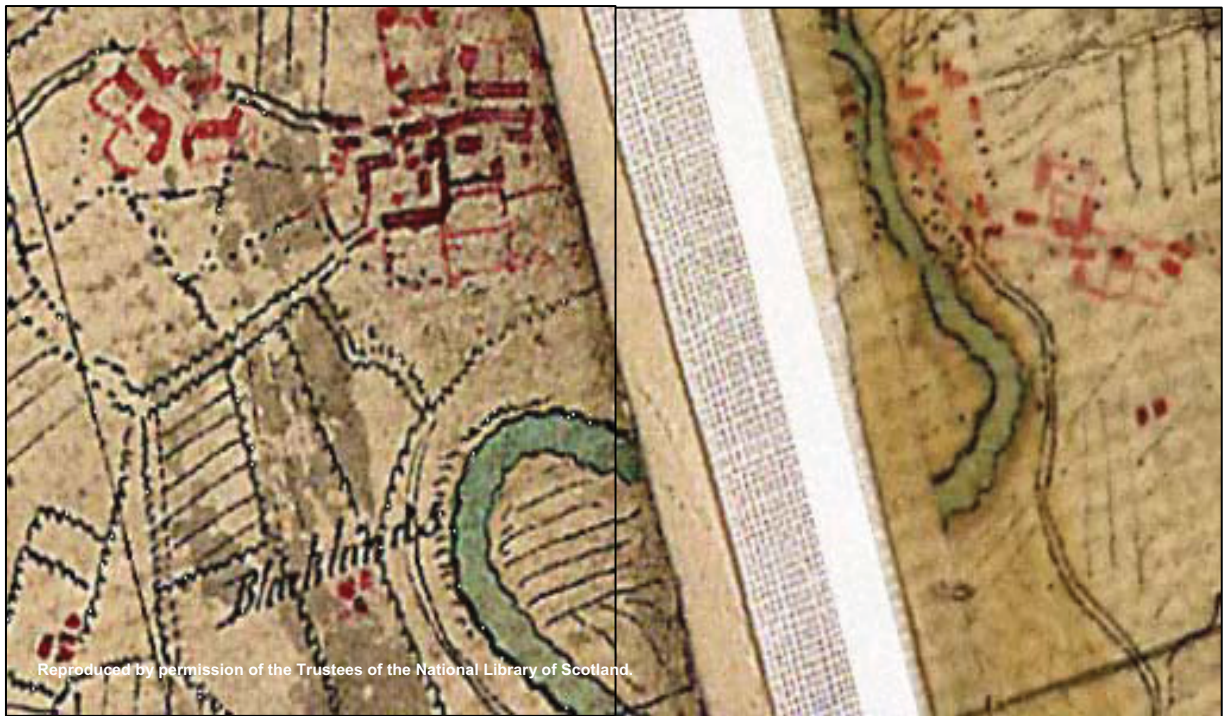
Figure 1a: Detail from Roys' Military Survey of Scotland (1747-55)

8. The first detailed post-reformation plan of Kilwinning is from 1747-55 (General Roy's Military Survey of Scotland); here, the town comprises a cluster of settlement composed of three distinct groups located along the length of what is now Main Street. The central hub is centred around the Abbey buildings, with another located on the east side of the river Garnock near the Corsehill, and a third to the west at Byres.

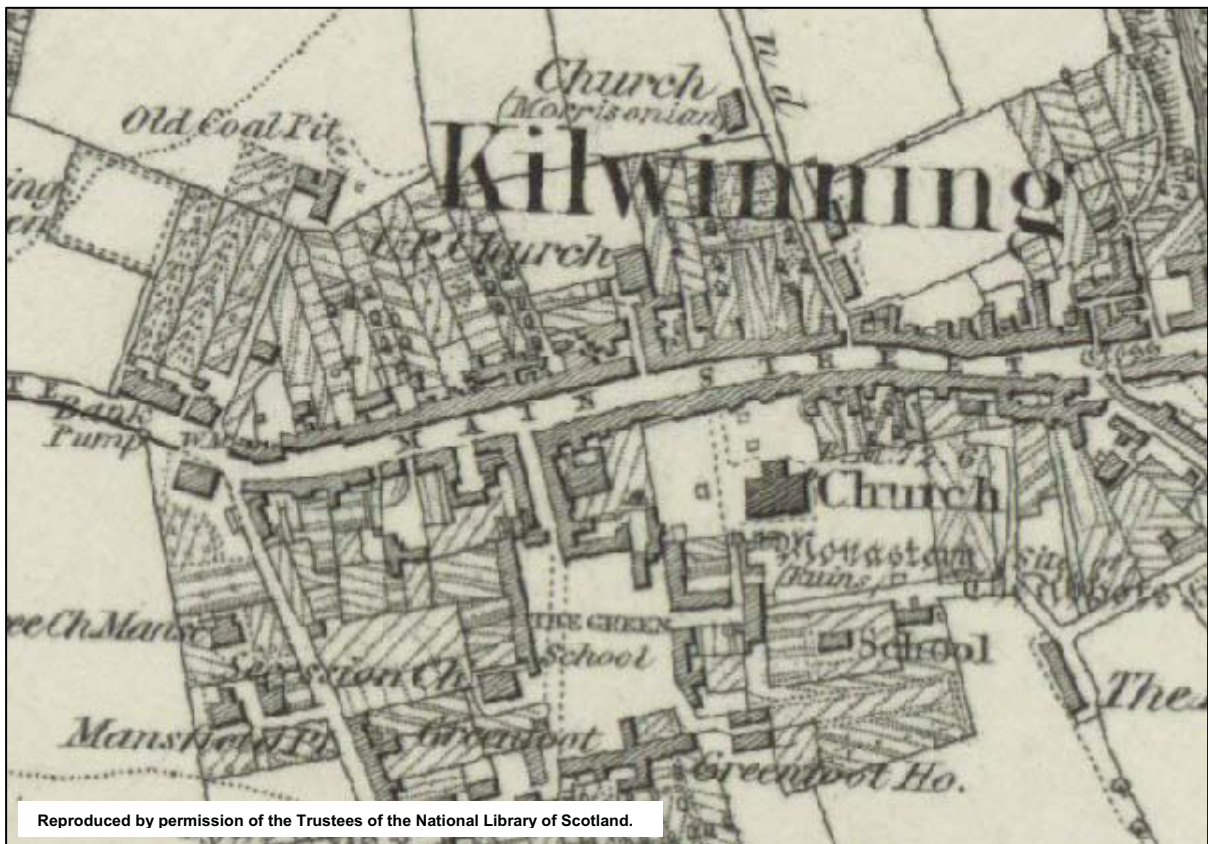
Figure 1b: Detail from 1st edition Ordnance Survey map (1856)

9. By the time the 1st edition Ordnance Survey map was published in 1856, Kilwinning had expanded to include a full street frontage on either side of Main Street. This streetscape was progressively altered through the nineteenth and twentieth centuries with the opening out of the 'square' area at the west end of the Main Street and clearance of buildings to form the entrance to the Old Parish Church (removing the original property given to the Freemasons for their Mother Lodge).
10. The archaeological potential of the Main Street has not in general been tested, except for excavation and monitoring works associated with the construction of new properties at Abbeygate in 1987 and 1994-5. While these did not reveal significant archaeology they did characterise made ground and foundations associated with nineteenth century frontage buildings and the survival of garden soils to the rear.

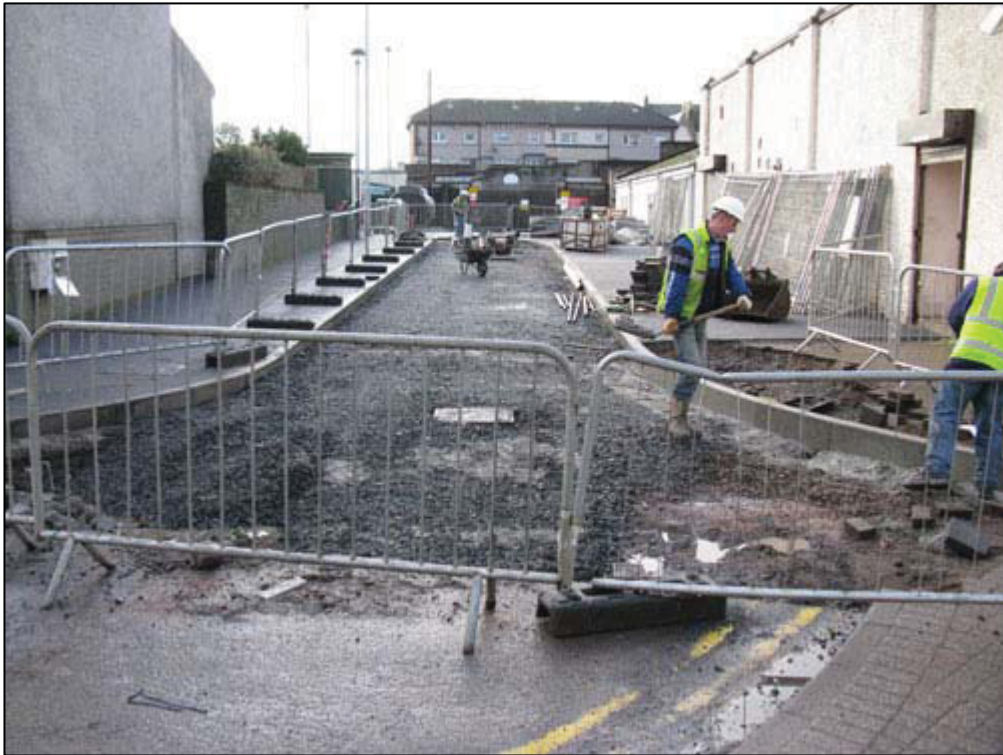
Figure 3a: Area1: Work in Progress

21. Archaeological monitoring was also carried out along the road between the Abbeygate car-park and the Post Office sorting office (Figure 3a), running parallel to Main Street. Both the north and south sides of this road were subject to refurbishment and archaeological monitoring. This involved ground reduction to a minimum depth of 300mm plus additional depth for the placement of kerbing and the placement of services. During this work, on 28th of June 2009, a small section of cobbled surface (021) (Figure 3b) was reached on the south side of the lane at the maximum depth of excavation. Approximately 1m by 0.6m of cobbled surface was exposed and recorded. No additional significant archaeological material was observed during the works in this area.

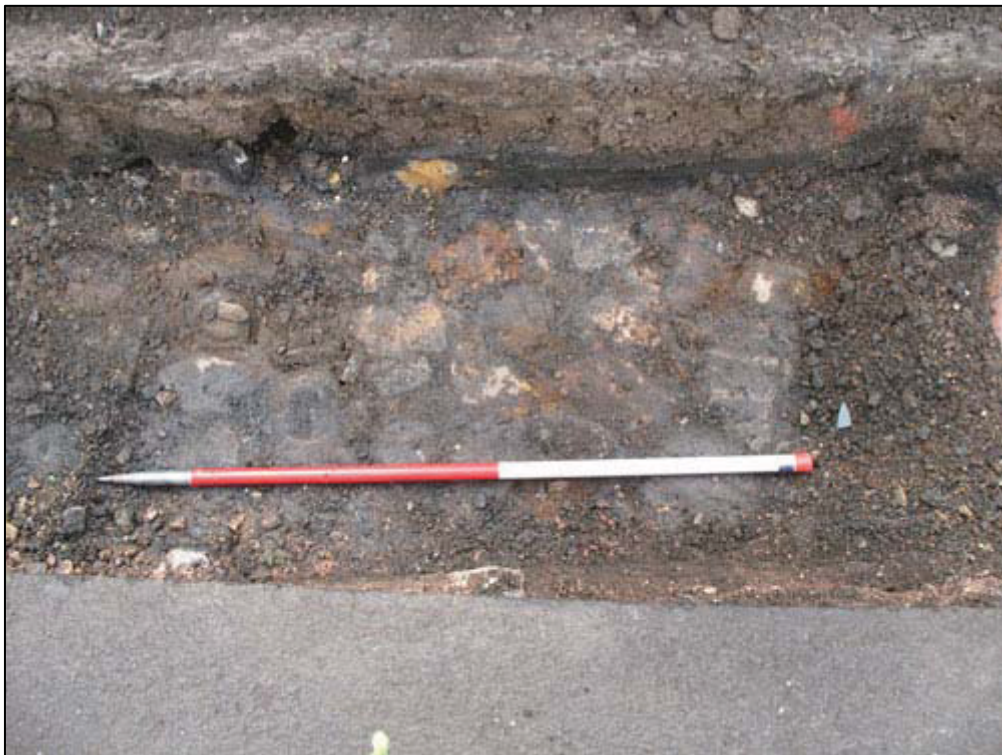
Figure 3b: Area 1: Cobbled Surface (021)

59. In only three places within the development area were potentially significant archaeological deposits uncovered. The small area of cobbles within Area 1 probably represented an old road surface but without any associated features or artefacts, this interpretation must remain speculative. Similarly the small section of wall recorded to the west of Area 2 survived without associated features or material and, at the depths recorded during these works, was surrounded by modern made ground. The third, the East-West linear feature recorded in close proximity to the abbey gates in Area 3, also proved problematic in that only a small length was exposed, it was disturbed by later activity on the site and proved to be utterly sterile and devoid of artefacts when investigated. From the general character of these features, it seems likely that they date to the modern period, perhaps the late eighteenth century. Both the wall and the linear feature followed a roughly east-west alignment, consistent with the streetscape as shown on historic mapping.

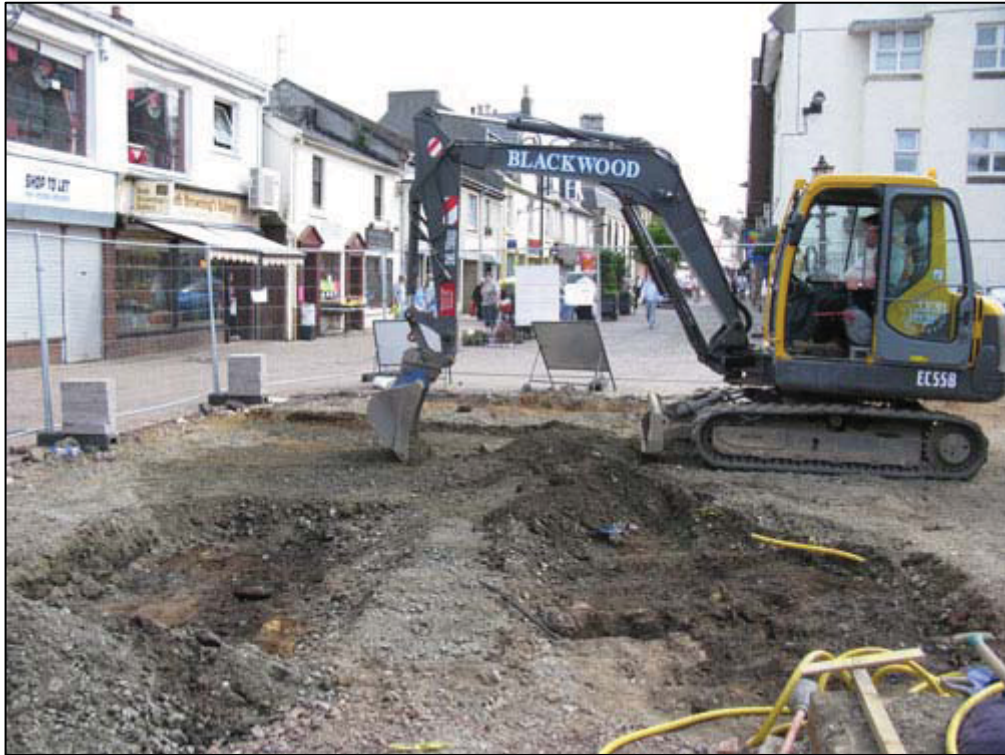
Figure 4a: Area 2: Ground Reduction in Progress

26. Ground reduction in Area 2 was carried out in sections to allow continued use of the Main Street by pedestrians. For this reason stripping immediately in front of No. 127 Main Street was not completed until the 25th June 2009. Reduction of the north side of the Main Street in Area 2 was monitored intermittently from 13th until the 18th of August 2009. In addition service trenches were dug for the placement of refurbished drainage. Often these excavations were carried out at least partially by hand due to the presence of existing services. At no point during these excavation works was significant archaeology located.

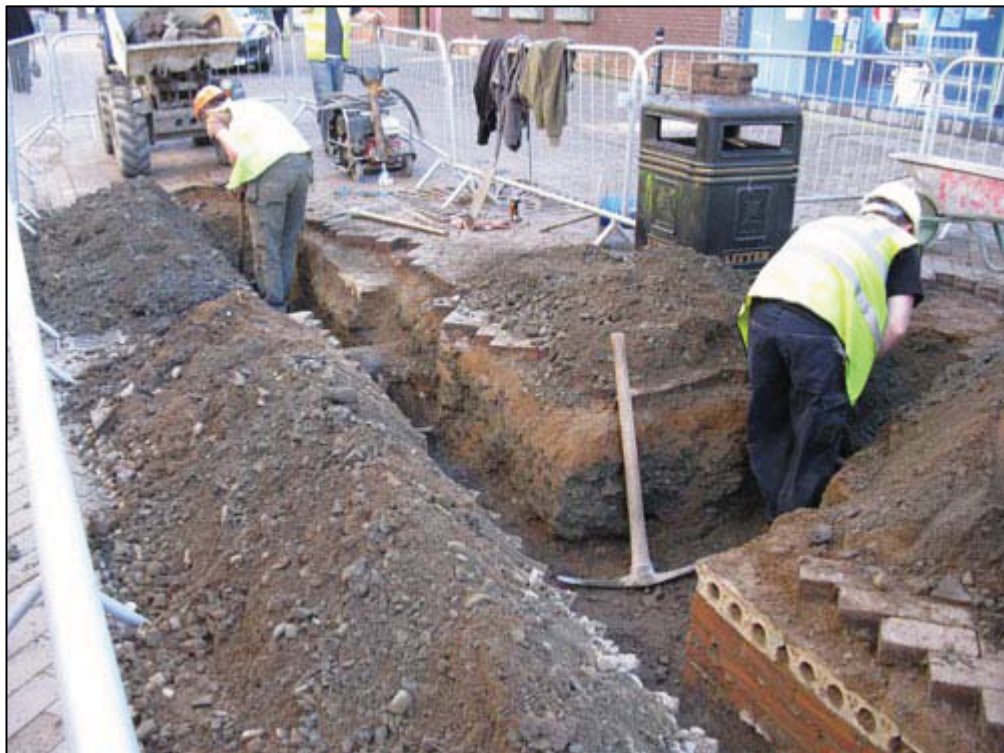
Figure 4b: Area 2: Excavation of Service Trench

28. The first works carried on in the eastern half of Area 2 comprised a service trench for street lighting (Figure 4b). This trench ran east to west along the centre of the Main Street; the sediments exposed in the course of this excavation were the same as those already described above.

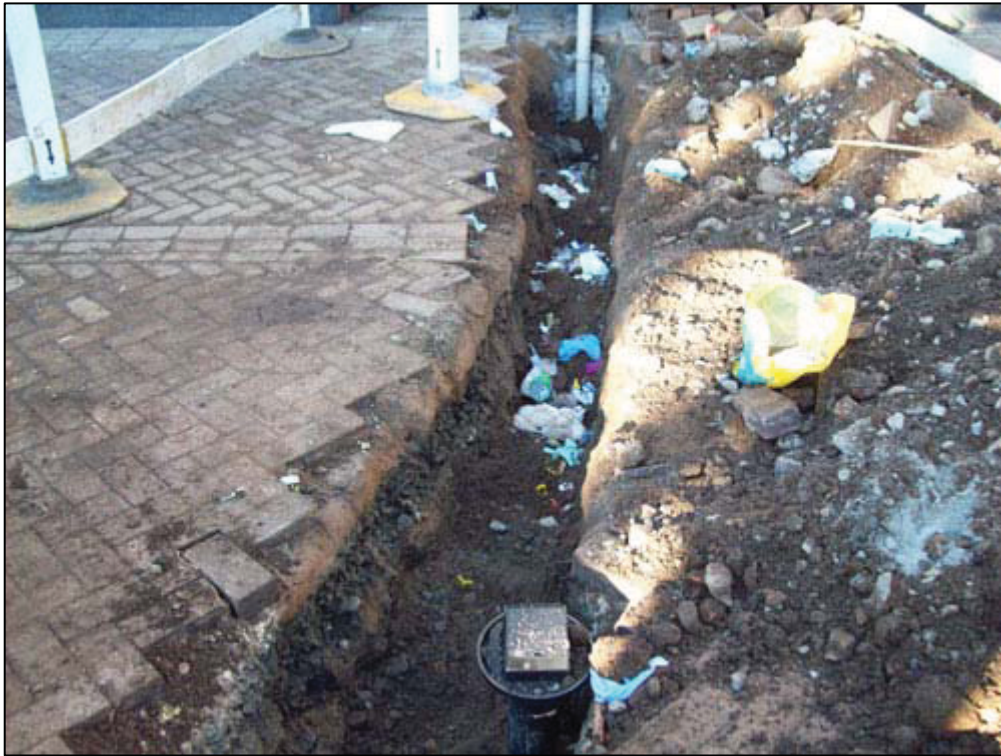
33. Excavation work was first carried out here on the 29th of January 2010 (Figure 5a). This work involved improvement of the existing gas services to adjacent buildings. Although this work was not a part of the refurbishment work, Rathmell Archaeology Ltd was on site and able to inspect the open trench. The trench was excavated to a depth of approximately 500mm and for a length of approximate 4m. Only made ground was evident in the section. The top 200mm was composed of sand and Type 1 bedding for the existing paving and the remaining depth consisted of dark brown silty-sand with fragments of brick. This trench was subsequently backfilled.

Figure 5a: Area 3: Initial Excavation for Services

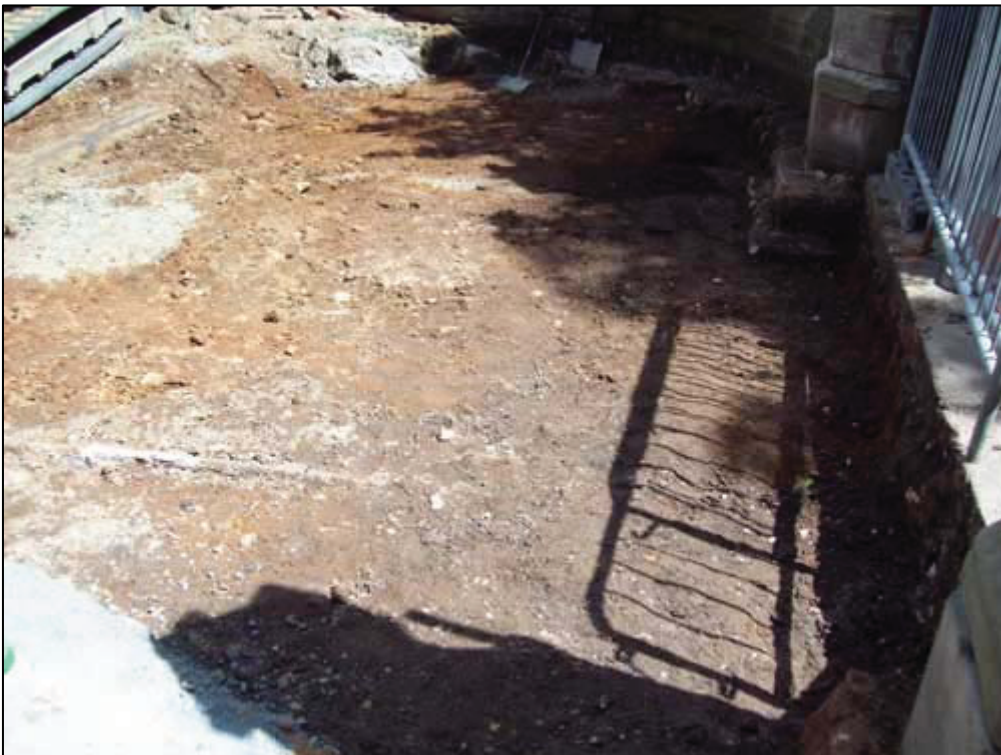
Figure 5b: Area 3: *In Situ* Old Ground Surface (023) Adjacent to 19th Century Boundary Wall.

by the survival of *in situ* original ground surface in the 'D'-shaped indent defined by the line of the nineteenth century gateway to the abbey grounds. The placement and density of services, especially in Area 2, has also meant that in many places at depths greater than 500mm any potentially significant archaeological deposits have been removed.

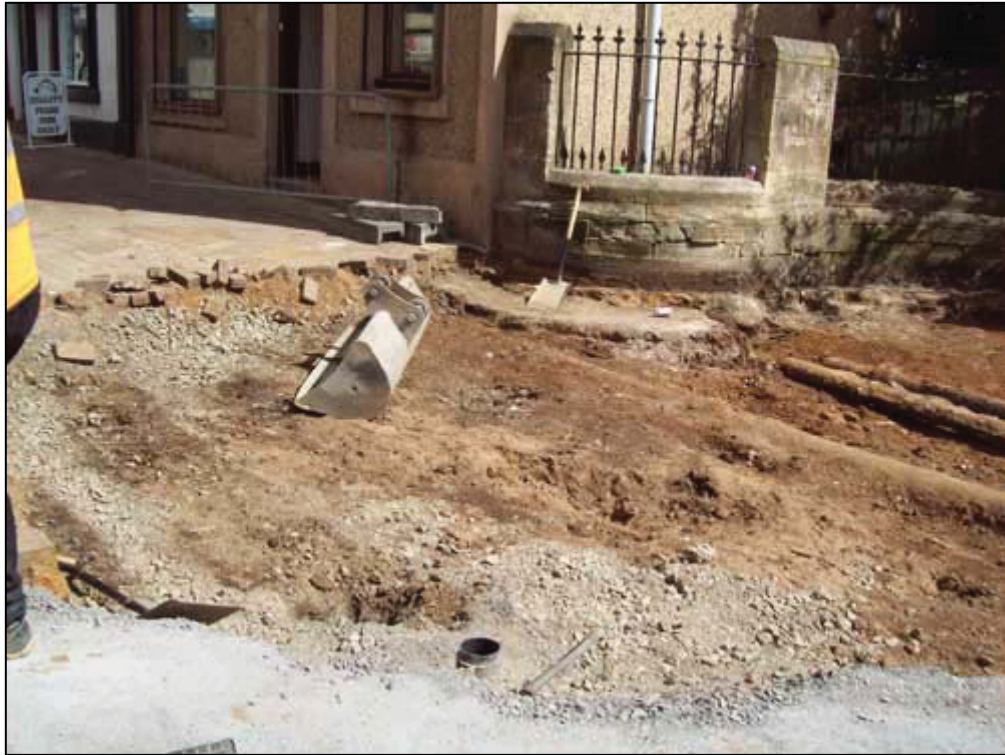
35. Work began in the south-west corner, in the area located adjacent to the nineteenth century gateway to the abbey grounds. The ground had been heavily disturbed, with a number of buried services running in both an east-west and a north-south alignment across the site. However, it was evident that at the south end, in an area extending approximately 2.5 north of the nineteenth century gateway, an area of intact original ground surface still survived (Figure 5b). To the north of this, disturbance resulting from the digging of the buried services had obliterated all traces of this earlier ground surface to a depth of 450mm (Figure 6a).

Figure 6a: Area 3: Disturbance caused by 19th & 20th Century Service Pipes

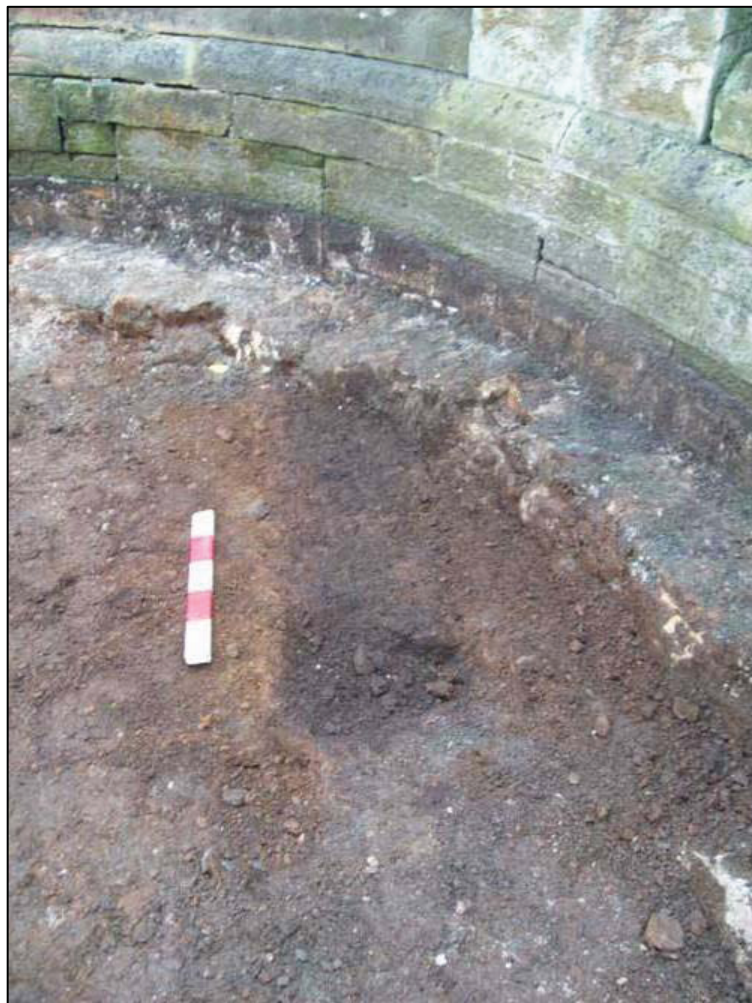
36. The situation was similar along the eastern strip of the area, which had been left in situ in order to allow access to the abbey grounds. Once again, the original ground surface survived intact for a distance of 2.5m to the north of the nineteenth century gates and boundary wall to the abbey. Here, however, there was a feature of potential archaeological significance identified. This comprised a linear feature running in an east-west direction, which measured 0.6m wide and extended for a distance of 3m from beneath the line of the boundary wall (Figure 6b).

Figure 6a: Area 3: Linear Feature [024]/(025)

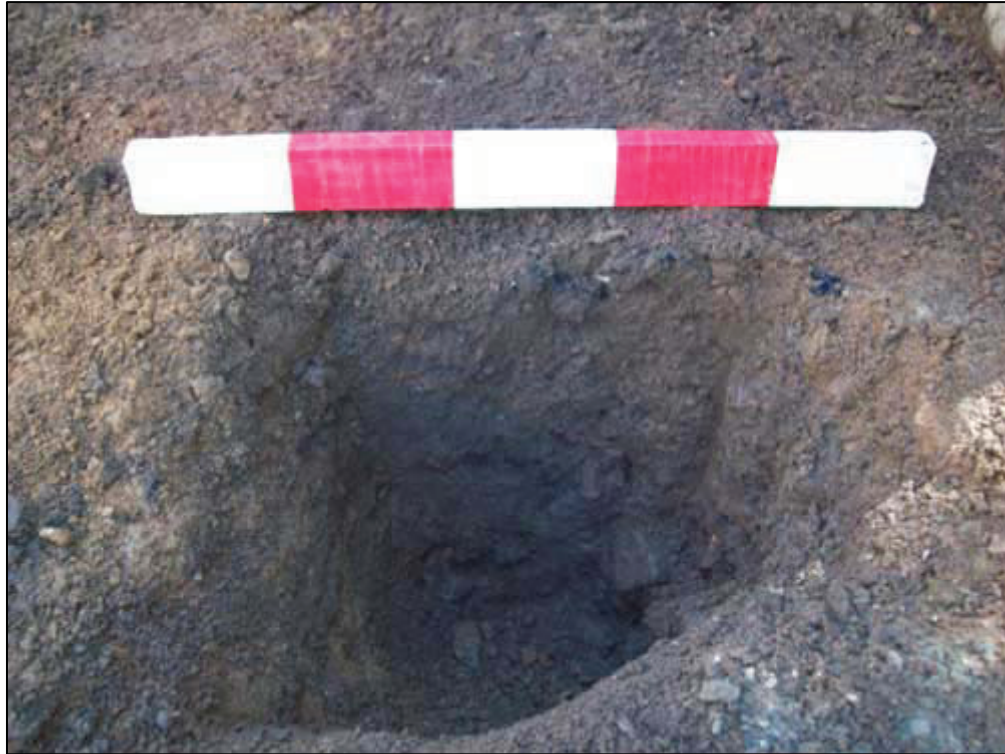
37. The feature was sectioned, revealing a U-shaped cut 0.3m deep with a dark-brown, silty-sand fill (Figure 7a). The fill contained occasional tiny fragments of burnt bone and charcoal, but unfortunately revealed no artefacts. It was also truncated by the foundation trench for the nineteenth century gatepier [028]/(029) which stood nearby. Judging from the linear feature's alignment and characteristics, it seems likely to represent either a ditch, or the robbed out remains of a foundation trench, perhaps associated with one of the buildings shown on the Ordnance Survey 1st edition map of 1856.

Figure 7a: Area 3: Linear Feature [024]/(025) Cut by Foundation Cut for Gatepier [028]/(029)

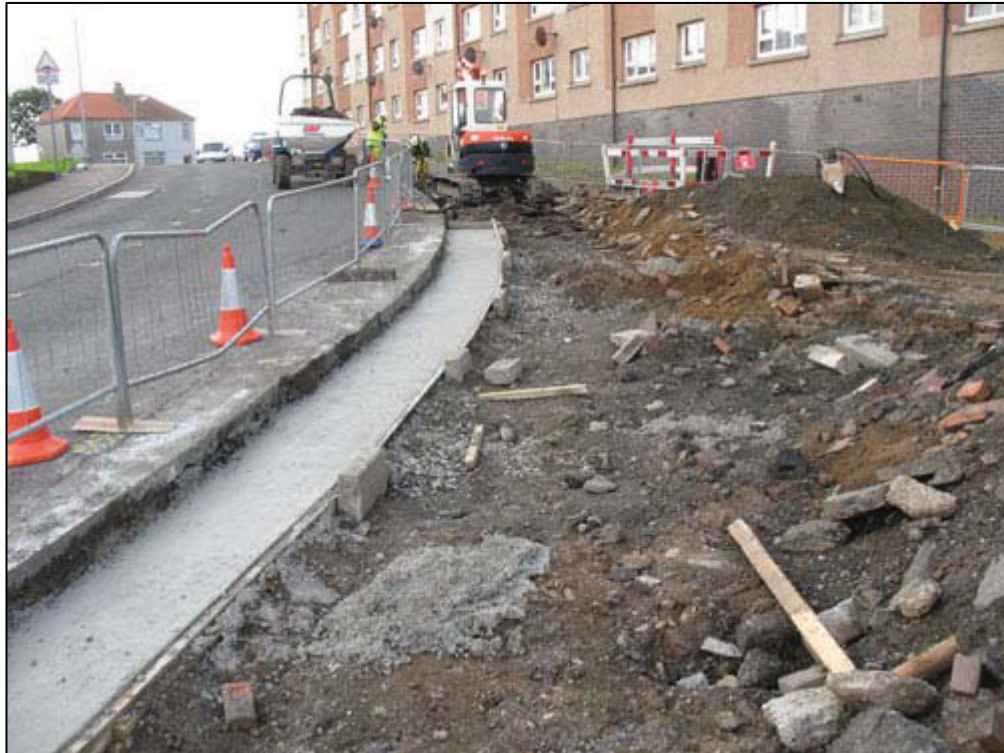
40. Rathmell Archaeology Ltd was able to monitor the removal of paving and ground reduction in the area between the east end of Main Street and the road on Church Street (Figure 7b). The southernmost portion of this area was resurfaced with the new paving, while the rest remained untouched. At no point during the refurbishment of this area did excavation works disturb anything other than made ground. Predominantly this consisted of bedding material for the original paved surface comprising bedding, sand and Type 1. However, cuts for service trenches reached dark brown silty-sand with fragments of brick.

Figure 7b: Area 4: Work in Progress

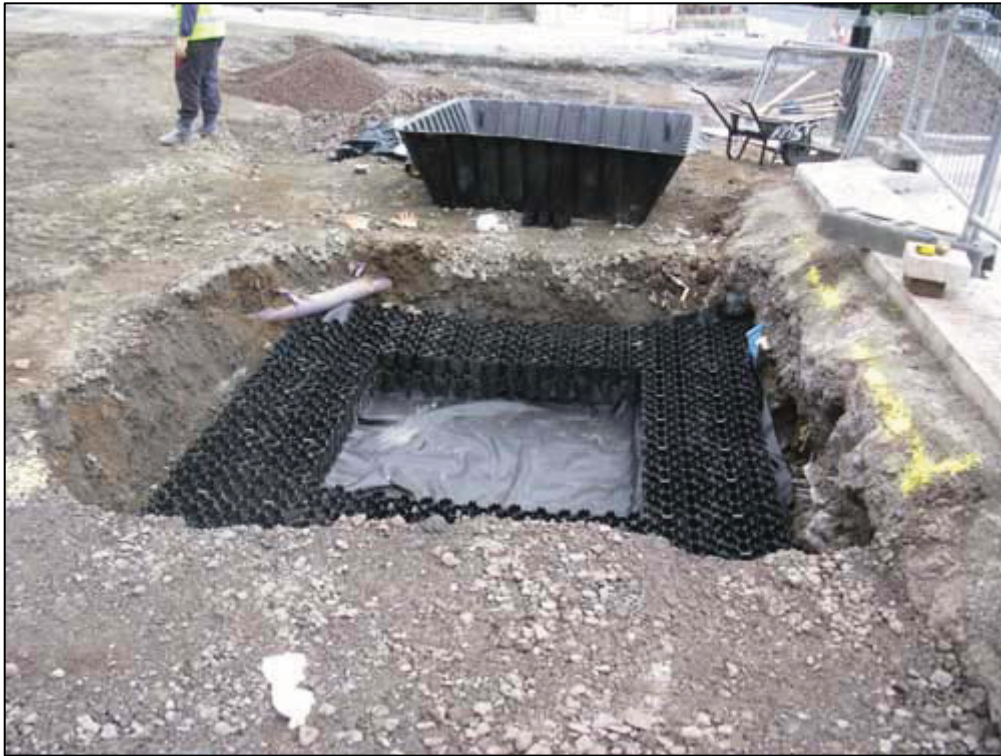
Figure 8a: Excavation of Tree Pits in Progress

43. Between the 23rd and the 27th July, 2010, the last phases of work in this area were carried out. Three large pits measuring 3 x 3m in extent and reaching approximately 1m deep were dug in various locations along the eastern edge (Figure 8a). Again, these excavations did not extend below the levels of the made-up ground.

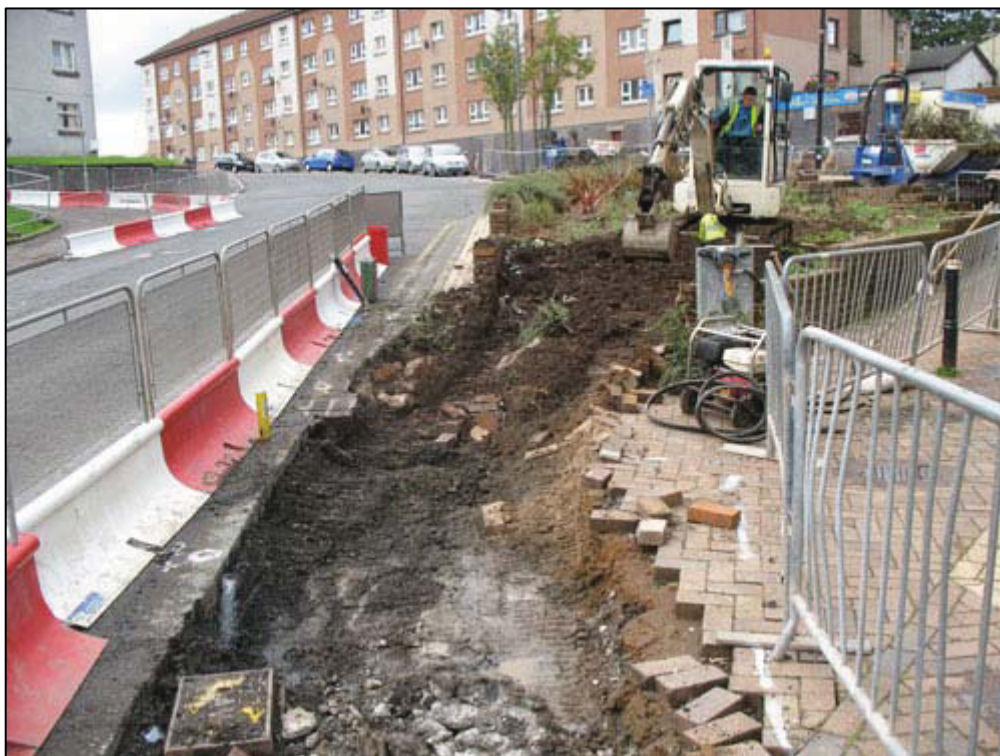
Figure 8b: Area 4: Initial works – Removal of Extant Flowerbed

45. Archaeological monitoring in Area 5 took place on an intermittent basis between the 11th of August 2009 and the 7th July 2010. The majority of the work carried out in this area during the Phase 1 works involved the removal of an existing raised flowerbed, lifting tarmac and kerbstones (Figure 8b). This revealed a pre-existing recent road surface. This was also removed along with portions of the surrounding tarmac and kerbstones. In addition, a service trench was excavated and monitored, with works commencing on the 26th of August 2009. This trench continued to a depth of 700mm, the first 400mm of which comprised bedding for the road, and the lower 300mm made ground. The removal and replacement of kerbing continued north round the corner into Lauchlan Way (Figure 9a).

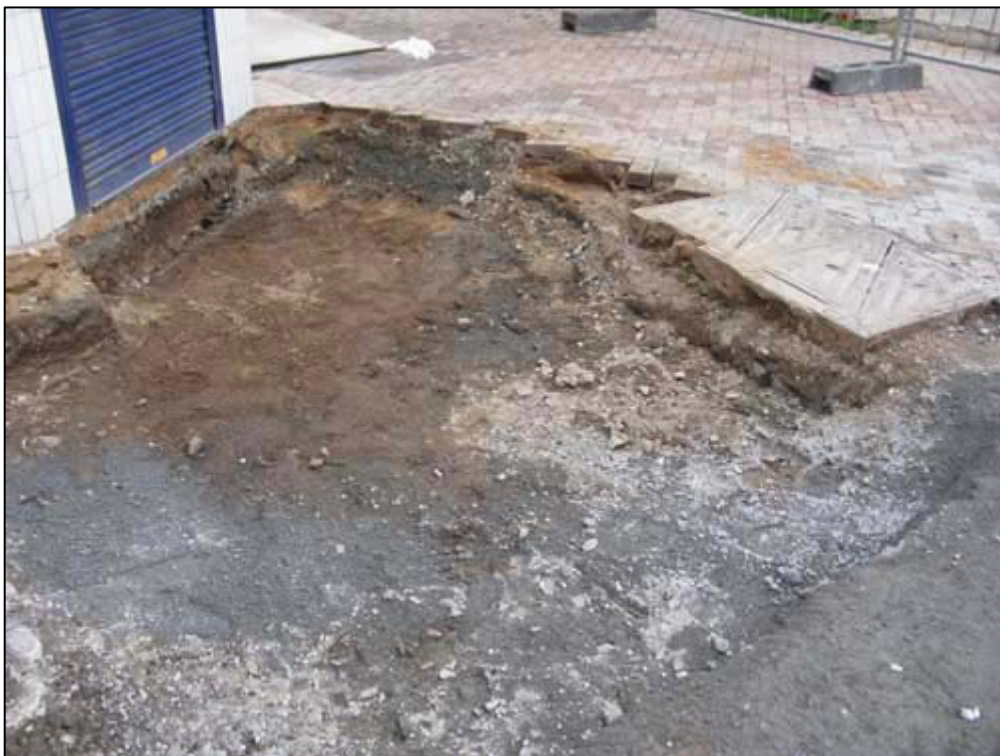
Figure 9b: Area 6: Works Commencing

47. This area comprised the lane running roughly north-northwest to south-southeast between Numbers 66 and 72 Main Street. This was the last area to be subject to monitoring, with works carried out between 23rd July 2010 and 19th August 2010.
48. The first area to be cleared here was that lying to the fore of the adjacent shop fronts at Nos. 66 and 72 (Figure 9b). Ground reduction took place to a depth of 300mm, revealing a heavily disturbed area of red-brown silty sand, apparently redeposited, with numerous buried services present. Work progressed northwards along the lane from Main Street, again reaching a depth of approximately 300mm and again revealing the heavily-disturbed and re-deposited red-brown silty sand cut by services.
49. Nothing of archaeological significance was identified in this location.

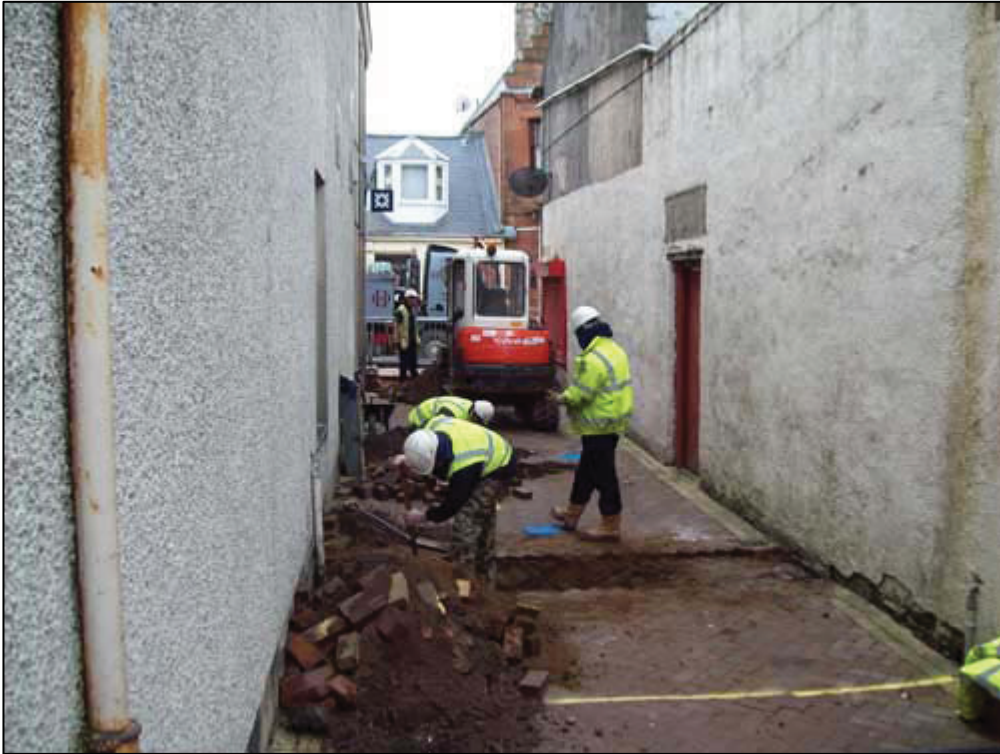
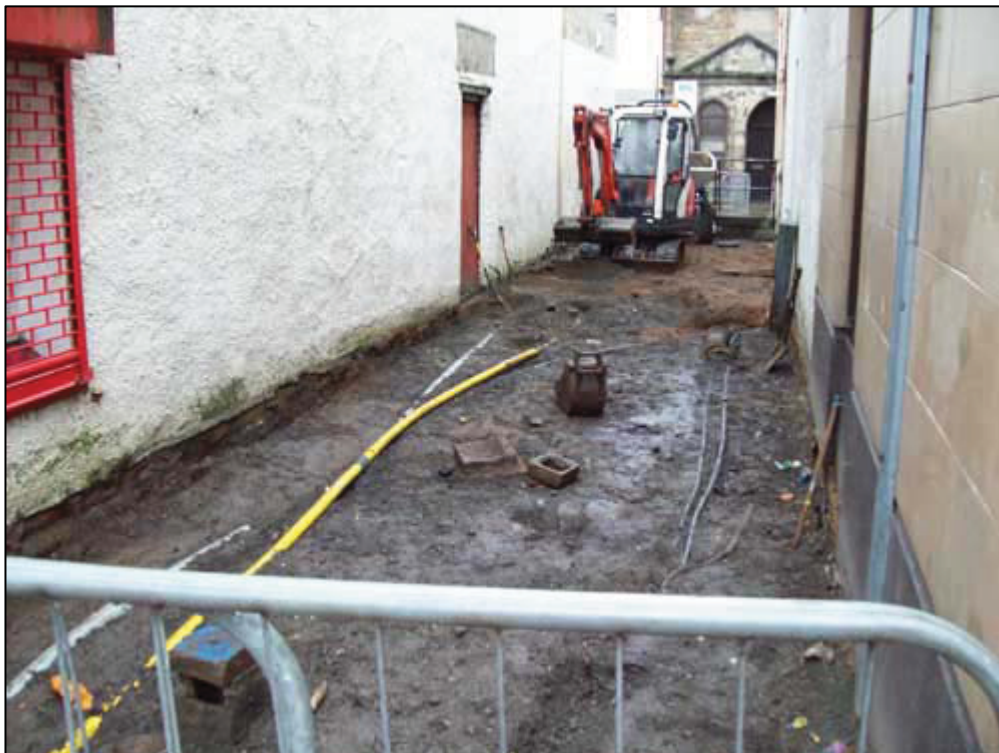
50. Area 7 comprises the lane running north-northeast to south-southwest between 102 and 104 Main Street. The main body of work took place here between the 23rd and the 27th March, 2010. This comprised ground reduction to a depth of 450mm, carried out using a combination of machine- and hand-digging (Figures 10a and b).
51. Throughout this area, the underlying layers were similar to those encountered elsewhere, namely a bedding layer of mixed sand and Type 1, overlying made ground which extended down to the base of the excavations. A number of buried services were revealed, along with several modern concrete strip founds.
52. The final phase of works which impinged upon this area was the ground reduction to a depth of 300mm in the area lying before the frontages of the adjacent properties. These revealed the foundations of the nineteenth century buildings.

Figure 10a: Area 7: Initial Works

Figure 10b: Area 7: Ground Reduction Completed

53. No features of archaeological significance were identified in this particular location.

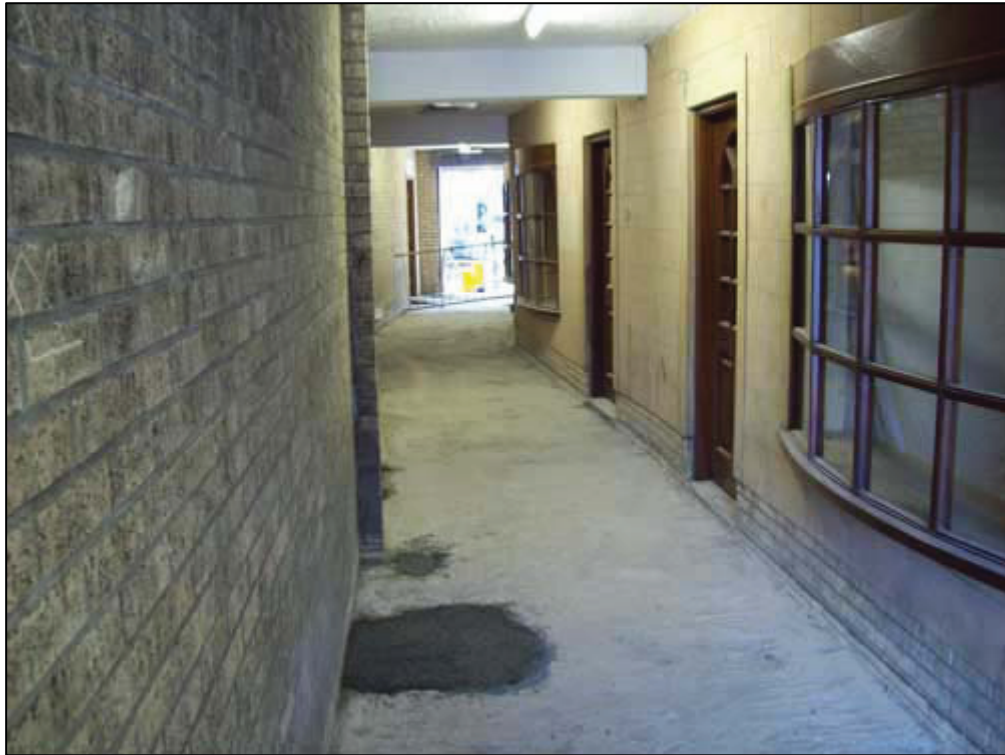
Figure 11a: Area 8: Work in Progress

54. This area is the lane which runs north-northeast to south-southwest and which is located between 116 and 118 Main Street. Work was undertaken here between the 20th and the 30th April, 2010. It comprised the breaking and removal of *in situ* concrete slab, with subsequent repaving work (Figure 11a). No features of archaeological significance were uncovered during these works.

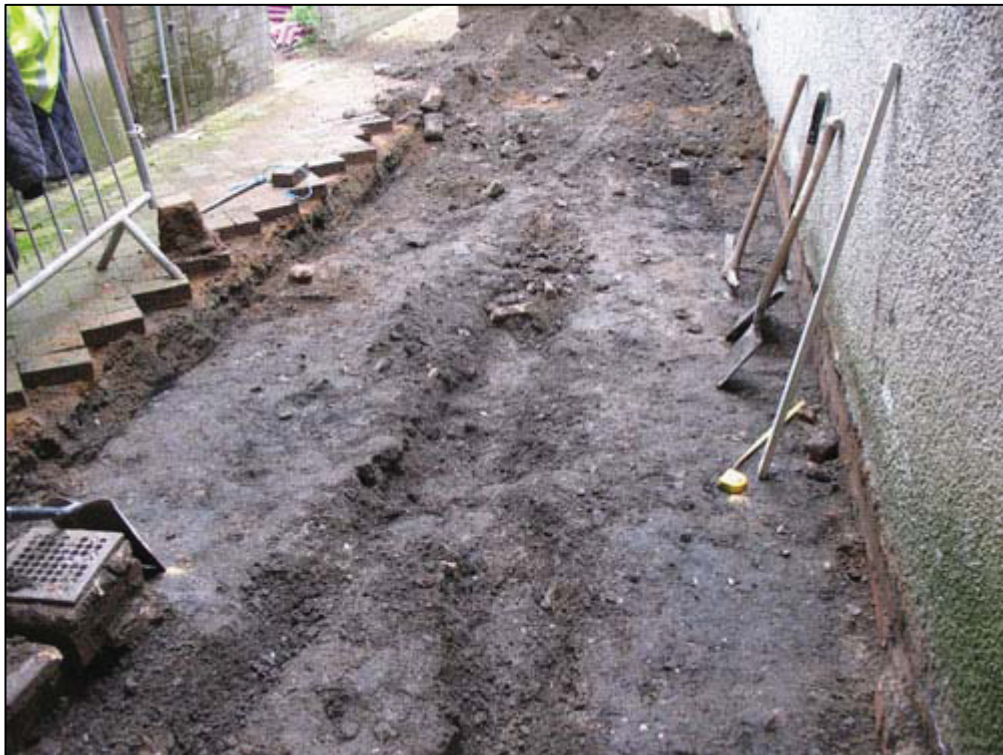
Figure 11b: Area 9: Ground Reduction in Progress

55. Area 9 is the lane which runs north-northwest to south-southeast between 132 and 136 Main Street. Archaeological monitoring was carried out in this area from the 11th until the 31st of August 2009 (Figure 11b). This work began with the hand digging of the western side of the lane before progressing to include the entire area. This was reduced by approximately 350mm, though in some places this increased to as much as 500mm. Only made ground and type 1 were exposed in the course of the works. The made ground consisted of dark brown silty-sand with frequent fragments of modern brick. The works also included service channels cut for ducting and the placement of a gully pot, but the latter lay outwith the archaeologically sensitive area. None of the works exposed any significant archaeology.

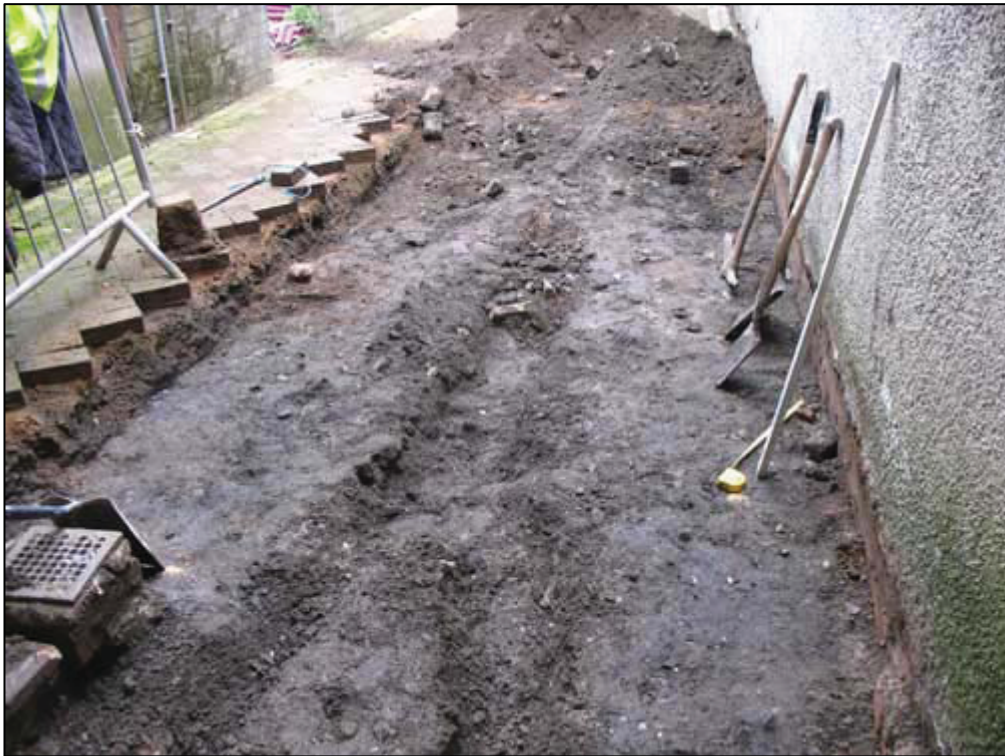
Figure 12a: Area 10: Ground Reduction in Progress

56. Area 10 covered the lane running north-northwest to south-southeast between 144 and 148 Main Street. It was subject to intermittent archaeological monitoring from the 11th to the 28th of August 2009. The southern half was reduced initially, followed by the northern portion. Works were carried out to a depth of 350mm, i.e. sufficient to remove the existing paving (Figure 12a). Typically it was found that the paving had been bedded on concrete and so the only sediments disturbed by the works were concrete and, beneath that, made ground consisting of dark brown silty-sand with fragments of brick. No significant archaeological material was uncovered in the course of these works.

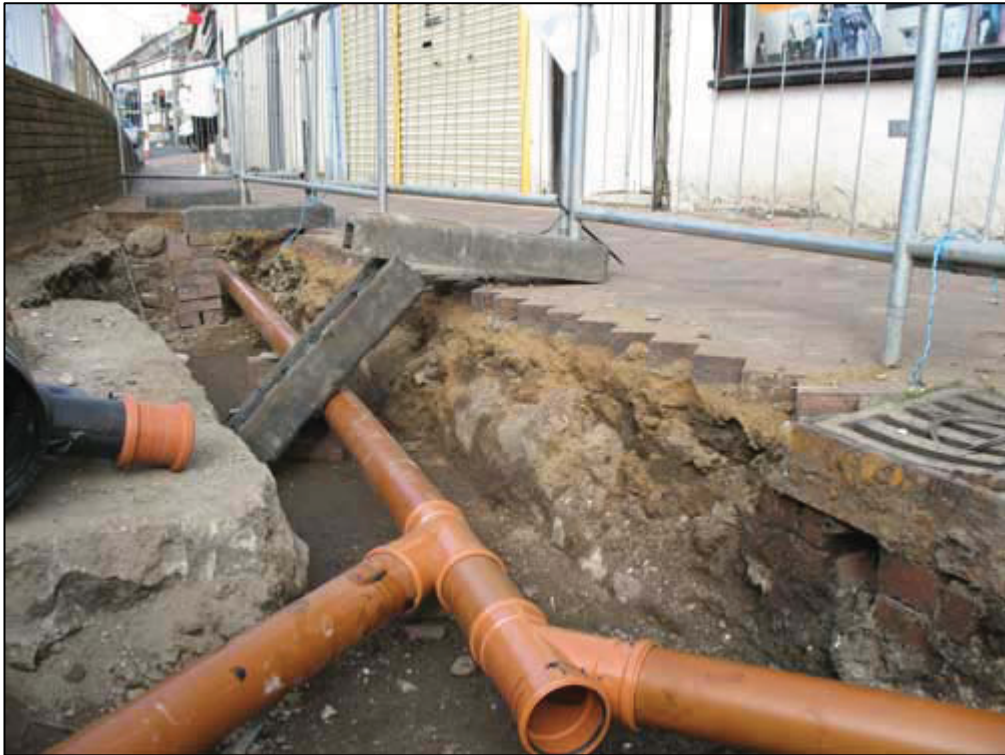
57. Final mention should be made of additional work carried out the defined areas of interest. On 17th of June 2009, Rathmell Archaeology Ltd staff were called out to record, at the request of the main contractor, a short stretch of sandstone walling (018) which had been exposed during works. The wall ran parallel to the frontage, at a distance of 1.6m, on the north side of Main Street close to the junction with Almswall Road (Figure 12b). It was not mortared and consisted of two courses of unworked rubble sandstone blocks which ran approximately east-west for 4m, broken by a service track in the centre. The wall, which was not associated with any other significant find or feature, was surrounded by made ground containing only modern material, and so little information could be gained from examination at this depth. Further examination was outside the scope of this work.

Figure 12b: Wall (018), to W of Area 2
