**Castle Hill, Lochmaben Golf Course:
Archaeological Assessment**

Data Structure Report

Rathmell
Archaeology Ltd

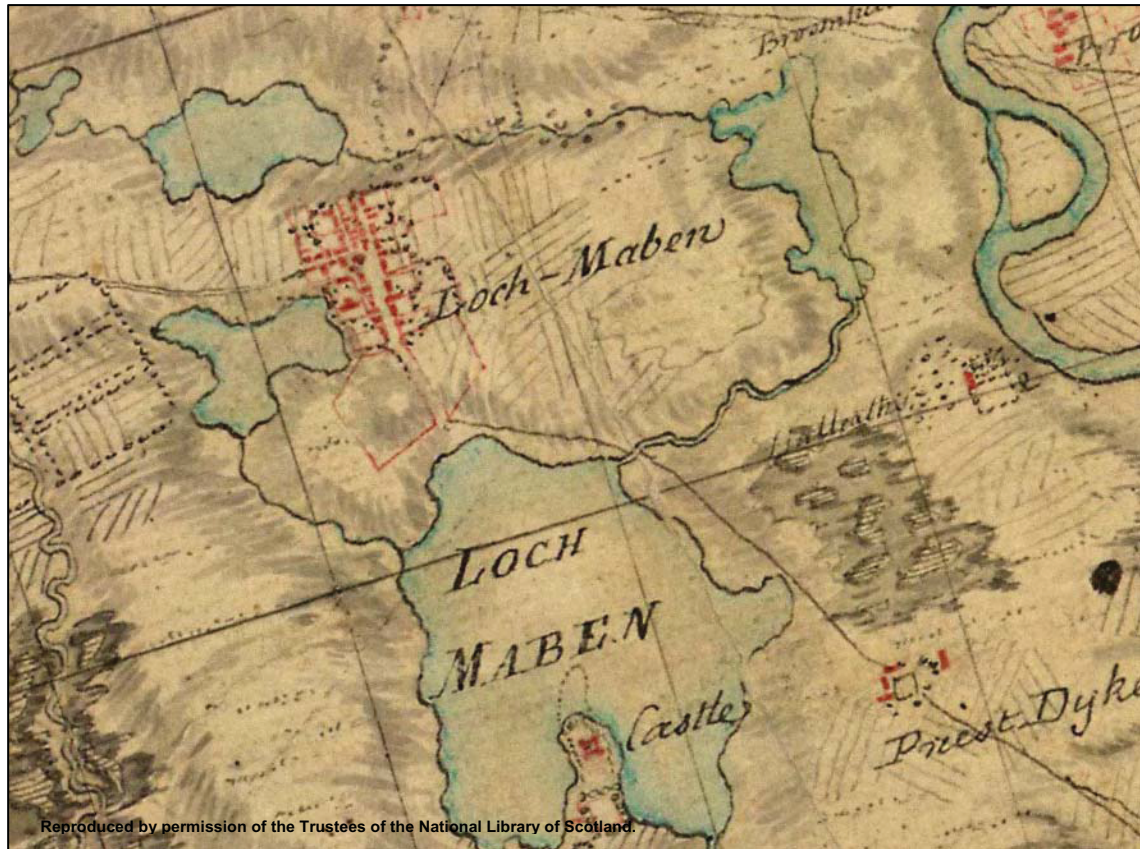
16. The earliest informative mapping which provides an insight into the town's development is William Roy's Military Map of 1747-55 (Fig. 1a). Here, the town plan is clearly shown, with its main street running N-S and a wide central market place. The surrounding area is subject to widespread cultivation, as denoted by the representations of rig-and-furrow shown throughout. While the motte is not itself shown, the area where it is located is

Fig. 1a: Extract from Roy's Military Map of 1747-55

depicted as an enclosed hill. Of note is that Castle Loch and Kirk Loch are both depicted as being more extensive in the mid eighteenth century with the motte benefiting, in defensive terms, from its placement between them.

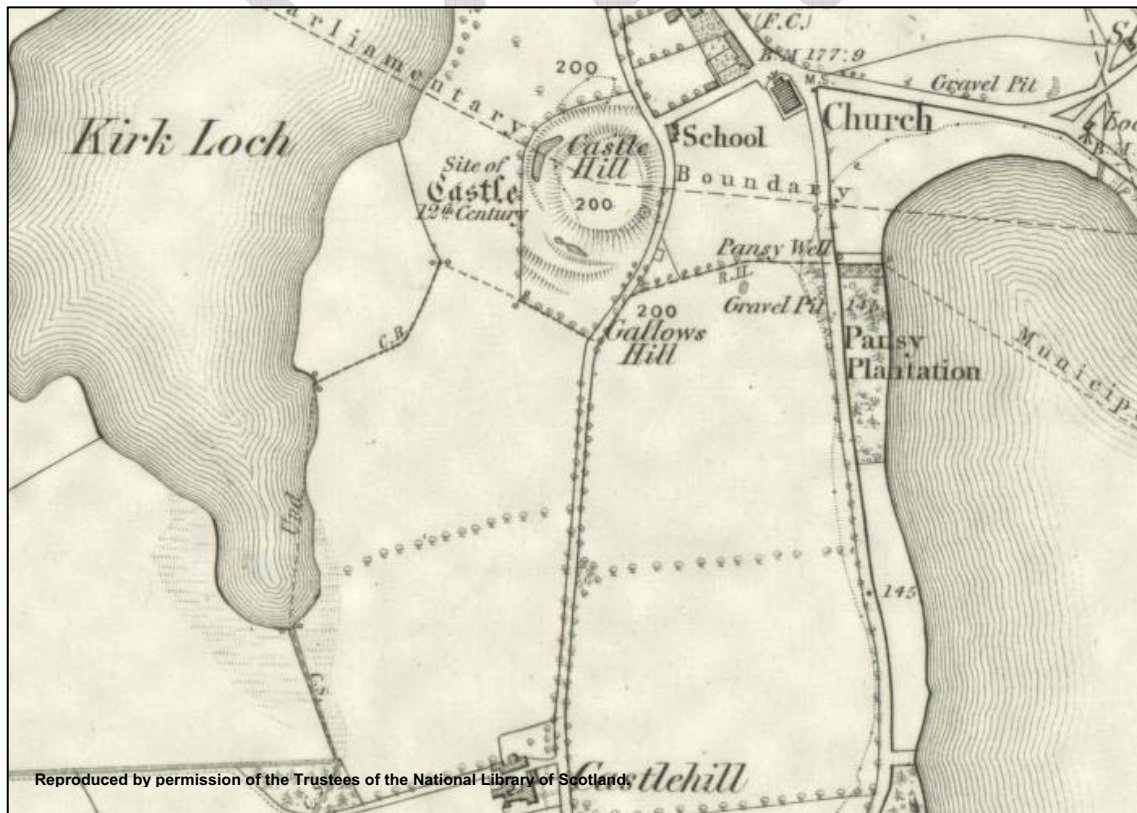
Fig. 1b: Extract from 1st Edition Ordnance Survey Map of 1856

17. By the mid-19th century, when the 1st edition Ordnance Survey map of Dumfriesshire was surveyed, upstanding antiquities were routinely depicted, and the Lochmaben Motte is no exception (Fig. 1b). It is clearly shown as an upstanding earthwork comprising a central mound with two parallel ditches lying to the south-east. The primary, closest motte ditch is shown as holding standing water in the north-west and south sections of its circuit. The monument is contained within an enclosure, the outline of which is still partly visible today and is followed by the modern scheduled area.

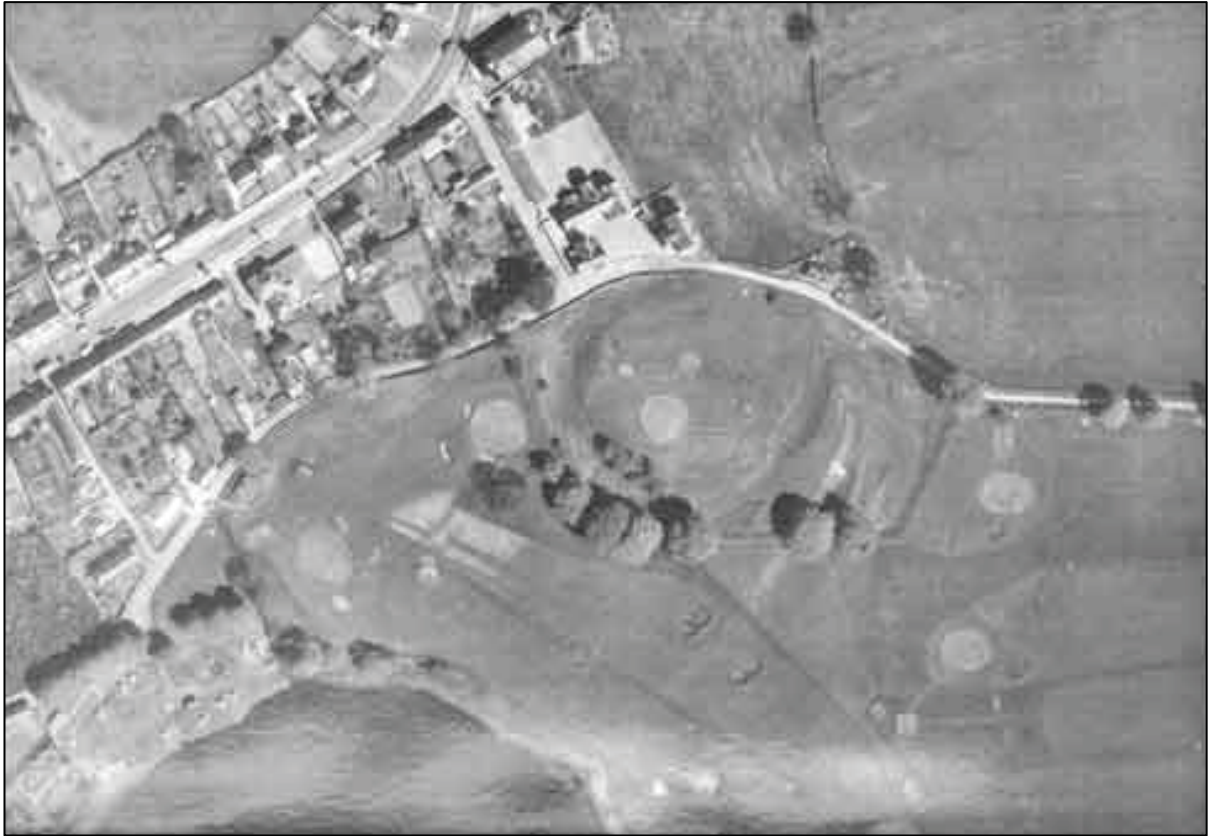
20. The motte is utilised for the golf course throughout this time, but it seems likely that prior to 1948, its surface had not been extensively modified into tees, greens, etc. Instead, the tees and greens appear to comprise mown areas of grass on a pre-existing ground surface. By 1966, these informal arrangements had been replaced by more clearly-defined earthworks.

Fig. 3a: Vertical aerial photograph showing Lochmaben Motte prior to enlargement and build up of tees, etc. (c.1948)

30. The western, northern and eastern flanks of the monument were covered by rough grasses, willow herb, woody scrub and trees. This contrasts with the historic condition of these slopes (see Figs 3a and 3b) which have consistently supported trees, but appear to be otherwise only clad with rough grasses. Some whin bushes have also established themselves on the outer bank to the south, within the limits of the scheduled monument.

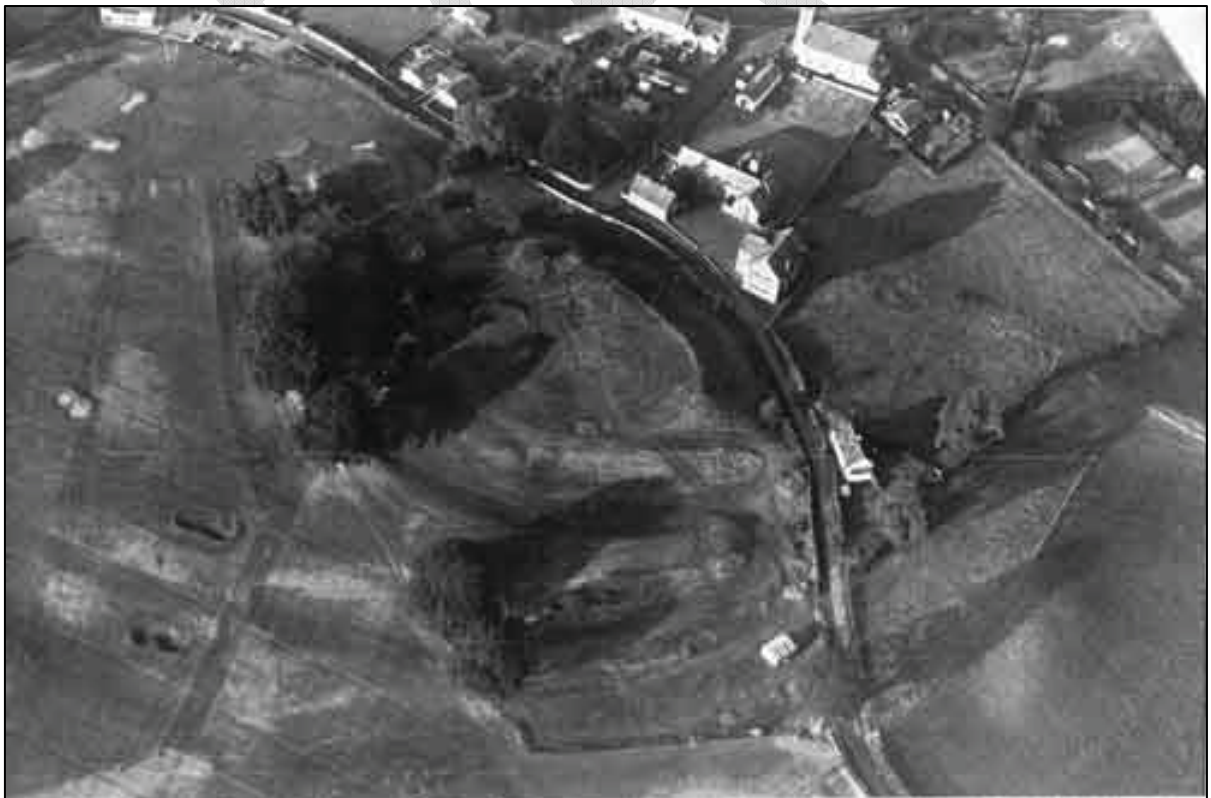
21. Oblique aerial photographs held by both the National Monuments Record and Dumfries & Galloway Council Archaeology Service help to show the nature and extent of the 1950's to 70's alterations to the surface of the motte more clearly (Fig. 2a & b).

Fig. 3b: Oblique Aerial Photograph showing Lochmaben Motte (c.1976)

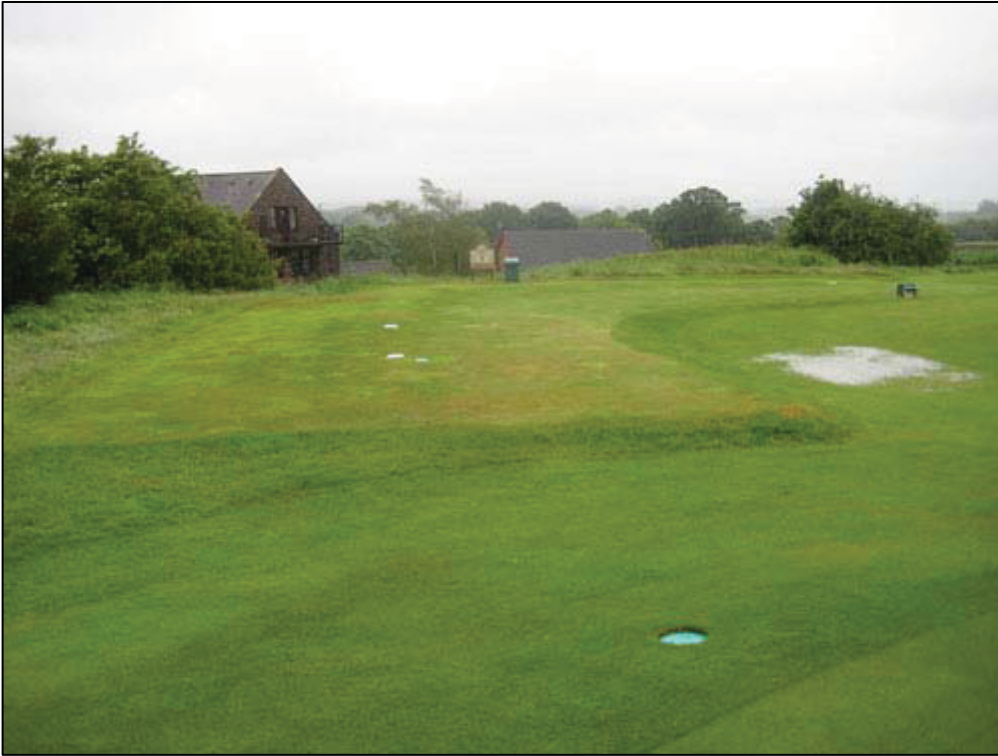
32. The tees for the 3rd hole are clearly raised level structures formed of imported material to the summit. A shell path, generally in good repair, falls from the southern edge of the summit to the southeast edged by a wooden rail.

Fig. 4a: Main Tee for 3rd hole on the summit area (from north edge 2nd Green), note standing water to front of raised tee

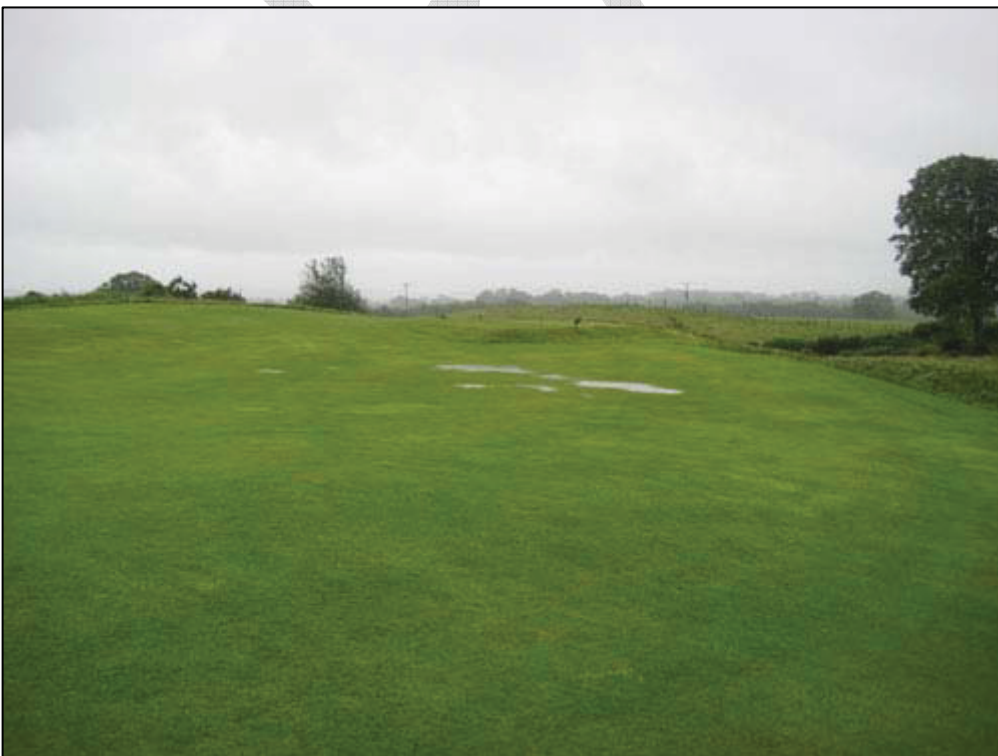
Fig. 4b: Secondary Tee for 3rd hole on summit area from west, note standing water in foreground, Gallows Hill visible to rear of shot.

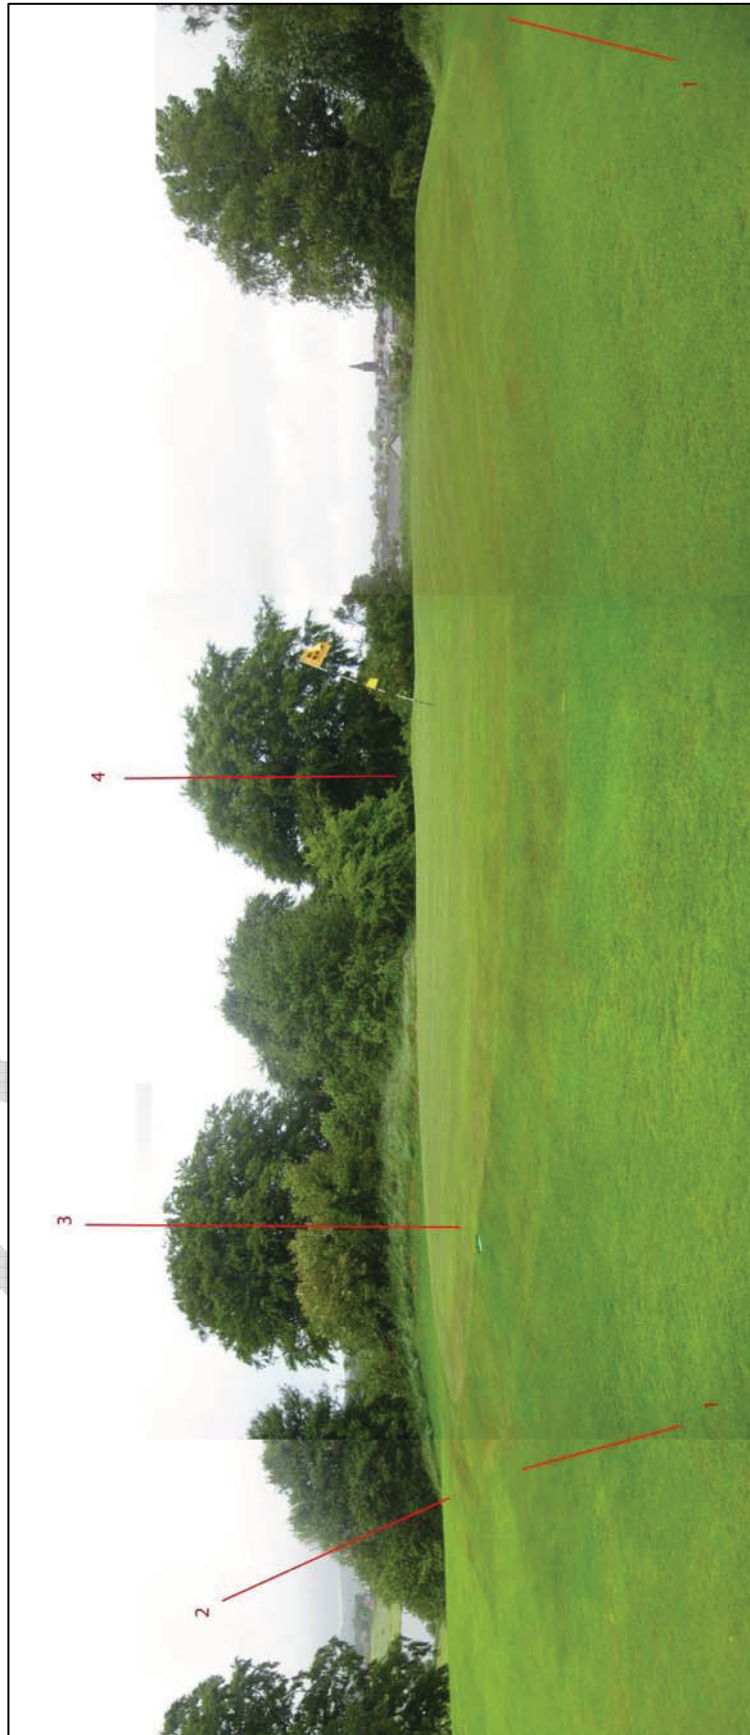
31. The green for the 2nd hole is clearly a raised, roughly level structure formed of imported material to the summit. There is a clear topographic break where the imported material starts; the scale of this is uncertain but the resulting feature is at least 400mm high. The green is ringed by a recessed sprinkler system which extends to the green from the tee for the 3rd hole to the northeast. The outfall for a drain from the green is identifiable to the northwest as the ground starts to fall from the summit.

Fig. 5b: Panorama of the 2nd Green from the east.

Key: 1 – break of slope, 2 – area for new drain where turf failing, 3 – recessed sprinkler system, 4 – outfall of main drain (out of shot at base of bush)

37. The works proposed by the Golf Club are designed to stabilise the drainage on the green and in particular the interface between the raised green and the underlying topography on its southern edge. This would be achieved through:

- a. insertion on 300mm grid pattern across the surface of the raised green of 600mm deep aeration holes to be filled with sharp gravel and coarse sand; and

- b. arcing catch drain (600 to 800mm deep) curving around the southern flank of the green draining to the northwest to either connect with or discharge at similar point to existing drain.
