**Dunduff Quarry Extension, South Lanarkshire:
Archaeological Survey**

Data Structure Report

by Thomas Rees and Claire Williamson

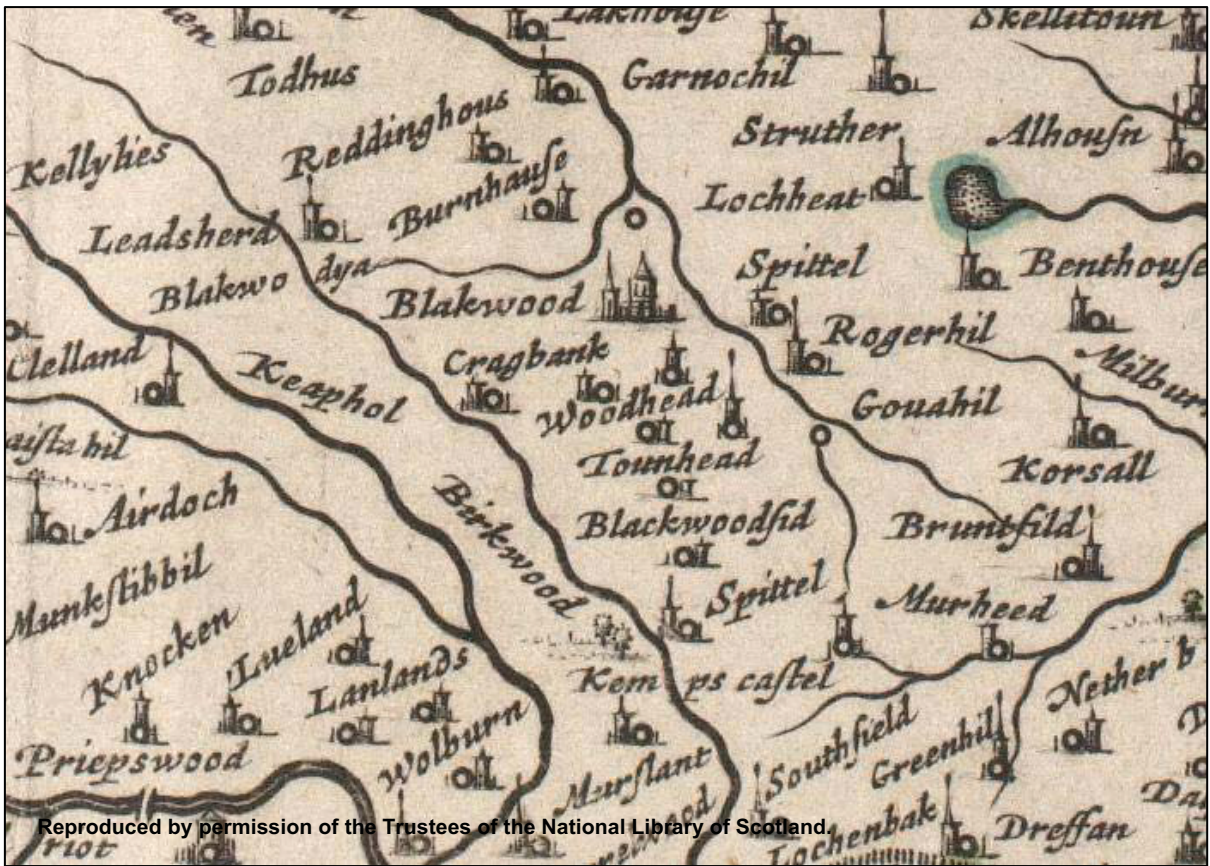
7. The earliest map evidence for the area is provided by Blaeu's map of 1654 (Figure 1a) which identified numerous significant settlements and several geographical features which can still be identified within the modern landscape. Like Blaeu, Moll's Map of 1745 features the most striking geographical features in the area (Figure 1b). Neither depict any settlements within the inferred areas of the quarry extension and access road.

Figure 1a: Extract from Blaeu's Map of 1654

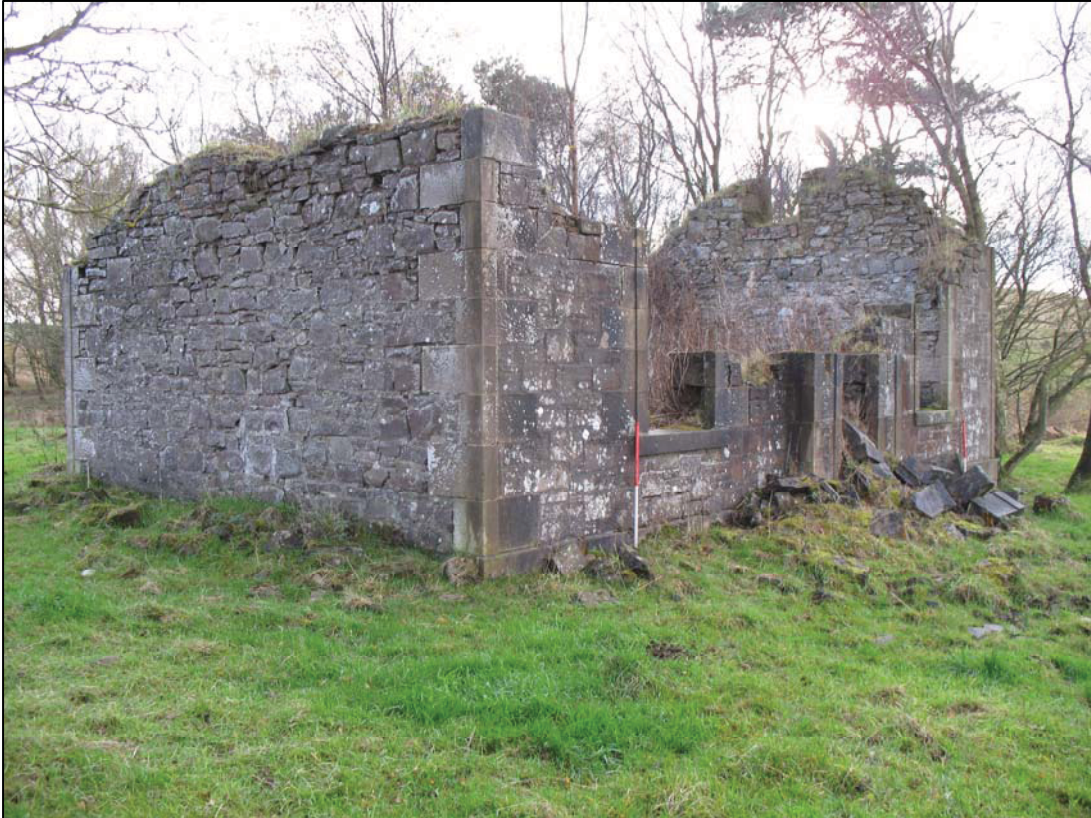
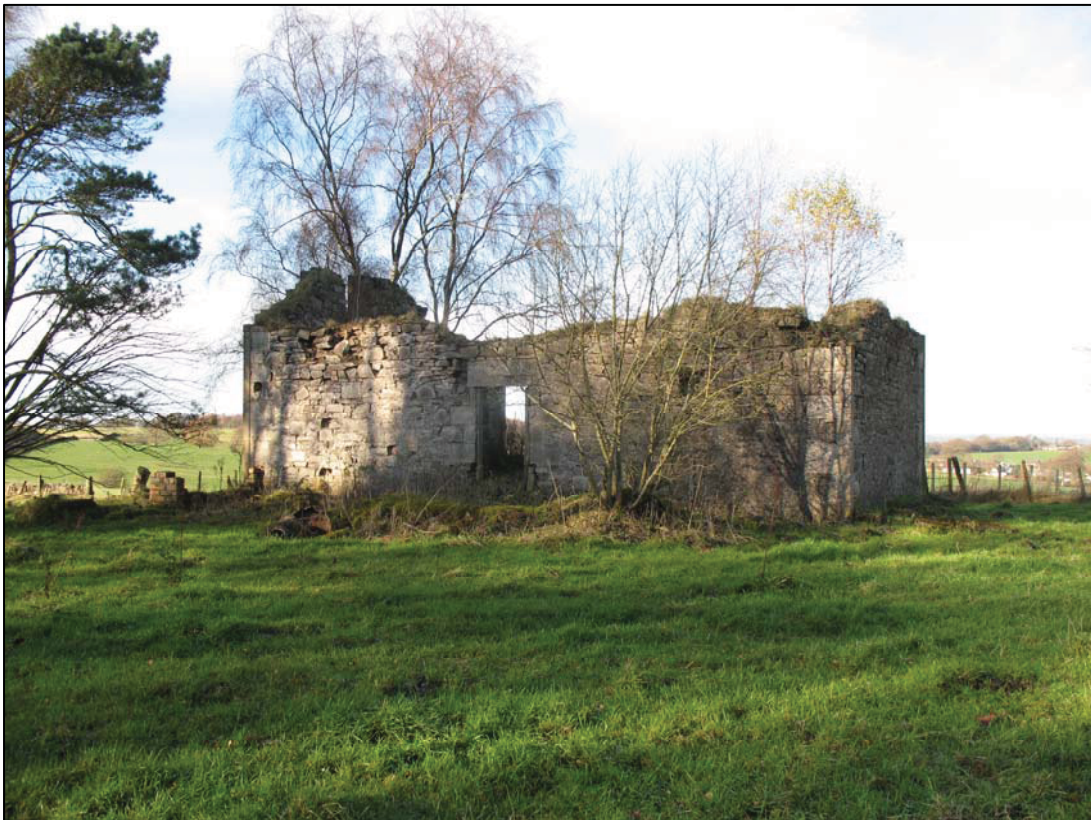
20. A walkover survey took place on the 9th November 2009 which inspected the proposed northern extension area and access route in its entirety.
21. The rectangular structure (S1) identified on the 2nd edition Ordnance Survey (1898) was inspected by the walkover survey and was characterised as a late nineteenth century dwelling (Fig. 5a & 5b). The core structure was some 10.8m by 6.2m and survives with all four walls standing to substantial height; the northern, front elevation is pierced by two windows and a doorway while the rear is pierced by a single doorway. The western gable is also pierced by a small window at height, while the eastern gable has evidence of a fireplace and aumbrey.

22. To the south, rear, of the structure there was evidence of some small extensions, some of which were constructed with brick. No evidence was noted of the enclosure depicted on the 1944 4th edition Ordnance Survey.

Figure 5a: Ruined Dwelling **S1**, front elevation from northeast

Figure 5b: Ruined Dwelling **S1**, rear elevation from southeast

35. The desk-based assessment and walkover survey revealed two archaeological features within the proposed extension area (Figure 6). The dwelling house (S1) is inferred to have been built within established woodland in the late nineteenth century (between 1860 and 1898 based on Ordnance Survey editions). The dwelling has been modified and expanded, identified through 3rd and 4th editions Ordnance Survey (1912 and 1941 respectively) and through the composite nature of the ancillary elements of the structure on-site during the walkover survey. The dwelling appears to have fallen into disrepair in the mid to late twentieth century. The relatively late and simple character of this dwelling leads us to ascribe it a 'local' significance.

44. Site 1 is the only archaeological site which has been assessed to be of local significance (in the absence of any regional or nationally significant sites) is not of sufficient significance where retention is appropriate within any proposed extraction scheme. Should the core structure be lost within the scheme we would recommend that the building is subject to a Level 1 survey in accordance with *Recording Historic Buildings: A Descriptive Specification* (RCHME Third Edition, 1996).

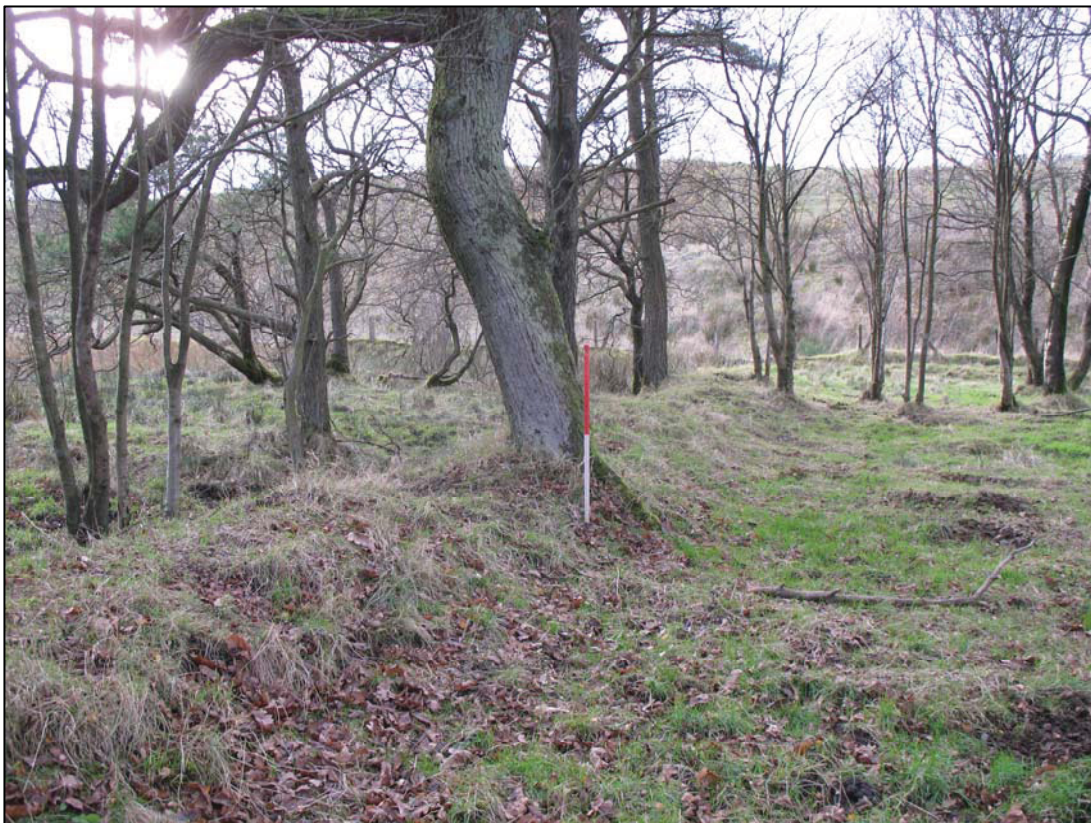
23. A denuded earthen bank (S2) was also identified to the south of the structure (Figure 6b), running roughly east to west through the unimproved ground which was predominantly covered by rough woodland. The bank was grass covered some 2m wide and 0.5m high where observed. The line of this bank matched closely the boundary between the retained woodland and the cleared ground depicted on the 3rd edition Ordnance Survey (see above).

Figure 6b: Enclosure bank **S2** to rear (south east) of dwelling **S1**

36. The earthen bank (S2) matches the line of a temporary felling limit marked on the 3rd edition Ordnance Survey of 1911. This suggests that this is an early twentieth century land boundary which may have marked more the limit of clearance of the woodland prior to the subsequent felling of the whole woodland block (as depicted on the 4th edition Ordnance Survey). The relatively recent date and simple character of this feature leads us to ascribe this site a 'nil' significance.

45. The balance of the identified archaeological sites that have the potential to be impacted by the extraction proposal (i.e. not Site 3 Muirhouse) have been assessed to be of nil significance being predominantly 20th century agricultural structures. Consequently no further archaeological mitigation is recommended in response to the loss of these specific archaeological sites.

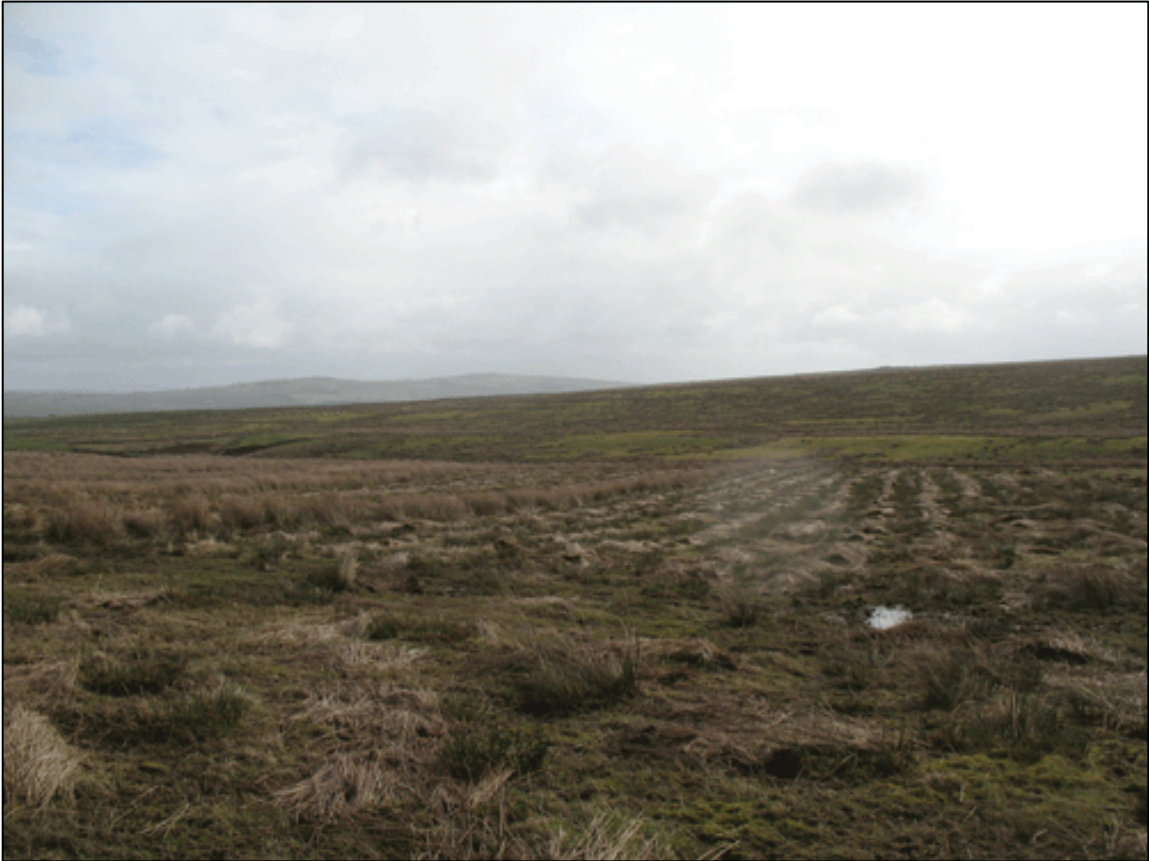
28. An area of possible rig and furrow (S4) (Figure 8a) was identified in the furthest northeast field running WNW-ESE. It sat in an area of unimproved poorly drained land and covered an area of approximately 98m by 35m. The rig and furrow appeared quite crisp and very easily identifiable while on site pointing to the likelihood that it is modern in date, possibly for drainage channels.

Figure 8a: Area of rig and furrow **S4**

41. While an area of rig and furrow (S4) has been recorded in the fields to the east, it is most likely modern, possibly the product of cutting a narrow interval pattern of drainage channels. The majority of the ground has reverted to being overgrown by reeds reflecting impeded drainage, although two fields to the immediate east of Muirhouse farmstead (S3) are in better condition. It does appear however, that all of the ground has, historically, been improved with the exception of the area of Muirhouse Plantation in the northwest which has appeared as woodland consistently through the Ordnance Survey mapping sequence.

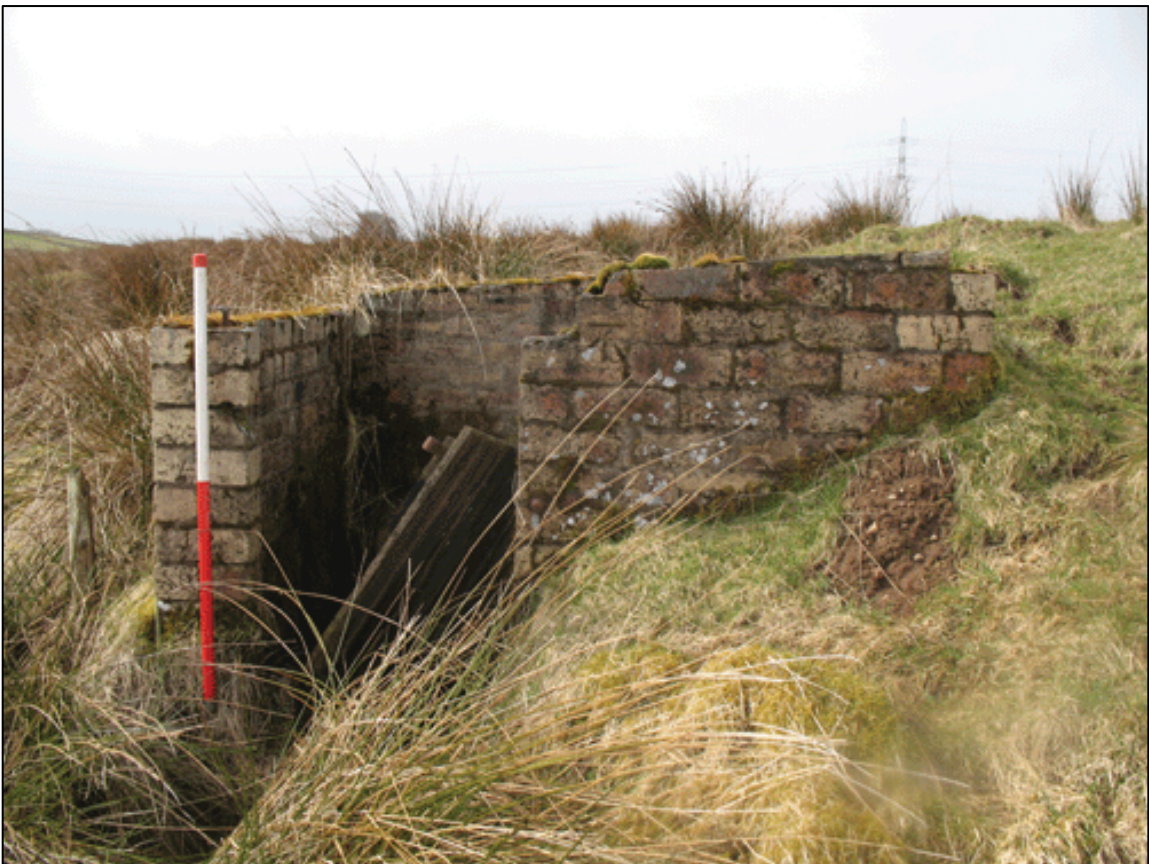
29. In the field south of this a small brick structure (S5) (Figure 8b) measuring 2m by 1.9m by 0.9m high was set into the western bank of the Birkwood Burn which runs along the eastern edge of the study area. The structure had a small wooden door on its northeastern side and although no roof was present, iron brackets suggest one may have originally existed. The interior of the structure contained iron mechanisms including a wheel along the northeastern side. The structure can be identified as a 'pump' depicted on the 1944 4th edition Ordnance Survey.

Figure 8b: Pump **S5**

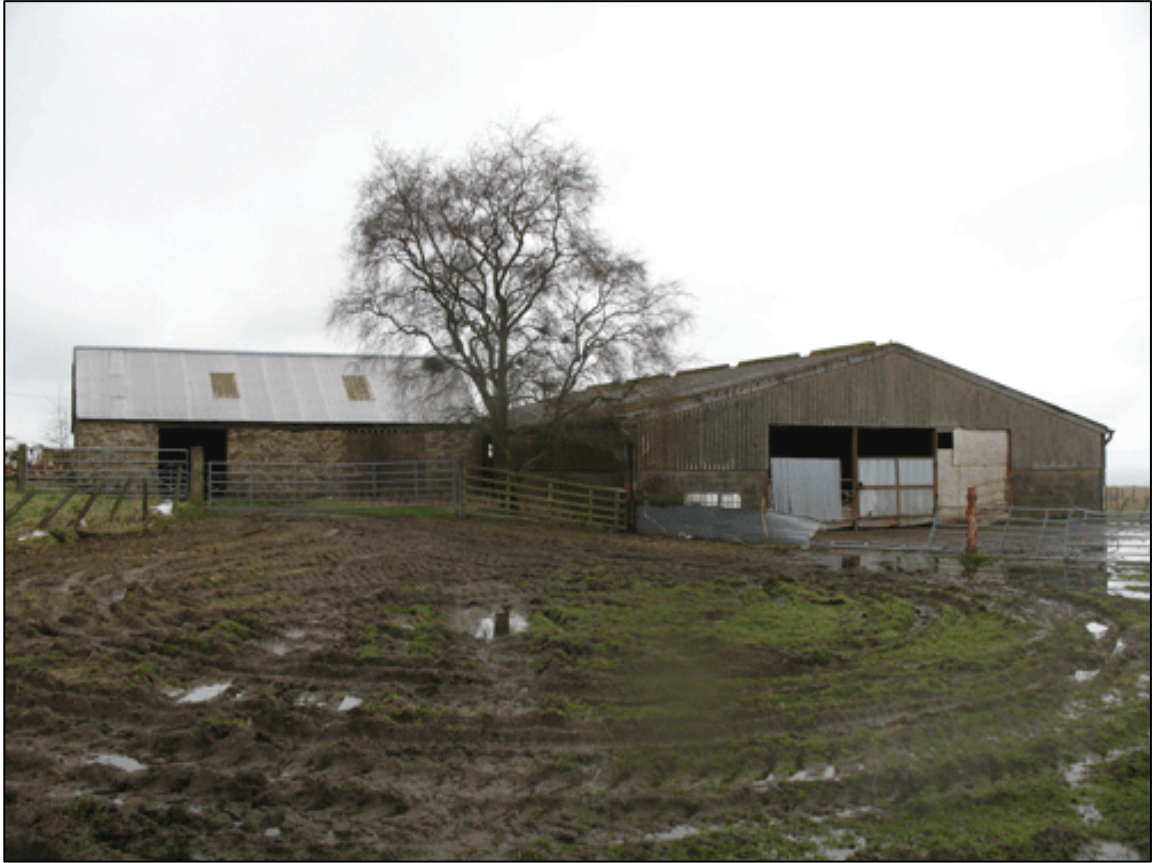
31. The barns sitting to the east of Muirhouse farmstead (S3) were also inspected by the walkover (Figure 9a). The rectangular western barn (S7) measured approximately 13m by 11.7m and is constructed of yellow brick with a corrugated iron double apex roof. The eastern barn (S8) is larger measuring approximately 18.9m by 20.9m and is constructed of a steel frame in-filled with breeze-blocks across the bottom half with corrugated iron sheeting across the top half and a gable roof. While these barns will have originally been part of the Muirhouse farmstead (S3), they appear to be 20th century constructions with no earlier elements visible.

Figure 9a: Muirhouse Barns **S7** and **S8** from the southwest

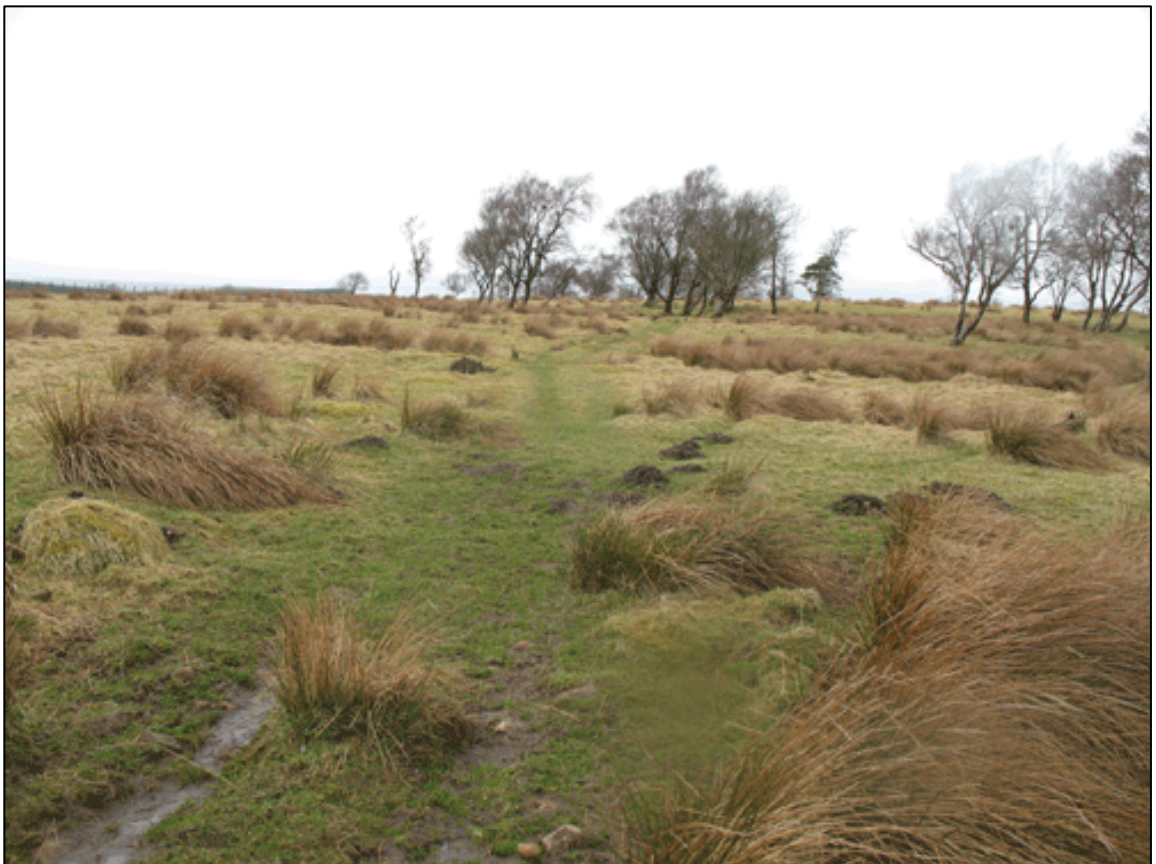
32. Two trackways were also discovered which do not appear on current mapping. The first (S9) runs WSW-ENE along the fields to the west of Muirhouse (S3) and survives as a raised earth platform approximately 1.5 to 2m wide and 62m long. Towards its eastern end it has a metal surface. It appears to run towards Muirhouse although it stops at the western boundary of the study area no longer visible in the fields beyond. Another trackway (S10) (Figure 9b) runs NW-SE through the southern section of the area of the Muirhouse Plantation measures approximately 2-3m wide and runs approximately 46m from the southeastern boundary of the plantation before disappearing in the middle of the plantation area. Neither of these trackways corresponds with any visible on the mapping for the area and are likely to be 20th century in date.

Figure 9b: Muirhouse Plantation trackway **S10**
