**Block 1a, Collegelands, Glasgow:
Archaeological Monitoring**

Data Structure Report

issued 30th April 2010

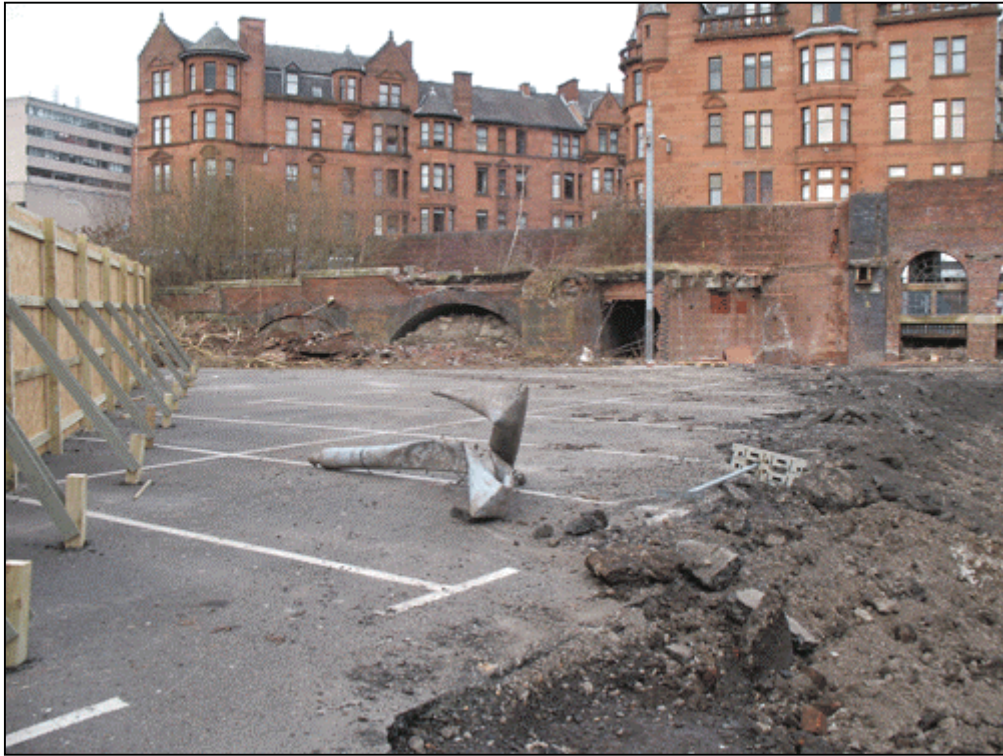
Figure 3a: Pre ex shot of sensitive area from the southeast, showing the access ramp in the background prior to its demolition

23. At an earlier stage in the works, this ramp had been demolished to ground level and the material (004) from this was still present covering the northern area. The two excavated areas in the northwest and northeast sat within the footprint of the ramp and revealed that remains of the ramp (005) were still *in situ* beneath the demolition material (004) which had infilled the area (see Figures 4a and 4b). As well as supporting brick piers which carried down the full depth, the two areas revealed a concrete surface at their base which comprised the floor of the arched compartments visible in the ramp prior to its demolition (see Figure 3a). The excavation works halted at this concrete floor in both areas.

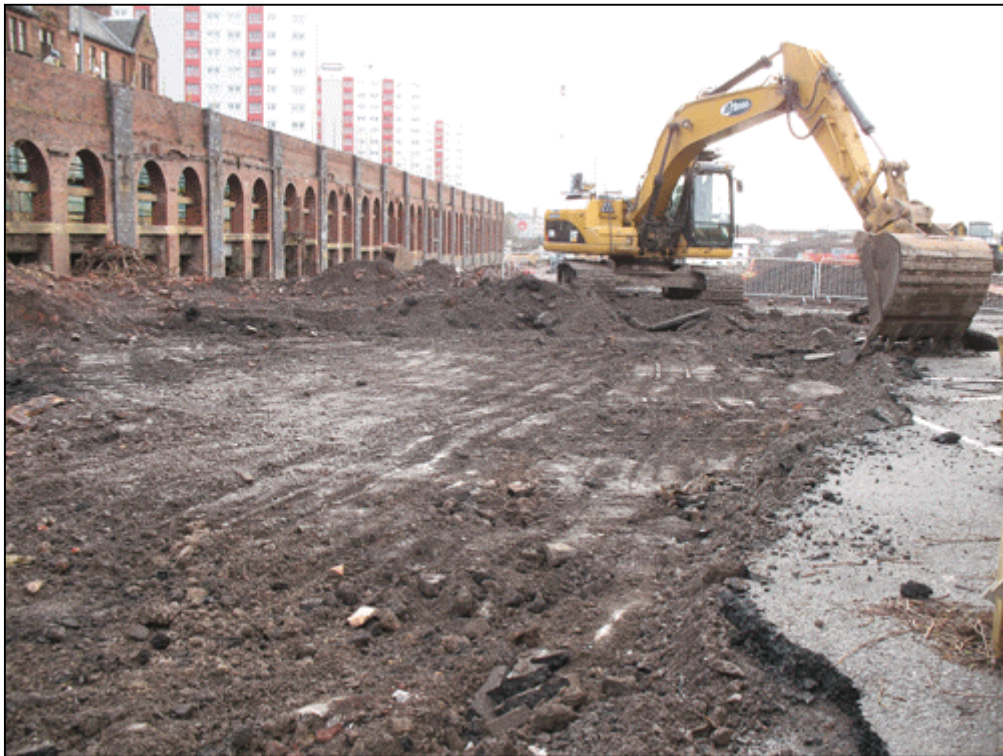
Figure 3b: Shot of sensitive area from the northwest after the general reduction by 350-400mm

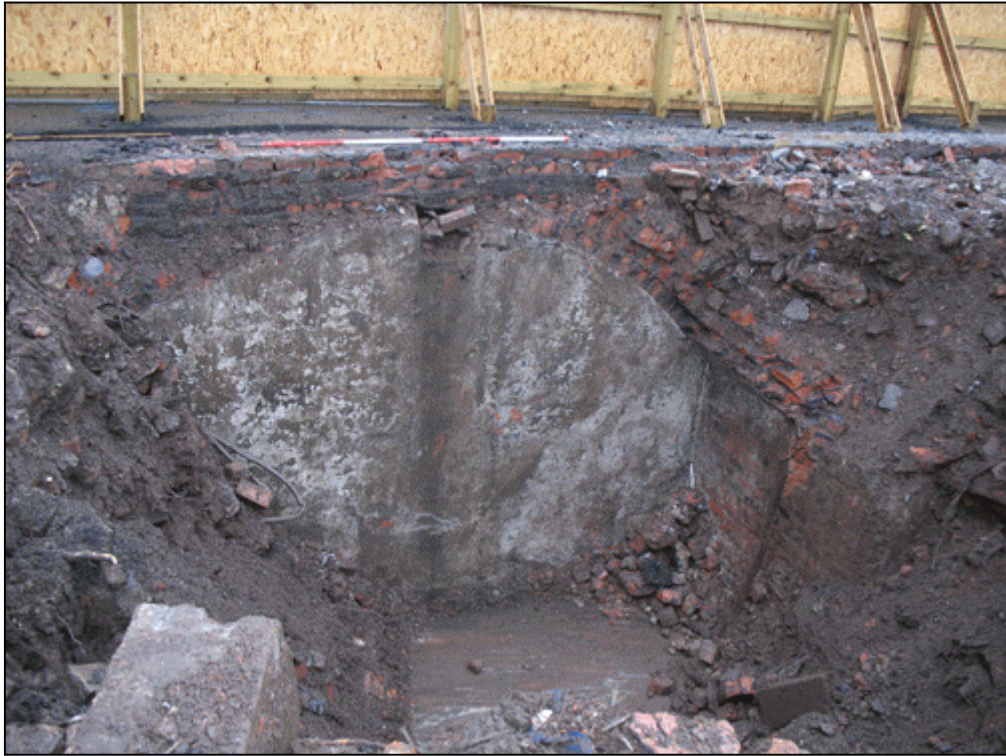
Figure 4a: Northwest excavated area from the southwest

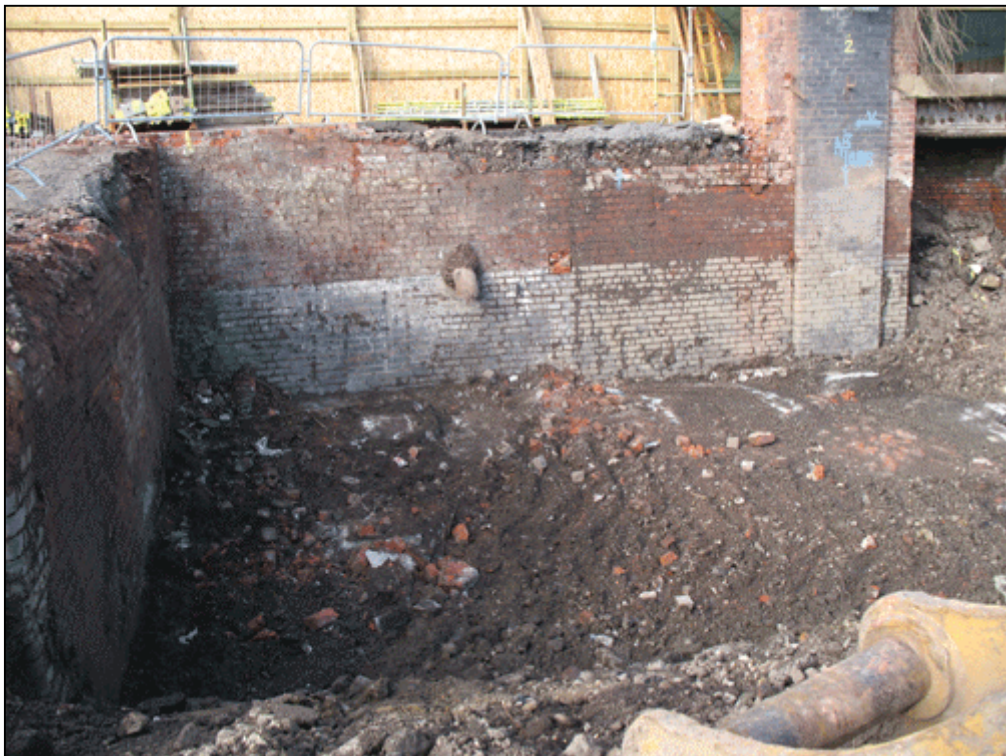
Figure 4b: Northeast excavated area from the southwest
