Station Building, Saltcoats, Ayrshire: Archaeological Mitigation

Data Structure Report

issued 9th February 2010

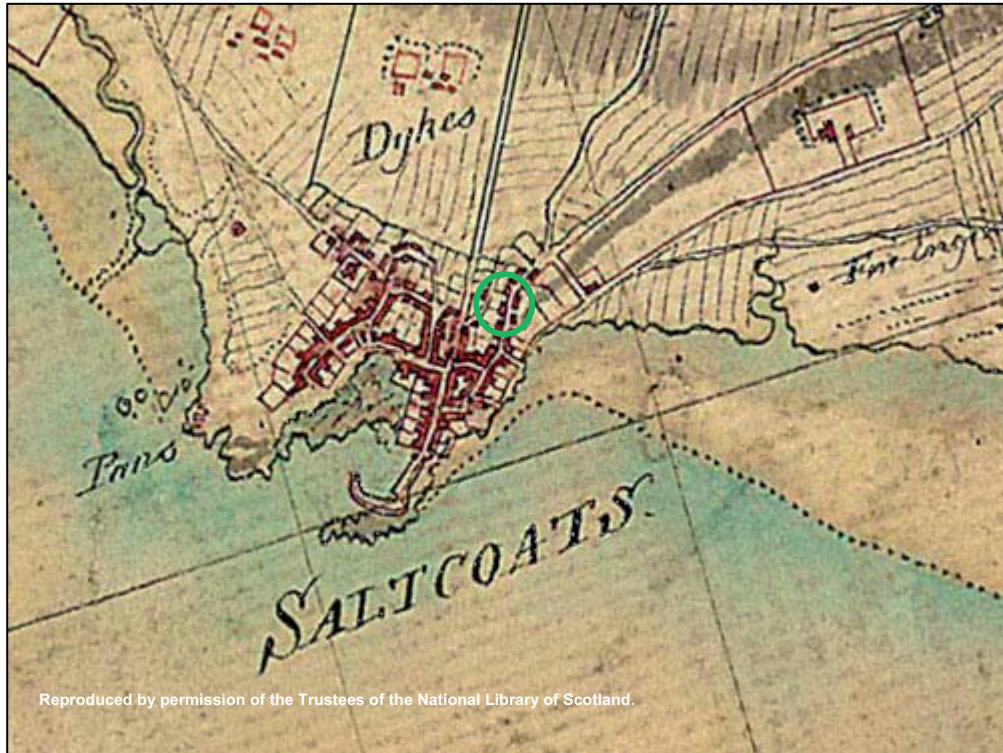
Figure 1a: Roy's Military Survey 1747 - 1755

7. Evidence from historic mapping is of limited value except to show the marked difference in the layout of Saltcoats since the 1700s. Roy's Military Maps (1747-1755) (Figure 1a) shows Saltcoats as a small harbour town expanding a very little north of what is now Manse Street and Vernon Street. It served only to demonstrate the potential for survival of contemporary material within the development area. The 1st edition Ordnance Survey Town Plan (1855) (Figure 1b) shows the railway running along its present route through the town. Not surprisingly the road layout differs slightly and the town centre is shown as being far less urbanised with more land given over to back-plots. This map places the development area in the back-plot west of where Nine Yards Street crosses the railway.

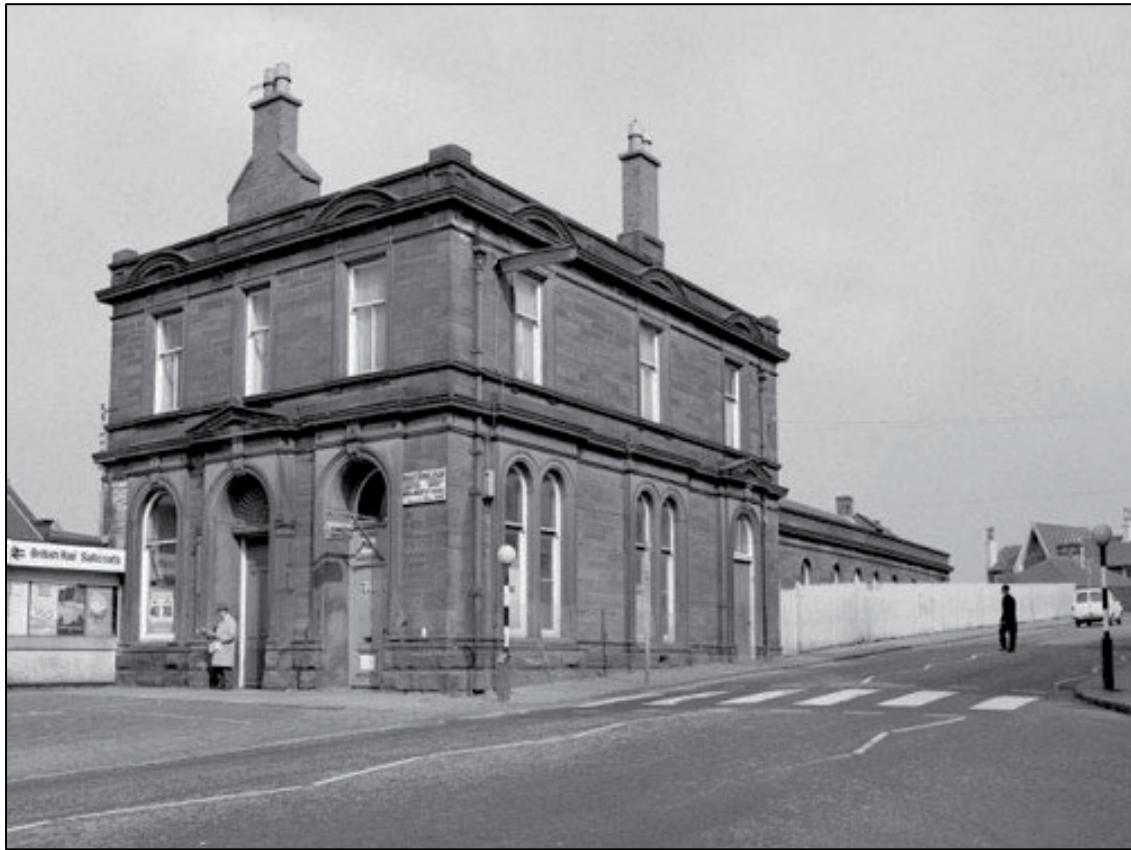
Figure 2a: John Hume photograph 1974 of the Station Building

9. The historical and archaeological potential of Saltcoats can be demonstrated by the number of significant historic buildings which survive in the modern town. In the immediate vicinity of the development area these include; the Gas Works (Canmore No. NS24SW 31), the Town Hall on Green Street (Canmore No. NS24SW 50), the Free Church of Scotland to the south (Canmore No. NS24SW 152) and the Railway Station (Canmore No. NS24SW 62). Hume's 1974 photograph (Figure 2a) of the station building shows the extension to the rear, now demolished (Figure 2b).

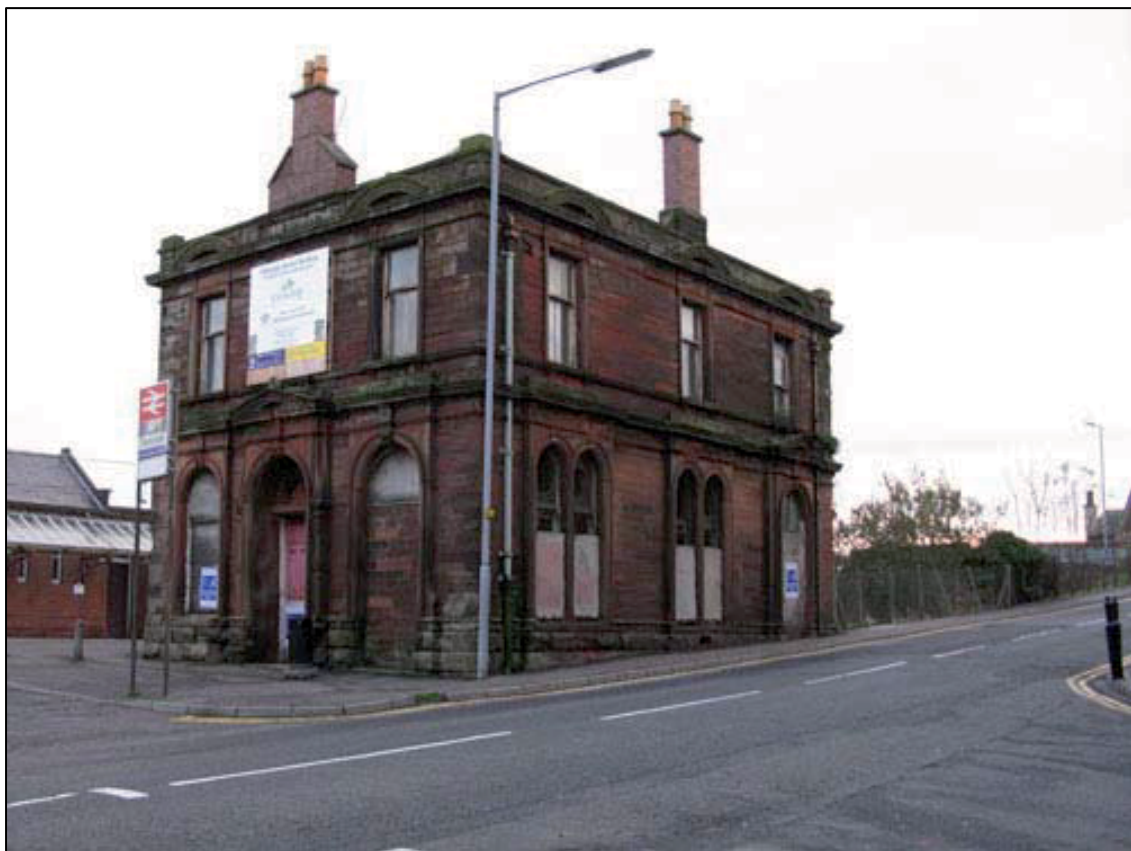
Figure 2b: Station Building prior to redevelopment commencing

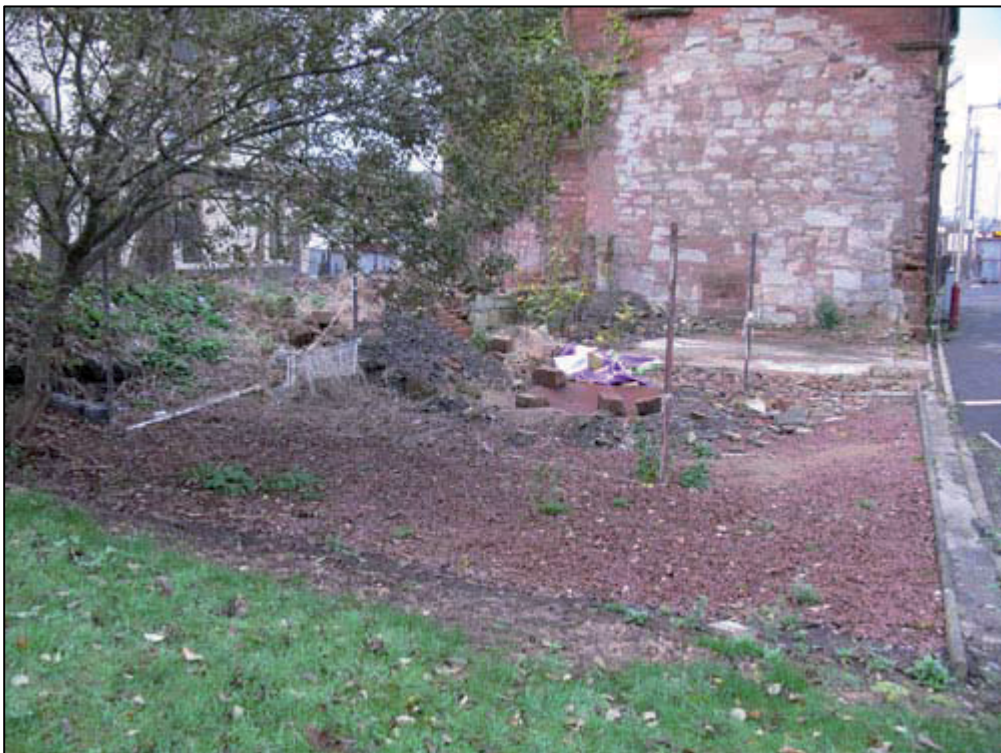
Figure 4b: Development area to rear of Station Building

12. At the commencement of the archaeological monitoring of the development works the site was a small patch of waste ground at the rear of the Station Building. To the immediate north of the development area is the edge of the railway platform. The concrete slab, in place at the commencement of monitoring works, was roughly level with the platform. The ground level rose by about 1.5m over a distance of about 4m to the south to the road level of Vernon Street (Figure 4a). The difference in level increases the further east as the road crosses the railway. Prior to excavation works it appeared as if the area had been heavily landscaped for the construction of the railway, the Station Building and the road (Figure 4b).

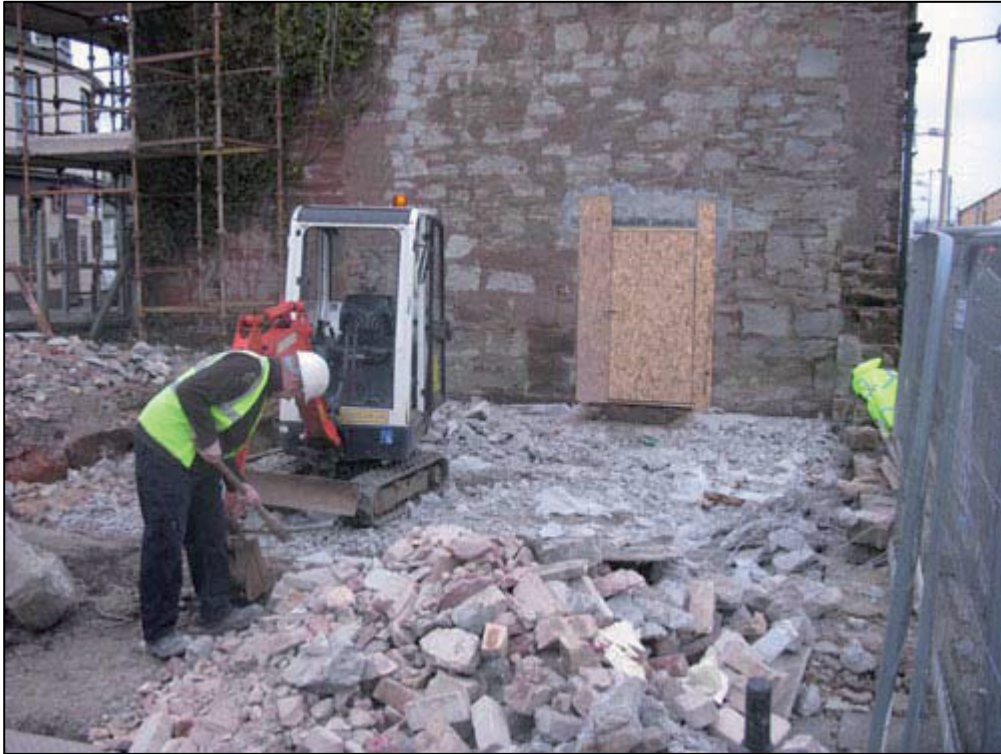
Figure 5a: After breaking the concrete slab

13. In compliance with the terms of the Method Statement (Williamson 2009) archaeological monitoring began with the removal of the concrete slab (Figure 5a). Due to the limited space available within the development area this work was carried out by hand using a combination of hand tools and a pneumatic breaker. As a result of unfavourable conditions the work progressed slowly and after monitoring for most of 27th of January it became apparent that there was no archaeological benefit in monitoring the breaking up of the concrete slab. It was agreed, in consultation with West of Scotland Archaeology Service, that archaeological monitoring would recommence following removal of the concrete.

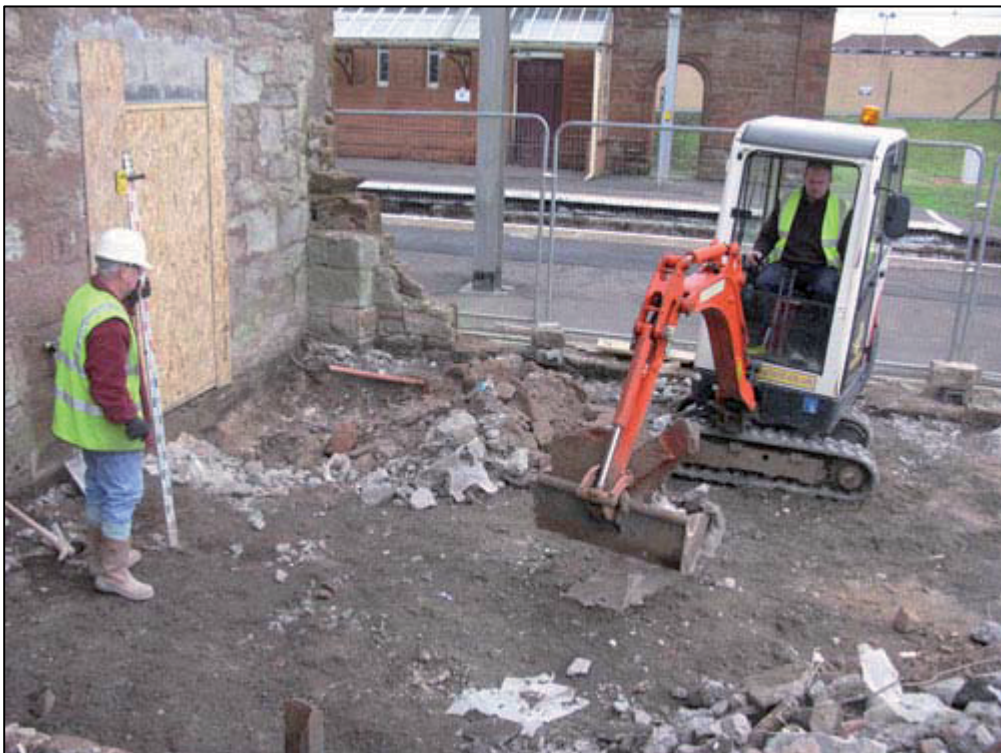
Figure 5b: Starting reduction of the development area

14. By the 1st of February 2010 the concrete slab had been completely broken up (Figure 5b). Ground breaking work continued with the removal of the broken concrete and the reduction of the entire area of the proposed extension by 400mm. All of the sediment removed was made ground. It consisted of rubble, mortar fragments, large sandstone blocks and modern brick. It appeared that most of the sediment removed at this stage was composed of demolition material (001).

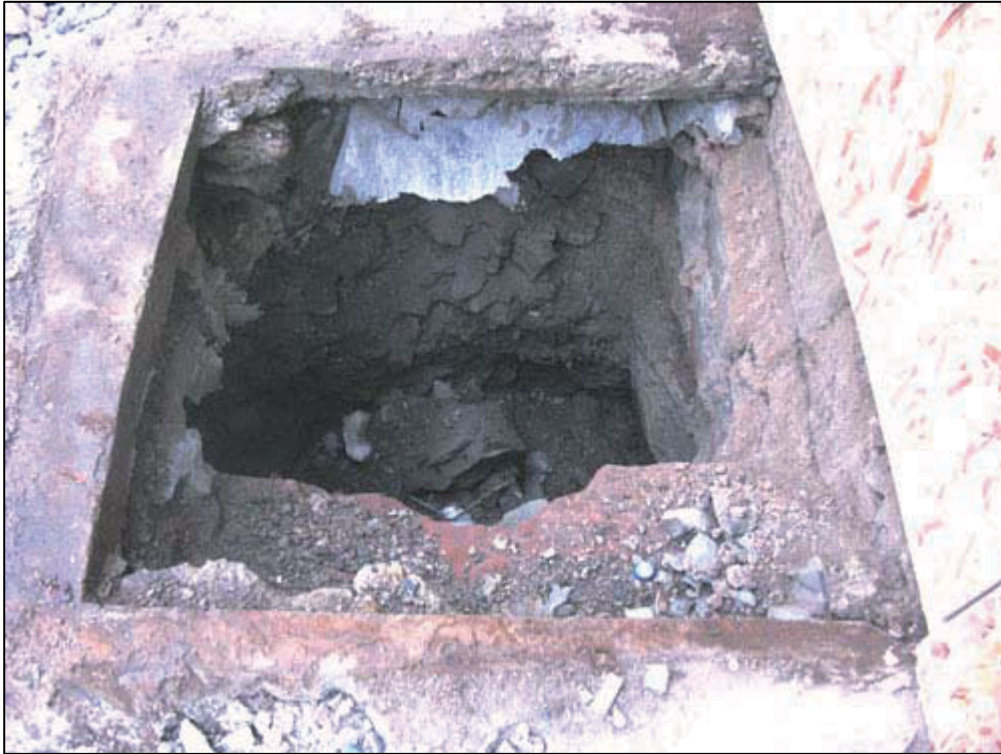
Figure 6a: Down hole beside Station Building

15. Within the development and immediate adjacent to the existing Saltcoats Station Building one of two large holes had been excavated prior to the development works commencing (Figure 6a). The other was approximately 15m east of the building, beyond the area of the proposed extension (Figure 6b). These holes were approximately 1m in diameter and at least 1.5m deep. No structural remains or services were noted in these holes but it was possible to observe the accumulation of deposits. Within these holes it was evident that inside the development area made ground continued to a depth of more than 1.5m. These holes were exposed and then made safe in the course of the development works.

22. At some point in the recent past two manhole size holes had been excavated to the rear of the Station Building within the development area. These holes, excavated to a depth of more than 1.5m, have no apparent use but do reveal the depth of made ground within the development area. It should be noted that at no point during the archaeological monitoring works was archaeologically sterile drift geology reached. In order to reach natural soil excavations to a depth in excess of 1.7m would be required. There is of course the possibility of archaeological remains surviving at depth but given the depth of disturbance within the development area this is unlikely.

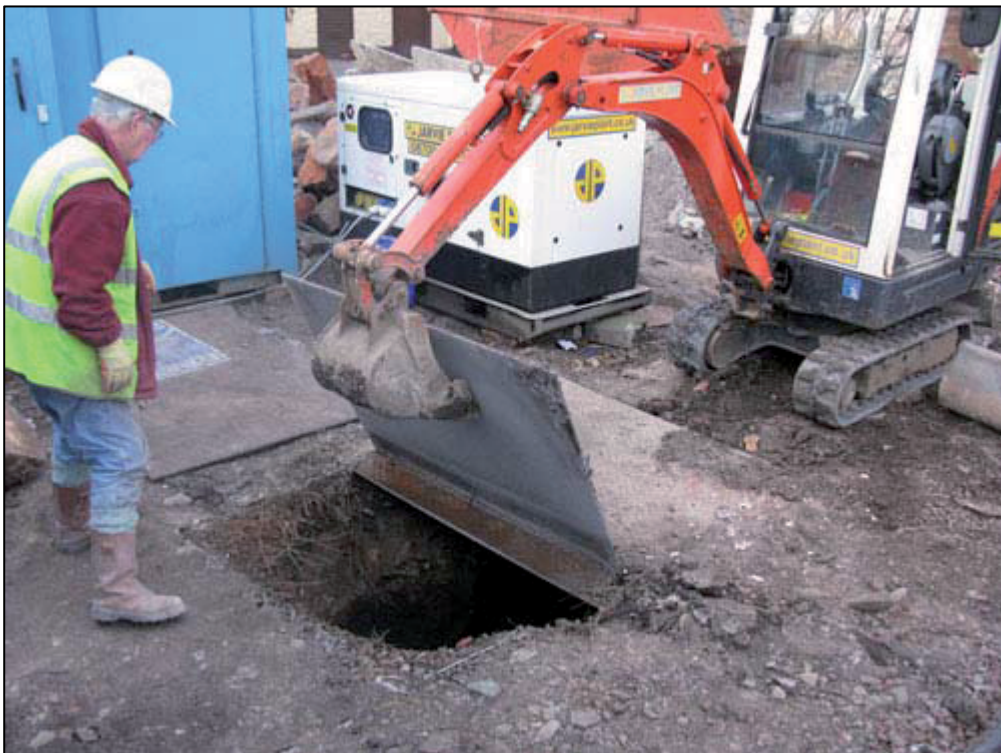
Figure 6b: Second hole within the development area

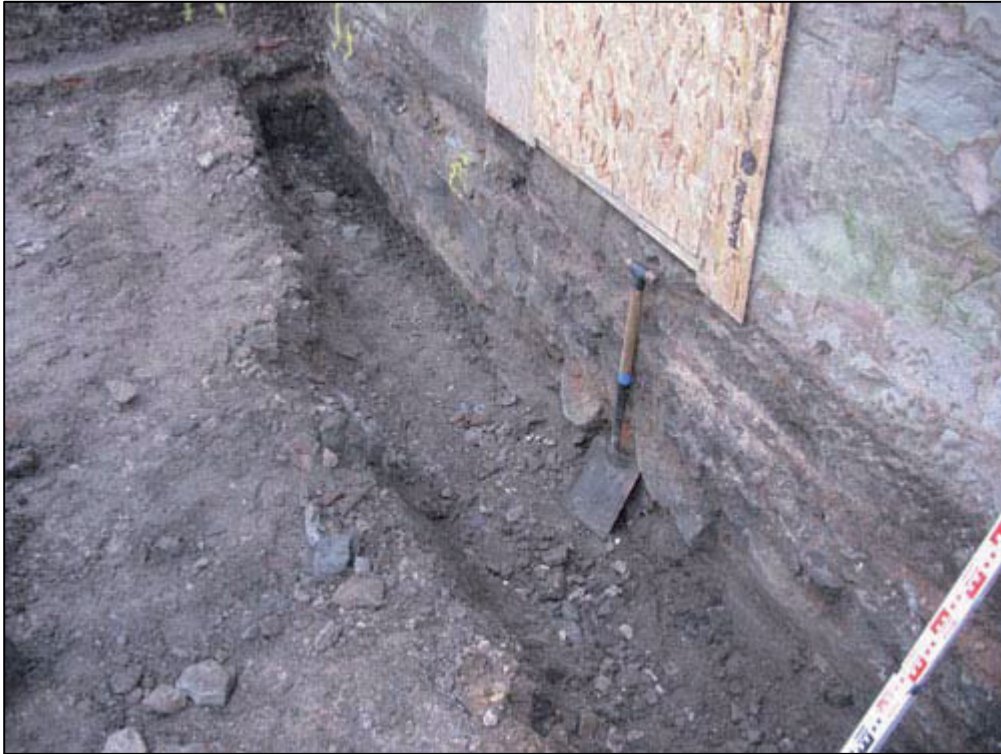
Figure 7a: Foundation trench adjacent to Station Building

16. Development work continued with the excavation of foundation trenches. These trenches were approximately 600mm wide and an additional 500mm below the reduced level of the area (approximately 1m below the level of the railway platform). Foundation trenches were excavated along the west side of the proposed development area (adjacent to the Station Building) (Figure 7a). Trenches were also partially excavated along the north side (adjacent to the railway platform) and on the east side. All of these trenches were excavated though made ground although the character changed with depth. At depths greater than 600mm the made ground changed from demolition material to dark brown sandy silt containing fragments of brick and rubble (002).

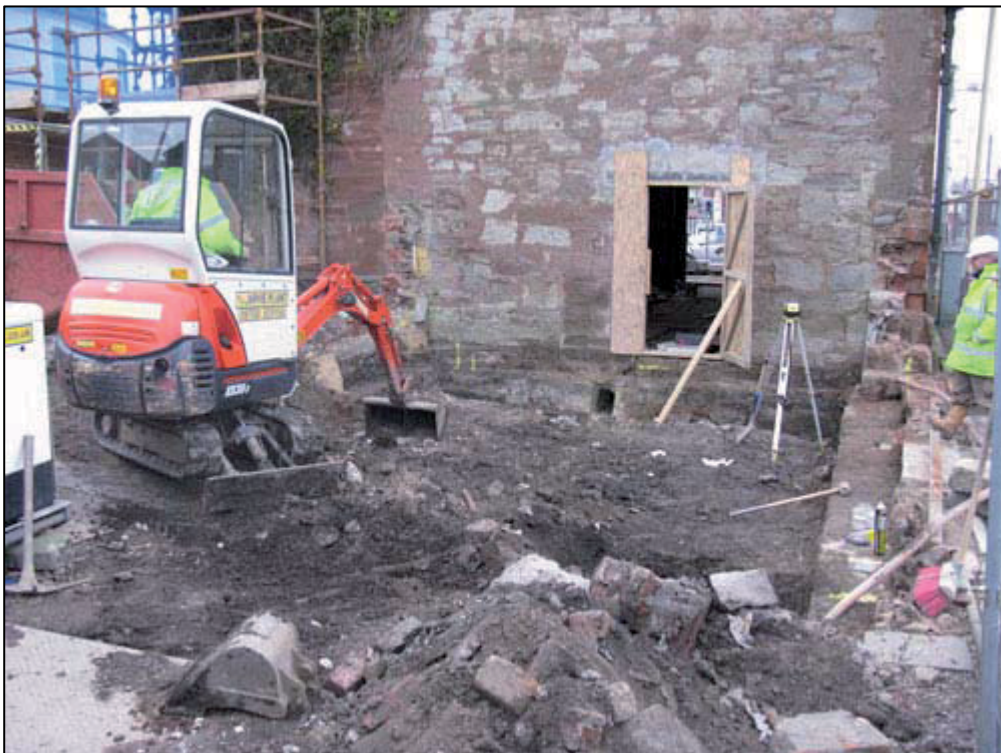
Figure 7b: Development area on the 3rd February 2010

17. In addition to the works described above a service trench was partially excavated running west to east in the centre of the development area, away from the existing Station Building. This trench was 400mm wide and 300mm below the level of the reduced ground. The sediments in this trench were as described above but it did serve to confirm the inferred character of sediments within the centre of the proposed development. The work was constantly hampered by the lack of space in the restricted work area. It is for this reason that trenches were only partially completed when the archaeological monitoring was stopped (Figure 7b).
