Ramornie Quarry, Fife: Archaeological Evaluation

Data Structure Report

by Alan Matthews

issued 30th November 2009
reissued 18th December 2009

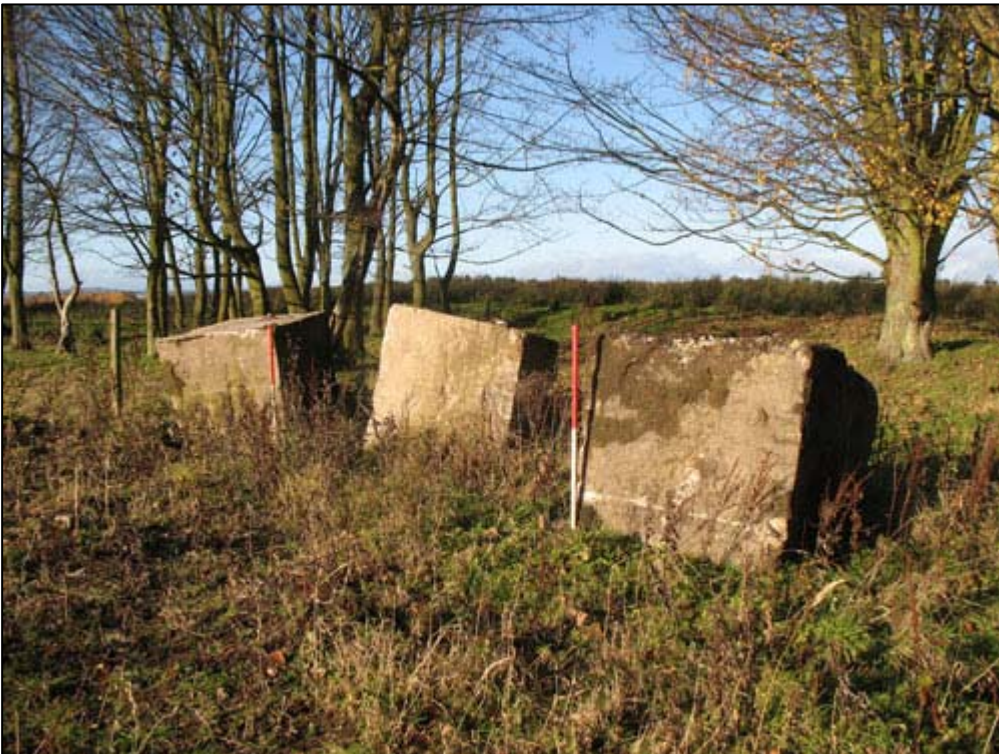
Figure 4b: Anti-tank obstacles (not in-situ)

30. The anti-tank obstacles located within the proposed extraction area had been moved in recent times and so their original location is unclear. Investigation of the ditch demonstrated that it had been steep sided and with a roughly square base. The fills of the ditch had been heavily disturbed by trees. No artefacts were recovered from the ditch fills. It is doubtful that more may be gained by further examination of this feature.

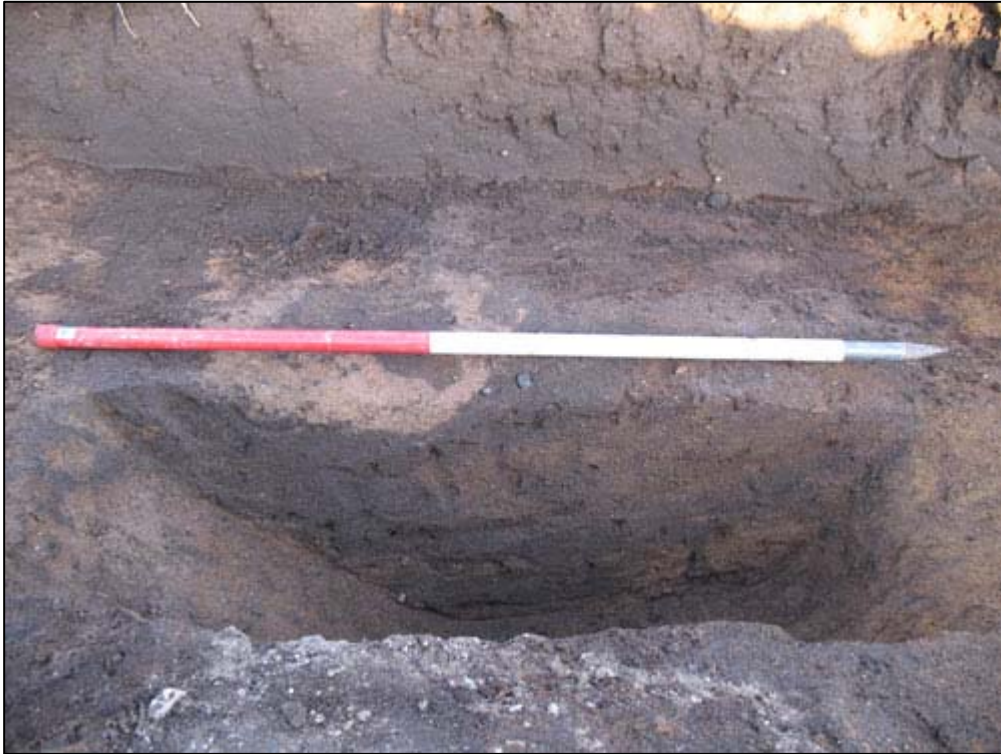
Figure 5a: Feature (007)

007	26	Feature	Linear feature orientated NNW-SSE. U-shaped section. Slightly steeper on E side, rounded flattish base. Measures 1m wide x 330mm deep x unknown length as runs outwith trench. Filled by dark grey brown clayey silt with patches of sand and pale gravel with some slate inclusions.	Appears to be a modern feature. Possibly a drainage ditch.
008	26	Feature	Linear feature orientated NNW-SSE. Steeply sloping sides with a flattish base. Measures 0.52m wide x 280mm deep x unknown length as runs outwith trench. Filled by very dark brown compact clayey silt.	Appears to be a modern feature. Possibly agricultural.
009	27	Feature	Linear feature orientated roughly N-S. Steeply sloping sides with rounded flattish base. Measures 0.42m wide x 210mm x unknown length as runs outwith trench. Filled by topsoil.	Appears to be a modern feature. Possibly agricultural.

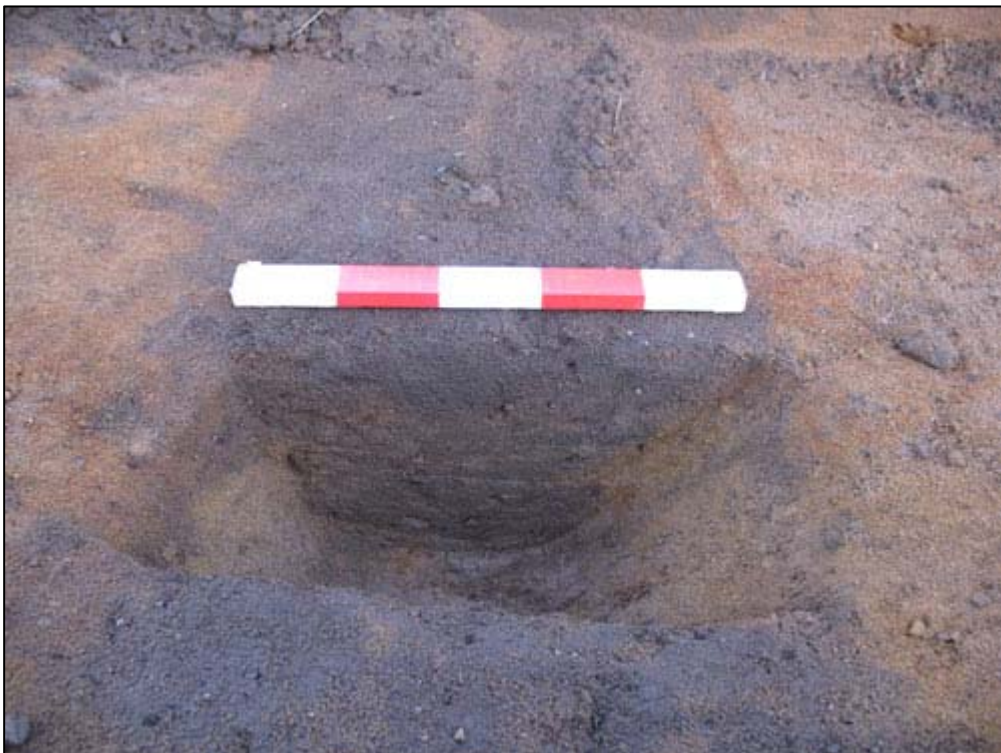
Figure 5b: Feature (008)

26. Features similar to (014) and (015) were found in several parts of the site; e.g. (019) in Trench 12, (005) in Trenches 25 to 27, (008) (Figure 5b) in Trenches 26 and 27, (009) in Trench 27, (017) in Trench 47 and (018) (Figure 8a) in Trenches 48 to 50. These features fell into two categories; those which were less than 300mm wide and those which were between 300 and 500mm wide. In all cases they were less than 400mm deep, filled with dark brown silty sand similar to the topsoil. No anthropic material was recovered from any of these features.

34. Those more substantial linear features; (005), (008), (009), (014), (015), (017) and (018), also suggest a modern origin although no material culture was recovered from anywhere on site to confirm this. The presence on site of modern drainage and services suggests that multiple attempts may have been made to improve or change the use of the ground. This is especially true in the central part of the evaluation area in proximity to the site of what was once the mansion house. The two bands of disturbed subsoil running through the central part of the site were interpreted, upon excavation, to be the remains of farm tracks. The modern use and reuse of the central area is demonstrated in one large pit in Trench 33 which was entirely filled with broken glass (Figure 10a). When identifiable the glass was almost entirely wine and champagne bottles and so most likely relates to the later occupation of the mansion house.

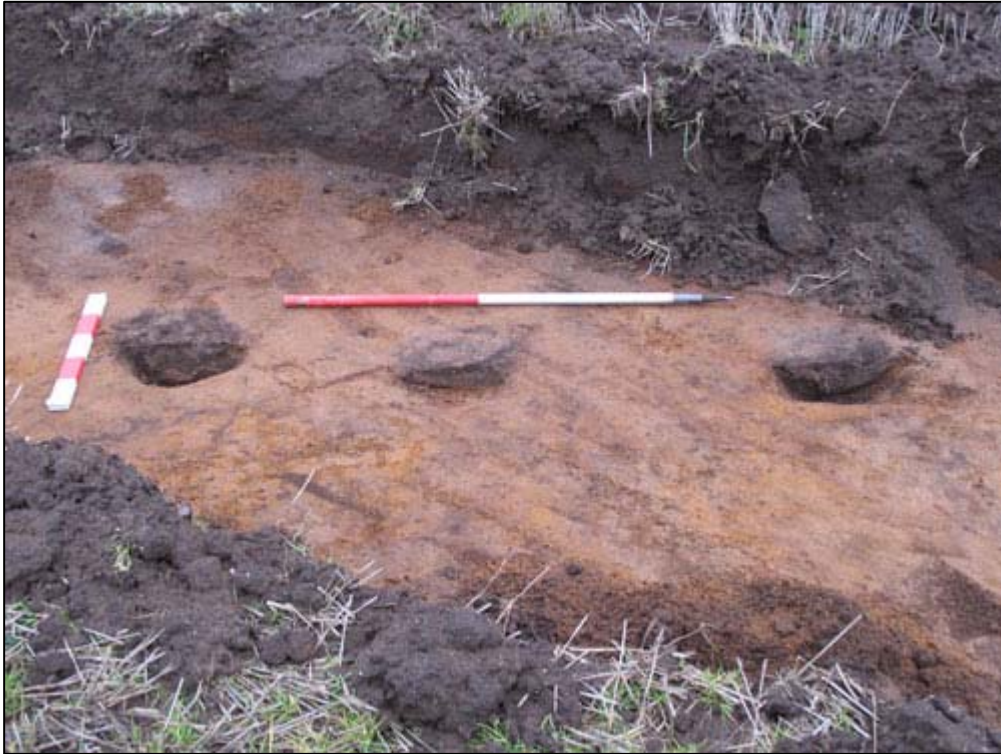
Figure 7a: Feature (010)

24. Three shallow postholes, similar to those mentioned above, were recorded in Trench 28; feature (010) (Figure 7a). As before, these measured about 200mm in diameter and less than 100mm deep. No anthropic material was recovered from these postholes and their fills were very similar to the topsoil.

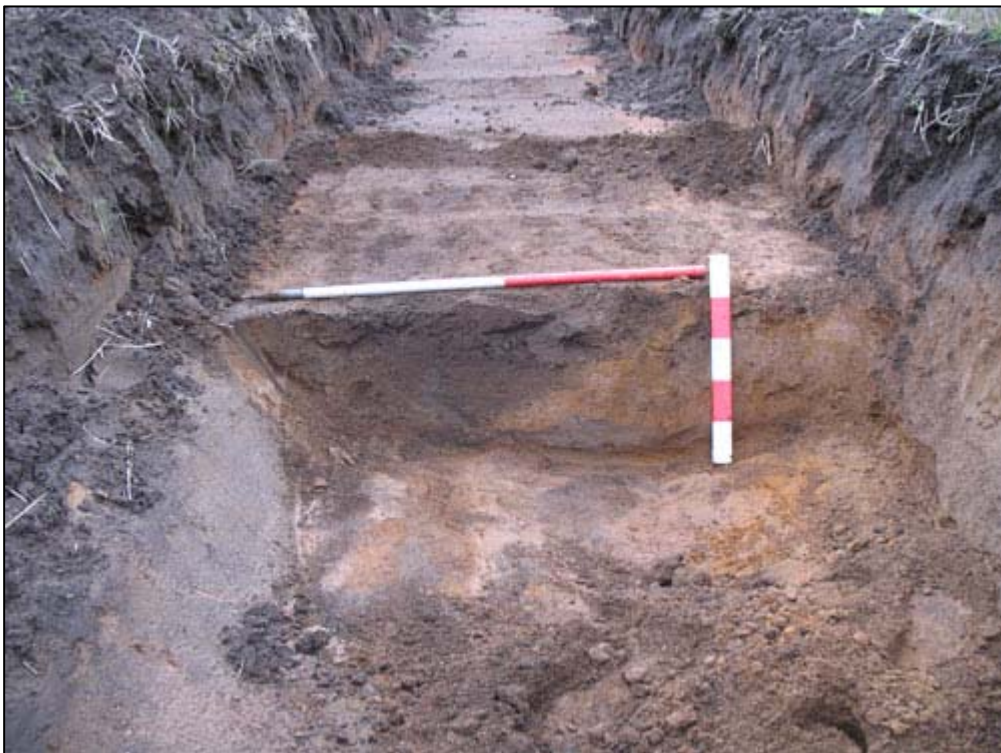
Figure 7b: Feature (011)

22. A long linear feature (011) (Figure 7b) ran almost the complete length of Trench 30 and also appeared in Trenches 23 and 24. This feature was investigated in multiple locations along its length to best characterise its nature. Its width was never more than 800mm and its depth never more than 300mm. However the profile was constantly irregular. In addition to the irregularity of the feature roots were very evident in the fill.

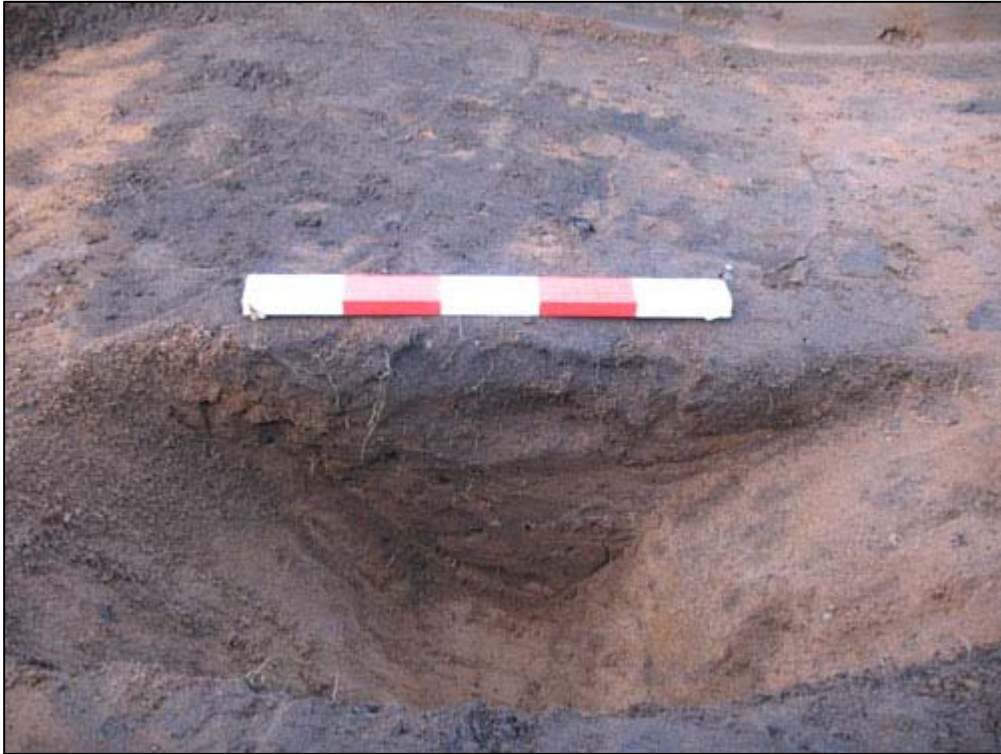
Figure 8a: Feature (018)

018	48, 49, 50	Feature	Linear feature orientated NW-SE. Irregular V-shaped section with gradually sloping sides and a narrow slightly rounded base. Measures 0.9m wide x 400mm deep x unknown length as runs outwith trench. Dark topsoil-like fill.	Appears to be a modern feature. Possibly agricultural
019	12	Feature	Large area of disturbance. Mid-dark brown silty sand with	Appears to be a modern feature. Possibly a

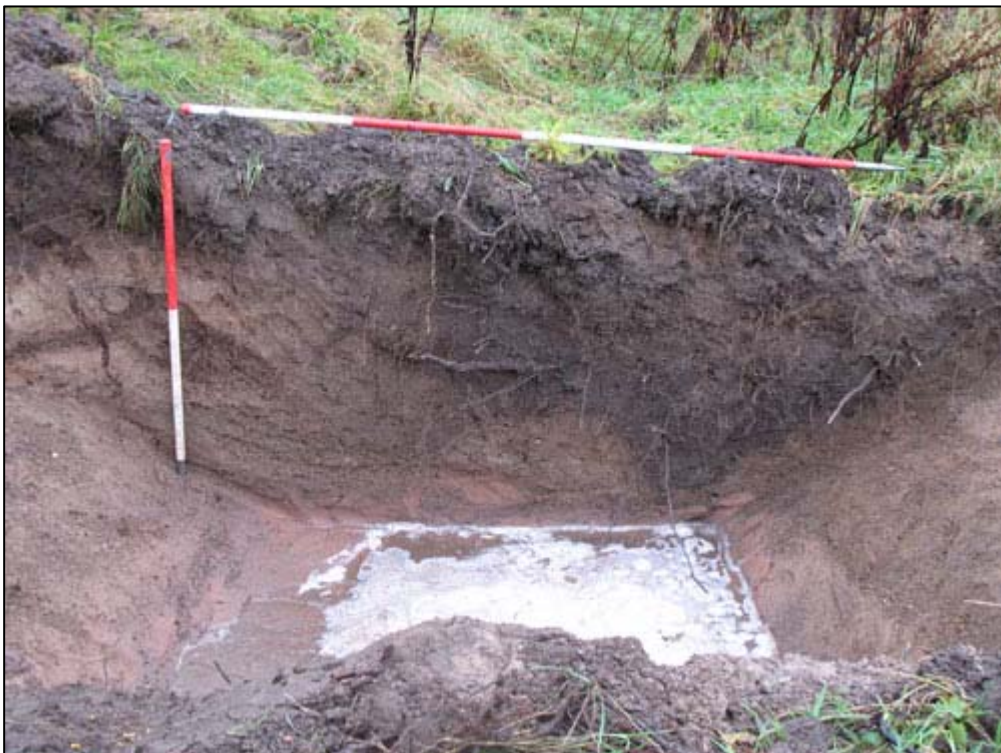
Figure 8b: Feature (020)

-
16. The excavation of the possible anti-tank ditch (020) (Figure 8b) revealed extensive disturbance of the sediments by tree roots. It would appear that trees, now in some cases removed, had grown extensively over almost the entire observable length of the ditch. The surviving profile suggests a ditch approximately 1.2m deep and 2.5m wide. The ditch was steep sided with a roughly flat base. The original fills of the ditch, (022) and (023), survived only on the western side at the base the remaining fill of the ditch was dark brown silty-sand (021) almost indistinguishable from the topsoil (001). No artefacts were recovered from the fills of the ditch. No evidence was recovered to support the idea that this ditch formed a part of the Second World War anti-tank defences and so the validity of this interpretation remains in doubt.

29. The only potentially significant feature recorded was the ditch (020). This feature was located in the westernmost part of the evaluation area and was associated with concrete anti-tank obstacles. On 27 May 1940 a Home Defence Executive was formed under General Sir Edmund Ironside, Commander-in-Chief Home Forces, to organise the defence of Britain. At first defence arrangements were largely static and focused on the coastline (the coastal crust) and, in a classic example of defence in depth, on a series of inland anti-tank 'stop' lines. The stop lines were designated Command, Corp and Divisional according to their status.

38. During the fieldwork described above the feature identified by SUAT as a Second World War anti-tank ditch was located and recorded. In addition a profile of the ditch was obtained by the excavation of two trenches through the ditch and subsequent recording of the sections. It was clear from these works that the ditch has been heavily disturbed by trees along almost its entire length. In addition the complete lack of material culture observed during the excavation work suggests that there is little value in further investigation of this feature. After consultation with Fife Council Archaeology Unit it is agreed to be unlikely that this feature represents a part of the Second World War anti-tank defences. Its location, origin and profile are now recorded and so Rathmell Archaeology Ltd recommends that there is no value in further archaeological examination of this feature.

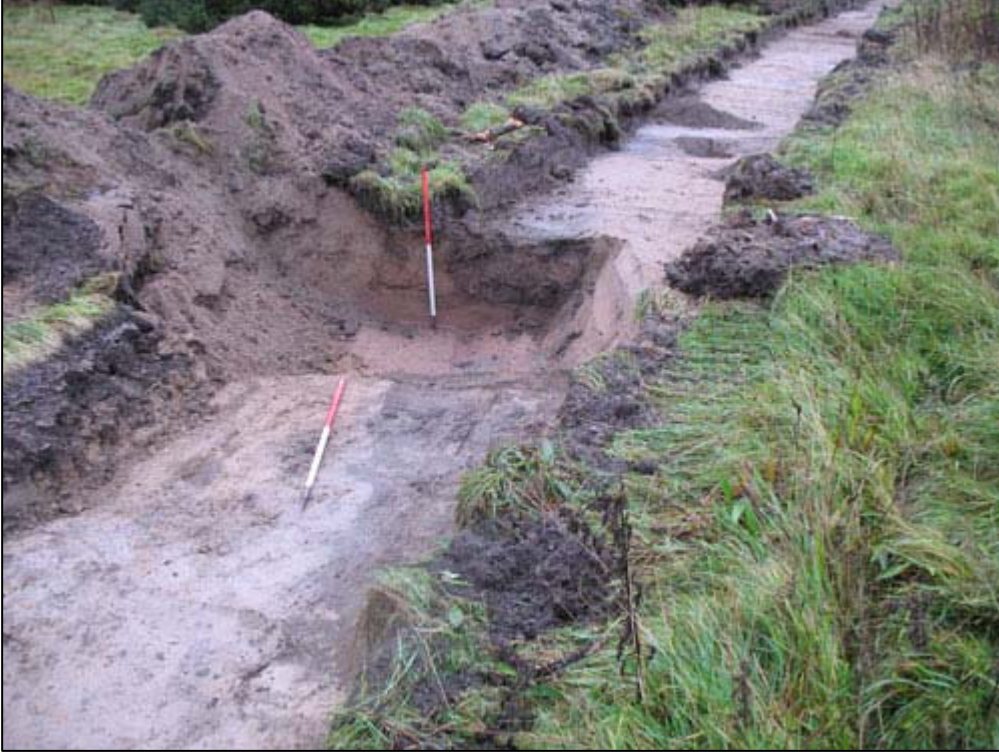
Figure 9a: Feature (026)

36. Feature (026) (Figure 9a) would appear to be modern structural remains judging from the similarity of its fill to the topsoil and that its straight sided profile may have been machine dug. The only other structural remains located on site were the three lines of postholes; (010), (024) and (025). However, these were uniformly shallow and lacking material culture. Although their origin remains uncertain there is nothing to suggest that they are other than modern and therefore nothing to suggest value in their further study.

026	2	Feature	Linear feature forming an 'L' shape. Near vertical sides with a slightly rounded square base. Measures 0.92m wide x 520mm deep. Filled by mixed sandy topsoil and subsoil.	Appears to be a modern feature.
027	12	Feature	Linear feature orientated NE-SW. Measures 1.4m wide. Filled by mixed mid orange clay and dark brown silt. Unable to be excavated due to heavy waterlogging.	Appears to be a modern feature.

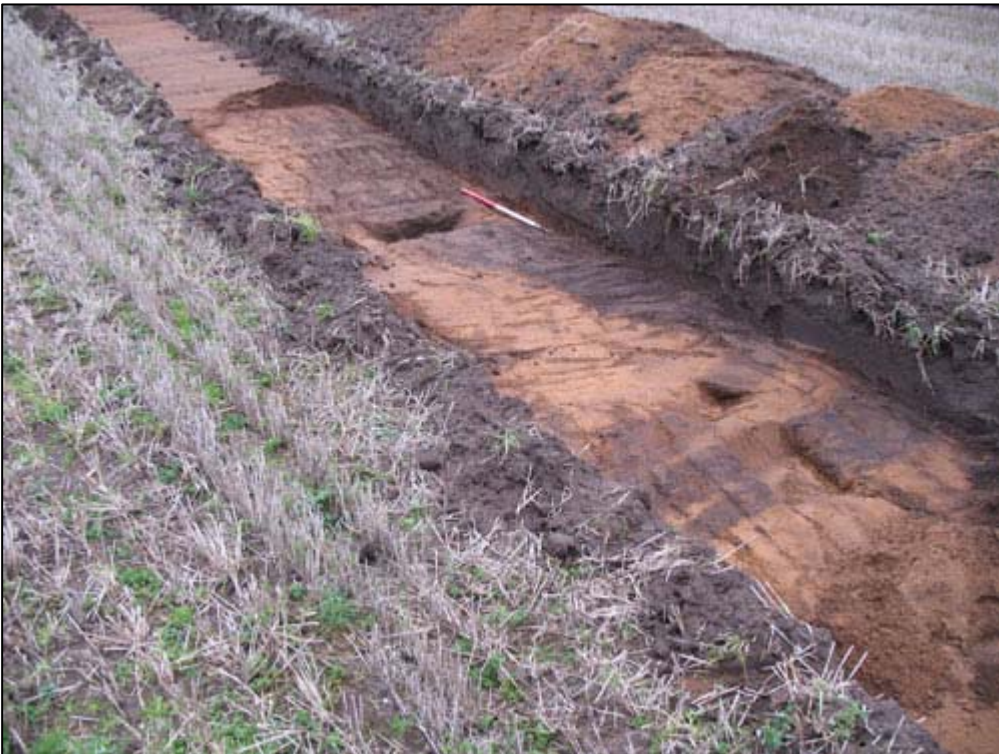
Figure 9b: Features (013), (014) and (015)

25. In the central part of the site, Trench 34 had three features in close proximity; (013), (014) and (015) (Figure 9b). Feature (013) was a half circle emerging from the north section of the trench. This feature was about 400mm in breadth and 200mm deep. The fill was similar in composition to the topsoil and no anthropic material was recovered. To the east of (013) two linear features, (014) and (015), ran north-south. Both were less than 300mm wide and 150mm deep.

35. In Trench 34 features (013), (014) and (015) were difficult to interpret due to the complete lack of material culture recovered. These features were shallow and with fills very similar to the topsoil and so a modern origin is most likely. After excavation the features were interpreted as the result of continued agricultural use of the area.

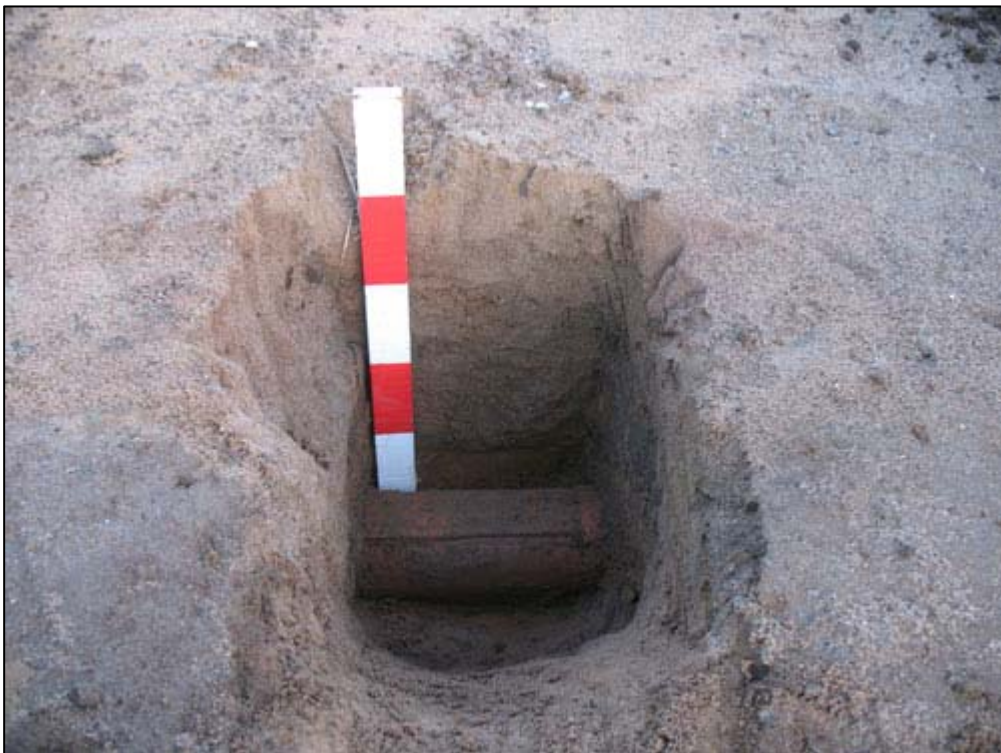
Figure 10b: Modern drain in Trench 26

27. There was solid evidence for the placement of modern services in the central part of the evaluation area. Despite the fact that the subsoil is made up of well drained sand ceramic drains were recorded in three locations, Trench 23, Trench 26 and Trench 34. Upon excavation two of the drains had ceramic pipes (Figure 10b) at their base and the other had a plastic pipe. In addition to the above a water main ran from the corner of the slaughterhouse to the north-west corner of the central area. This water main was recorded in several trenches; Trenches 8, 9, 12, 13, 14, 23 and 24.
