**Watermill Hotel Extension, Paisley,
Renfrewshire:
Archaeological Mitigation**

Data Structure Report

by Louise Turner

issued 14th September 2010

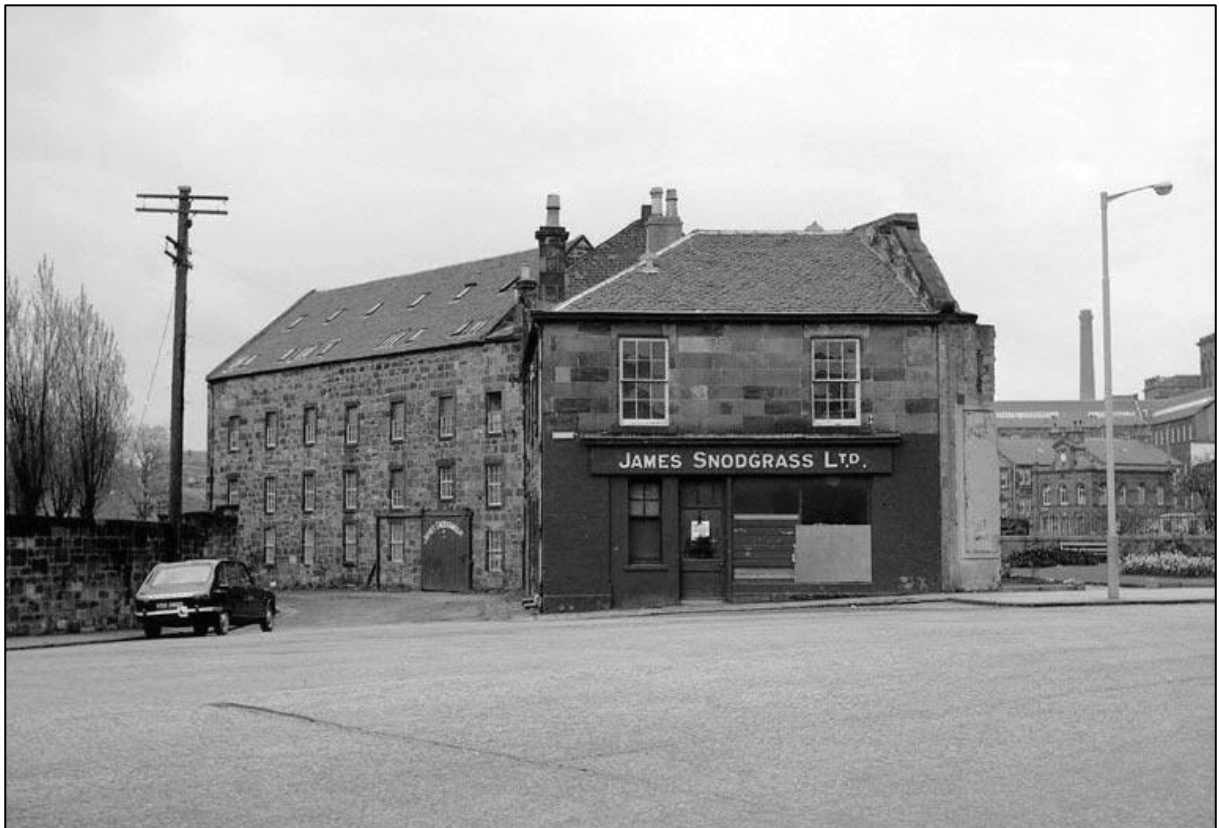
Figure 3a: The Saucel Mills: View From W as Photographed by Hume in the 1960s

18. A series of photographs taken by the industrial archaeologist John Hume in the 1960s (Figures 3 a & b) indicates that by this time, the nineteenth century mill complex had already been much reduced. The large rectangular building on the bank of the White Cart is still upstanding, as is the angled building which once fronted Bladda Lane. The buildings to the rear, however, appear to have been entirely removed by this time.

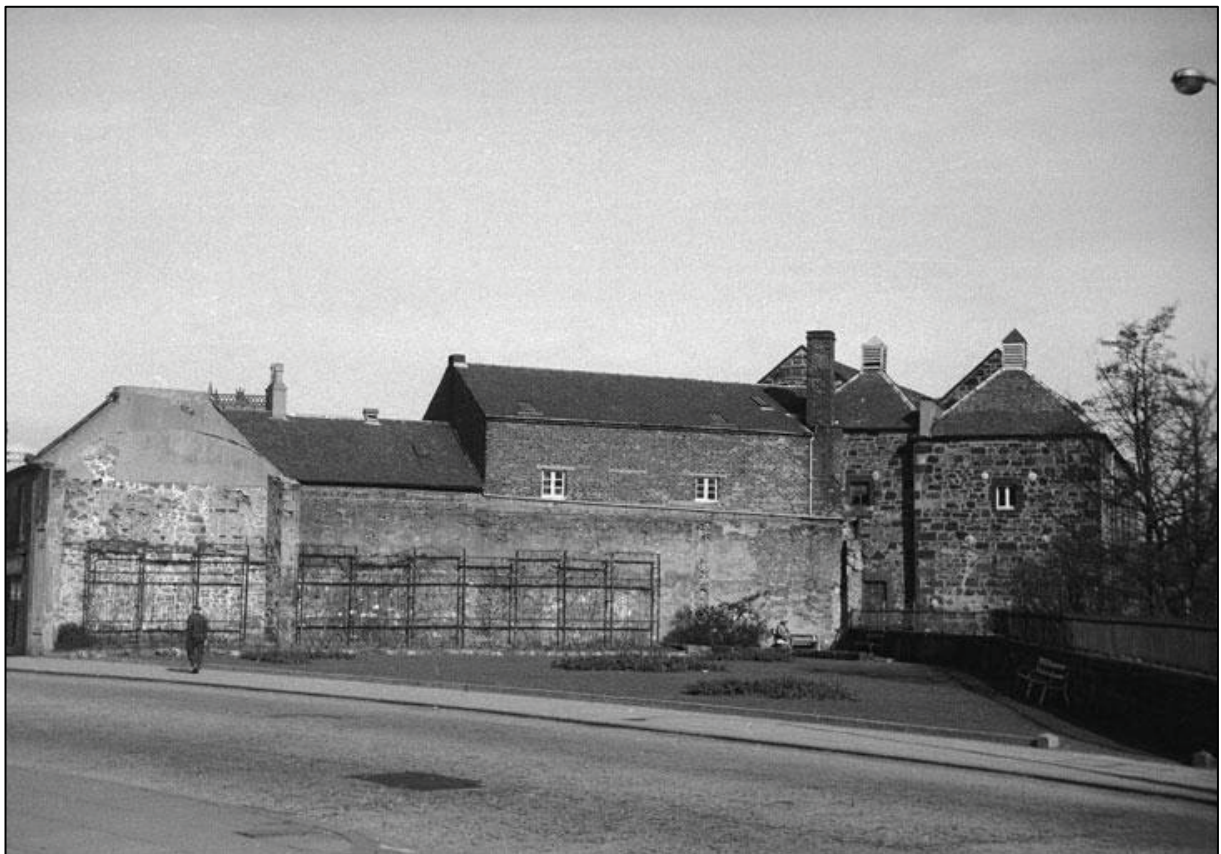
Figure 3b: The Saucel Mills: View From S as Photographed by Hume in the 1960s

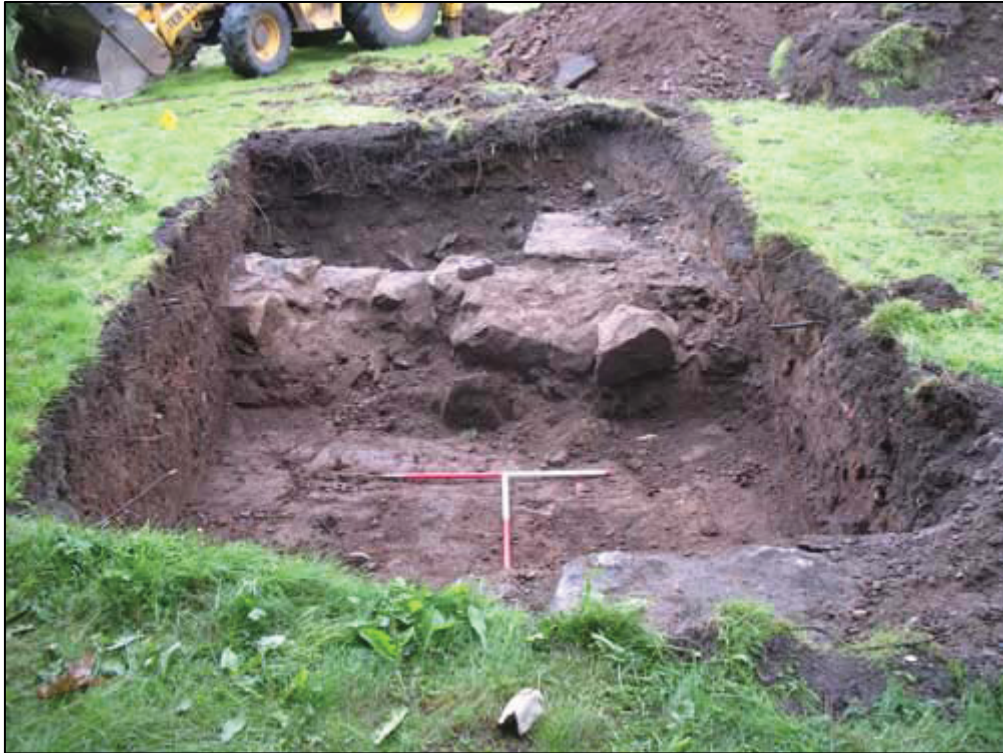
25. Trench 1 was oriented east-northeast to west-southwest and located in the north-east corner of the site. It revealed two features of interest, both comprising stretches of sandstone walling (018) (Figure 5a) and (019). The walls were bonded with lime mortar, which indicated a likely modern origin. They were therefore interpreted as comprising elements of the late eighteenth/nineteenth century courtyard building which had lain to the immediate south of the mill complex. No other features were noted, in a trench which predominantly comprised banded layers of modern levelling deposits (Figure 5b) e.g. (003), (008).

Figure 5a: Trench 1, View of Wall (018), With Wall (019) in Foreground

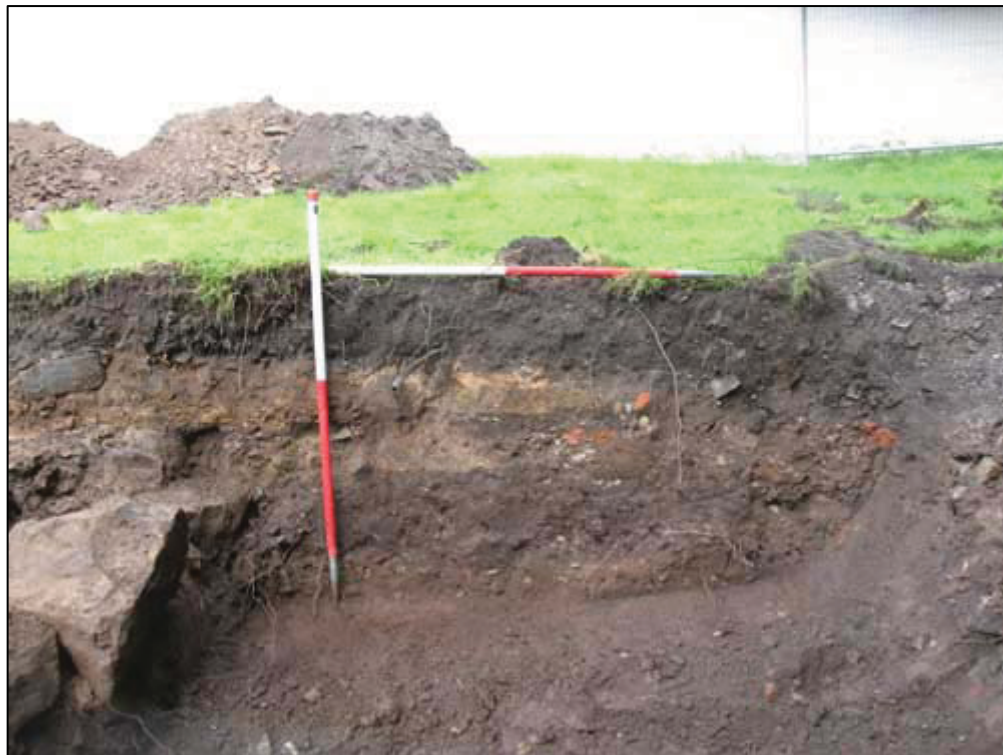
Figure 5b: Trench 1, Eastern Half of S-Facing Section, Showing Layers of Made-up Ground

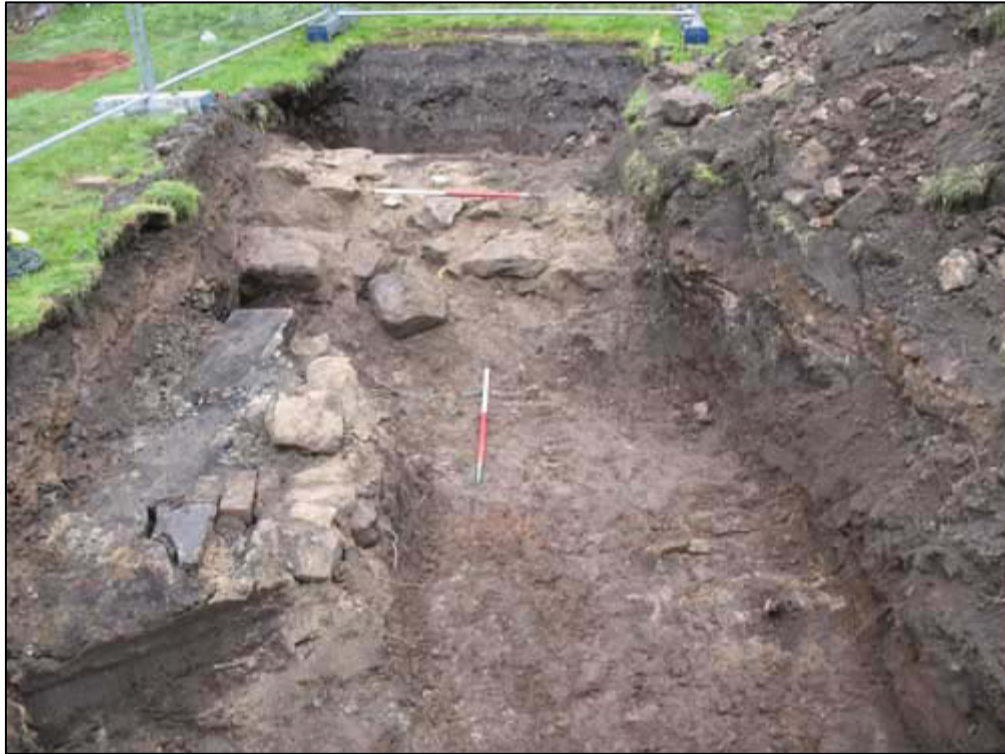
26. Running from north to south, Trench 2 revealed several features of interest within its extent. These included a sandstone wall (025), which ran west-southwest to east-northeast across the base of the trench, and a fragmentary structure (027) which appeared to represent the remains of a floor (Figure 6a). Wall (025) was, once again, bonded with lime mortar, and the possible floor (027) revealed red brick within the structure, so again an association with the late eighteenth/nineteenth century courtyard range can be demonstrated. There were no other features, the basal levels of the trench revealing natural subsoil (023) and (029) which in places overlay bedrock.

Figure 6a: Trench 2 – Possible Floor (027) to fore, with Wall (025) to rear

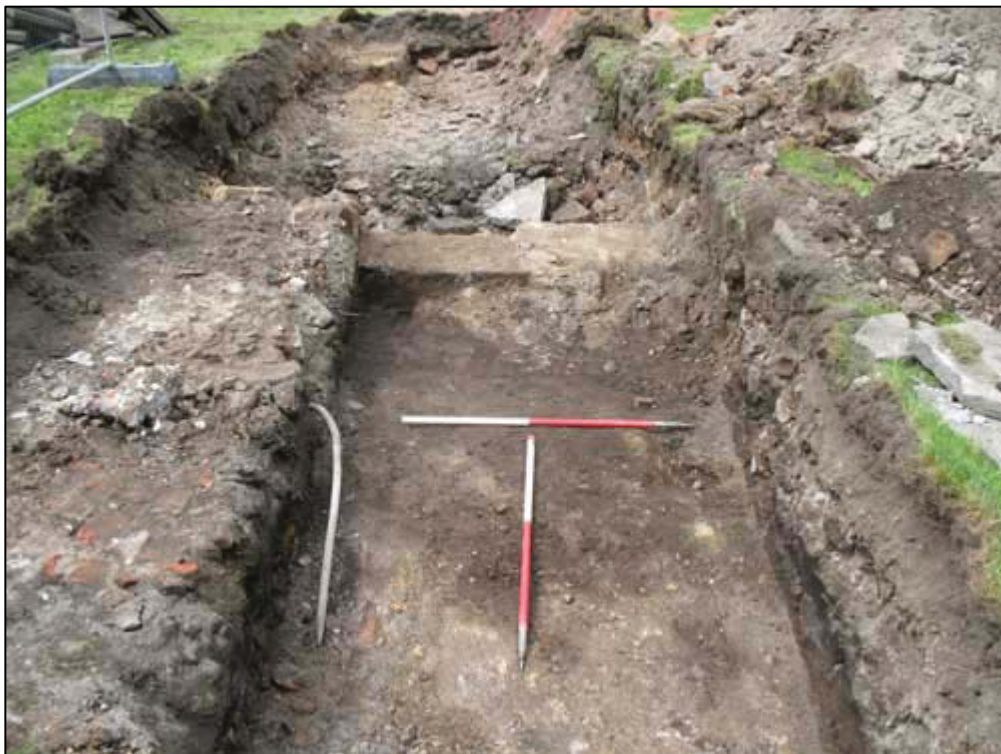
27. Trench 3 lay at the west side of the development area, at a point roughly central in the north-south axis. It included the area once occupied by the pend which accessed the courtyard of the late eighteenth/early nineteenth century courtyard range from the west. It was oriented north to south. The key feature within this particular trench was Surface (041), which comprised a modern red brick and concrete surface (Figure 6b). This abutted a lime-mortar bonded sandstone wall (042), itself forming the external wall of a building, with Surface (041) representing the former surface of the pend, and Wall (042) the external wall of the building lying immediately to the north, i.e. the north-western element of the range structure.

28. The removal of Surface (041) revealed a series of underlying deposits, including a black coal-rich bedding layer (043) and a dark brown clay silt (044) which appeared to be an earlier soil horizon. The latter clearly pre-dated the construction of the pend and was therefore deemed archaeologically sensitive. Dating evidence for this layer proved elusive at this stage: it was therefore determined by the West of Scotland Archaeology Service that further investigation of this layer was required at a subsequent follow-up stage of works.

Figure 6b: Trench 3 – Surface (041) Partially Excavated

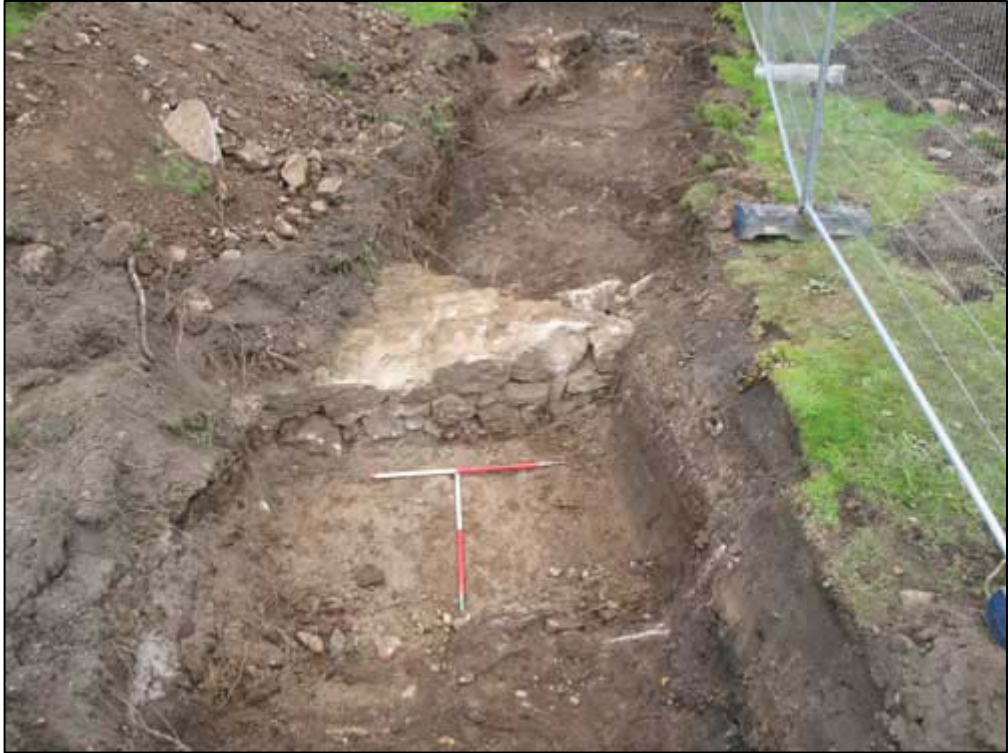
29. Trench 4 ran from east to west and was located in the central part of the development area. Two walls were identified in total. The first of these, Wall (040), crossed the trench on a roughly north-south axis, while the second (038), was identified in the N-Facing section. Again, both walls were bonded with lime mortar, indicating an association with the late eighteenth/nineteenth century courtyard building.

Figure 7a: Trench 4, Wall (040)

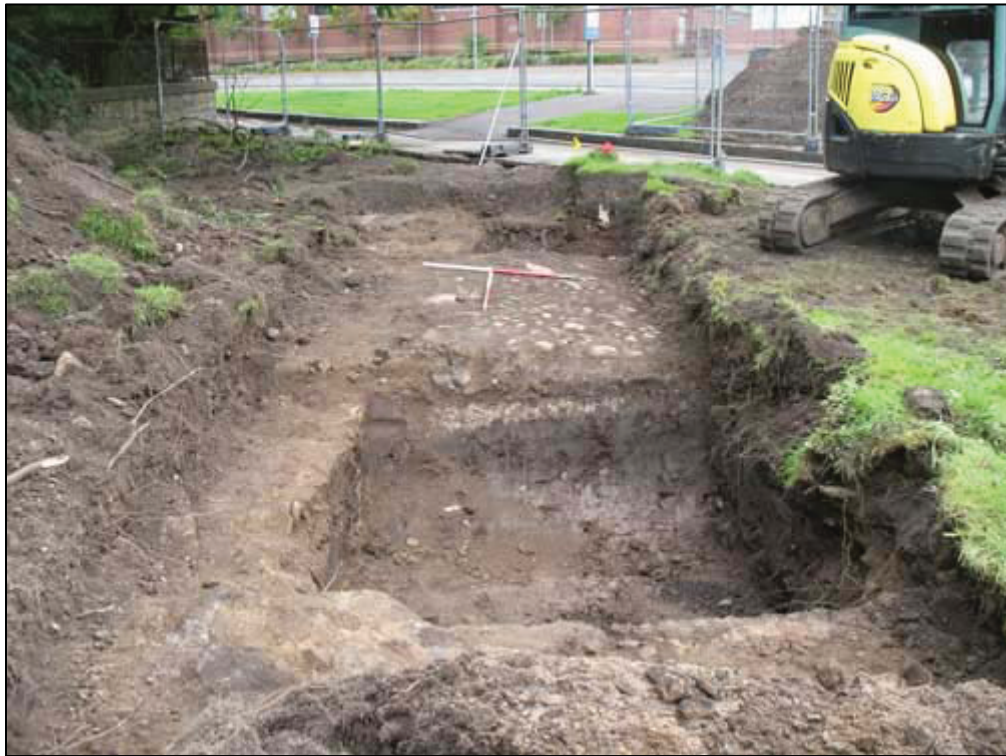
30. Oriented roughly north-south, Trench 5 was located at the south end of the development area. The major feature of note was a cobbled surface (037), which was interpreted by the excavators as an internal floor (Figures 7b and 8a).

Figure 7b: Trench 5, Cobbled Surface (037)

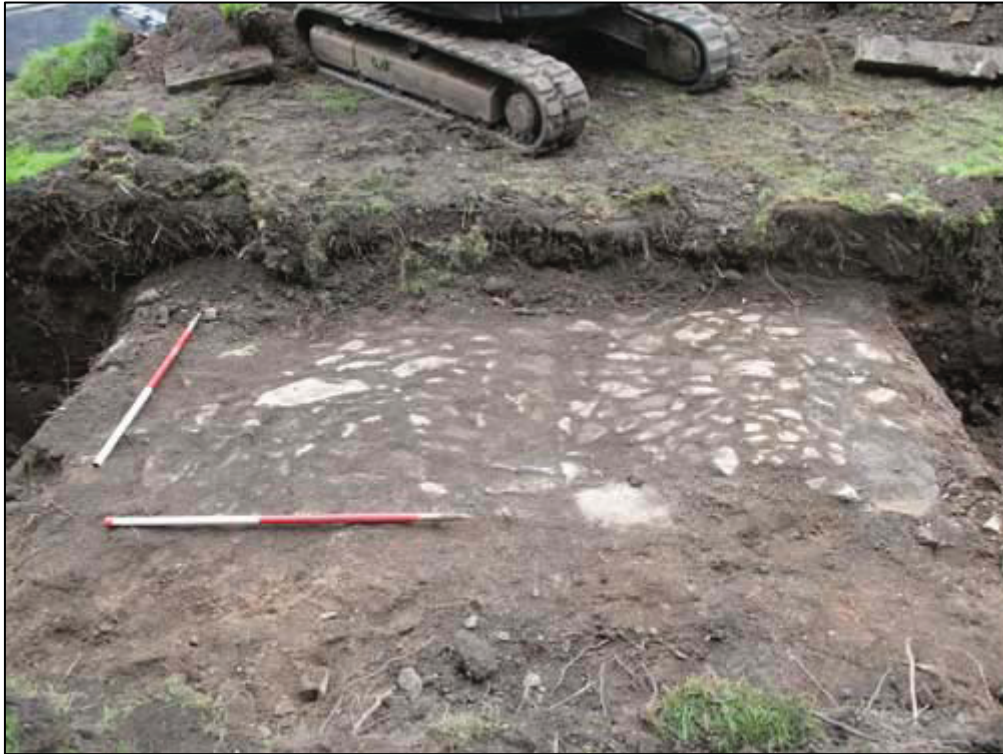
Figure 8a: Trench 5: Cobbled Surface (037)

34. Lying south of the new building footprint, Surface (037), was to remain intact and undisturbed with the ground reinstated over it. However, Surface (041), the former pend, was to be cut by the foundation trenches of the new building. Monitoring would continue in this area, with the aim of investigating the surface and in particular, its underlying deposits, more fully, in the hope that further information could be gained which related to the initial construction of the surface and the land use prior to this date. The method agreed upon to carry out these works was to reduce the upper levels by machine, then for the archaeologist to remove those archaeologically sensitive layers underlying the 'modern' pend surface by hand, with the aim of recovering artefactual evidence which might improve our understanding of these layers.

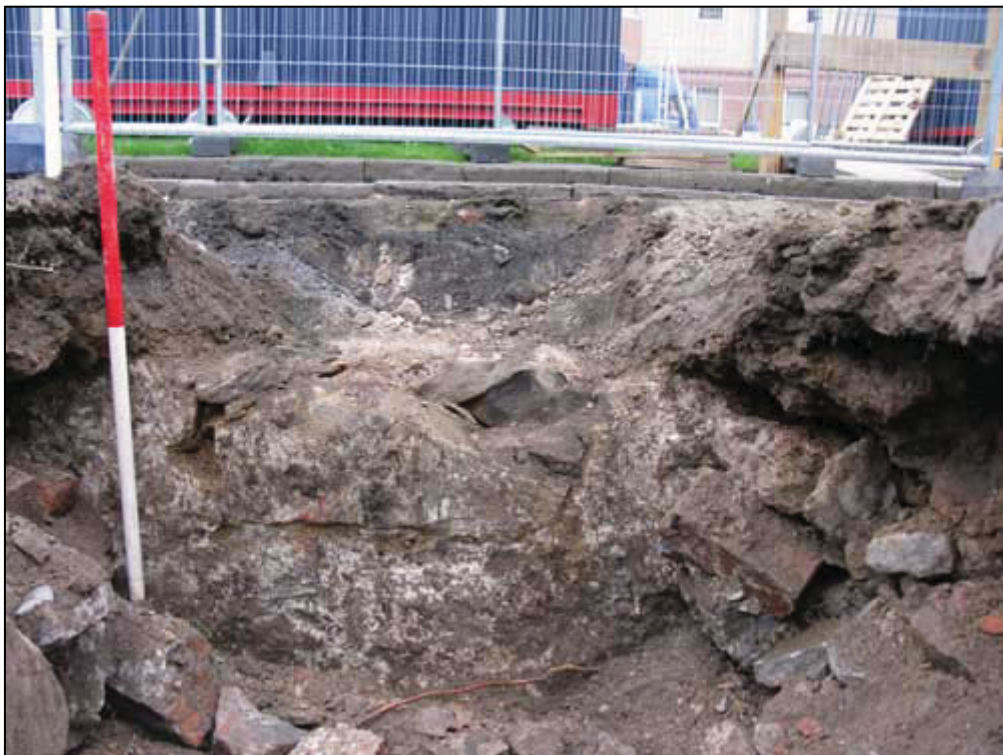
Figure 8b: Area A: Line of Late 18th/19th century Wall (102) at W Edge of Development Area

36. Removal of the loose rubble (101) from the N end of the foundation trench revealed a wall (102)/(103) running roughly north-northwest to south-southeast at the west side (Figure 8b), and another wall (104) crossing the trench in a roughly west to east direction. These corresponded closely with the courtyard structure shown on historic mapping.

37. The walls were revealed to a depth of 0.9m maximum (where the base of the structure was reached, comprising concrete slabs, suggesting that the cellars were in use until a fairly late date) and were consistent with a modern, late-eighteen/early nineteenth century structure, i.e. roughly worked sandstone blocks, sometimes massive (up to 0.5 x 0.3m in extent) in the basal courses, and bonded with lime mortar. The internal faces on both walls had evidence of limewash, which suggests that they formed part of a cellar, rather than functioning purely as foundations. The extent of the rubble infill, and thus the cellaring, matched that of the north-west courtyard building as shown on the historic mapping. Across this area, all earlier deposits had been completely obliterated.

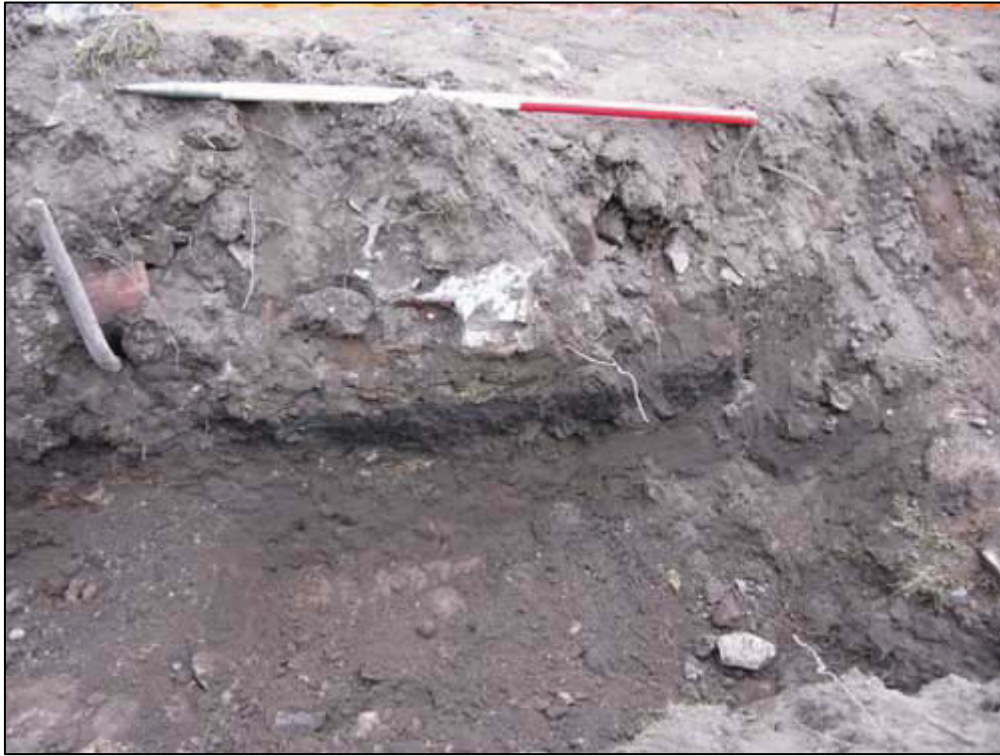
39. It proved difficult to identify the actual surface of the pend as a discrete entity during the excavation process beyond the section located during the evaluation, which suggests it may already have been disturbed to some extent. But identification of the underlying deposits proved straightforward enough, and a clear picture was obtained of the site's long-term occupation history. The pend may have been reformed on at least one occasion: its structural elements (109) overlay a pale brown sandy bedding layer which included fragments of red clay tile drain. This in turn overlay a narrow, black, coal-rich layer (108) which proved to extend over much of the central portion of the site (Figure 9a & b). This would suggest that the original surface would have comprised not only the pend but also the entire courtyard area.

40. Underlying (108) was a dark-brown clay silt (107) which was flecked with charcoal and burnt bone. It reached a maximum depth of 0.3m in places and directly overlay bedrock (114). It revealed a variety of ceramic types, including two fragments of medieval White Gritty Ware, and two sherds of glazed white earthenware and a sherd of salt-glazed earthenware pipe. It is possible, however, that the modern finds were intrusive contaminants from the fill of Foundation Trench [105]/(106), which was virtually identical to (107) and only discernible in section.

Figure 9a: E-Facing Section of Pend. Showing Surface (109) (Equivalent to (041) and underlying sediments, including coal-rich layer (108) and earlier soil horizon (107)

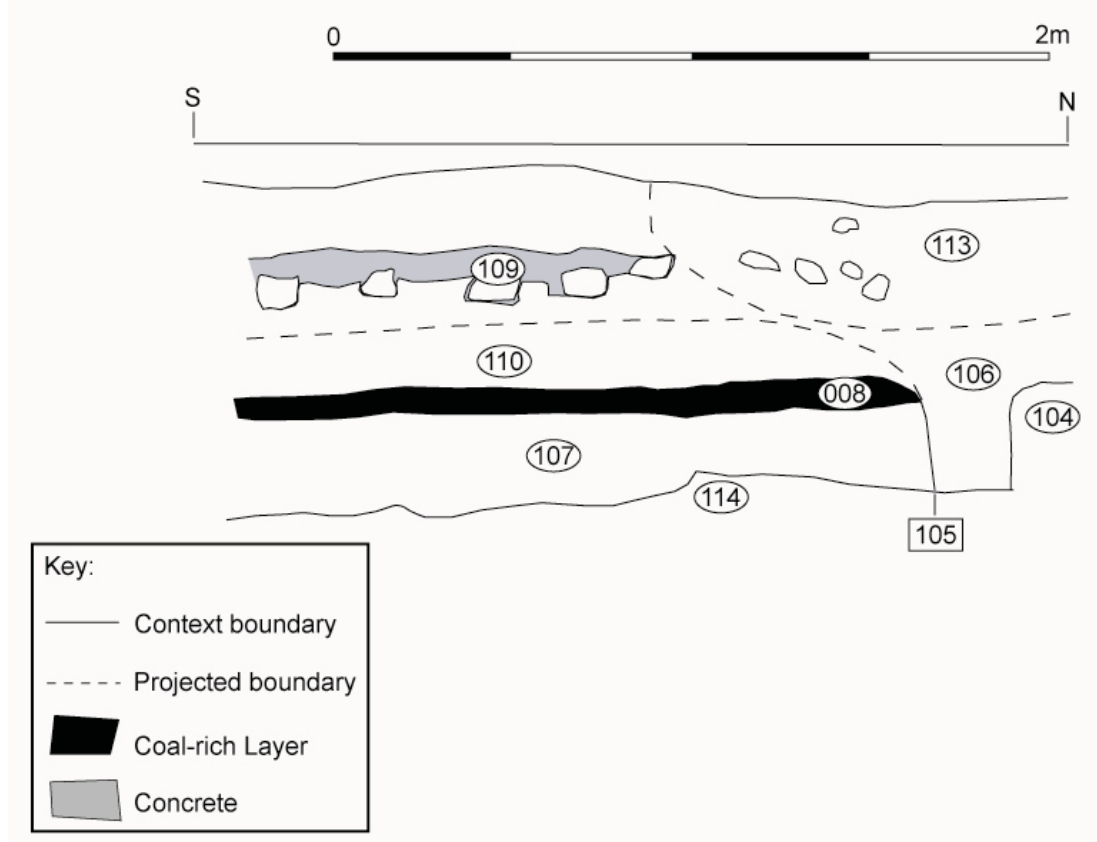
Figure 9b: Section Drawing of E-Facing Section of Surface (109) and Underlying Sediments

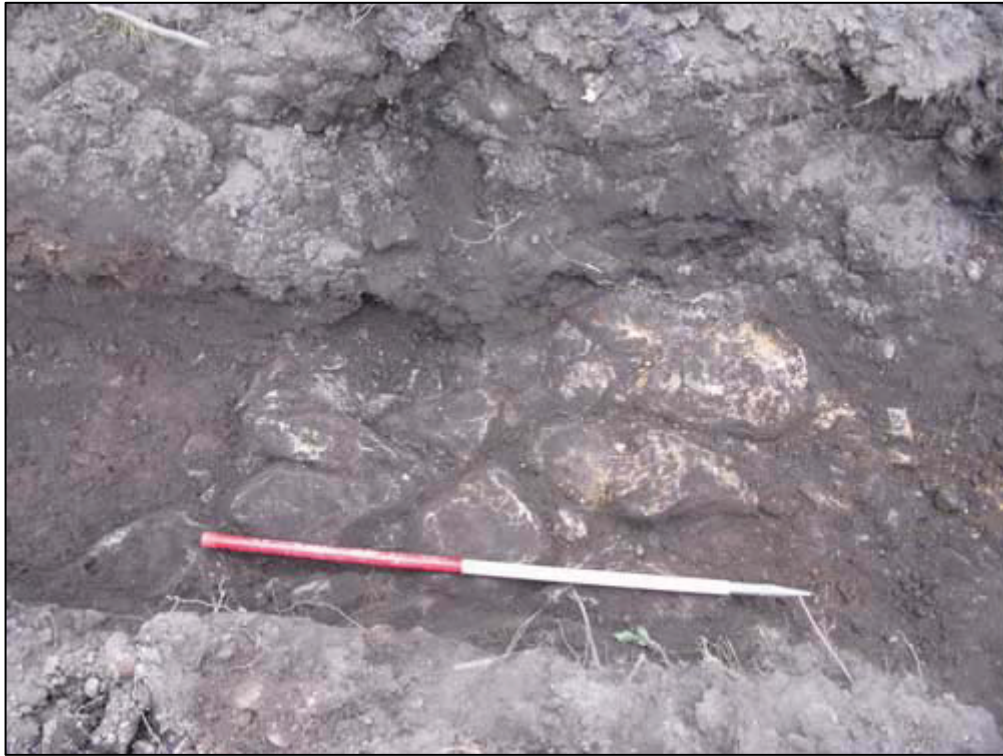
41. Bedrock (114) was itself quite problematic to interpret at first. In places, it was deeply fissured, sometimes giving the appearance of buried walling, a situation exacerbated by later cuts such as [112]/(113) (Figure 10a). However, removal of the overlying sediment (107) revealed its true nature, and by the completion of the excavations, the base of the trench had been reduced to bedrock along its length.

Figure 10a: Bedrock (114), with (108) *in situ*, and cut by (112) at left of picture.

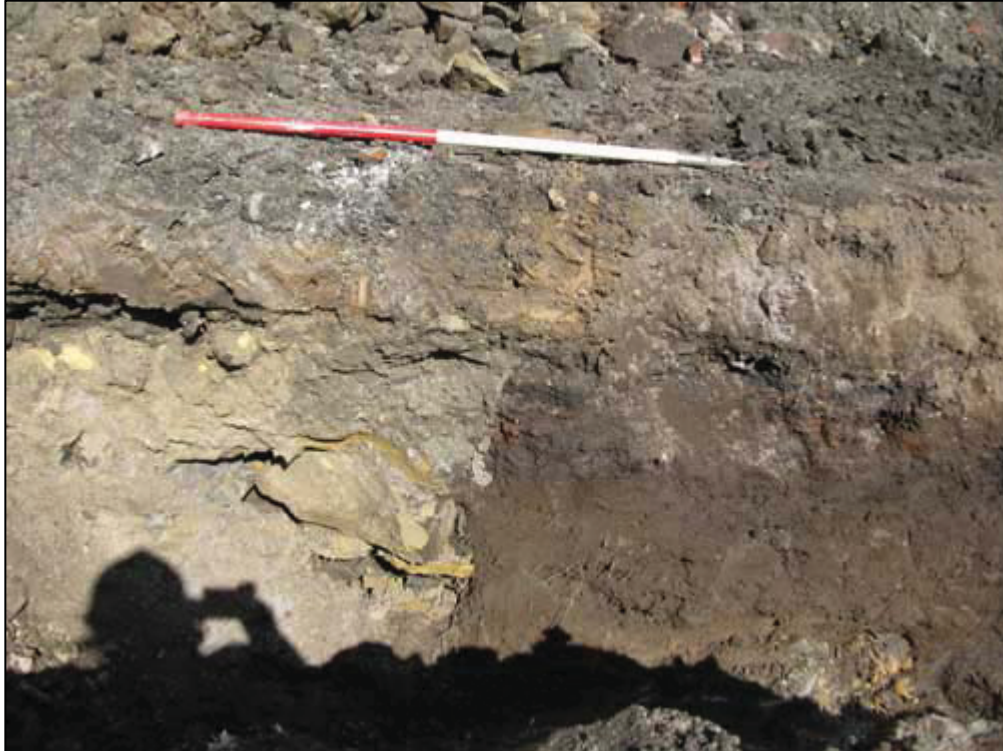
43. Large-scale disturbance was evident around this area, with some large excavations apparent, including one substantial trench [121]/(122) which appeared to truncate Wall (120). This was packed with sandstone rubble (Figure 10b): it may have been a robber trench, sunk to grub out the foundations of the courtyard structure, rather than a service trench, as there was no trace of a buried service within it. On the south side, [121] cut a series of layers (Figure 10b). The uppermost (124) was very mixed in character and had clearly been redeposited. The lower, [119], was a dark, charcoal-flecked clay-silt which was very similar to (107) and which probably represented the same layer, i.e. the remnants of an earlier cultivation horizon sealed beneath the late eighteenth/nineteenth century courtyard and pend. Layer (119) survived in isolated patches elsewhere in this area, but no features of archaeological significance were identified.

Figure 10b: Area B: Cut [121] with Made Ground (124) overlying earlier horizon (119)
