**Mauldslie Castle Nuseries:  
Archaeological Evaluation**

Data Structure Report

by Douglas Gordon

issued 17<sup>th</sup> June 2011

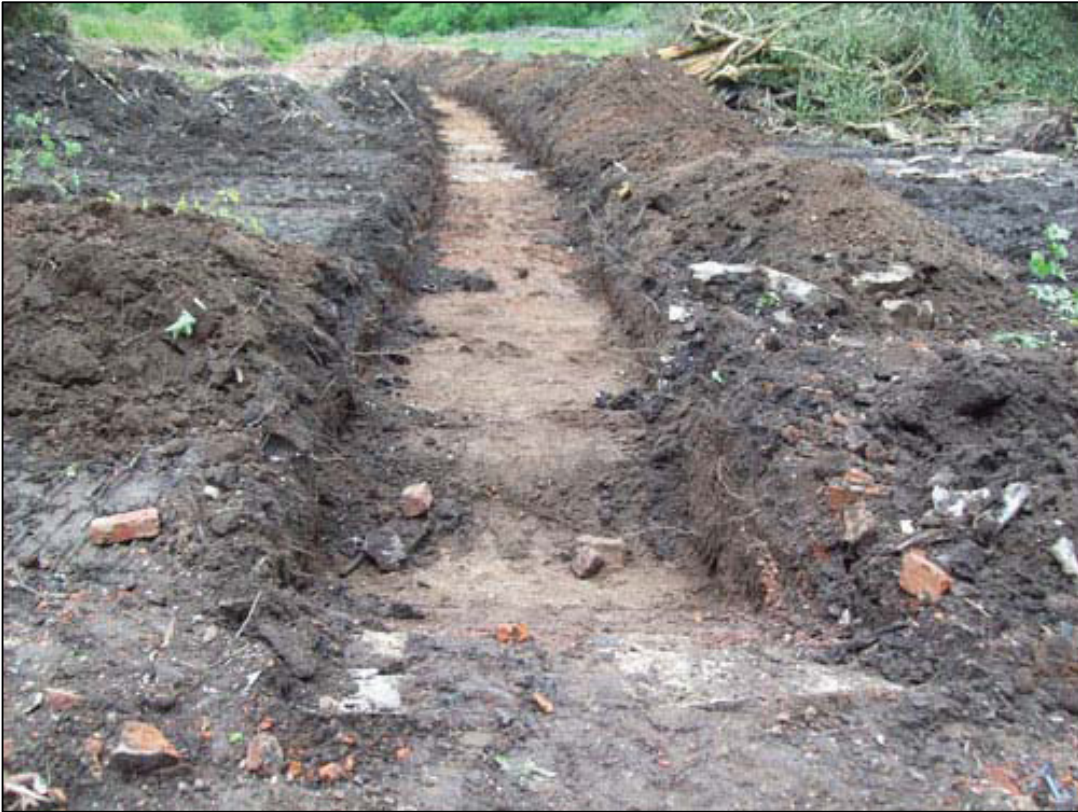
Figure 5a: Trench 1 from the North

22. Brick walls (012), (067) and (071) were evident within Trenches 2 and 10. Of particular interest was (067) which formed a square measuring 2.2m by 2m around a concrete base (069). From the north and south sides of the square the wall extended to the west outwith the trench. Between these extensions and the concrete base was a black humic silt, rich with large roots (070). There was also a sandstone wall (009) that was exposed within Trenches 1 and 2.
