# **Nether Auchendrane House: Archaeological Monitoring**

Data Structure Report

by Alan Matthews

issued 7<sup>th</sup> February 2011

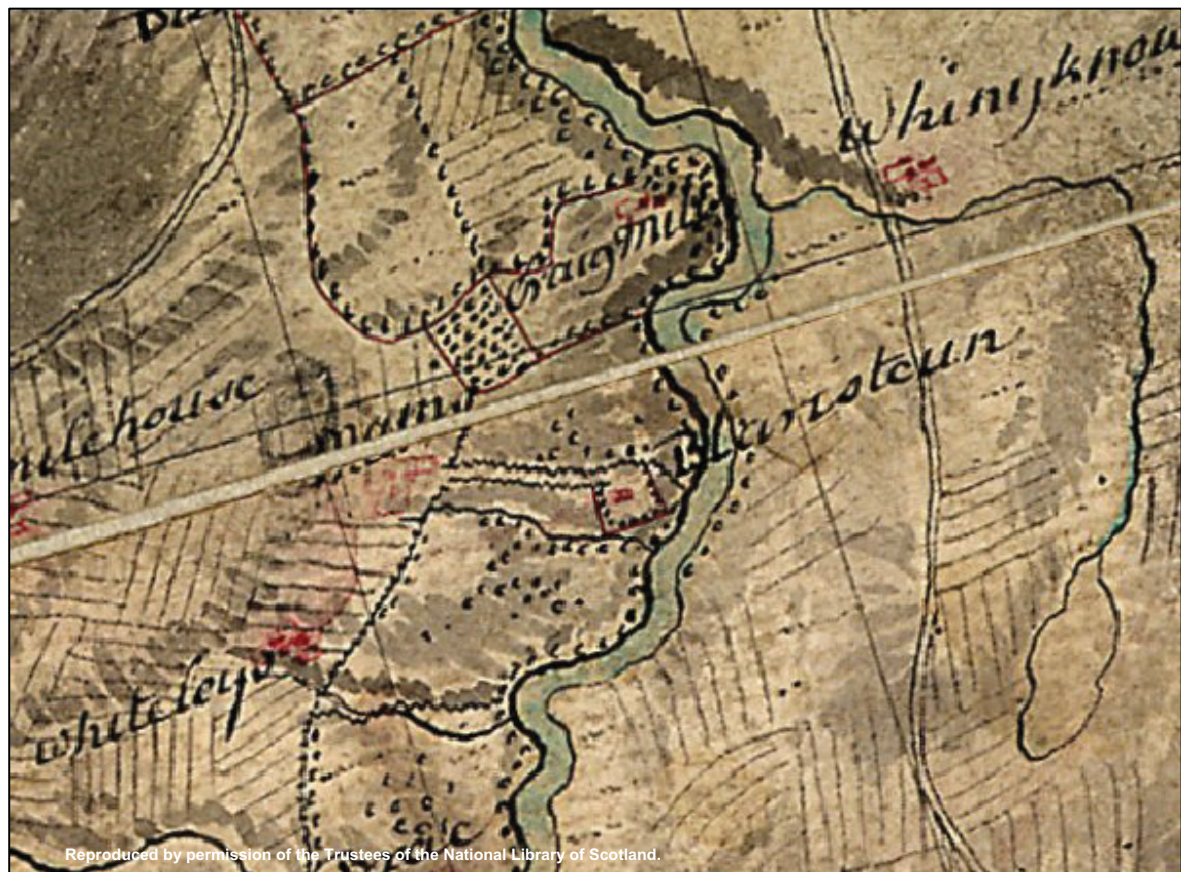
8. Roy's Military Survey of 1747-55 (Figure 1a) shows a large rectangular building in the location of the house labelled as 'Blaristoun' which sits within an almost square tree-lined enclosure and has a tree-lined avenue running in from the west. The 1<sup>st</sup> edition Ordnance Survey mapping (Figure 1b) is the first mapping to show the house by the name of Auchendrane and shows an extensive designed landscape surrounding the house including heavily treed areas and extensive orchards.

Figure 1a: Detail from Roys' Military Survey of Scotland (1747-55)

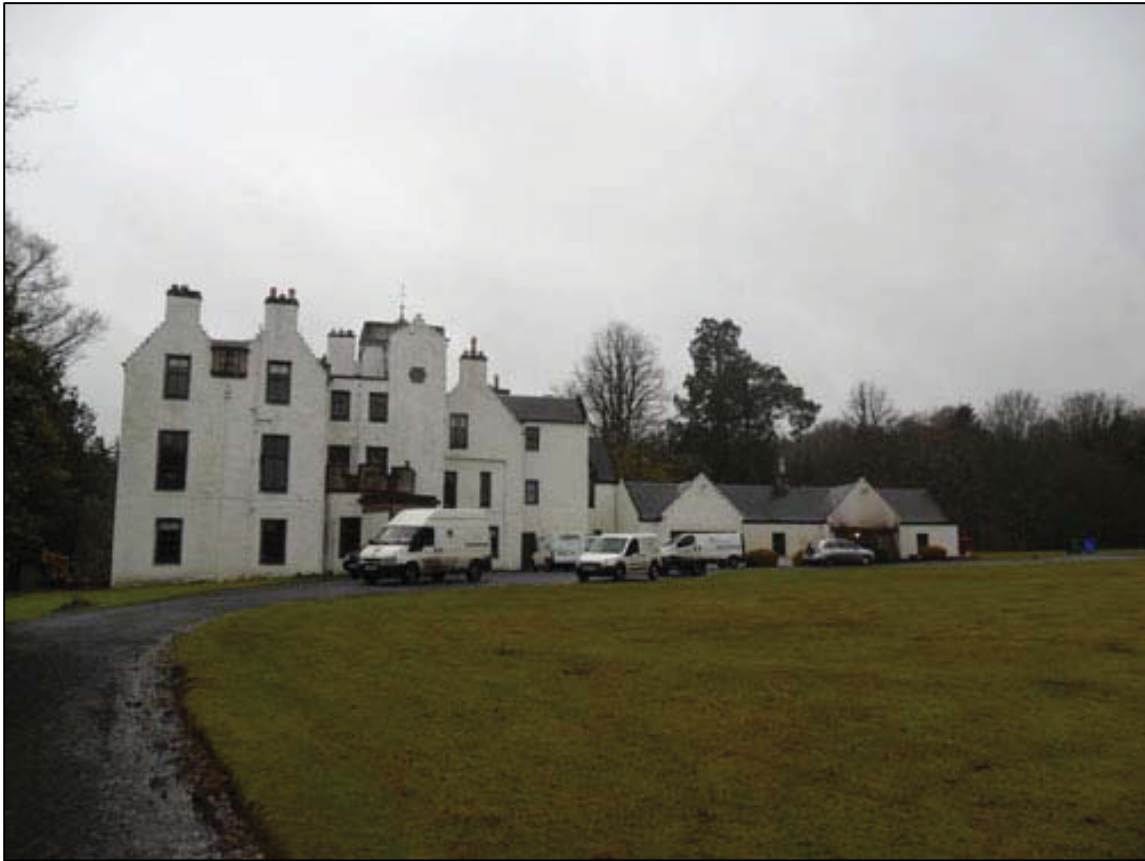
Figure 2a: Nether Auchendrane House from the North

14. Nether Auchendrane House is located in the midst of large gardens to the south of Alloway and Ayr. Despite the age of the house it has been extensively modified in modern times (Figure 2a). The archaeological monitoring work described here took place at the westernmost end of the extended house furthest from the original structure. Adjacent to the development area is the single story extension of the original Nether Auchendrane House.

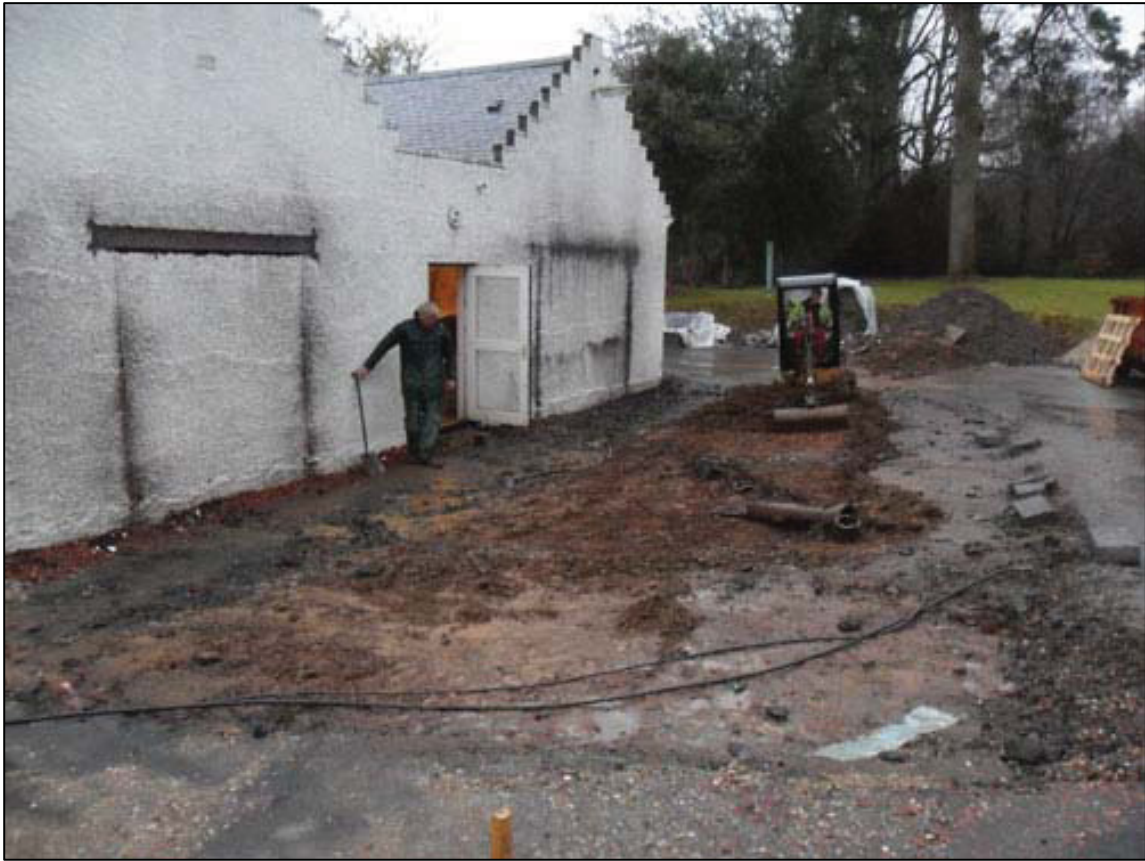
16. Archaeological work commenced on this site with removal of the tarmac and bedding material (001) along with the retaining wall to the immediate west of the existing structures (Figure 3a). This process removes only modern (20<sup>th</sup> century) material in the form of tarmac, type 1 gravel and modern brick. The only artefacts observed during this process related to the modern use of the site. This process also revealed the upper surface of what may have been disturbed natural soil.

Figure 3a: Stripping the upper surface of (004)

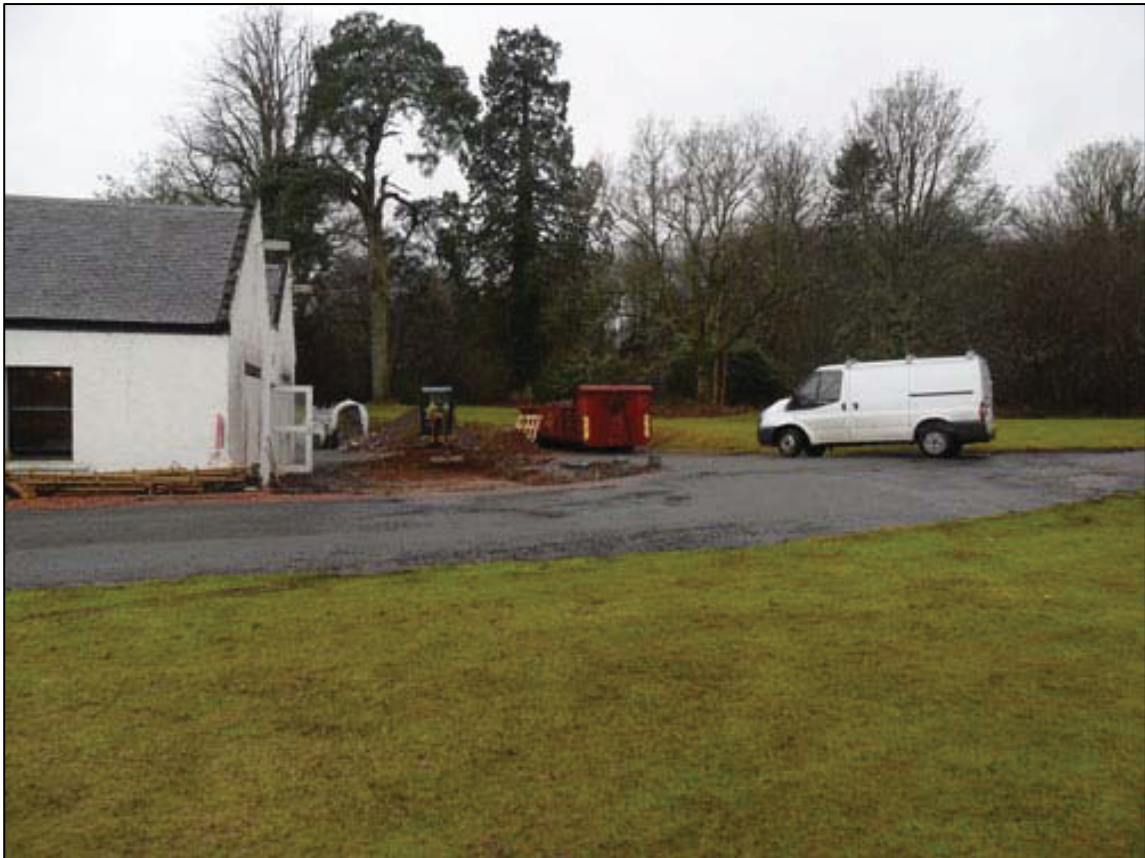
Figure 3b: Area surrounding development area.

22. Examination of the topography (Figure 3b) in the course of the archaeological monitoring works suggests that the area of the extended house and the area immediately to the west have been levelled for construction by excavating into the natural slope. It is difficult to accurately gauge the extend of underlying disturbance relating to the existing structures however some suppositions can be made by examining the sediments exposed during archaeological monitoring works.

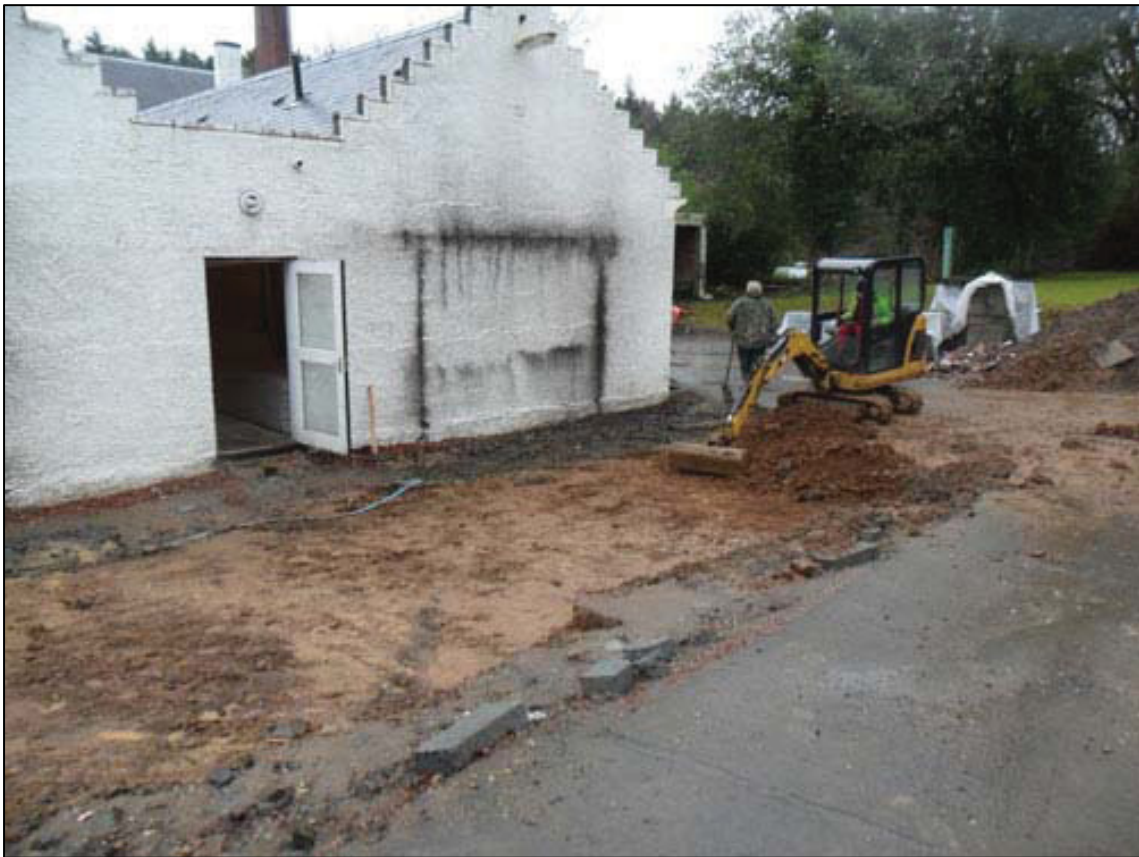
Figure 5a: Surface of (004)

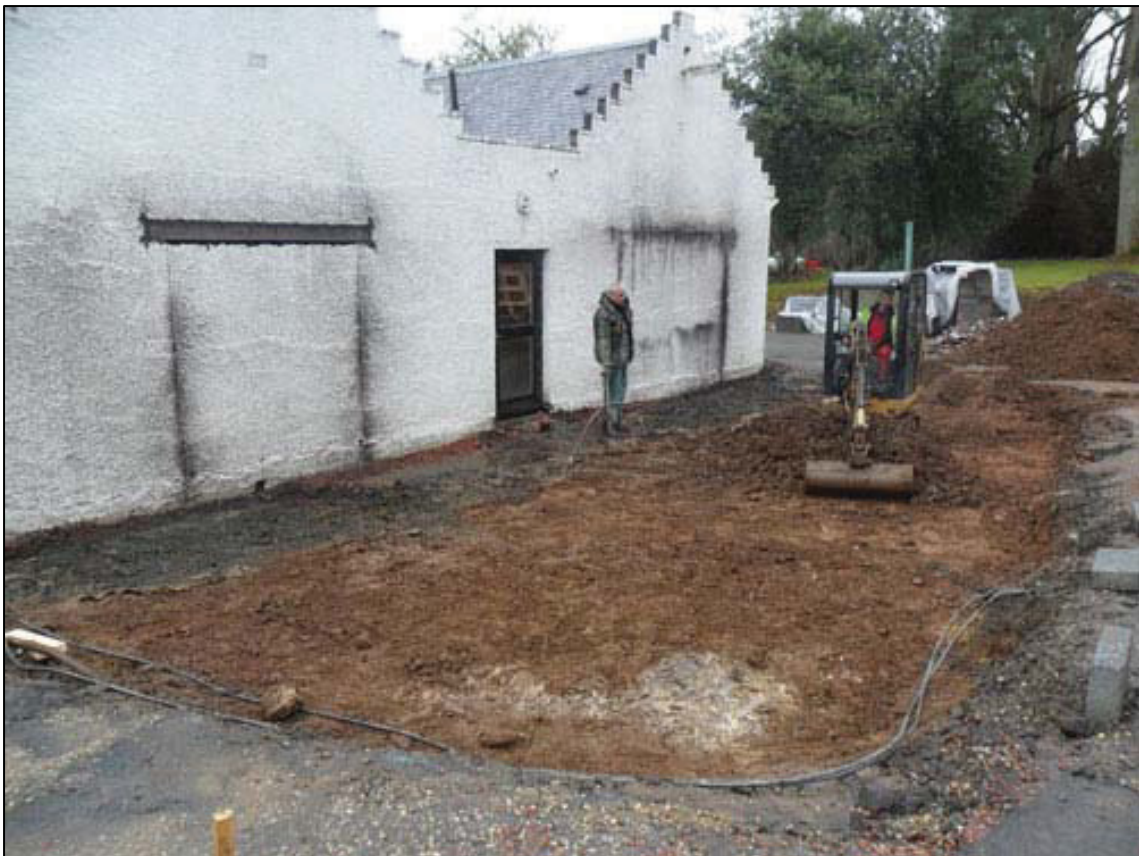
26. The archaeological monitoring works failed to identify any significant archaeological deposits or material within the development area (Figure 5b). By archaeological monitoring it has been possible to establish that the modern occupation of the site has removed any traces of previous occupation within this area.

Figure 5b: Surface of (004)
