**Sports Facility, Calderglen, East Kilbride:
Archaeological Mitigation**

Data Structure Report

issued 17th September 2010

Rathmell
Archaeology Ltd

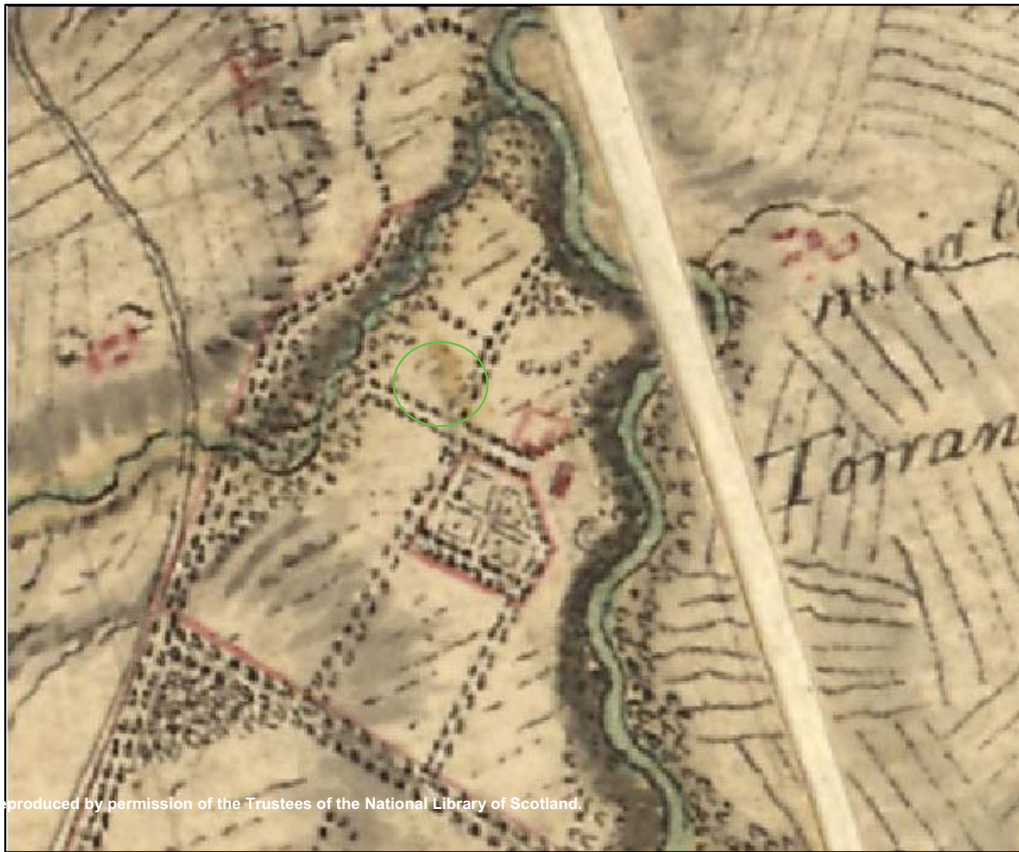
Figure 1a: Roy's Military Map (1747-55) Showing Torrance House (16th century)

8. Roy's Military Survey of Scotland (1747-55) predates the construction of the mansion in 1875. This map (see Figure 1a) depicts the development area as being within parkland associated with a substantial structure to the south-east (roughly at the location of the later Torrance House – inferred as the tower house). A free standing structure between Torrance House and the development area is also mapped on the 1st edition Ordnance Survey (see Figure 1b) and has been identified as a dovecot of late 17th or early 18th century character (WoSAS Id 9319).

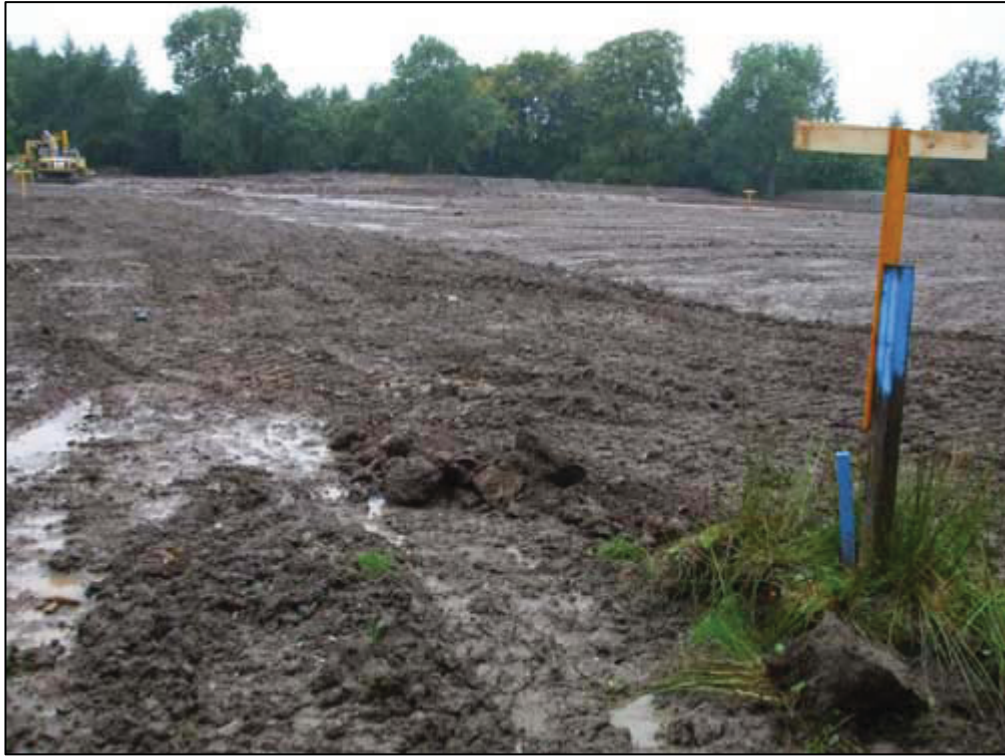
15. The archaeologist was not present during the ground-breaking works, which were undertaken by a 360° tracked excavator using a toothless ditching bucket. At the end of this phase of works, the surface of the subsoil had been exposed over an area which covered approximately 70% of the sports arena (Figure 3a). The subsoil had not, however, been compromised to any large extent across the majority of the site: there was some disturbance due to the passage of tracked machines over the freshly exposed surface, but when the archaeologist attended, a smooth finish was evident over much of the site which was perfect for identifying archaeological features.

Figure 3a: Trench 1, Subsoil exposed

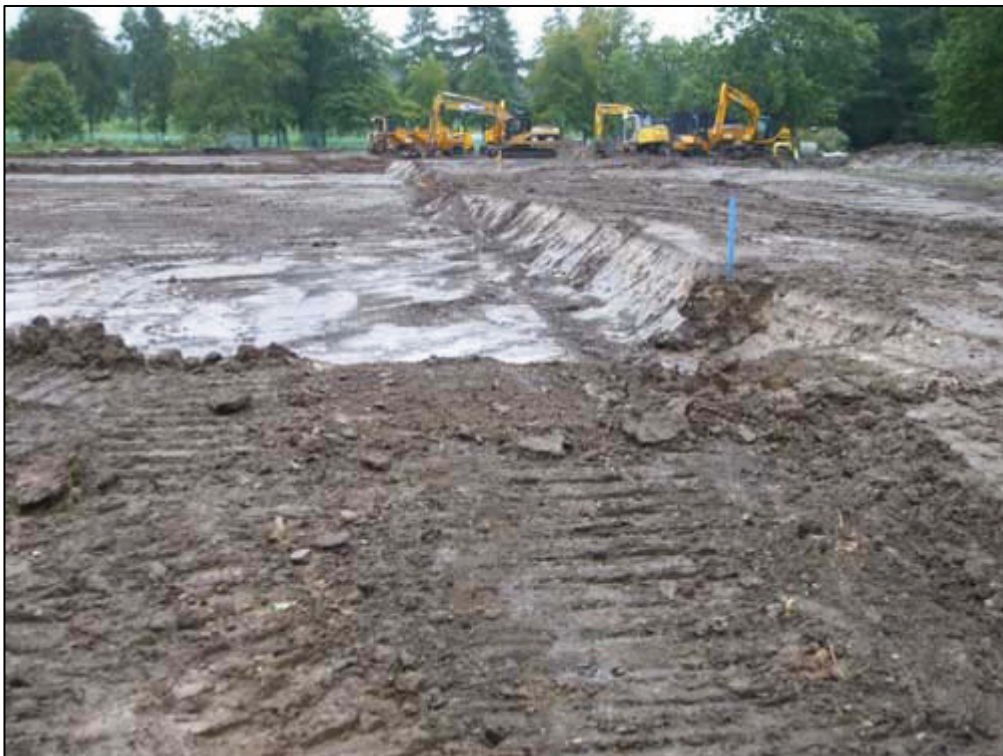
Figure 3b: Ground Reduction in North-West Corner of Sports Arena

16. An area in the eastern half had been subject to the dumping and compacting of soil in order to raise the levels prior to the drainage works taking place here, while at two locations, in the north-west (Figure 3b) and north-east (Figure 4a) corners respectively, the land had been subject to ground reduction, with levels dropped to a maximum extent of 0.4m below the original ground surface in places.

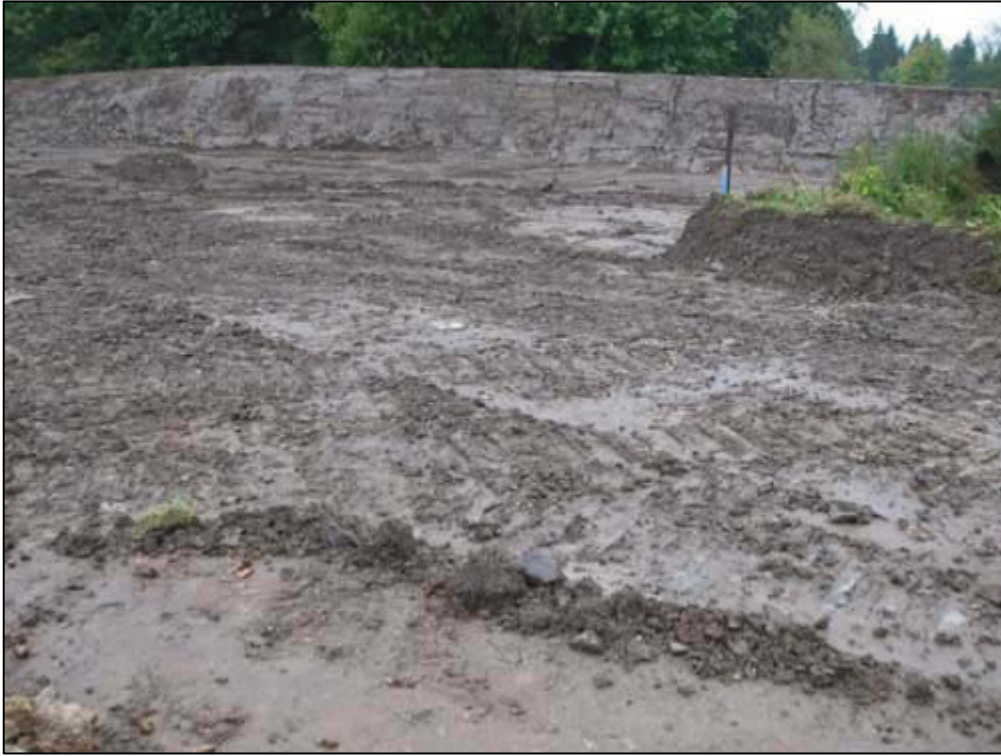
Figure 4a: Ground Reduction in North-East Corner of Sports Arena

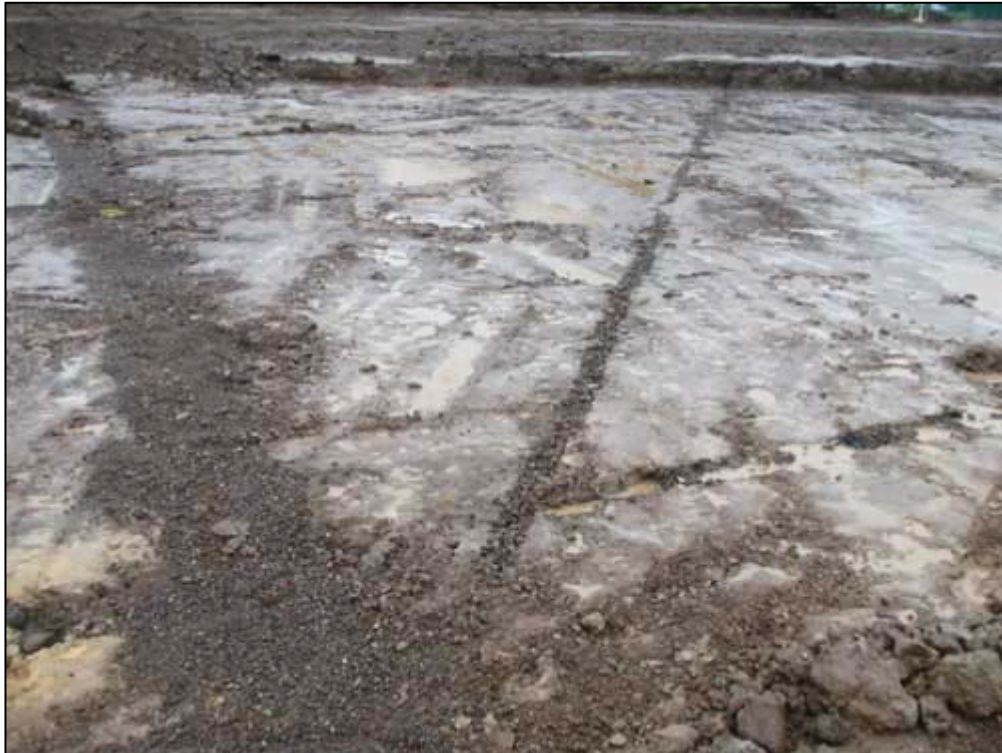
19. The earliest evidence of this land management was provided by the fragments of clay tile field drains which lay scattered extensively across the development area. These measures had apparently failed, or had not worked sufficiently well for current needs, as a complex network of modern drains had been laid across much of the site. These comprised alkathene pipes set within a matrix of pea gravel.

Figure 4b: Network of Field Drains in Southern Portion of Site
