**8-10 Vennel Street, Stewarton,
East Ayrshire:
Archaeological Mitigation**

Data Structure Report

by Louise Turner

issued 2nd July 2010

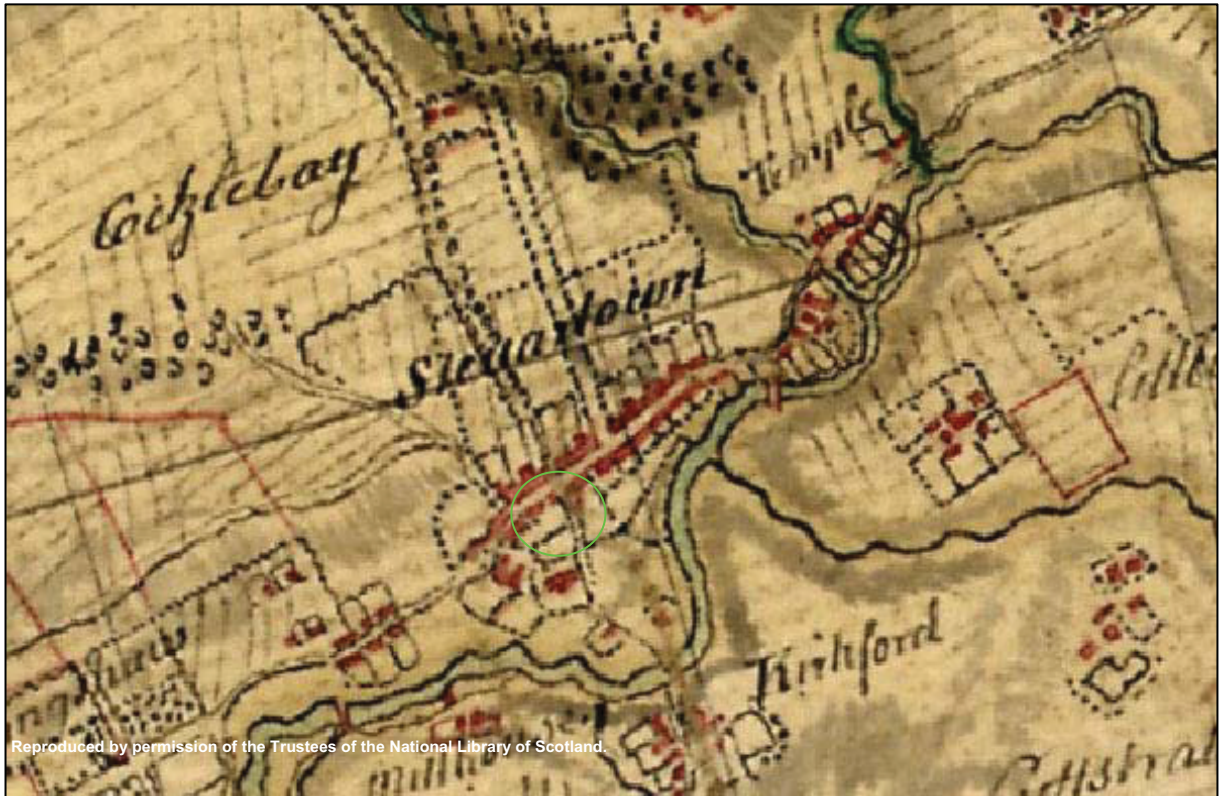
14. The first mapping evidence to show the area in any detail is William Roy's Military Map of 1747-55. By this time, Vennel Street has been laid out on plan and the street frontages have already been built upon. However, there is no indication of intensive land use in the backland areas of the plots now occupied by the late nineteenth century Commercial Buildings complex.

Fig. 1a: Roy's Military Map (1747-55) Showing the Town of Stewarton

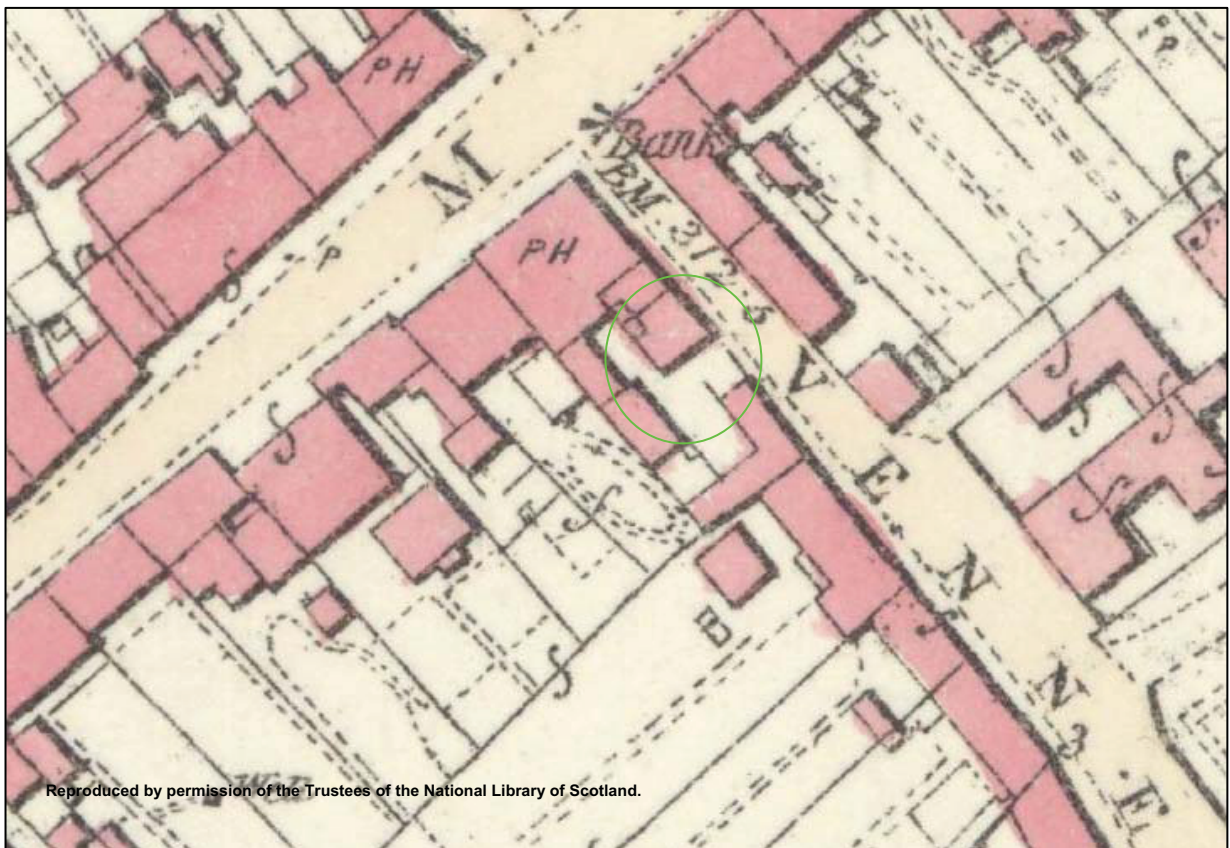
17. The 1st edition Ordnance Survey map of 1858 shows that by this time, the backlands area to the rear of Vennel Street has become increasingly built up in the intervening years. There is in particular a single large structure occupying the corner of Main Street and Vennel Street. Marked as a 'Public House' on large scale maps of the town, this appears to be much larger on plan than the late nineteenth century structure which currently occupies the site. It extends to the rear of the adjoining property, which itself comprises two adjoining properties.

Fig. 1b: Excerpt from 1st edition Ordnance Survey Map of 1858

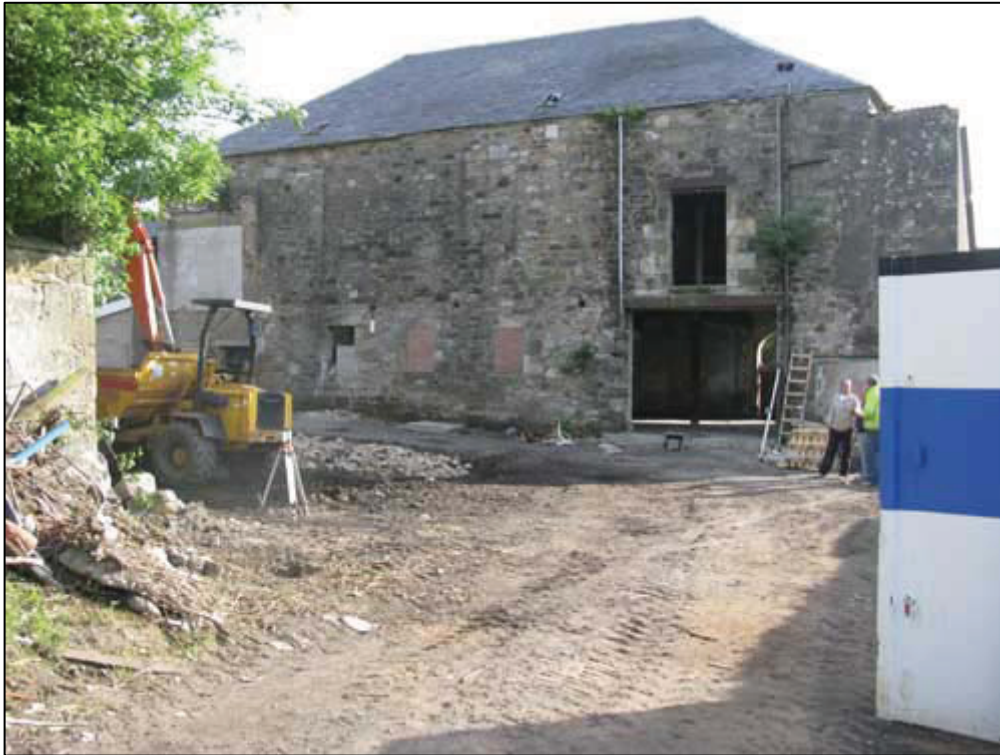
Fig. 3a: View Showing Rear of Late 19th Century Granary Prior to Ground Reduction

21. The remainder of the works comprised the reduction of a substantial area lying to the rear of the late nineteenth century building (Fig. 3a) to the level of the natural subsoil. These were carried out with an archaeologist in attendance.

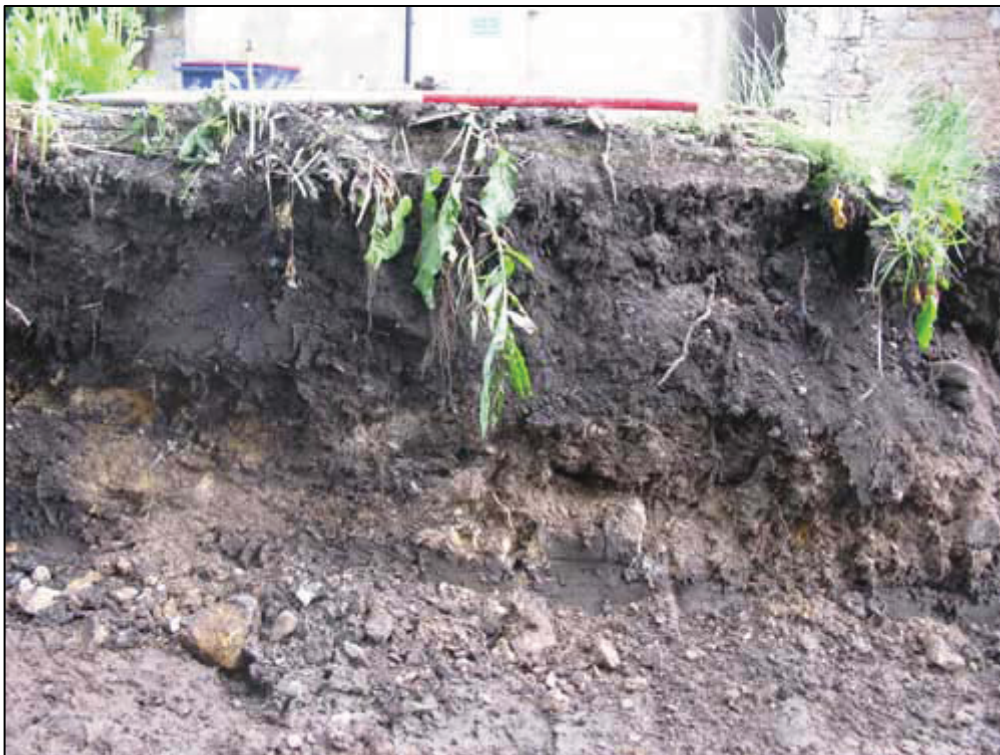
Fig. 3b: SW Facing Section, NE Corner, Showing Topsoil (001) Over Sandstone Rubble

24. The eastern half revealed *in situ* topsoil (001), which reached a depth of 0.5m in places. This was very loose and humic in character, suggesting that it had been subject to regular intensive cultivation until fairly recent times (perhaps subject to double-digging). There were numerous finds of modern glass and pottery, including sherds of blue-and-white transfer-printed white glazed earthenware and more modern ceramic types such as kitchen and bathroom tiles. There were some dumps of demolition debris (006) in places – this comprised fragments of blonde sandstone (Fig. 3b). This material appeared to be contained within the topsoil, which suggests that this may have been redistributed over the site in the past, or the even the existing topsoil augmented with imported material in order to improve the quality of the soil here. The topsoil directly overlay a compact pink-brown subsoil (002).

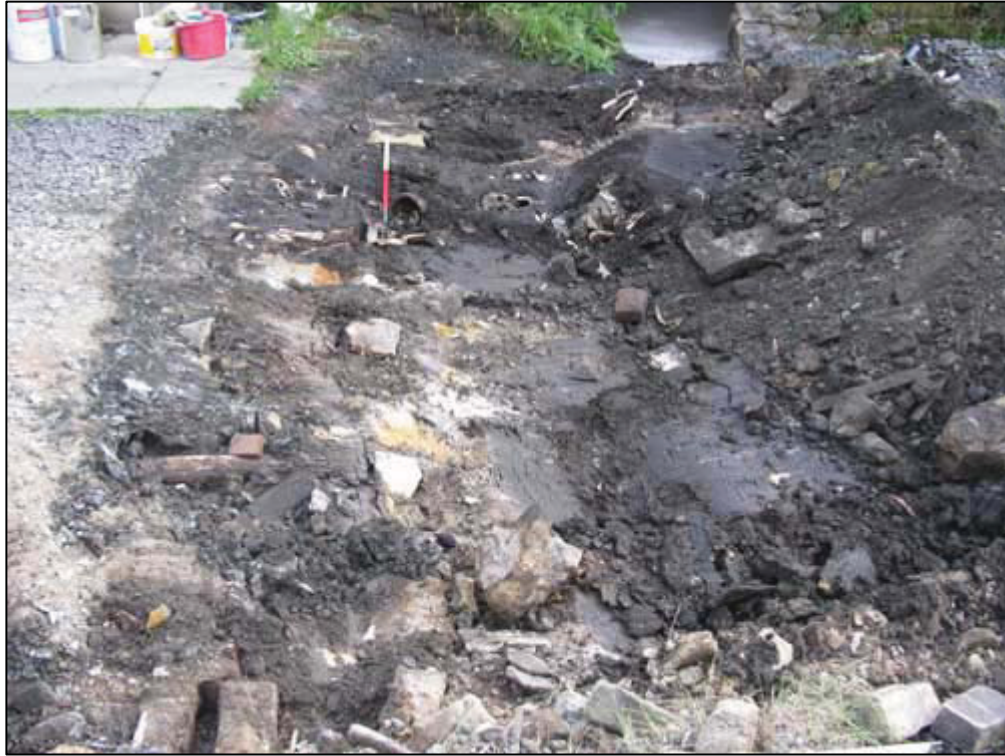
26. At least four stretches of wall footings were uncovered across the extent of the site. Three of these, (005) (Fig. 4a), (007) (Fig. 4b) and (011) (Fig. 5a) comprised squared rubble blocks of blond sandstone. There were no traces of mortar, but since these appear to represent buried founds, this omission can be interpreted as insignificant.

Fig. 4a: Wall (004) Running NE-SW From Rear of 19th Century Granary (?Structure)

30. Wall (005) followed a similar alignment to the N wall of the late nineteenth century building, which appeared to overlie it, and it therefore must be a precursor of this structure. However, this feature itself overlay a salt-glazed drainpipe, so it must be of nineteenth century date or later. It therefore seems likely to represent the rear wall of an earlier building, probably that of the public house shown on the historic mapping.

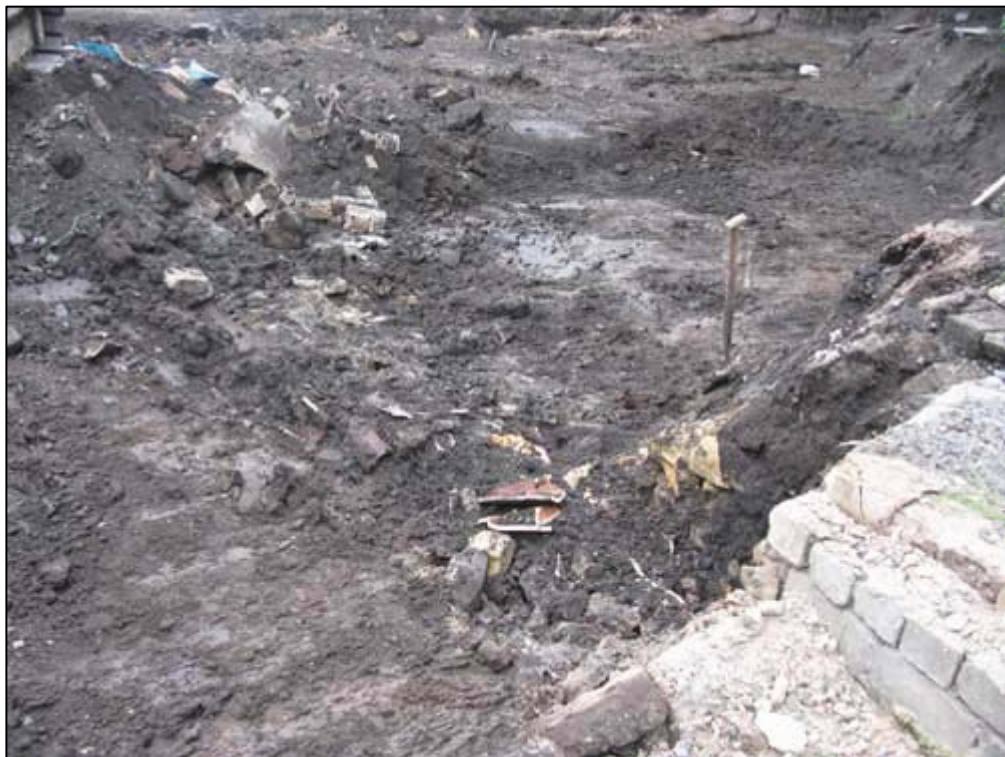
Fig. 4b: Line of 19th century Wall (005) Running NW – SE (?Former Boundary Wall)

31. Wall (007) ran perpendicular to (005). It was not clear whether both walls formed part of a larger structure, or whether they were abutting. However, it seemed likely that (007) once formed a boundary wall dividing the yard to the rear of the granary from an adjacent, domestic property. This may have post-dated the public house structure, though it is also possible that it employed the footings of an extant wall which once formed part of the now-demolished public house as a means of defining the backland plot.

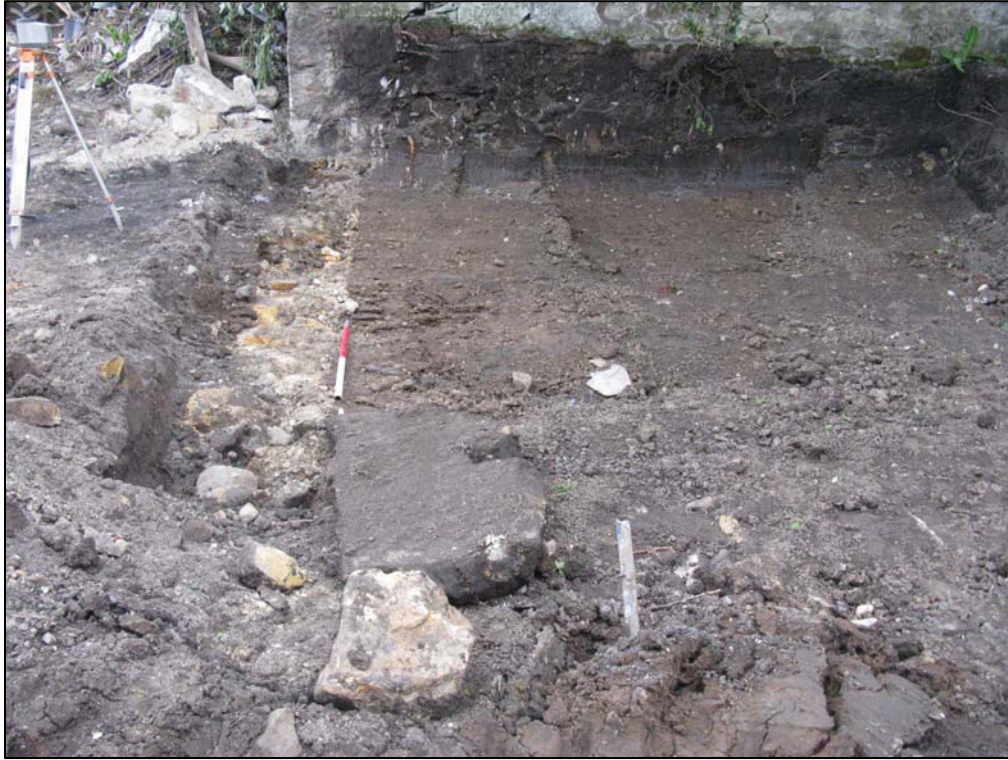
Fig. 5a: Line of Wall (007) Running NE-SW (?Former Boundary at Rear of Plot)

27. Walls (005) and (007) each overlay salt-glazed earthenware drainpipes of nineteenth century date, and abutted one another. They could conceivably have represented adjoining walls of the same building, though it is possible that (007) functioned also as a boundary wall. Wall (011) continued on the same course as that followed by the upstanding garden wall which forms the rear of the adjacent house plot.

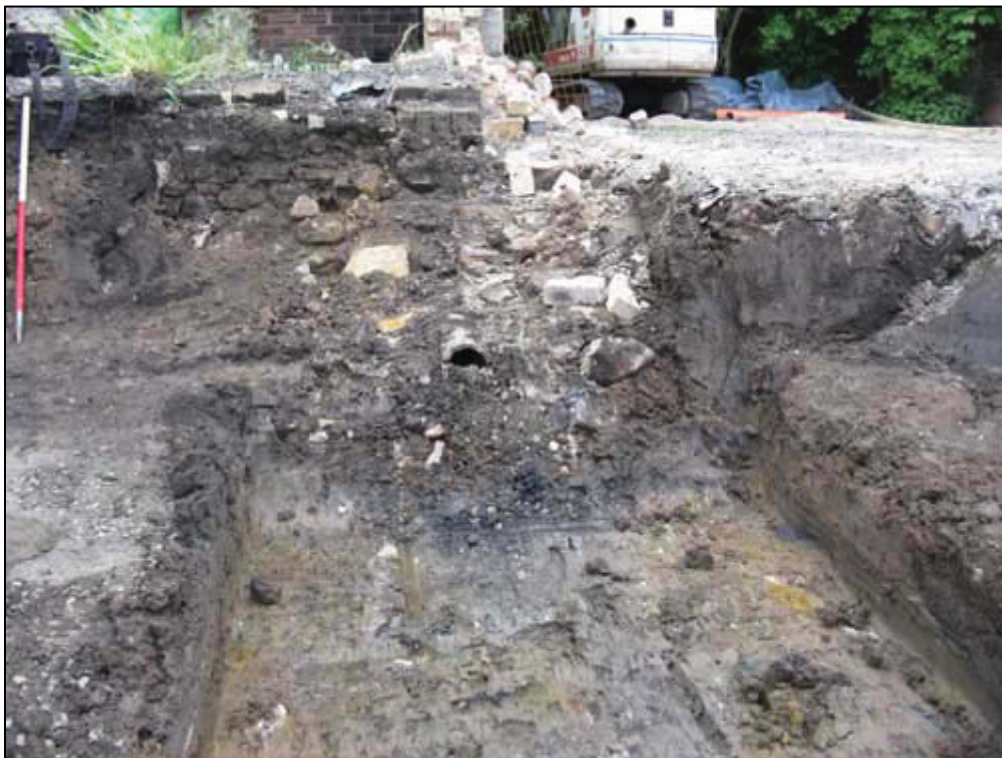
Fig. 5b: View along Line of Wall (005) & Underlying Drain, with Revetment Wall (012) to Left

28. Wall (012) was the best preserved of all these structural elements, surviving to a height of 0.6m (Fig. 5b). It was very roughly built, comprising an unmortared rubble face. Its survival appears to be related to the fact that it is still functioning as a revetment and helping to support a level patio area to the rear of the extant house/shop structure which currently occupies the site. Again, its late date was attested by the fact that it overlay a salt-glazed earthenware drainpipe. It may have formed a revetment wall for a semi-subterranean structure such as a coal cellar which was associated with one of the earlier properties which occupied the site.
