**Westwind, Dunragit, Dumfries & Galloway:
Archaeological Mitigation**

Data Structure Report

by Louise Turner

issued 28th May 2010

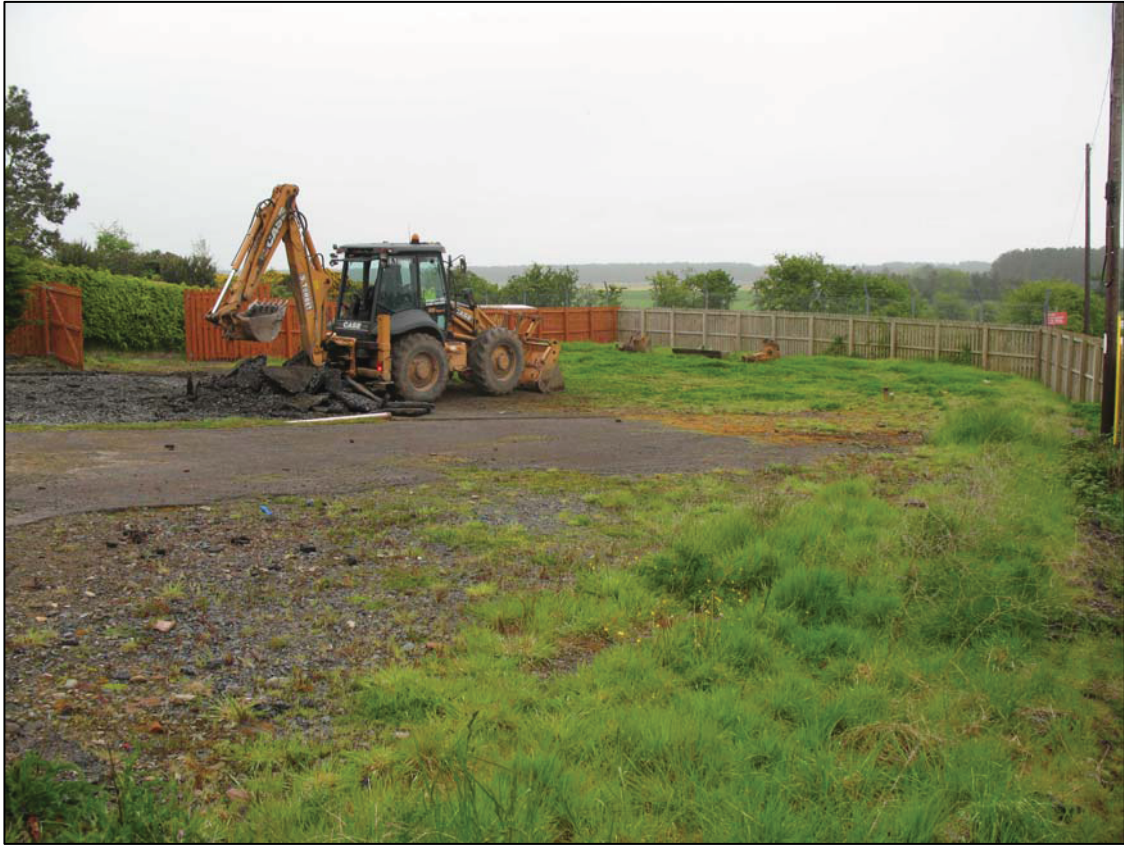
Figure 3a: View of the Site prior to ground reduction

17. The programme of works was carried out on the 20th May 2010 (Fig. 3a) in the form of archaeological monitoring of all ground breaking works as described in the Method Statement (Matthews 2010) and agreed with Dumfries and Galloway Council Archaeology Service.

21. Excavation works were undertaken using a JCB 3cx. The archaeological monitoring involved first of all the sinking of four test pits, one located in each corner of the site (Figure 3a). Each measured 1m x 2m in extent and were sunk to a depth of 2m, giving a detailed soil profile. The resulting observations obtained from these demonstrated that the north and south ends of the site were quite different in character.

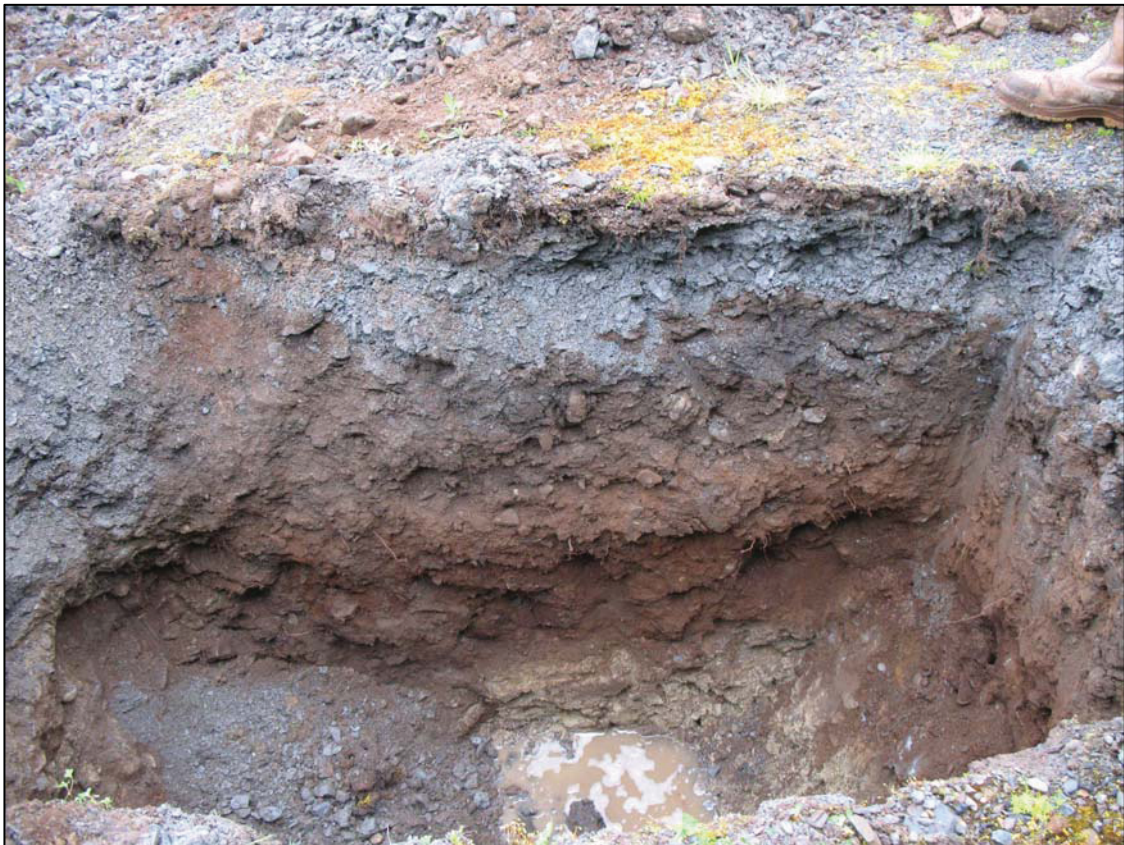
22. The two northernmost test pits, Test Pits 1 and 2, revealed a broadly similar soil profile (Fig. 3b). Beneath a layer of Type 1 0.3m deep (001), there was a broad band of dark grey-brown silty clay (002), measuring between 0.5 and 0.6m deep. There was no topsoil surviving *in situ*, but the smell of decaying organic matter suggested that some fragments of topsoil or turf had survived beneath (001). Below this level, there was a much cleaner, red-brown silty clay (003) which represented the original, undisturbed subsoil. A field drain and a modern sewer pipe were encountered at an approximate depth of 2m in Test Pit 2, but no traces of any cuts could be seen in the section, perhaps indicating the modern date at which these works were carried out.

Figure 3b: Test Pit 1 – Soil Profile, E-Facing Section

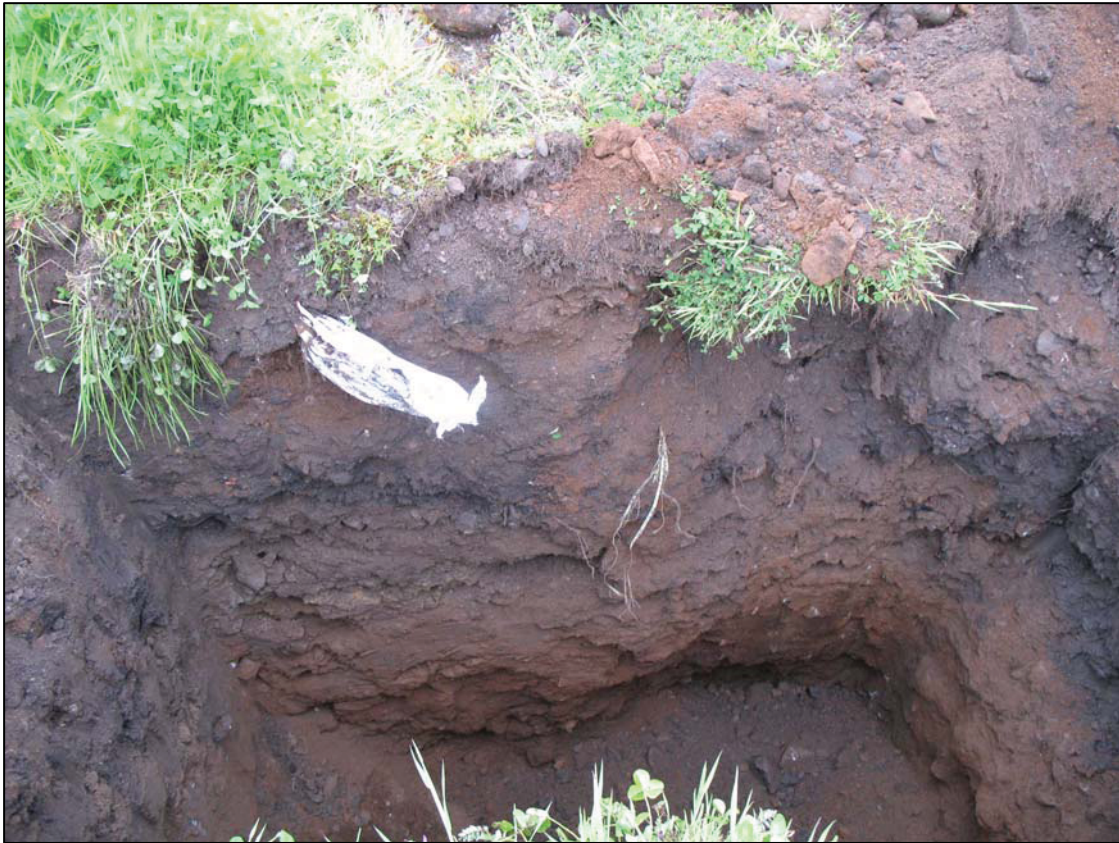
23. By contrast, the soil profile in the south-east corner (Test Pit 3) comprised a deep layer of overburden, characterised by a mixed red-brown/dark-brown sandy clay 1.2m deep (004). At a depth of approximately 1m, a brick wall (005) was revealed running E-W across the S end of Test Pit 3. Some traces of this wall were revealed on the surface, but over much of its extent it had been completely covered by overburden. The findings in Test Pit 4 were similar, though the wall was not encountered in this particular trench.

Figure 4a: Test Pit 3 - E-Facing Section

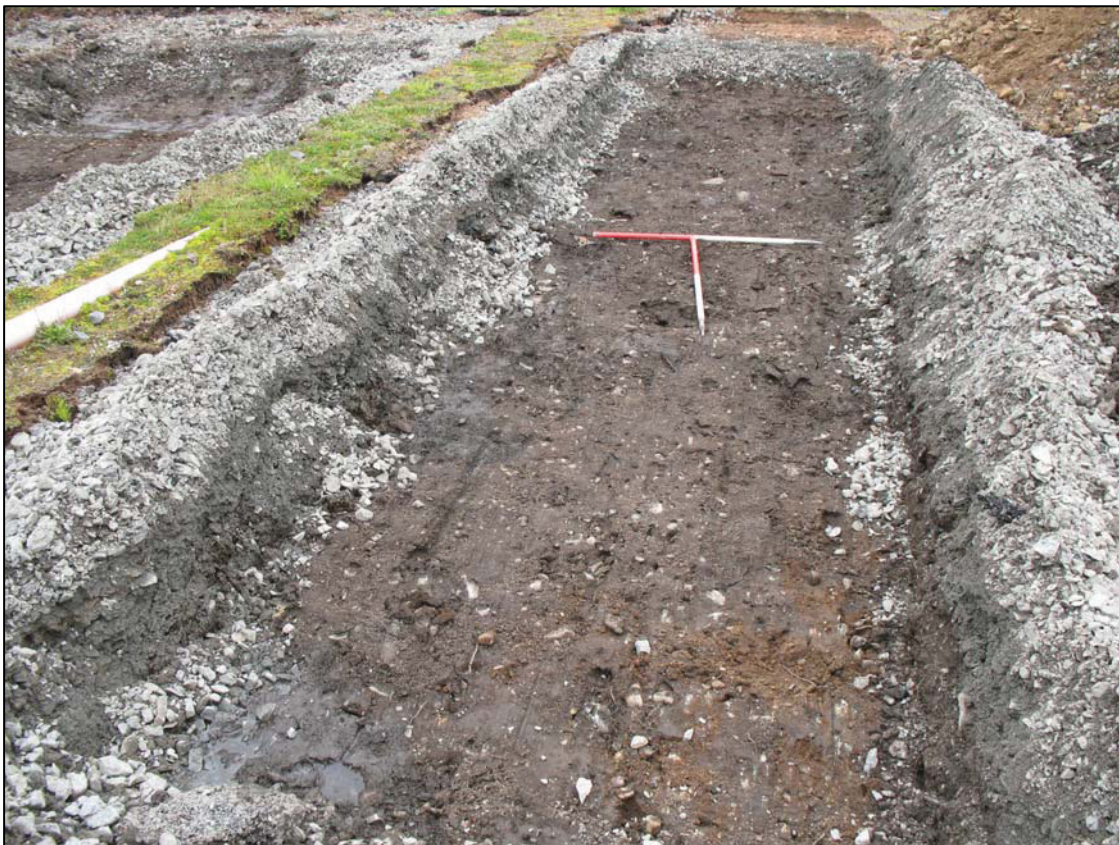
24. Informed by the findings of the test pits, additional areas within the footprints of the proposed house-footings were stripped of their Type 1 to the level of the subsoil. In Trenches 1 and 2, at the north end of the site, this revealed a similar dark grey-brown silty clay as (002). The colour was not, however, uniform, with frequent lenses of red-brown silty-clay evident. This layer was very compact, and had occasional flecks of coal present. Modern finds were found upon the surface, including modern glass and ceramic.

Figure 4b: Trench 1 – Subsoil exposed

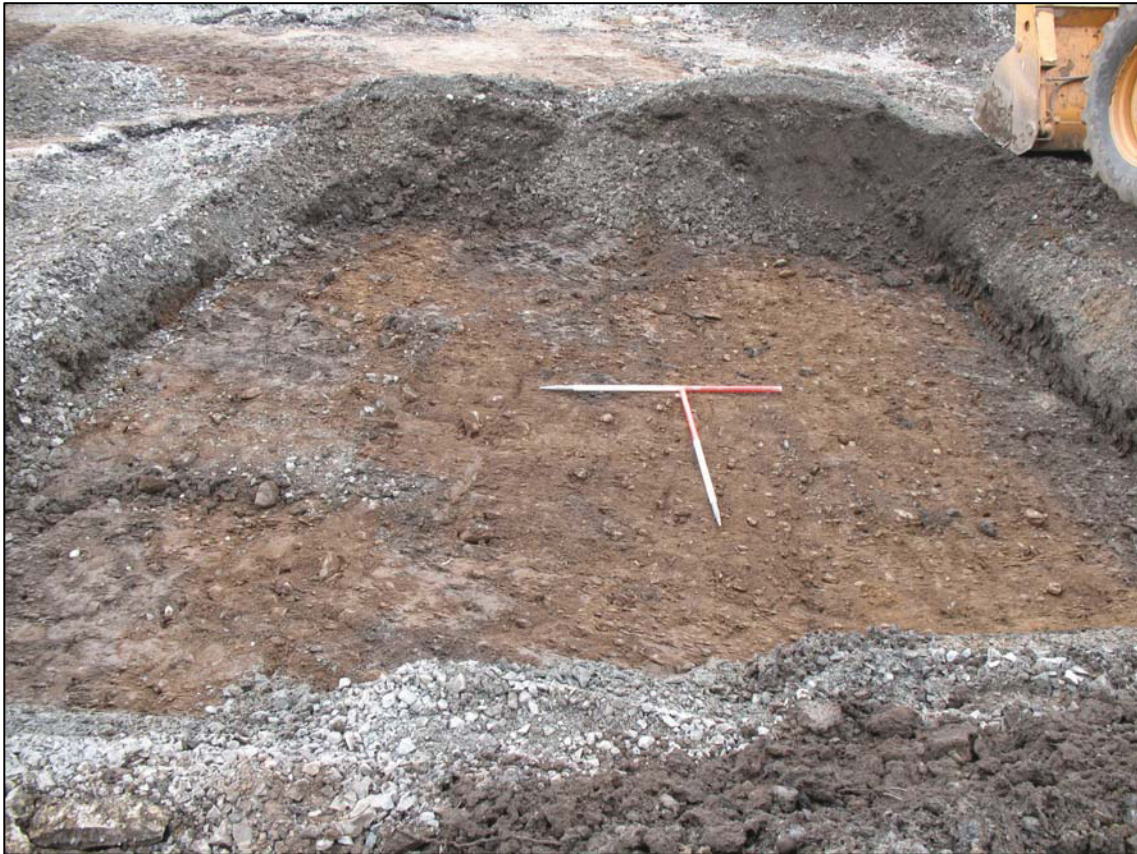
31. This situation was not repeated in the southern portion of the site, in particular Trench 3. Here, the layer of Type 1 (001) directly overlay a very clean, compact red-brown silty clay (006) which remained undisturbed over the full extent of the trench. At the south end of the trench, two parallel courses of concrete kerbstones were evident, running in a roughly east-west direction. These represented the remains of a former paved area, built in association with a car park which had once occupied the site.

Figure 5a: Trench 3, Showing Natural, Undisturbed Subsoil

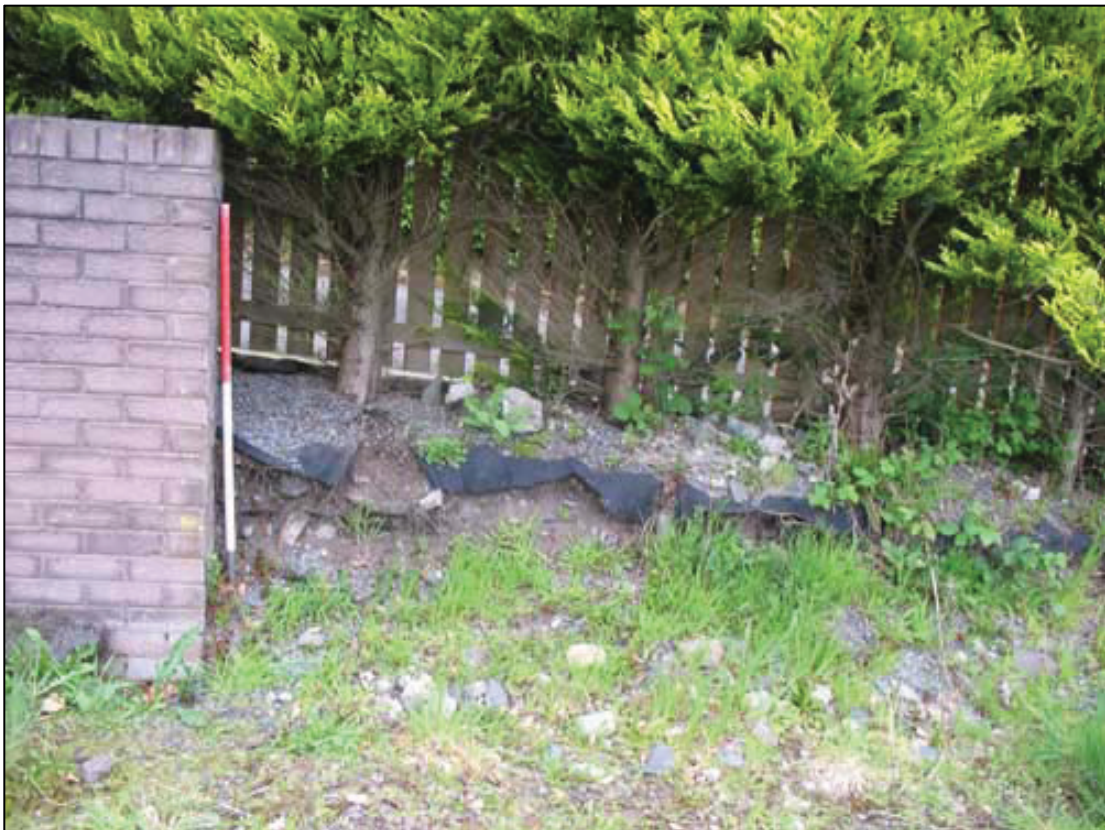
33. In both the northern and southern portions of the site, evidence was obtained of large scale earth-moving activities, which in the northern half had led to the large scale churning and disturbance of the subsoil, and which in the lower half had removed the topsoil down to the natural subsoil level. A comparison with the ground levels evident in the neighbouring access road gave further indication of large-scale landscaping works in recent times. Here, a drop of up to 0.5m was evident between the original ground surface, as evidenced by the line of the roadway, and the levelled area which had formed the car park/tennis court.

Figure 5b: Change in ground level between Development Area and adjacent road to East
