**Bogany Road, Rothesay, Argyll & Bute:
Archaeological Watching Brief**

Data Structure Report

by Diane Gorman

issued 30th July 2010

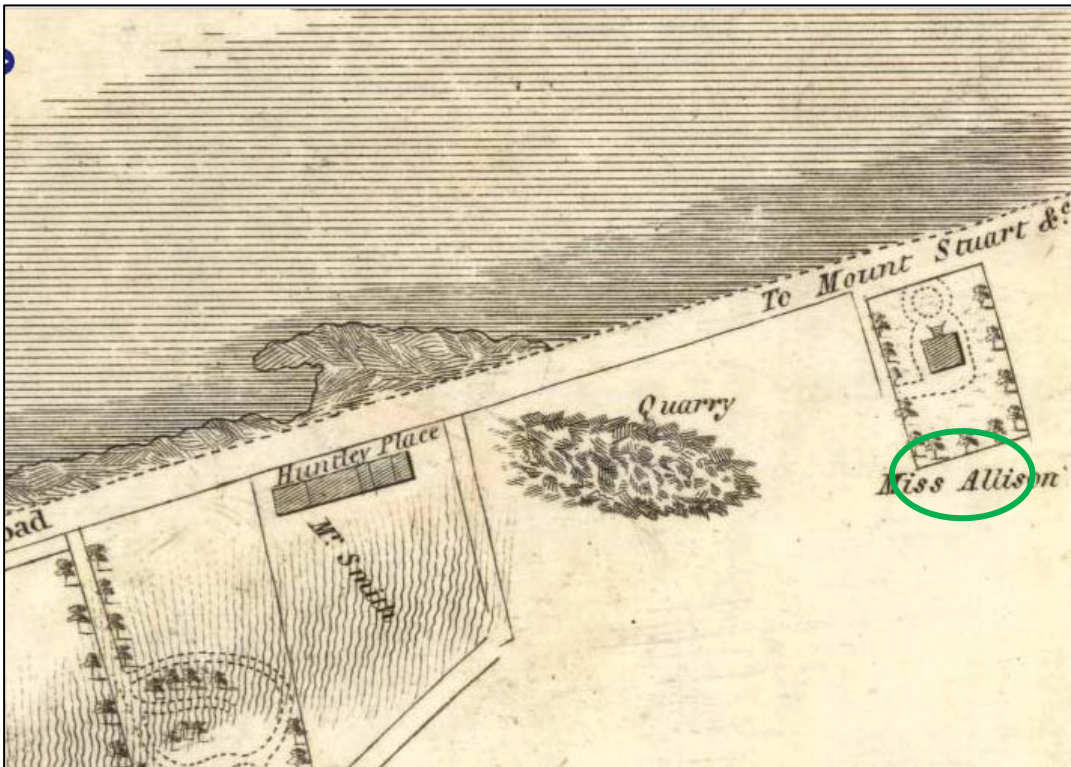
Figure 1a: Detail from Wood (1825) Plan of Rothesay

4. The development area is in the rear garden ground of Bogany House, shown on Woods' 1825 plan of Rothesay (Figure 1a). The development of Battery Drive, along to the shore to the east of Rothesay, is part of the suburban growth of the town which started in the early 19th century as prosperity grew.

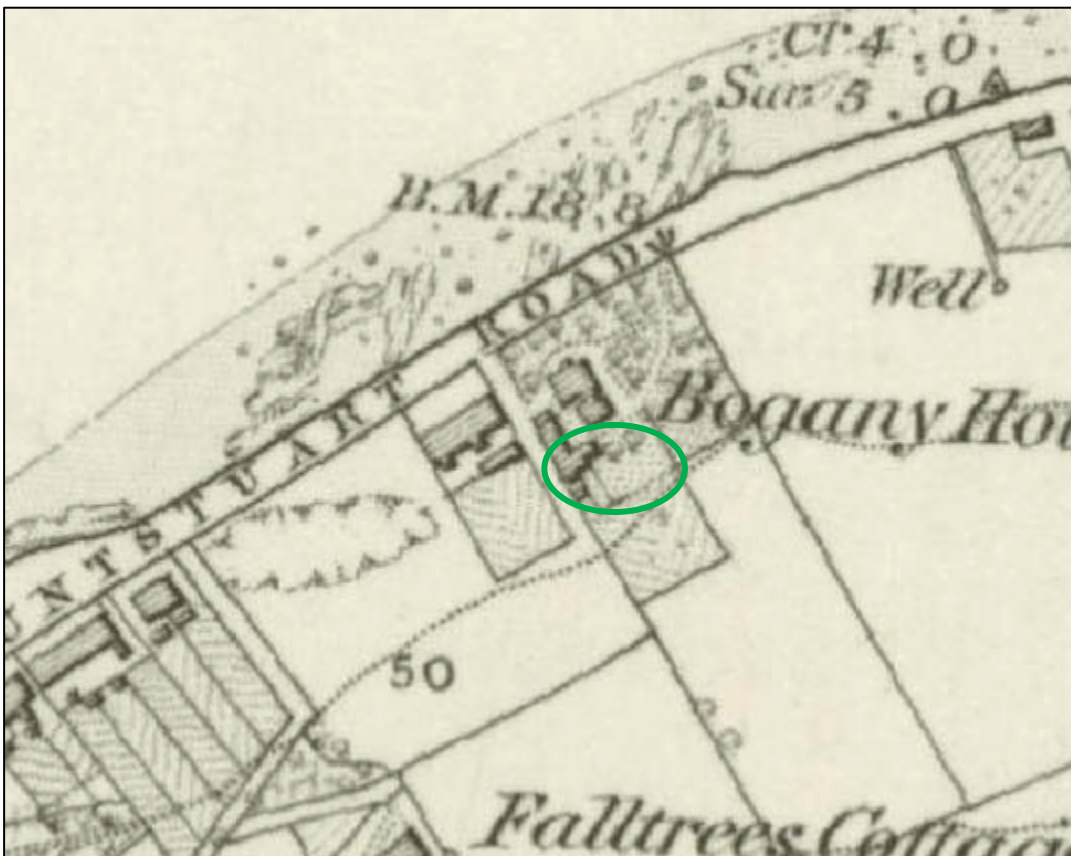
Figure 1b: Detail from 1st edition Ordnance Survey (1869)

5. Within the development area is the identified site of a building (WoSAS Id 62009). The upper storey of the building, which was shown on the 1st edition Ordnance Survey map (Figure 1b) was demolished in 1996, with the remainder cleared in 1997.

24. The small area of flat paving stones (008) located immediately east of (009) appears to be a floor surface. The surface looks to be relatively modern and given the presence of (009) directly below this deposit containing modern material it can be assumed it is of relatively modern date. The surface is located immediately north of wall (007) so it can be assumed that this surface is related to the interior floor for the building that (007) are the foundations of (see Figure 1b).

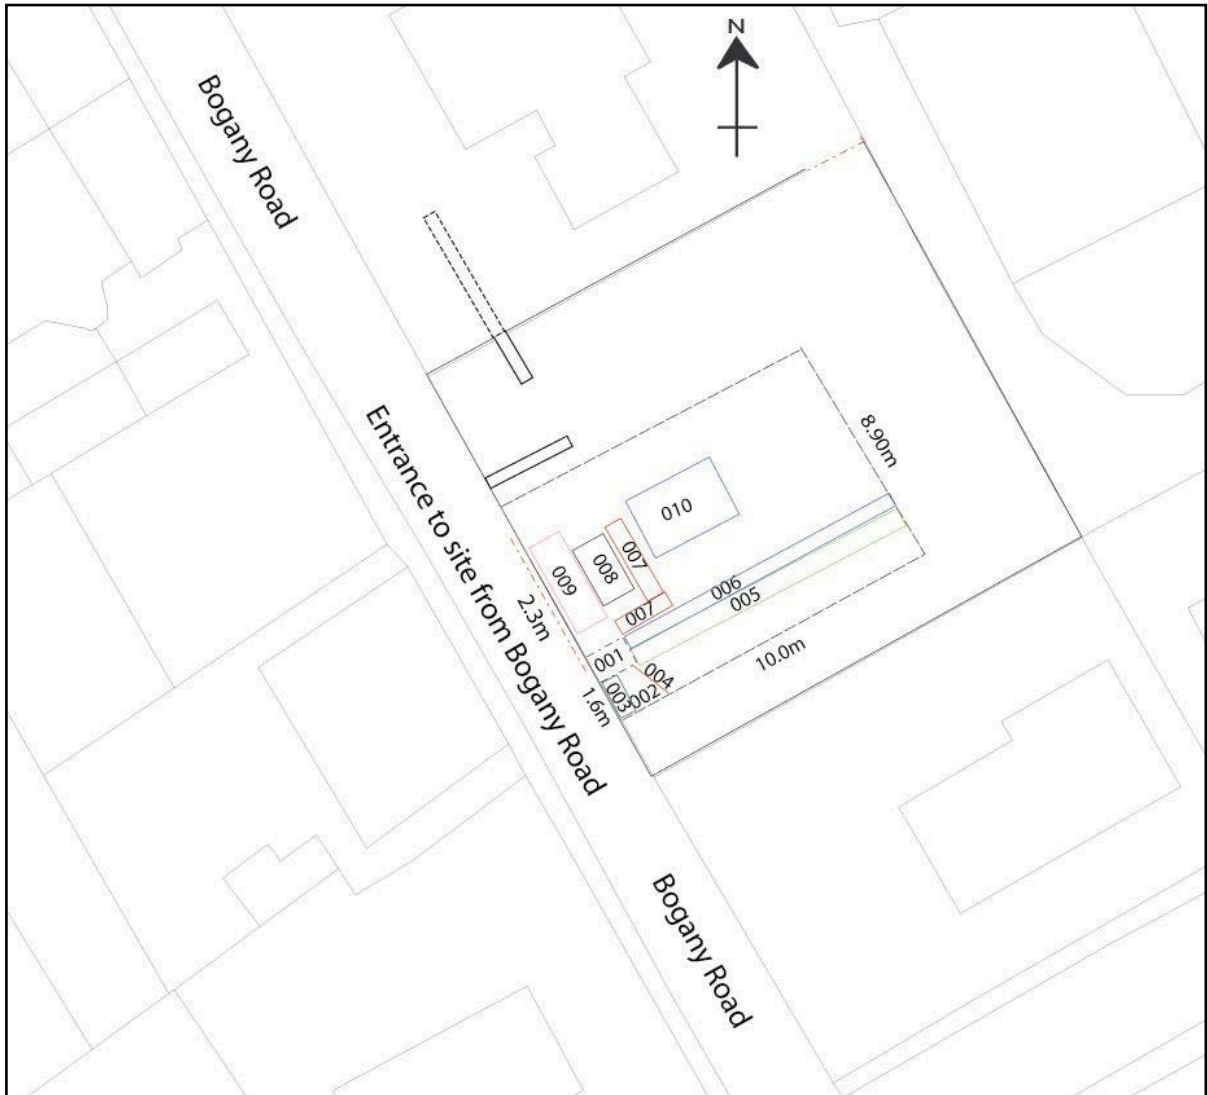
Figure 2: Dimensioned Site Plan (not to scale)

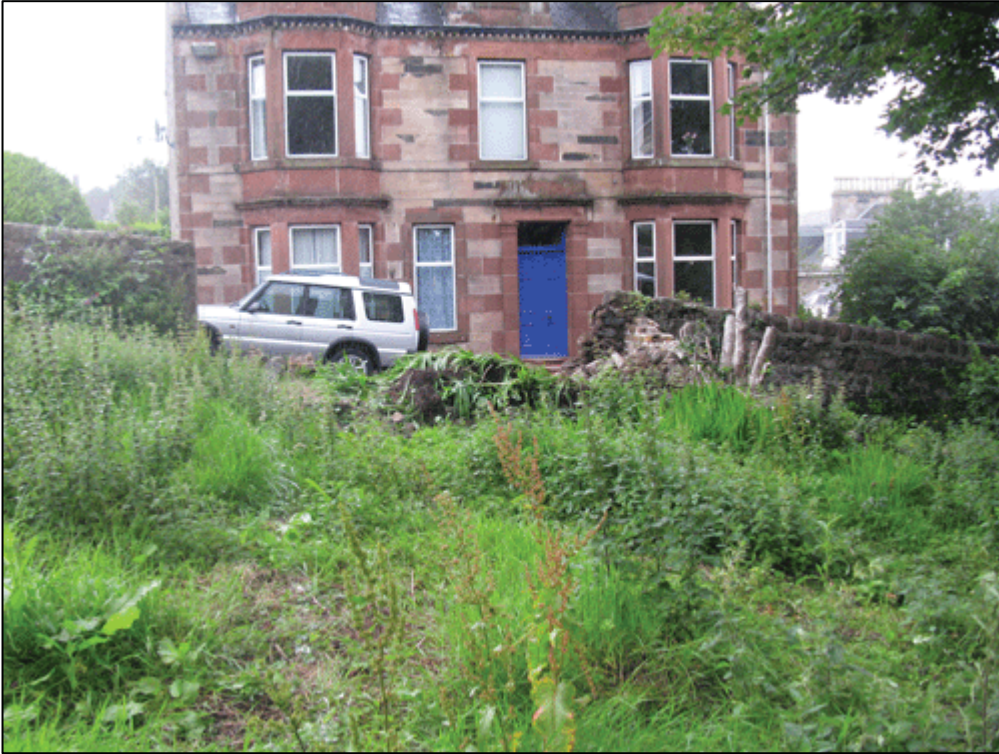
Figure 3a: Pre-ex shot of site facing entrance from Bogany Road

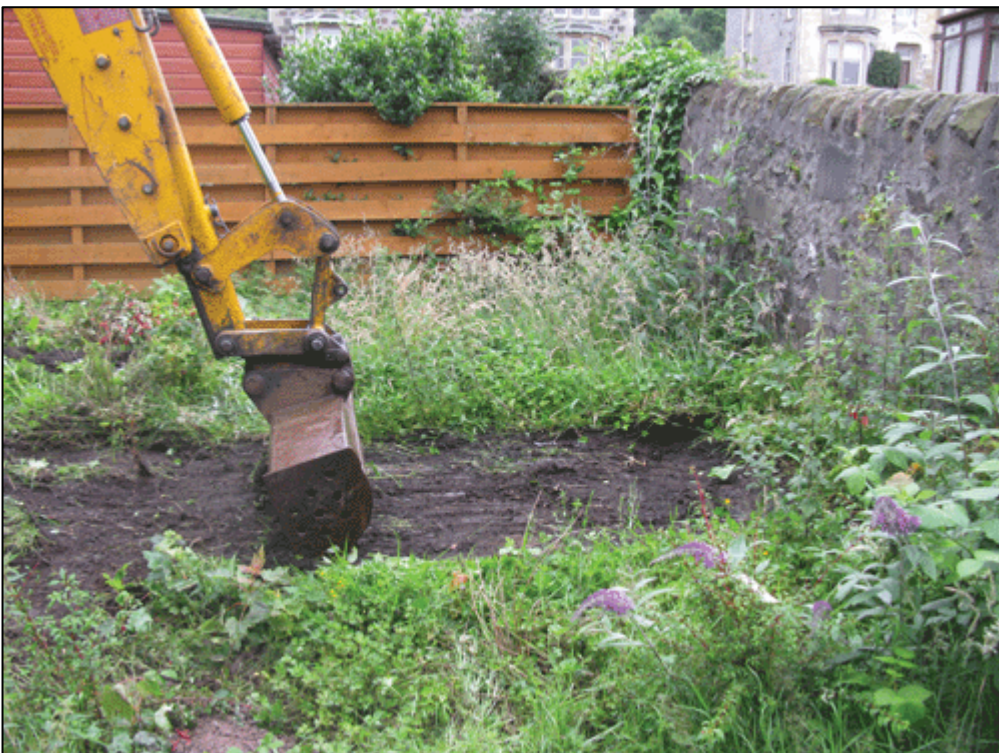
13. Topsoil in the area (001) was very dark brown/black silty sand. The topsoil was stripped from west to east across the site using a mechanical excavator (see Figures 3b & 4a). Due to the incline across the site the depth of topsoil varies according to location and ranges from approximately 0.3m to 0.4m (see Figure 4b).

Figure 3b: Mid-ex shot showing topsoil stripping

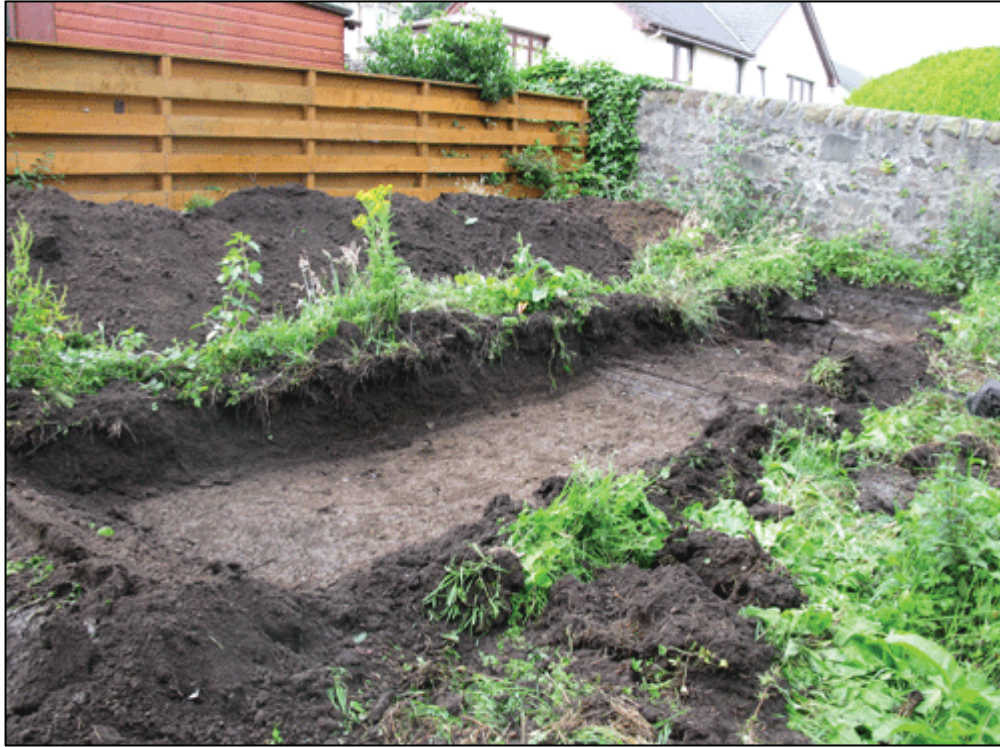
Figure 4a: Mid-ex shot showing partial stripping

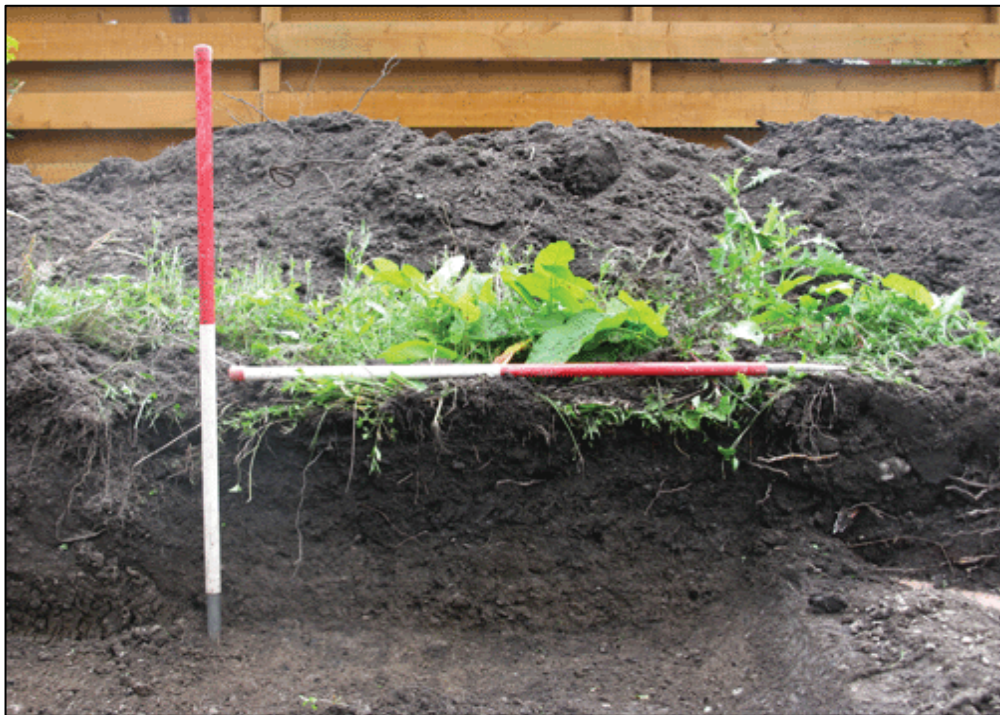
Figure 4b: Northwest facing section of stripped area

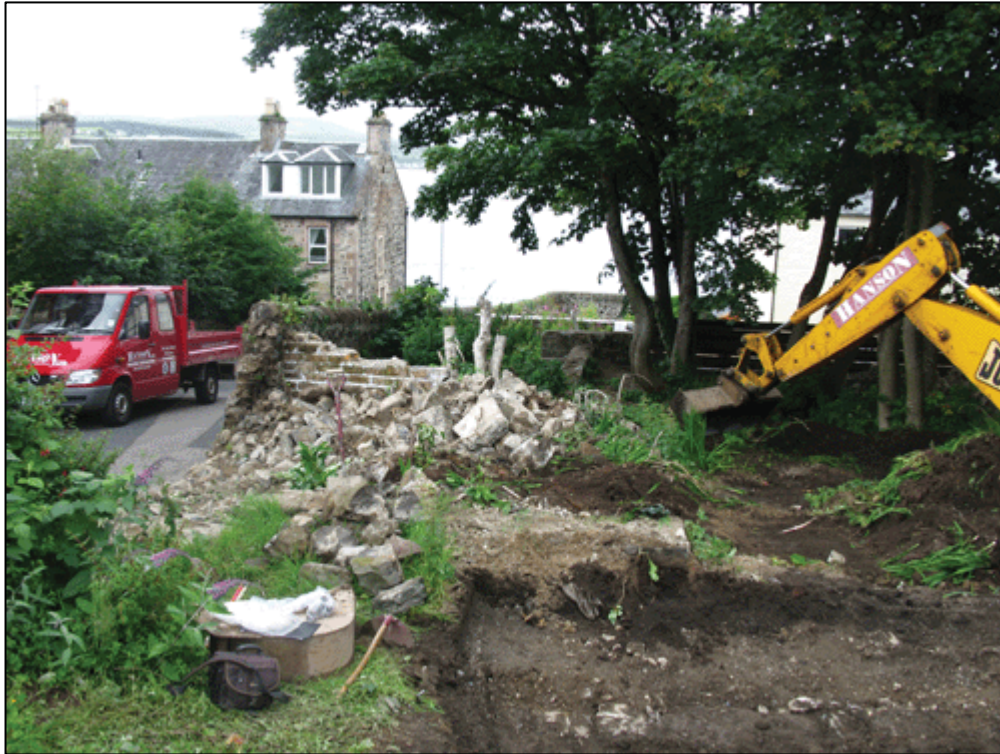
14. Subsoil in the area (002) was orange/light brown silty clay with frequent root inclusions and frequent small stone and stone flecks in addition to charcoal flecks. Most material removed during these works was either topsoil or subsoil. In the area immediately east of the site entrance from Bogany Road deposits composed of general demolition debris (red brick fragments, glass shards, ceramic sherds, wood fragments etc) in a sandy matrix (009) was revealed, covering an area approximately 1.3m x 2.3m. Directly above this was an accumulation of general waste and debris (011) assumed to be from the surrounding area covering an area of around the same dimensions (see Figure 5a).

Figure 5a: Shot of area immediately east of site entrance

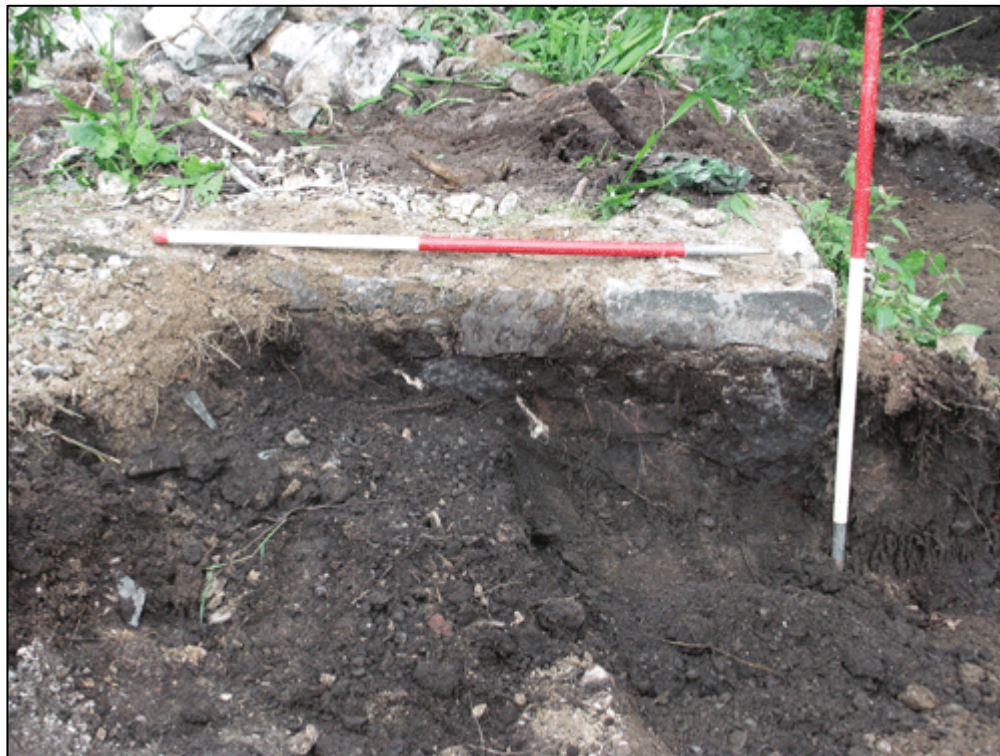
20. A section of standing wall (007) was located immediately east of the entrance to the site from Bogany Road. Due to the presence of (011) the extent of wall remained largely obscured during the course of these works and only a small area was revealed prior to demolition (see Figure 5b). The extent visible was roughly L shaped in plan, running west to east and then north to south respectively. Approximately 1.5m of this structure west to east was revealed and 0.9m north to south. The structure is of stone, single skin and at least 2 courses high as excavated but it is likely more remains below ground level. Only the top course of stones appear well worked (into a rough brick shape) the lower stones remain roughly worked. A layer of sand similar to (010) surrounding (007) on the southern and eastern sides was removed by the archaeologist.

Figure 5b: Shot of wall (007)

27. The stone wall (007) located immediately east of the site entrance appears to stand independently of any other structure on site. The area of paving located to the north of (007) is likely to relate to the interior of the structure which it was once part of but this cannot be definitively stated.

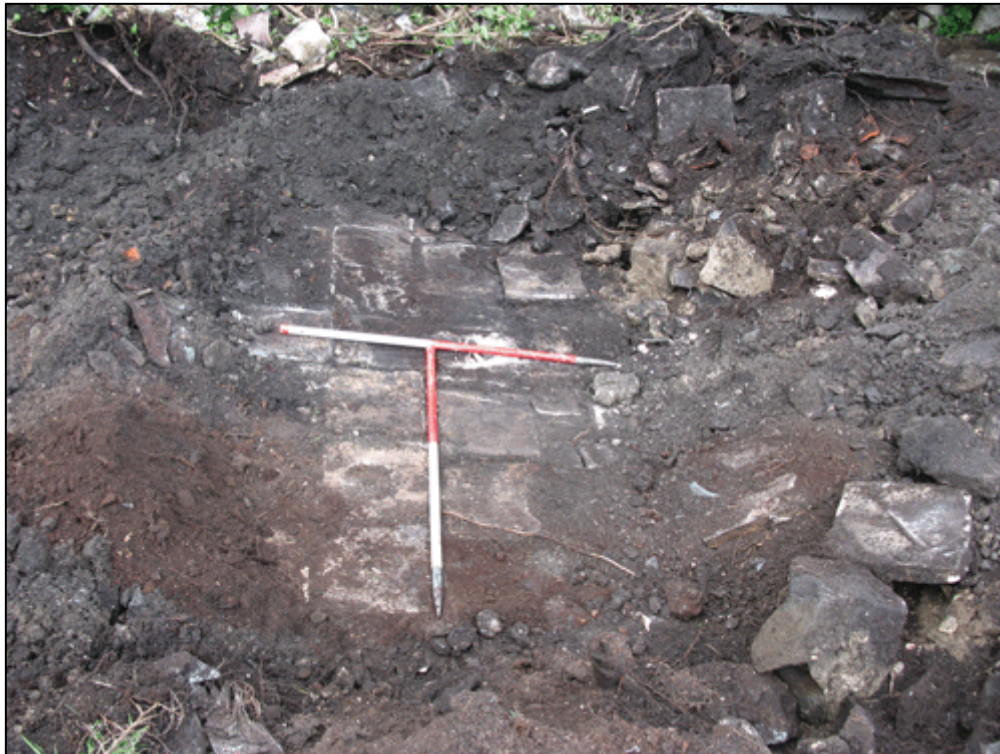
16. A small area of flat paving stones (008) was revealed in the area between (009 and 010) measuring 1.3m x 1.8m (see Figure 6a). These were removed, revealing a continuation of deposit (009) beneath.

Figure 6a: Shot of (008) paving surface

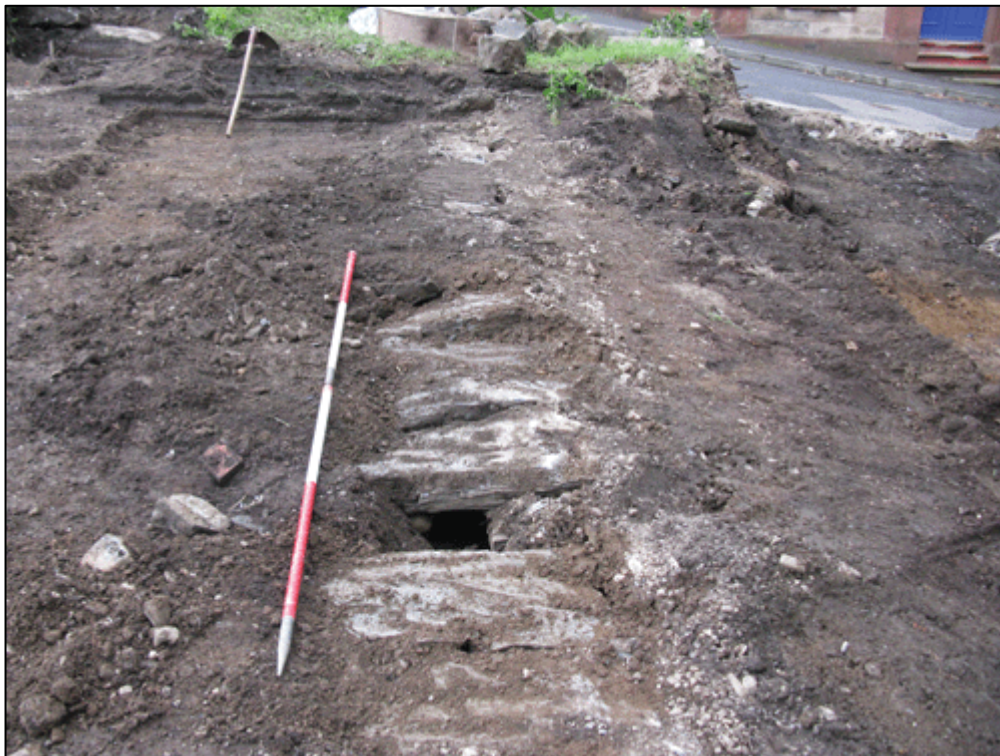
17. The southwest corner of the excavated area revealed a stone culvert (003) which runs southeast to northwest. It is 0.63m wide and 0.6m deep from top of ground level, with 1.6m in length revealed during excavation. The structure consisted of two parallel courses of stones covered by two large stones and was located in the subsoil. . No evidence of mortar was visible and stones do not show obvious signs of working. The full extent remains unknown as it is bordered to the south by limits of excavation and to the north by a small area left unexcavated due to the presence of drainpipe (004). Structure (005) was also revealed, running west to east across the site. It is approximately 0.54m wide and 0.26m deep as excavated (see Figure 6b). The full extent is unknown as it is

bordered to the east by limits of excavation and to the west by the area obscured by (004). It is likely that these structures are a continuation of each other although this cannot be confirmed.

19. A linear deposit of light-mid brown gravel in a silty matrix (006) was revealed running west to east across the site and located parallel and immediately north of (005) (see Figure 6b). The deposit is approximately 0.83m wide but full extent is unknown as it is bordered to the east by limits of excavation and to the west by the area left unexcavated due to the presence of service trench (004).

Figure 6b: Shot of stone culvert (005) facing site entrance

26. The stone culverts revealed are unlikely to yield a date of antiquity. There is no obvious relationship between structures (003) and (005) to any other archaeological feature or structural feature on site.
