Duke Street, Glasgow: Archaeological Evaluation

Data Structure Report

issued 24th August 2010

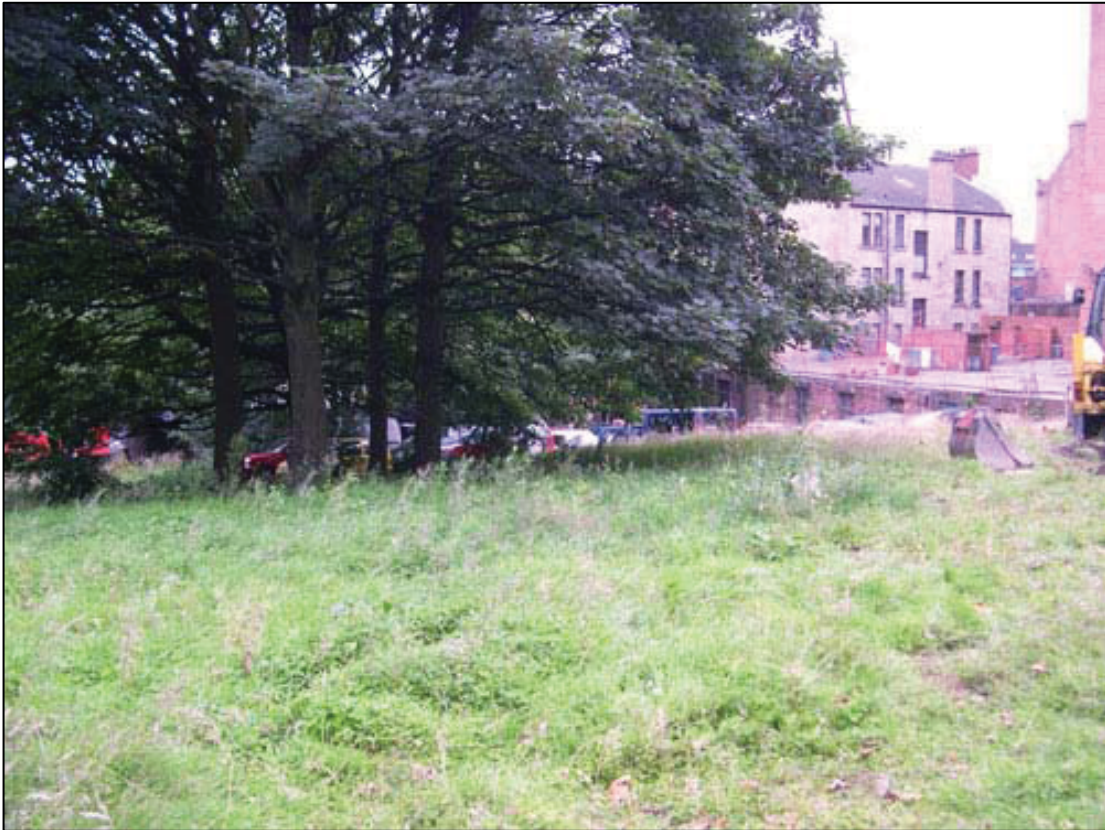
Figure 5a: General View of Site, Pre-Excavation

35. All four evaluation trenches (Figure 6) were excavated using a JCB 3cx excavator; details of the trenches may be found in Appendix 1 of this document. The trenches were located in accessible portions of the development area. The excavation area is bordered on the east edge by a concrete path; the south-west corner is occupied by a public house with a car park to the immediate north. The remainder of the development area is partially covered in large mature trees (Figure 5a).

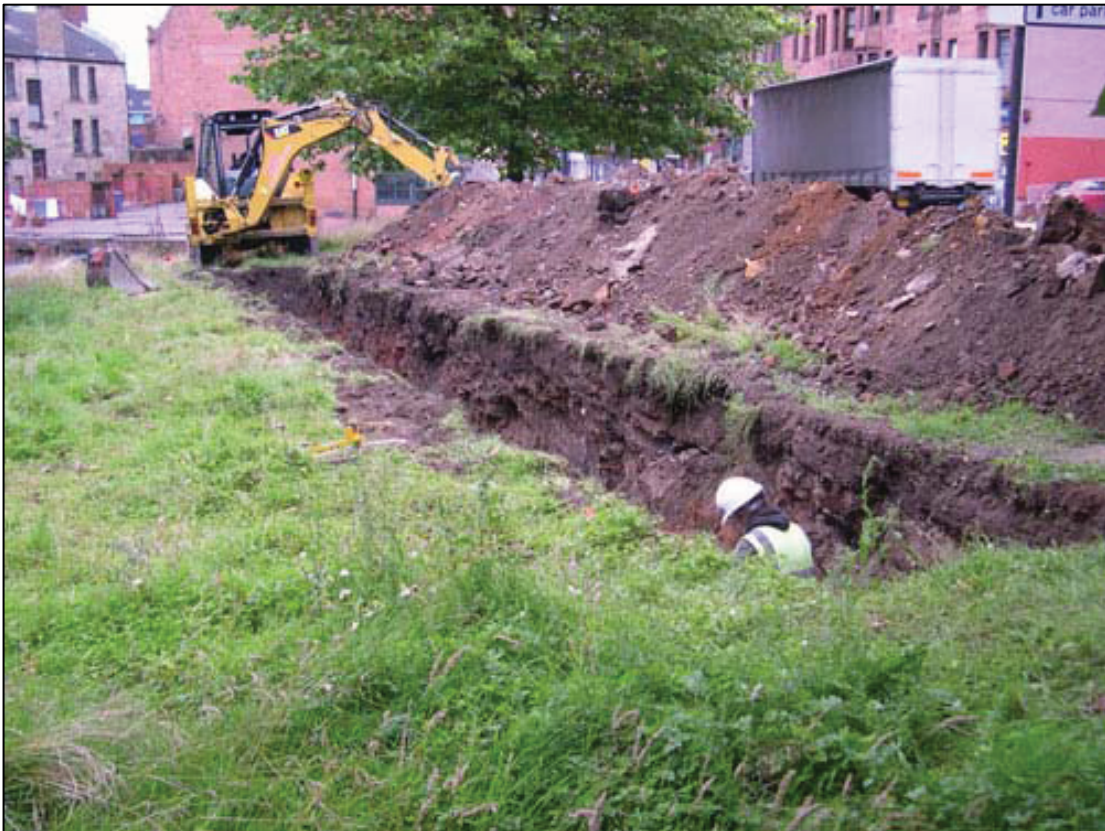
Figure 5b: Trench 3 – General View, Post-Excavation

37. Trench 3 was excavated to a minimum depth of 1.2m and for the most part continued to a depth of 1.5m although danger of collapse made the deeper portions of the trench unsafe to enter (Figure 5b). The entire 1.5m depth of Trench 3 was excavated through layers of made ground and structural material (302). In several places in the trench *in-situ* structural remains were noted (Figures 7 a & b) including; a sandstone wall face (304), two parallel sandstone wall faces (306) and (308), a concrete surface (310) and a rectangular brick structure (312).

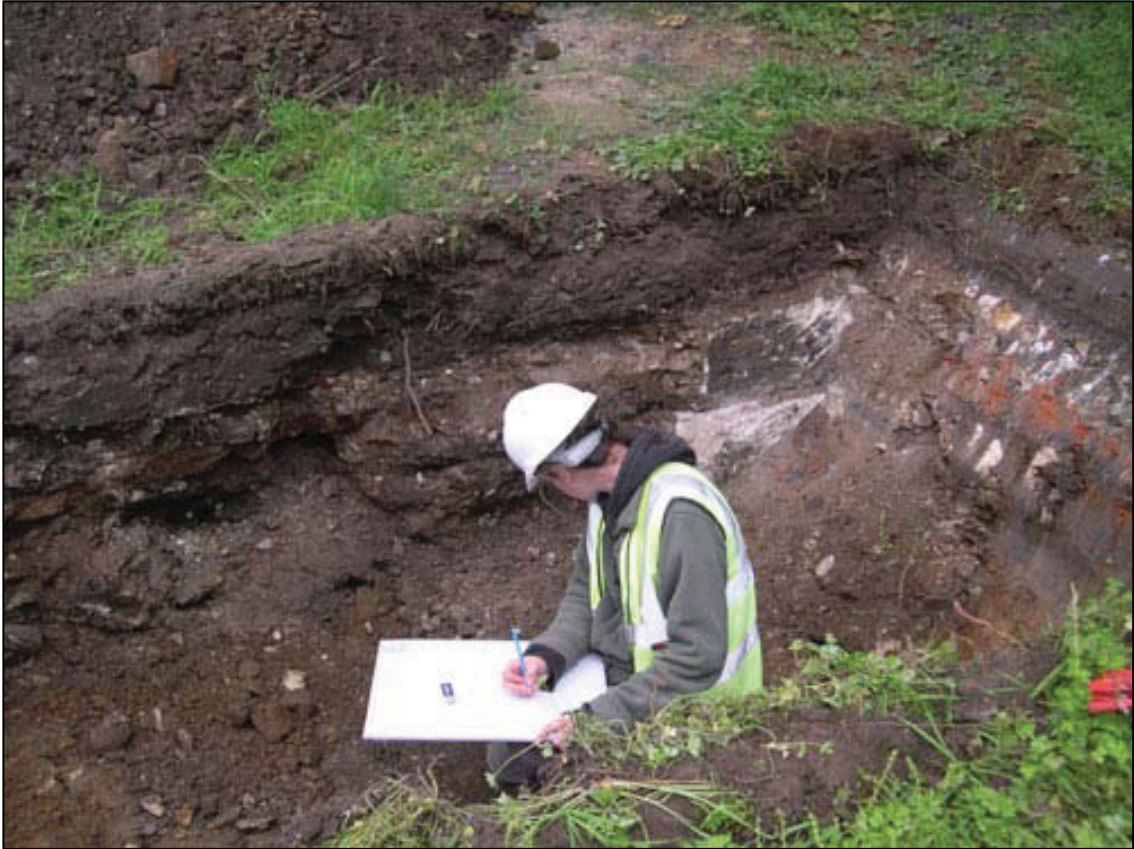
Figure 7a: Trench 3, Sandstone Structure (304) in S facing section

Context No.	Area/ Trench	Type	Description	Interpretation
304	Trench 3	Structure	2 large worked stones located in east end of Trench 3, south-facing section. Stones only visible in section, square in profile. Largest is 0.55m x 0.3m in extent. Sandstone, no evidence of mortar although stones fit on top of the other	Remains of sandstone foundations for tenement cellars.
305	Trench 3	Structure	One large stone that does not appear worked. No evidence of mortar. Remains of ceramic pipe jut out from section (north facing section) directly above stone. Located in eastern part Trench 3. Sandstone.	Possible remains of foundations for tenements now demolished due to presence of pipe.
306	Trench 3	Structure	Sandstone structure. Linear, only visible in south-facing section, Trench 3. At least 2 courses high but possibly extends deeper. Located in eastern part Trench 3. Looks to be part of the same structure as 308 and 309. Stone is worked into blocks. Approximately 1.0m visible in section. Profile of structure is blackened, possible soot or heat damaged?	Sandstone foundations for building relating to tenement cellars.

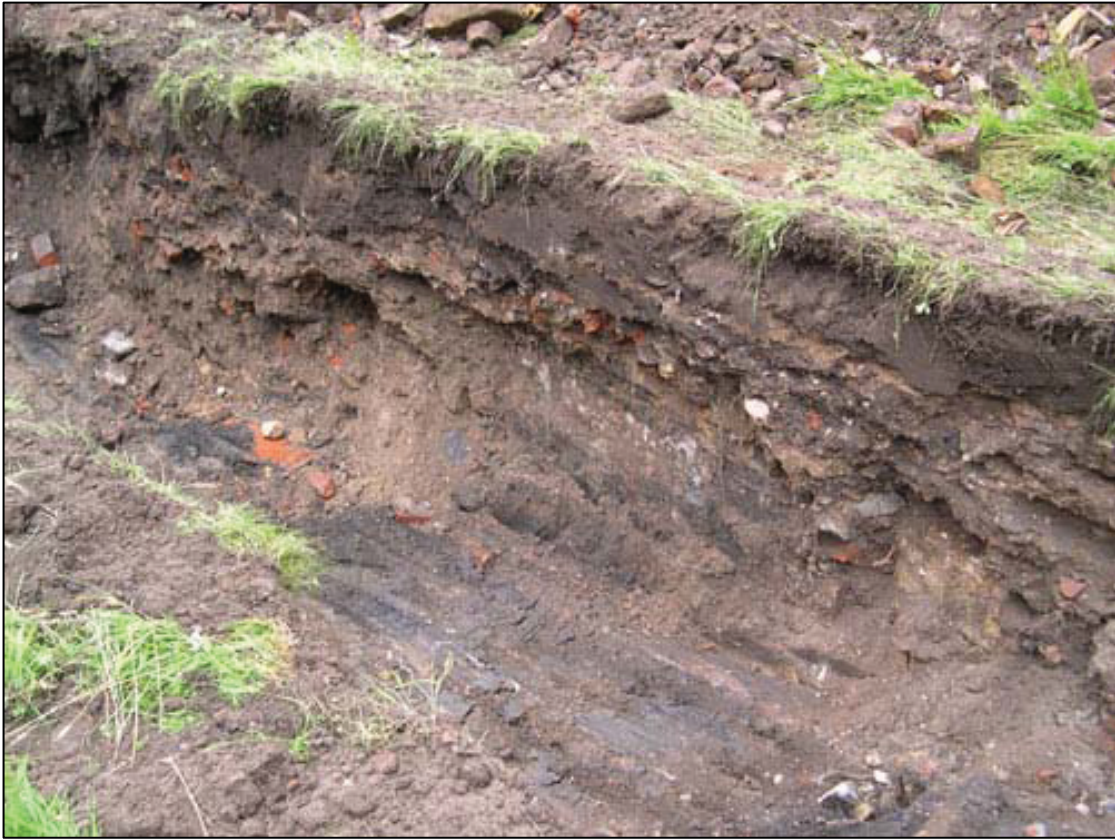
Figure 8a: Trench 3, Sandstone Structure (306)

38. The sandstone walls were all constructed of large cut sandstone blocks (Figure 8a), typically measuring 800mm by 400mm by 300mm, and pieces of similar blocks were noted amongst the layers of made ground. Similarly, fragments of brick were also common in the made ground indicating the demolition of more modern structures. In two areas of the trench no in-situ structural remains were located and so these were chosen as suitable locations for test pits.

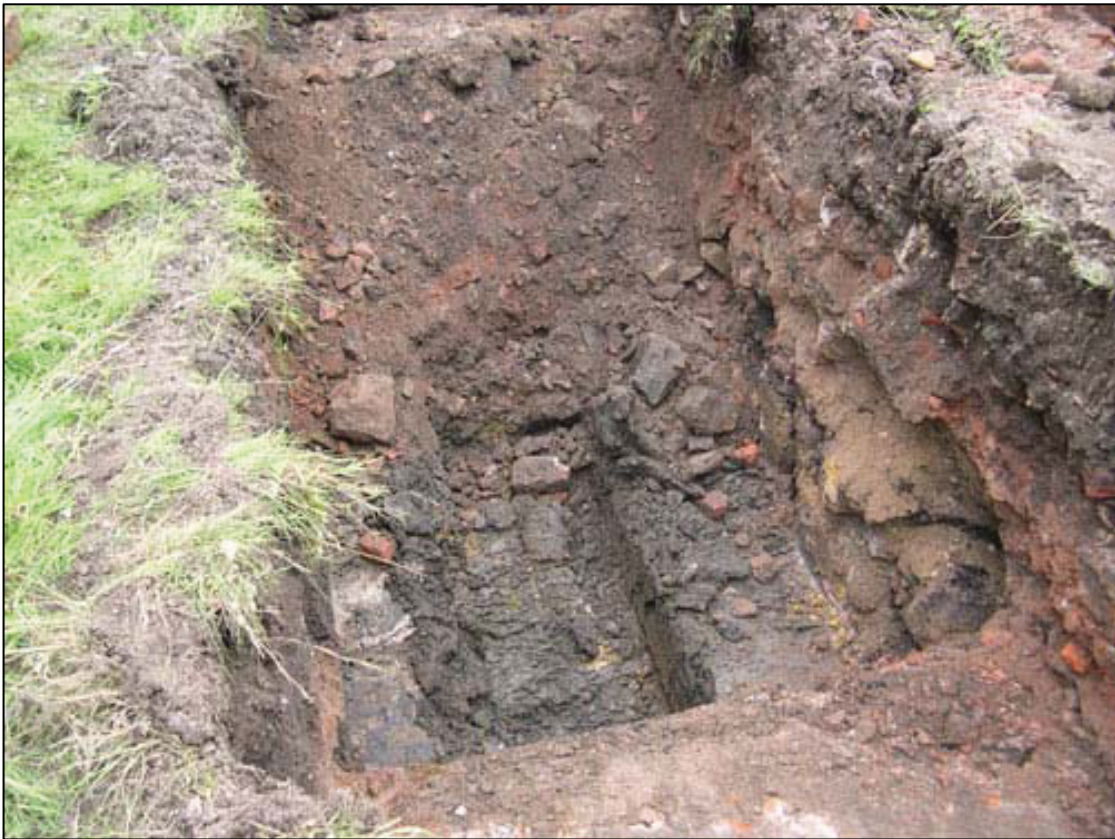
Figure 8b: Trench 3, Test Pit 2 Fully Excavated, with (314) revealed at base

40. Test Pit 1 was excavated near the north-eastern end of Trench 3 to a depth of 2m. Although more homogeneous sediments of grey silty clay (314) were uncovered the continued inclusion of sandstone and brick fragments meant that this was also identified as made ground. Test Pit 2, near the south-western end of Trench 3, was excavated into similar deposits of grey silty clay to a depth of 2.2m (Figure 8b). In this test pit the top of a line of sandstone blocks was uncovered along with a disused water pipe. Clearly, even at a depth greater than 2m the northern end of the development area was still in made ground.

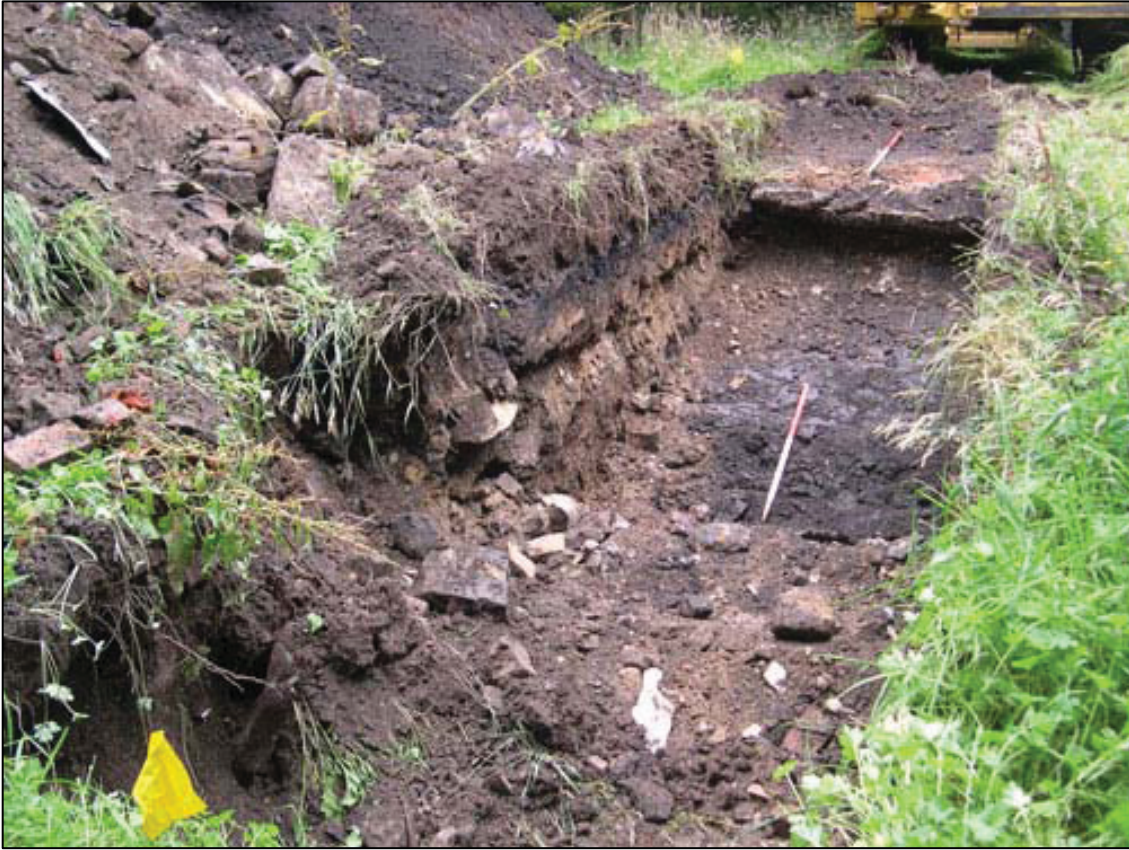
Figure 9a: Trench 4, General View, Post-Excavation, from N end

41. Trench 4 was excavated among the trees in the eastern central portion of the development area, just to the east of the car park. It was excavated to a depth of approximately 1.3m for 8m in length, running north to south (Figure 9a). The southern end of Trench 4 was made ground composed of brick and sandstone fragments (407); this deposit was extremely prone to collapse. The remains of a sandstone wall (405) were uncovered around the centre of the trench running east-west. To the north of this wall layered deposits of made ground were uncovered ((408), (409), (410) and (404)) and in the north end a shallow brick structure (403) prevented further excavation.

50. A sandstone wall (405) was uncovered running east-west in Trench 4 and was noteworthy because it seemed to delimit an area of demolition-filled made ground to the south from progressive layers of backfill to the north. This suggests that it may have been the rear wall of a structure facing onto Duke Street subsequently demolished to the south of the wall. The build-up of made ground in the northern part of Trench 4 is more difficult to explain, however; it would appear that it continues to a considerable depth, more than 2.5m.

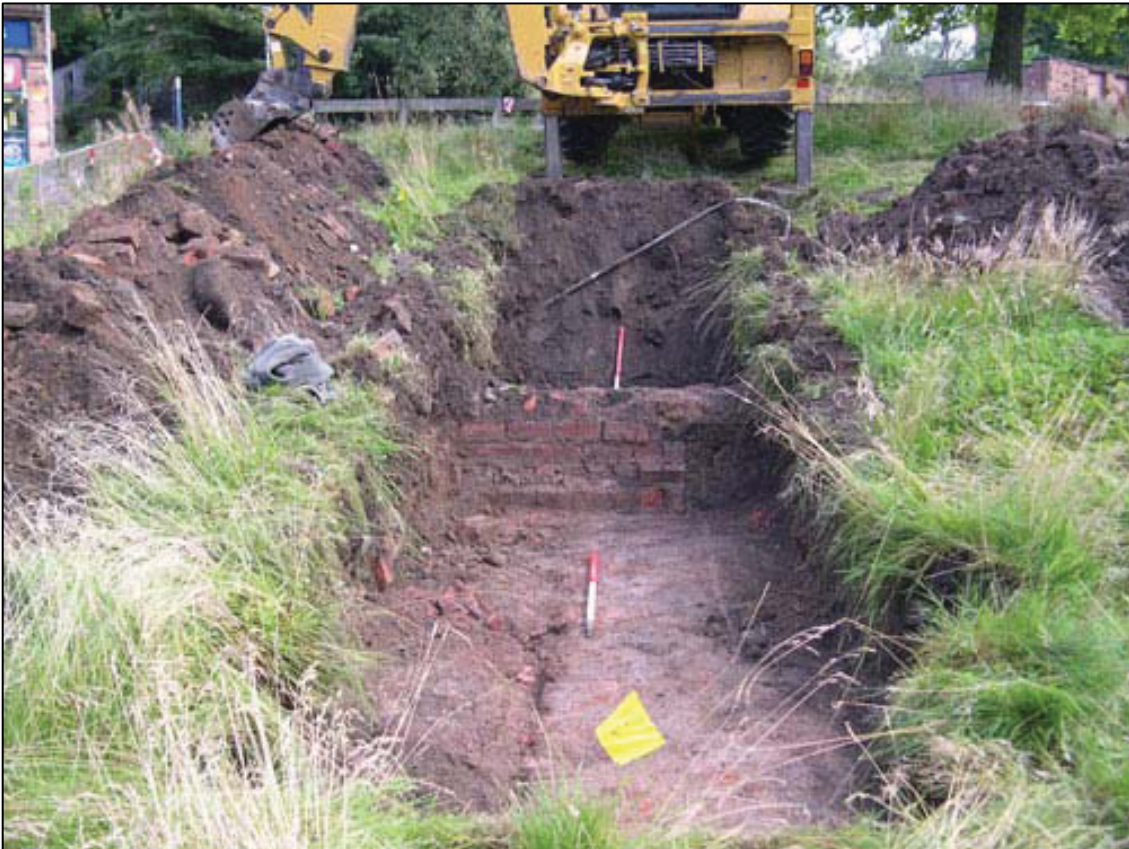
Figure 9b: Trench 1, Post-Excavation, with Brick Structure (104) exposed and sunken surface (102) in foreground

43. Trench 1 was excavated along the north-western boundary of the development area, running north-south and adjacent to Burrell's Lane (Figure 9b). The southern half of Trench 1 contained a level brick surface (102) ending in a wall (104) (Figure 9b), and so the southernmost point was excavated to a depth of 300mm. Because of the slope of the ground, the centre of the trench reached approximately 1m deep with the northern end, excavated through made ground (106), achieving a depth of 1.3m. The made ground was composed of sandstone, brick and other demolition rubbish. The risk of collapse in this area meant that further excavation ran the risk of undermining the adjacent road surface.

104	Trench 1	Structure	Red brick structure. Located in middle of Trench 1. Runs west to east across trench. 4 courses high is visible, although could go deeper than this. West and east ends of structure are obscured by limits of excavation. Appears to sit above 102 although this can not be confirmed. Looks to relate to 102, could once have been part of the same structure.	Red brick building foundations or interior wall of building. Likely to be related to tenement cellars once located in the area.
105	Trench 1	Deposit	Light-mid brown sandy clay. Frequent very small stone inclusions, occasional charcoal inclusions, and occasional red brick fragment inclusions. Located in base of Trench 1. Only visible in small area on eastern side of trench but likely to cover a larger area but the rest of the base of Trench 1 is obscured by 106.	Possible re-deposited natural once used as levelling deposit.

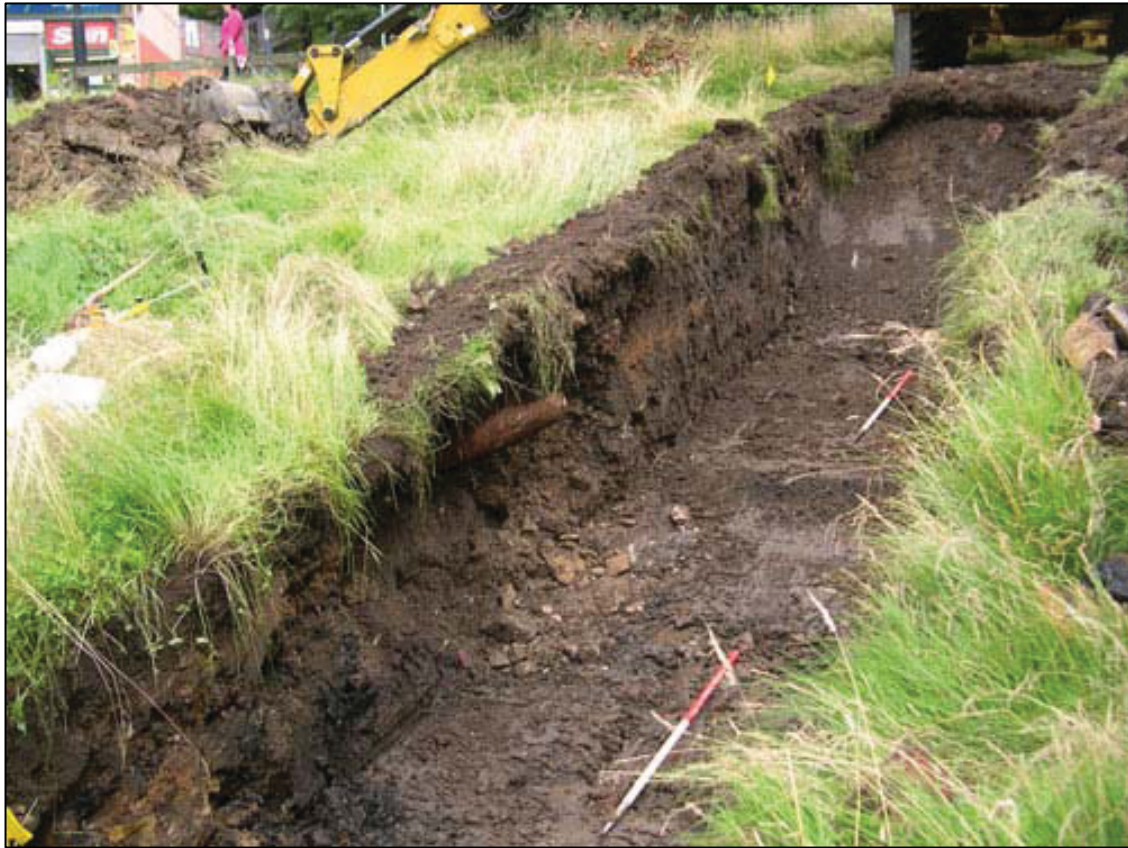
Figure 10a: Trench 2, General View, Post-Excavation

44. Trench 2 was excavated in the approximate northern centre of the development area (Figure 10a). Initially Trench 2 was excavated to a depth of 1.2m. The first 1.2m was composed of layered made ground ((207), (208), (209) and (210)) containing fragments of sandstone and brick. Beneath the made ground was a layer of silty clay (205) which may have been re-deposited subsoil. Upon further excavation of Test Pit 4 archaeologically sterile subsoil (211) was reached at depths greater than 1.4m (Figure 10b).

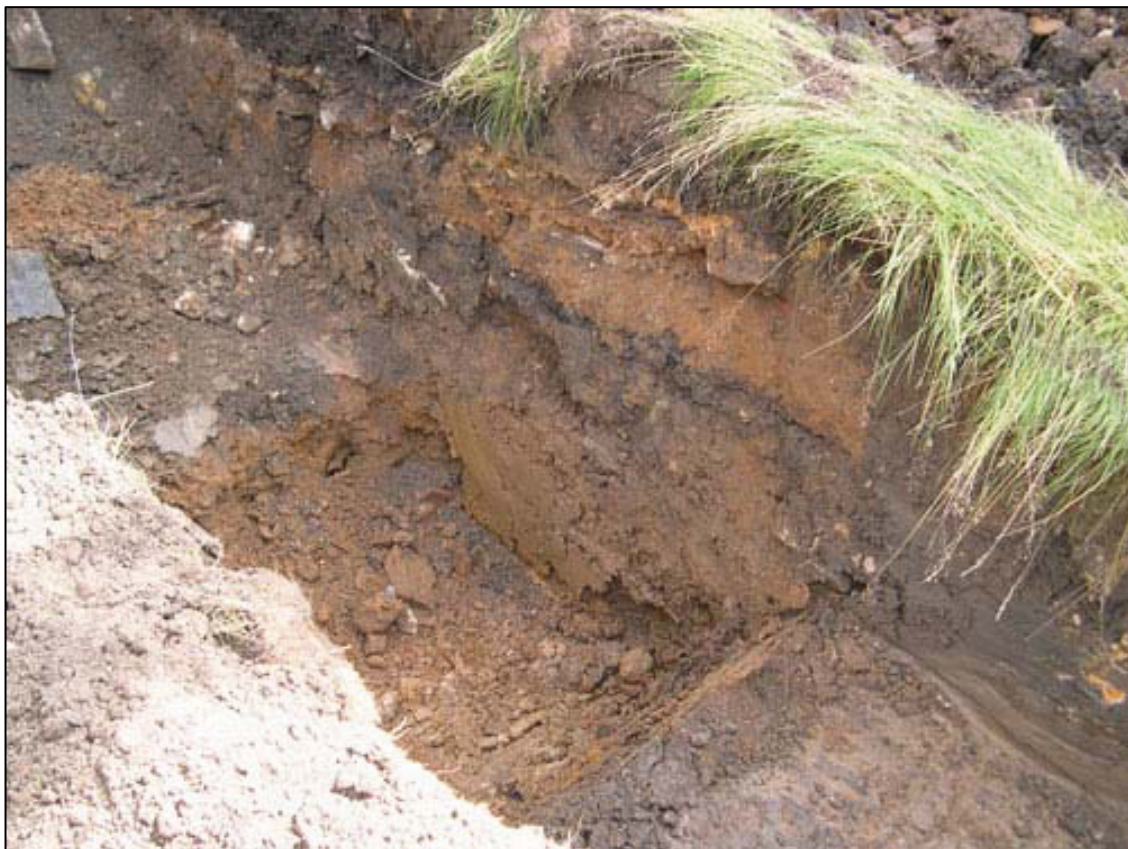
Figure 10b: Trench 2, Test Pit 4, Fully Excavated, with Natural Subsoil (211) exposed

47. Within one trench, Trench 2, a natural subsoil (211) was located that was judged to be *in-situ* and hence archaeologically sterile drift geology. This was only uncovered in a very small area (approximately 1.8m²) and was at a depth of 1.4m below modern ground surface. Given that the site was tested to more than 2m it is notable that only at one point was *in-situ* subsoil exposed and that this shallow survival was in the centre of the site, distant from the frontages onto High Street, Duke Street and Burrells Lane. However, note that no topsoil or other comparable sediment was noted overlying the fragment of shallow *in-situ* subsoil, implying that even this shallow fragment had been subject to some scale of truncation.
