**Kilwinning Old Parish Church, North Ayrshire:
Archaeological Monitoring**

Data Structure Report

by Claire Williamson

issued 4th October 2010

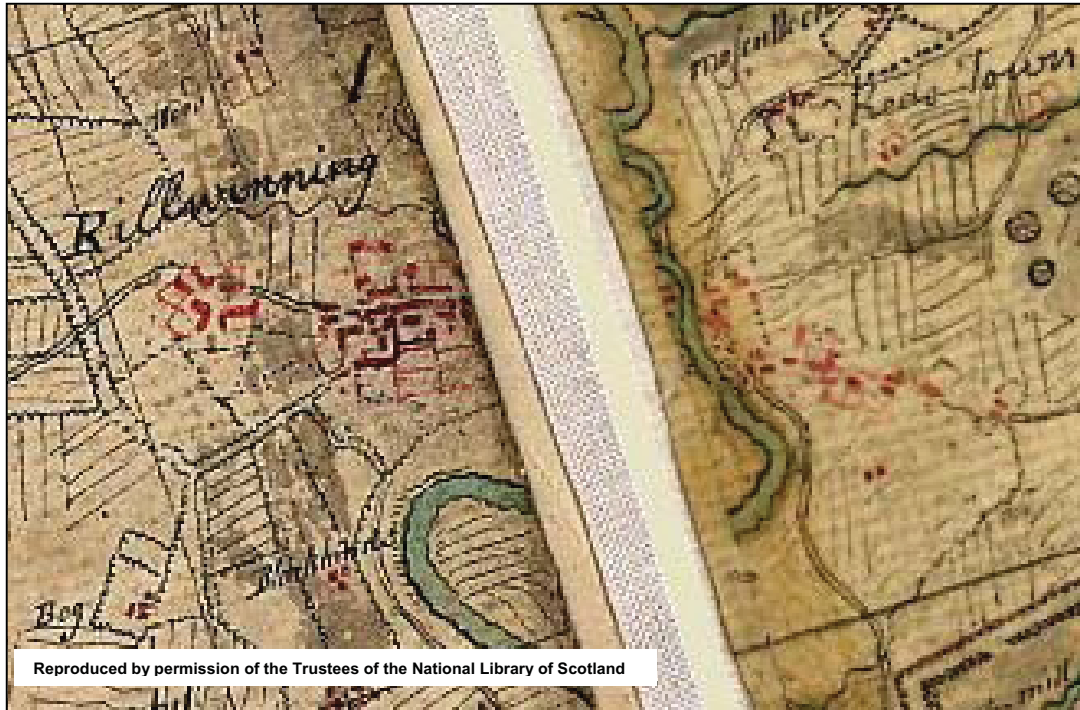
Figure 1a: Detail from Roy's Military Survey of Scotland 1747-55

6. The first detailed post-reformation plan of Kilwinning is from 1747-55 (General Roy's Military Survey of Scotland; Figure 1a); it forms a cluster settlement forming from three locales along what is now Main Street. The central hub is located around the Abbey buildings, another is located immediately on the east side of the river Garnock near the Corsehill and the third to the west at Byres.

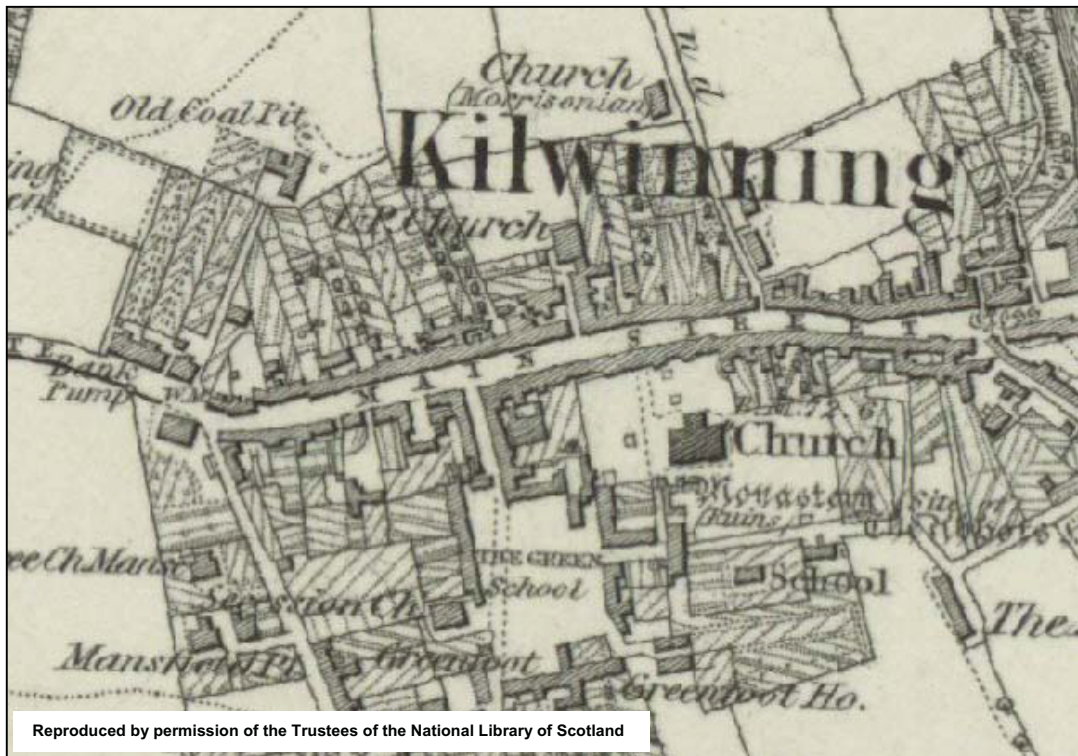
Figure 1b: Detail from 1st edition Ordnance Survey (1856)

7. By the 1st edition Ordnance Survey (1856) Kilwinning had expanded to include a full street frontage on either side of Main Street (Figure 1b). This rigid streetscape has been progressively altered through the 19th and 20th century with the opening out of the 'square' area at the west end of the Main Street and clearance to form the entrance to the Old Parish Church (removing the original property given to the Freemasons for their Mother Lodge).

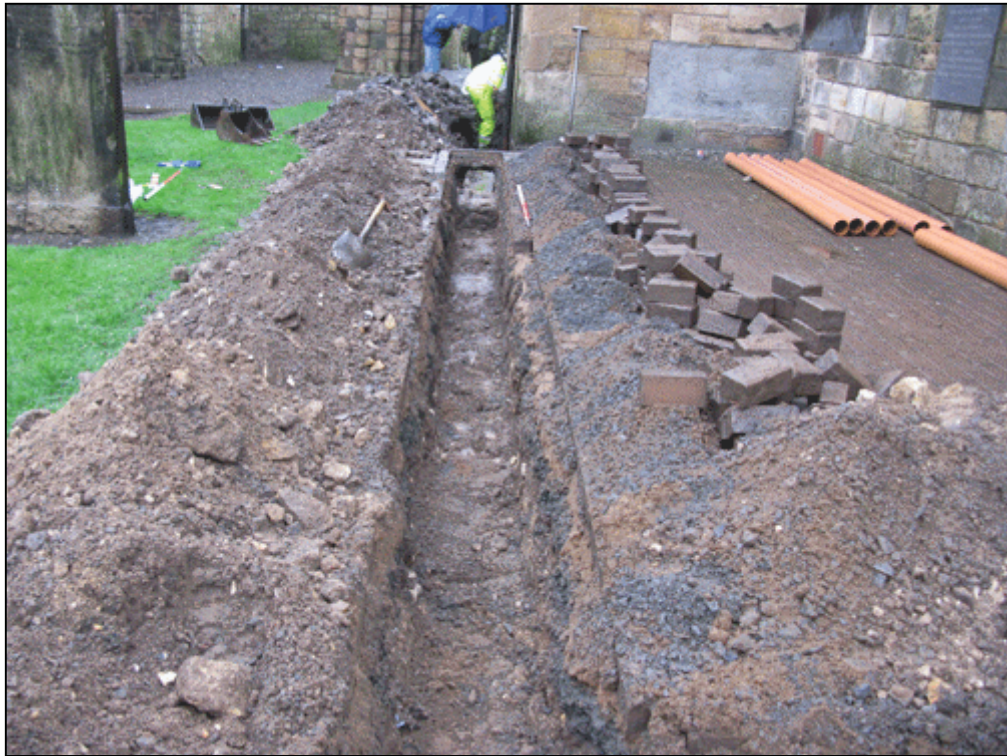
Figure 3a: Drainage Trench running east-west

14. Prior to excavation, the western half of the development area was covered by a thin layer of gravel (001) which made up the modern ground surface. The trench revealed this to be 80mm thick. Underlying this was a compact dark brown silty clay (002) which measured 550mm thick although ran deeper than what was excavated. This deposit contained frequent fragments of sandstone rubble and broken ceramic drain pipe, as well as occasional fragments of white glazed pottery. It appears to have been a modern deposit possibly from backfilling the area after previous drainage work.

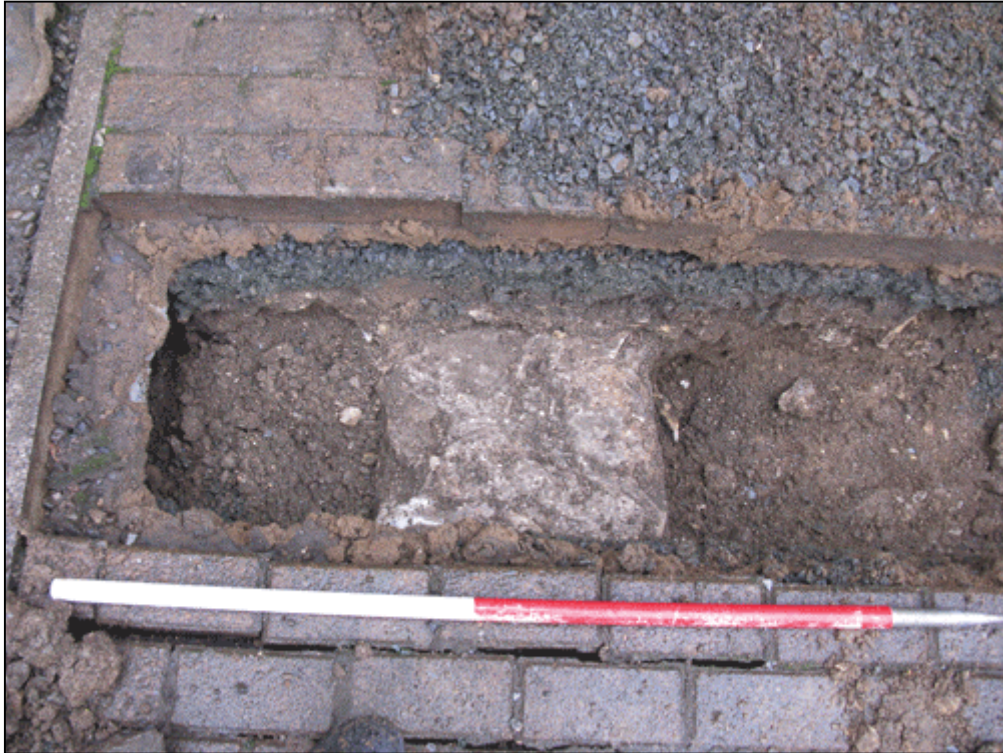
Figure 4a: Sandstone foundation (007) from the south

16. One feature discovered within the drainage trench had the potential for archaeology. A line of sandstone (007) (Figure 4a) ran approximately N-S across the trench 1.14m east of the eastern wall of the church's southern extension. It measures 0.45m wide and a minimum of 0.5m long by 300mm high. The feature ran outwith the area of the trench and its full depth was not revealed. It comprised of medium sized sandstone rubble blocks bonded with concrete and appears to have been a foundation for an earlier structure. However the nature of the concrete bonding suggests it to have been 20th century in date.

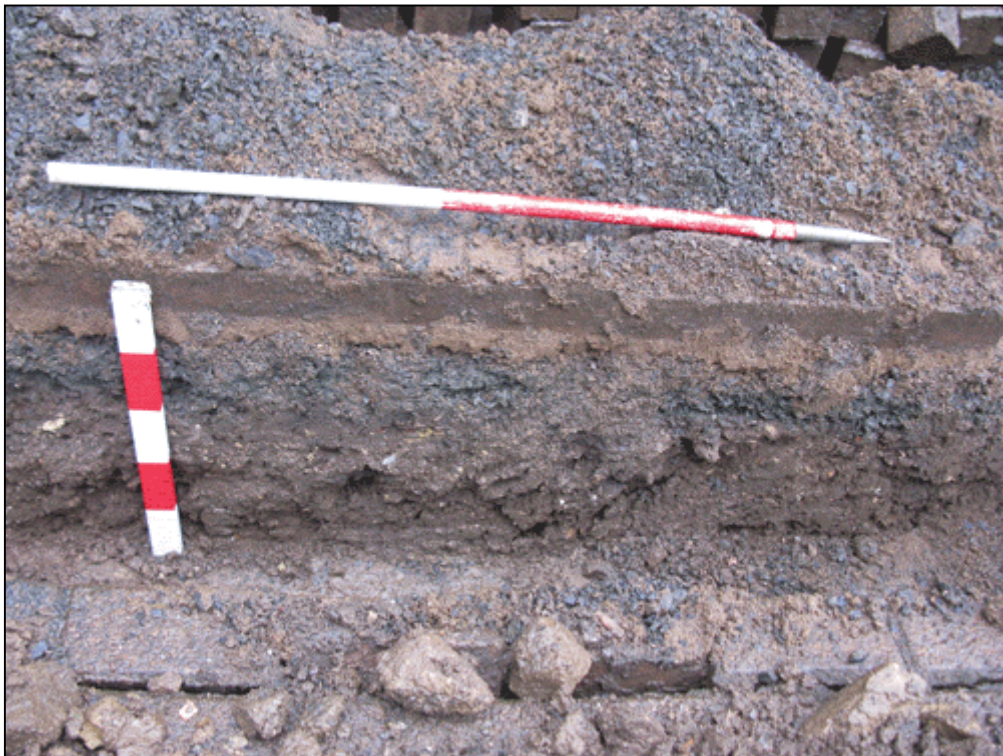
Figure 4b: South facing section of drainage trench through deposits (003)-(006)

15. The eastern half of the development area was covered by a layer of red monoblock paving (003) which was revealed to be 80mm deep. Underlying this were two bedding layers: a pale brown sand (004) which measured 40mm deep which overlay a pale grey gravel (005) which measured 100mm deep (see Figure 4b). Underlying these deposits was a compact mid brown clayey sand (006) which contained frequent small stone inclusions and some fragments of disarticulated human bone. It measured 300mm thick but ran deeper than what was excavated. This could possibly represent redeposited natural resulting as backfill from an earlier period of disturbance.
