**Flatt Farm, Largs, Ayrshire:  
Archaeological Monitoring**

Data Structure Report

by Alan Matthews

issued 5<sup>th</sup> October 2010

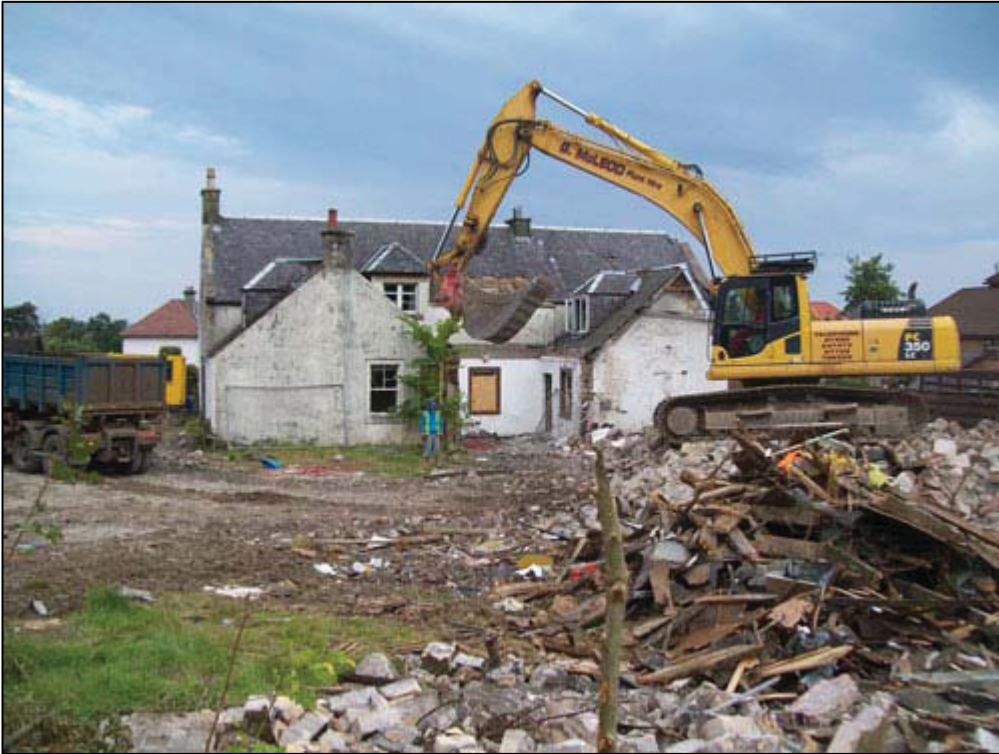
Figure 2a: Prior to demolition of main house

8. The programme of works comprised the archaeological monitoring of the removal of any surviving paved surface or floor slab and all groundbreaking works undertaken within the development area and during the demolition phase of the project. Prior to the commencement of archaeological monitoring most of the upstanding remains on the site had already been removed and only the main house remained (Figure 2a).

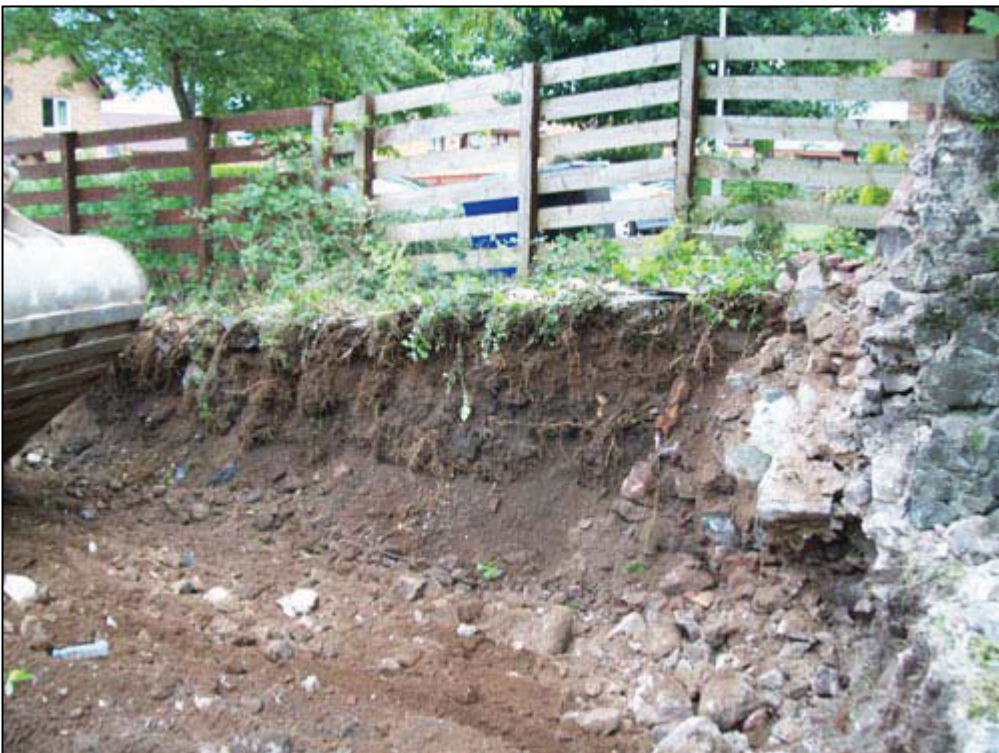
Figure 2b: Section in NE corner

15. In addition to the ground reduction in the north-eastern corner on 6<sup>th</sup> of September 2010 the retaining wall along the northern boundary of the same area was partially removed (Figure 2b). Although, at this time, the removal of the floor slab was through made ground (002) and did not reach subsoil over the entire area it was possible to see the potential depth of disturbance by the removal of this wall. At the eastern end of the removed retaining wall the depth of disturbance was more than 1.1m into the natural slope. Examination of this section showed only a progressive build up of topsoil (001) and hill-wash with no occupation layers.

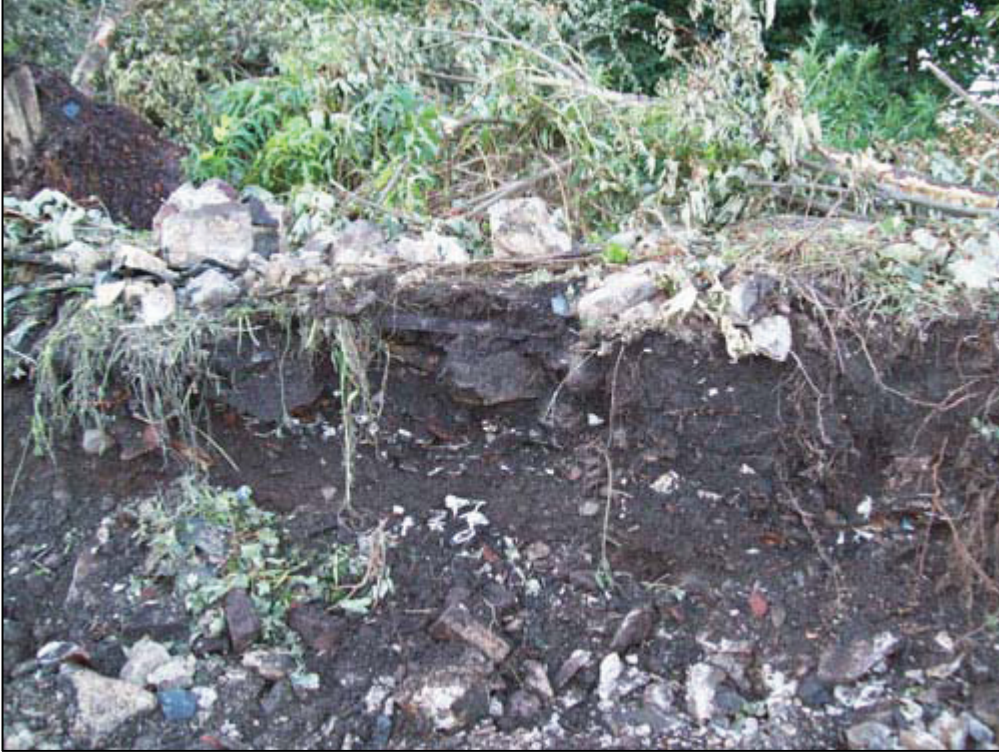
18. All potentially significant archaeological features were investigated according to the terms of the Written Scheme of Investigation (Rees 2010). Dumps of pottery and glass were uncovered on the southern boundary of the excavated area (003) (Figure 4a). All of this material could be identified as of late 19<sup>th</sup> or 20<sup>th</sup> century origin and as levelling material for flooring the large open barn in the south-eastern corner of the site. This is indicative of the fact that those sediments exposed in the western two thirds of the site were made ground and levelling deposits containing late 19<sup>th</sup> or 20<sup>th</sup> century material.

Figure 4a: Dumped ceramic in section (003)

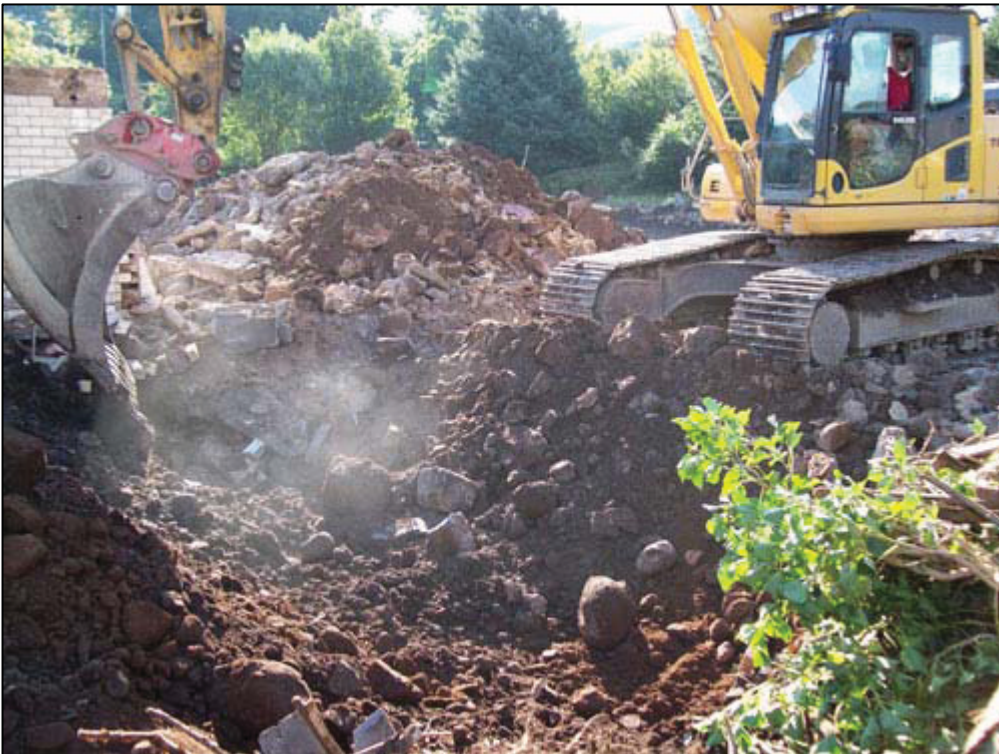
Figure 4b: Foundation removal in NW corner

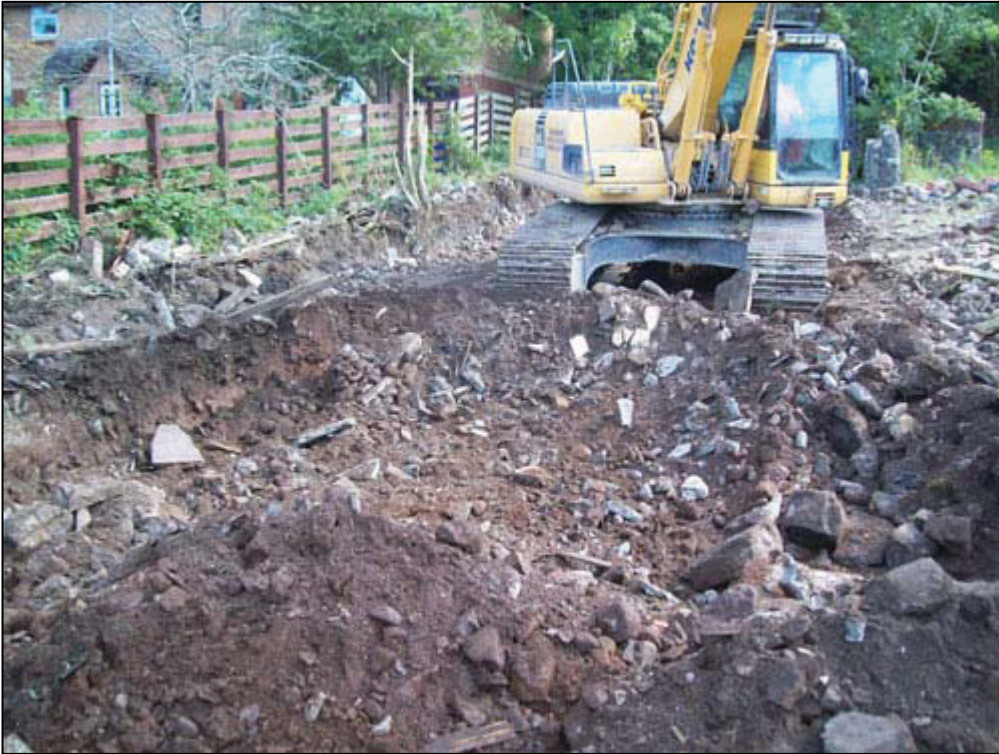
16. Archaeological monitoring resumed on the 8<sup>th</sup> of September 2010 covering the demolition and removal of the main farmhouse and remaining stone partitions off of the eastern boundary wall (Figure 5b). This was the final upstanding remains on the site. Subsequent to this ground reduction work included the removal of floor slabs and grubbing out of foundations for the main farmhouse along with all adjoining buildings to the east. The ground reduction involved excavation to a depth of between 1 and 1.5m covering the footprint of all buildings (Figure 3) removed from the northern half of the development area (Figure 5a).

Figure 5a: Ground reduction on N boundary

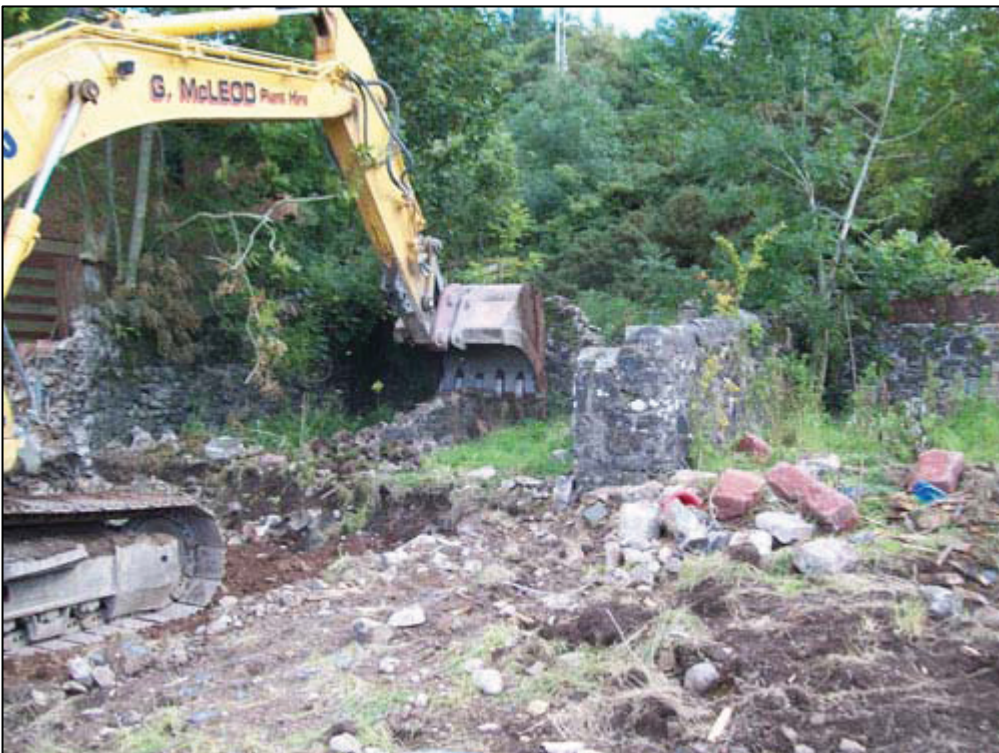
Figure 5b: Removing wall in NE corner

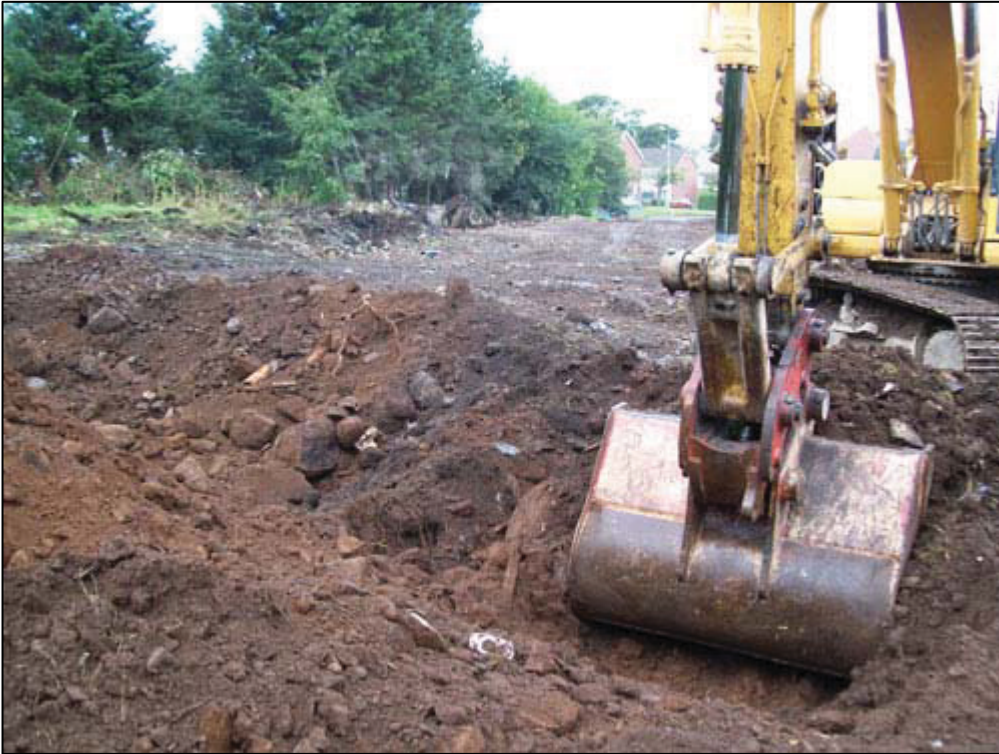
22. The entire footprint of the farm buildings was reduced to archaeologically sterile subsoil or more commonly bedrock (Figure 6a). Within the area of excavation for the demolition works, therefore, the potential for survival of significant archaeological deposits has been thoroughly investigated (Figure 6b). The remaining portions of the development area include two narrow boundary areas to the north and south, the area occupied by the driveway to the west and the edge of the steep grazing land to the east. Given the established sequence of sediments from the excavated area there is no reasonable chance of significant archaeological features surviving in the remaining portions of the development area.

Figure 6a: Ground reduction in E half

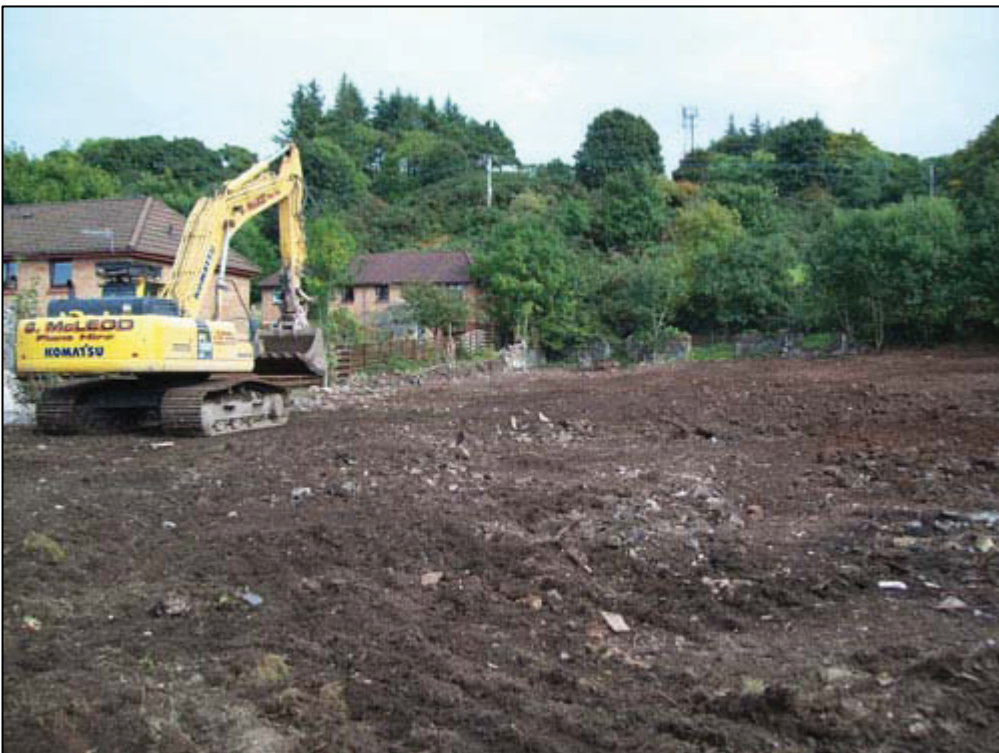
Figure 6b: Site after demolition work
