**Balmichael WTW, Arran
Archaeological Mitigation**

Data Structure Report

issued 16th July 2012

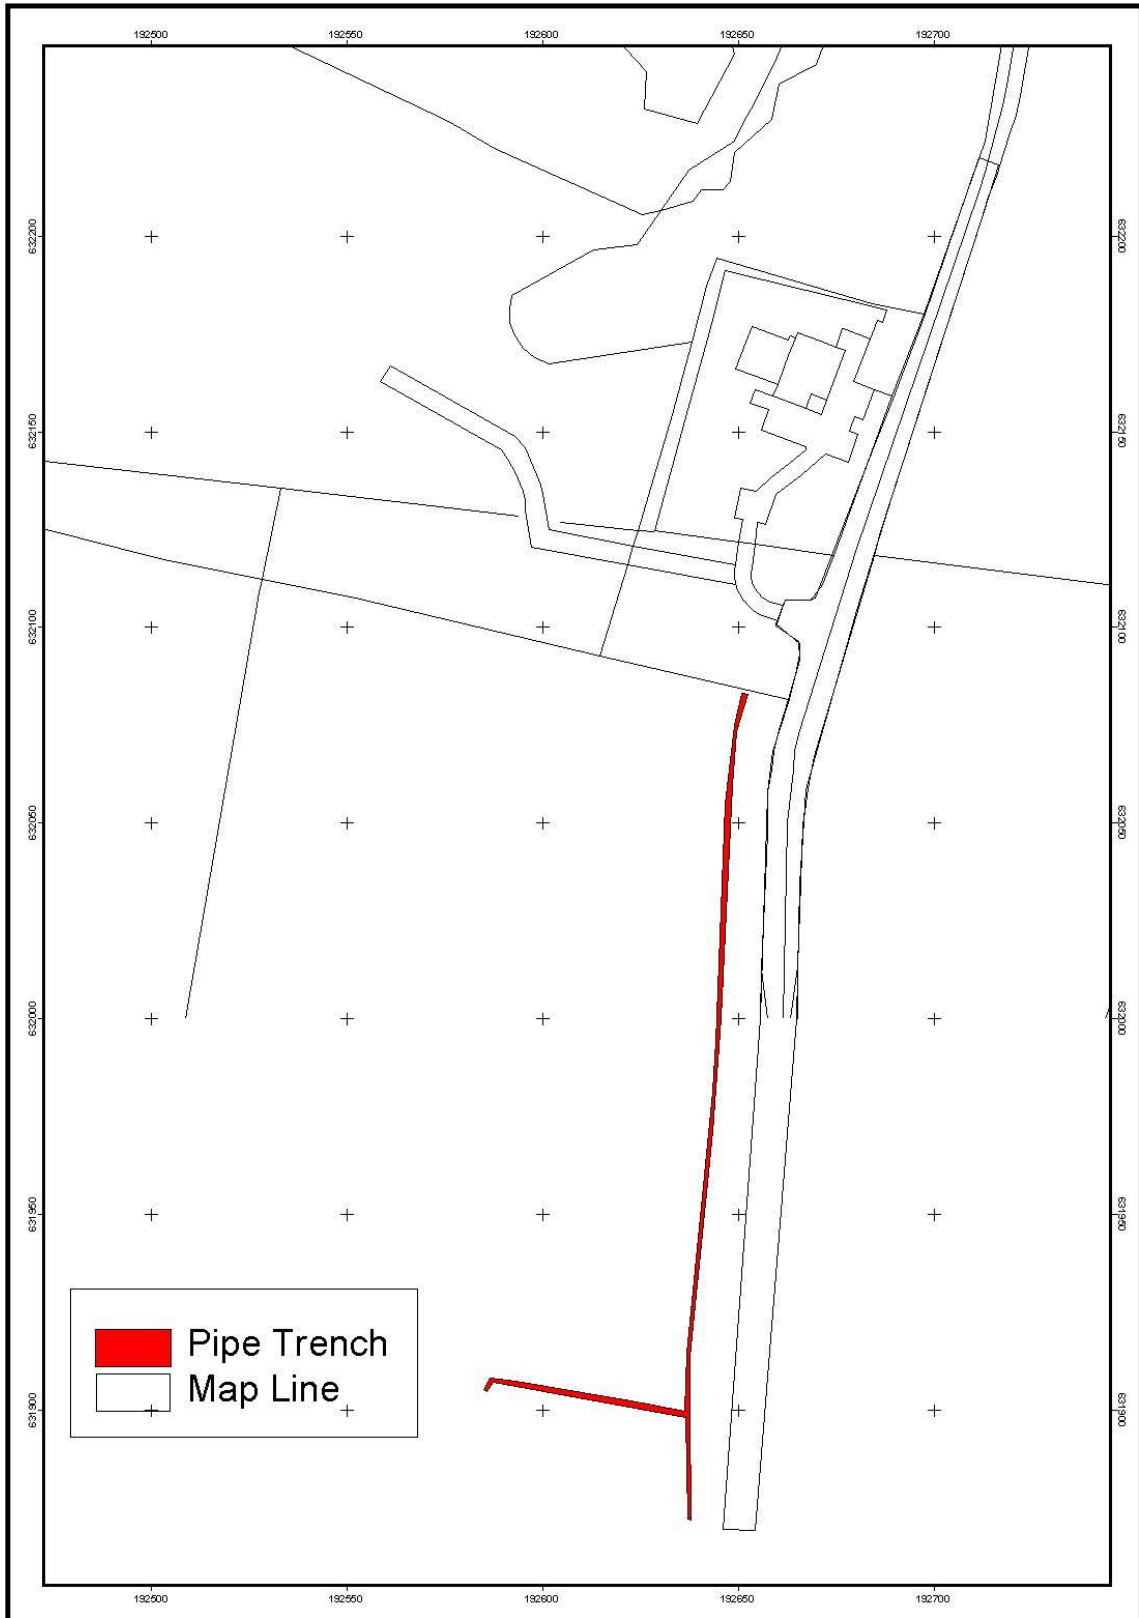
30. The outfall pipe was situated in the field to the immediate south of the existing WTW. The line of the pipe trench measured 208m in length and was aligned north to south running to the Ballymichael Burn. At +181.6m from the north end a spur extended westward for 50m.

Figure 1: Line of Pipe Trench Monitored

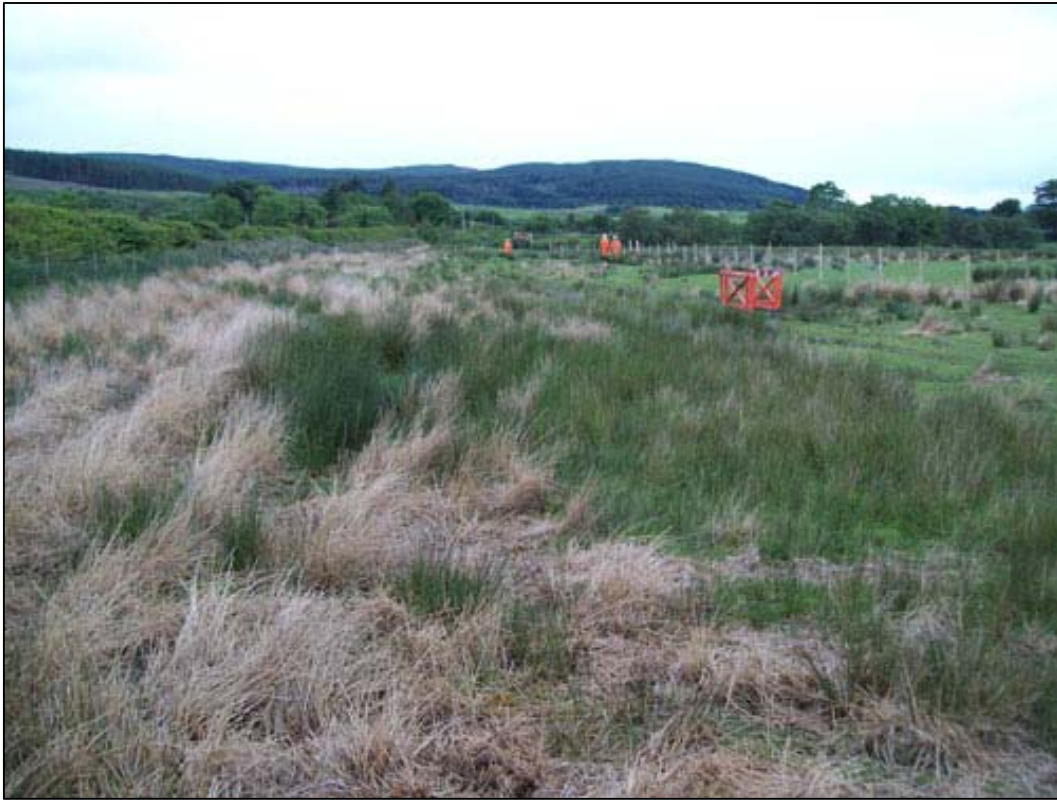
Figure 2a: General Shot of Study Area from the North

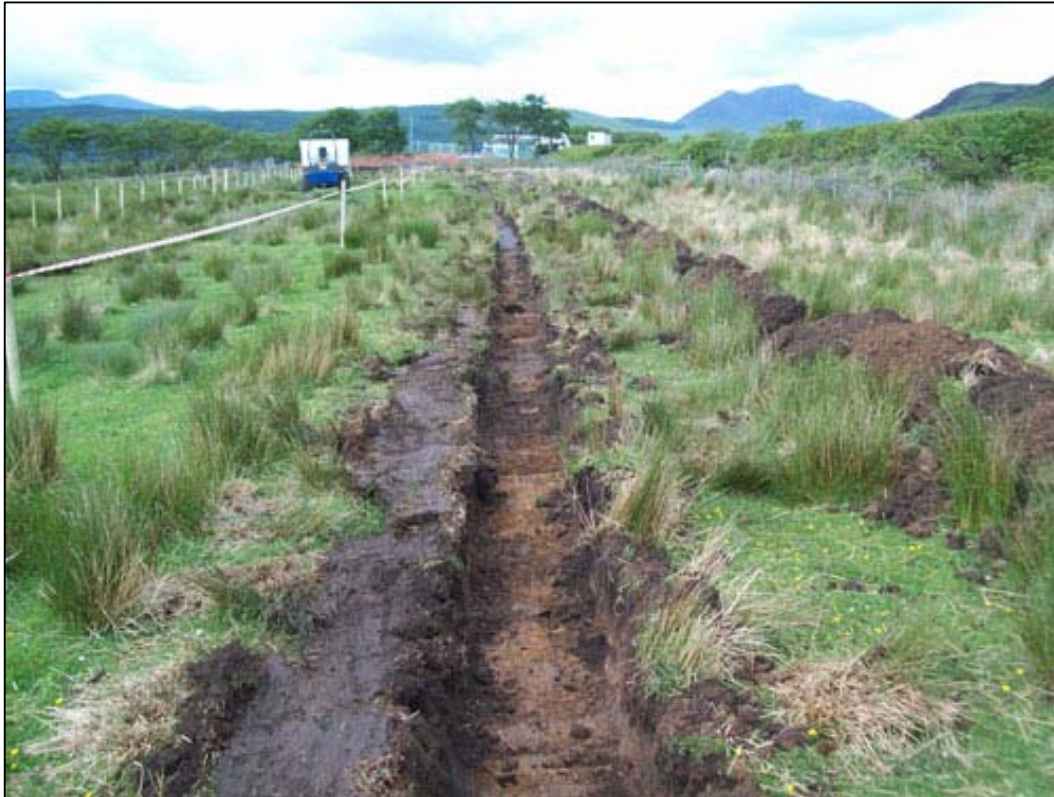
31. The pipe trench was 700mm wide and was stripped to between 300mm and 400mm deep. Within the trench the strata revealed was a saturated black brown clay peat (001) with occasional large stone inclusions over laying mid brown sand (002). (001) was present within the trench from the north end at +0m to +87.7m within the trench, after this point the topsoil (006) is a mid brown sandy humic soil with occasional sub rounded and sub angular small to medium sized stones.

Figure 2b: Pipe Trench from South

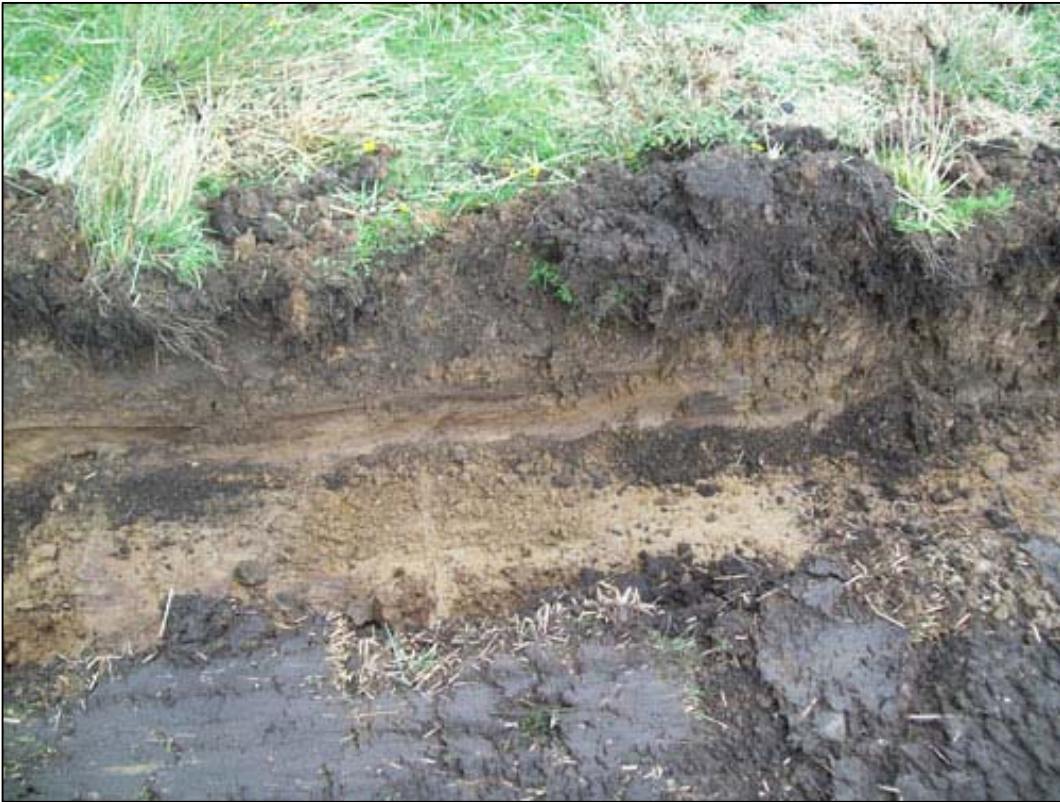
Figure 3a: Trench Section from the West

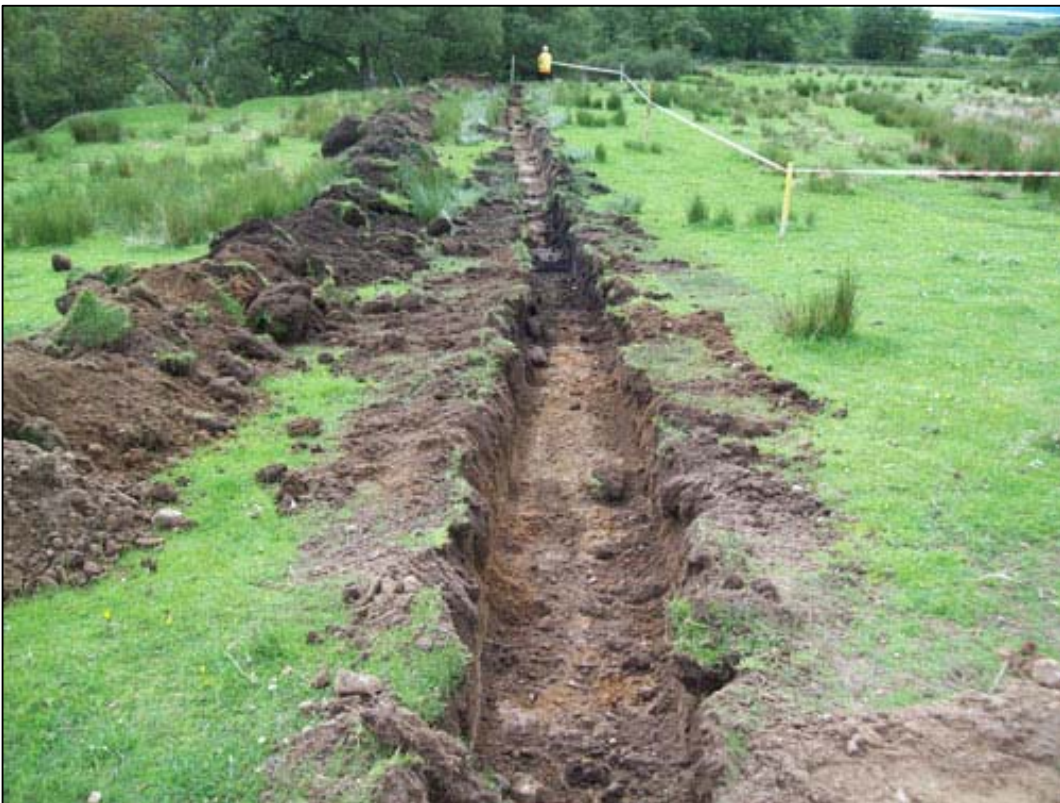
33. The pipe trench spur had the same stratigraphy as the southern portion of the main pipe trench (006) over (002), with the exception of a dark black brown peat deposit at the eastern end of the spur.

Figure 3b: Pipe Trench Spur from the East
